Your Inspection Report

Any street
Calgary, AB

INSPECTION DATE:
Wednesday, September 25, 2019

Report No. 1112, v.3

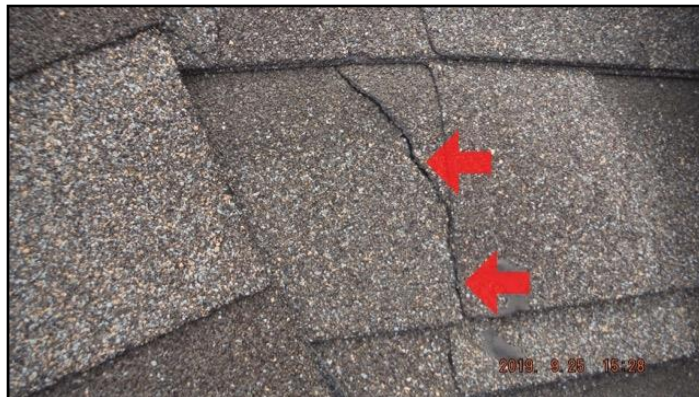
1. Condition: • Cracks

Location: Roof/Above bay window/Front

Cracks

Task: Have a licensed roofer repair

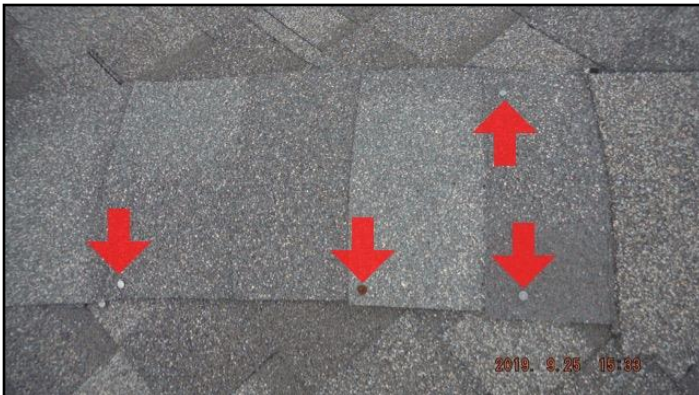
2. Condition: • Exposed fasteners

Exposed fasteners

Task: Have a licensed roofer repair

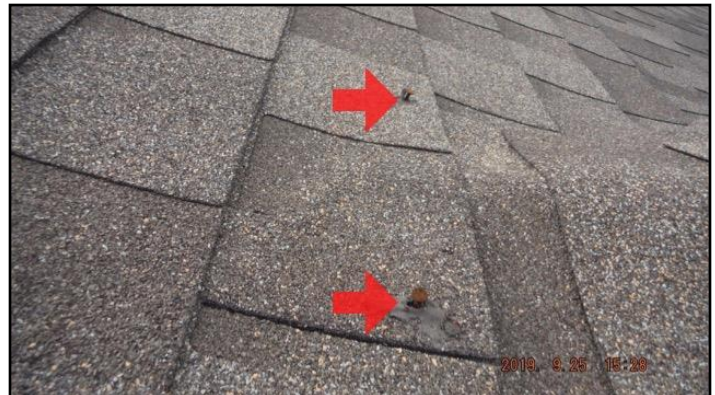
Exposed fasteners

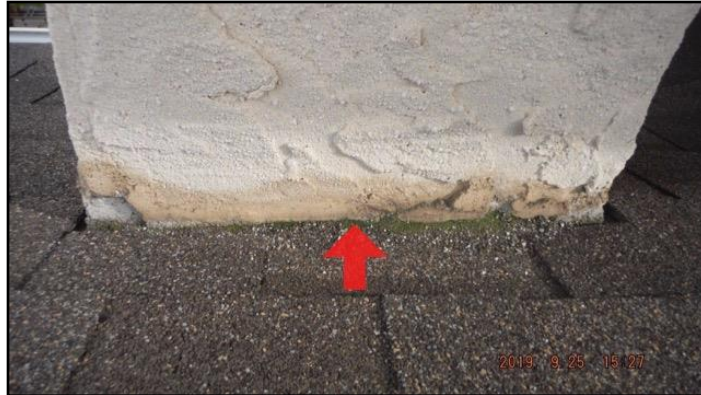
3. Condition: • Pan missing, inappropriate

Location: Column above front entry

Pan missing, inappropriate

Task: Have a licensed stucco installer correct

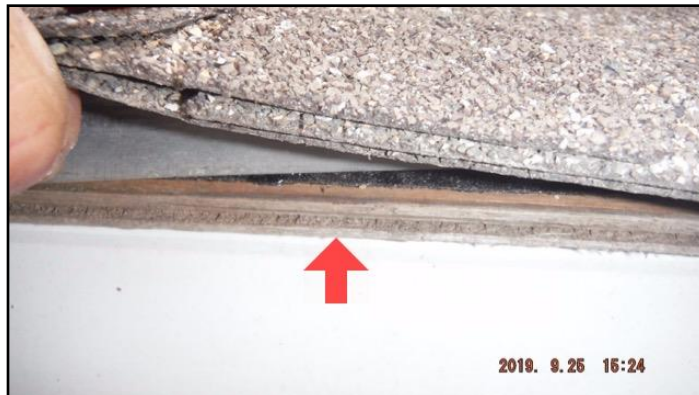
4. Condition: • No drip edge

Although drip edge is not required, I recommend having it installed to prevent early deterioration of roof sheathing

No drip edge

Task: Have a licensed roofer install

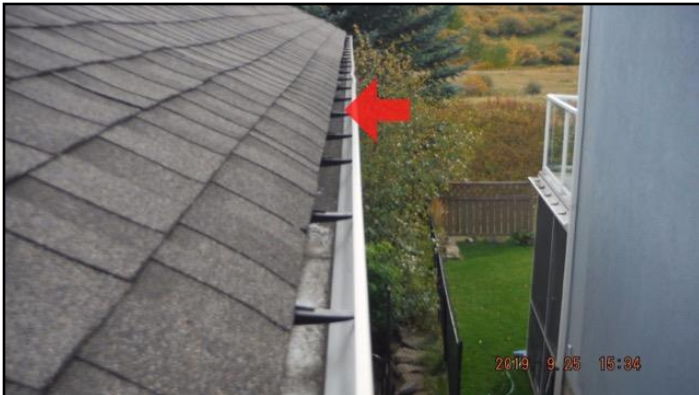
5. Condition: • Dirty/debris

Dirty/debris

Task: Have a licensed gutter company clean

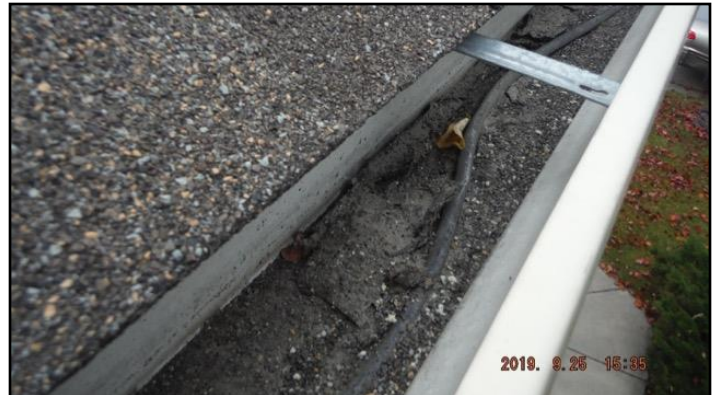
Dirty/debris

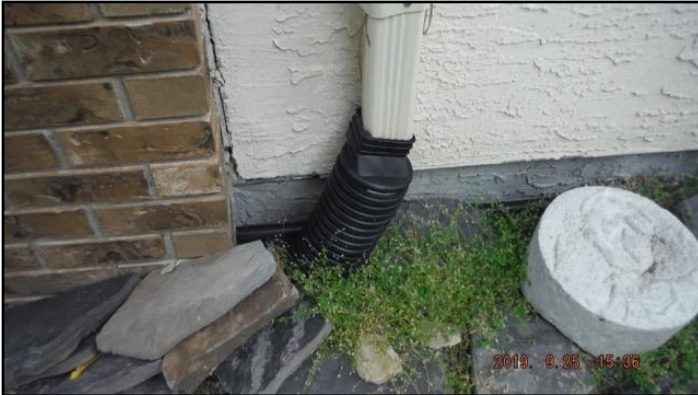
6. Condition: • Discharge below grade

Discharge below grade

Task: Have a licensed gutter installer correct

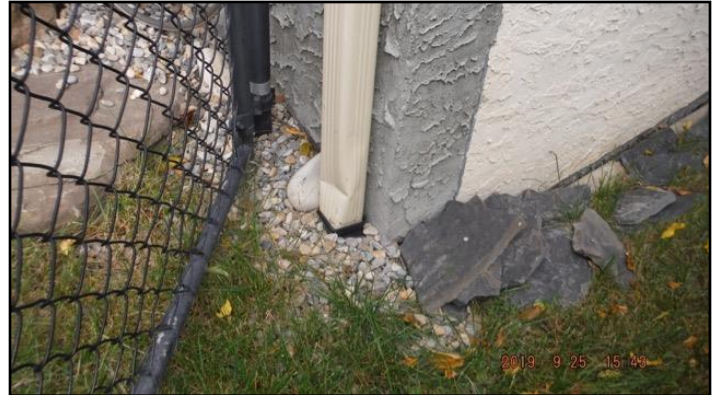
Discharge below grade

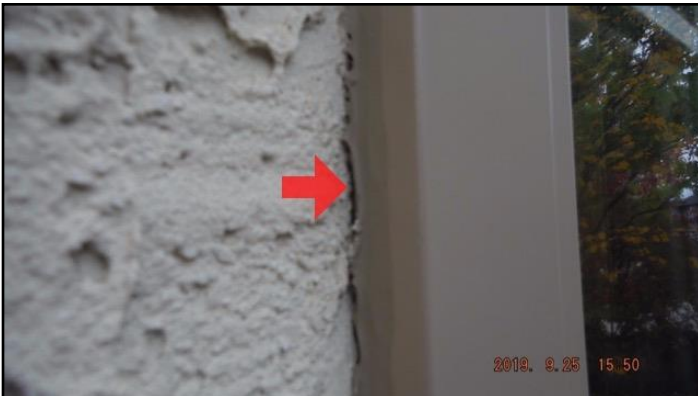
7. Condition: • Caulking missing or ineffective

Caulking missing or ineffective

Task: Remove old caulking/spray foam, and apply new caulking

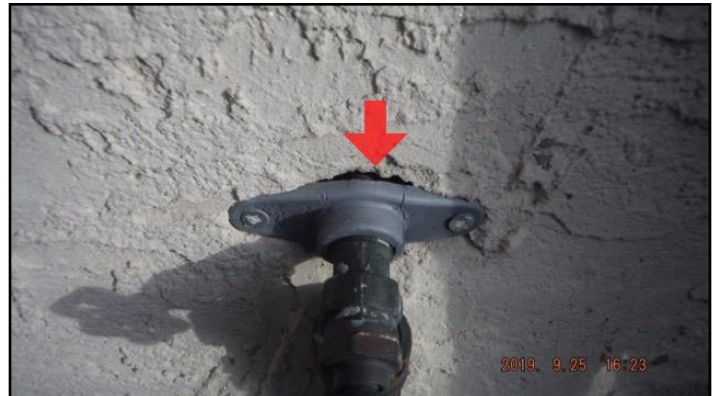
Caulking missing or ineffective

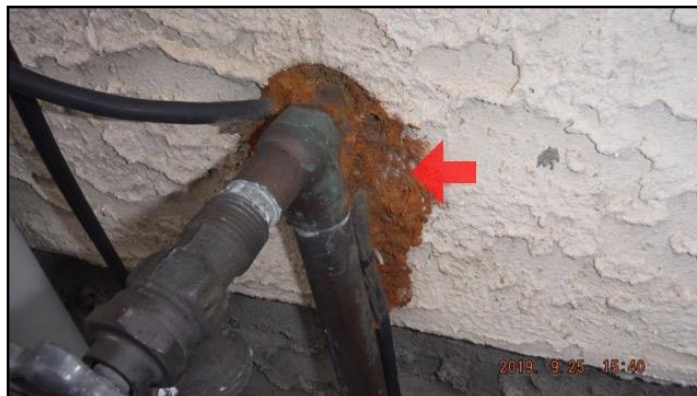
Inappropriate material

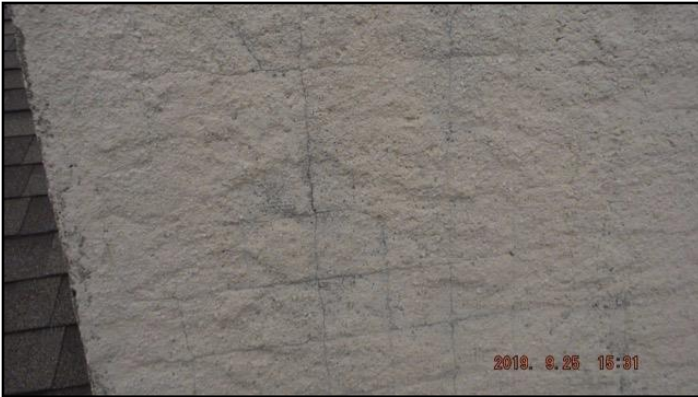
8. Condition: • Crumbling

Location: Various areas exterior walls/chimneys

Crumbling

Task: Have a licensed stucco installer repair

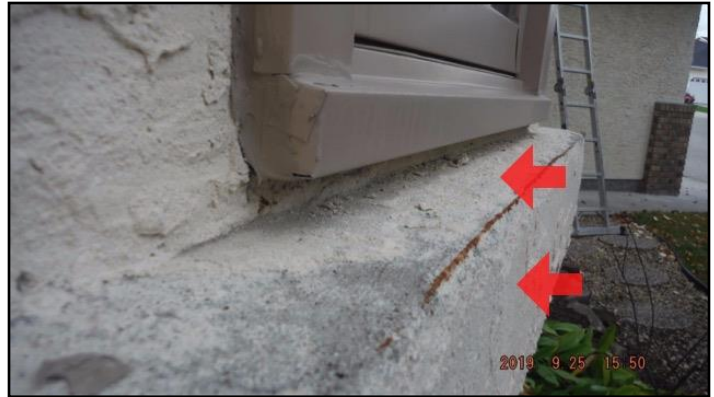
Crumbling

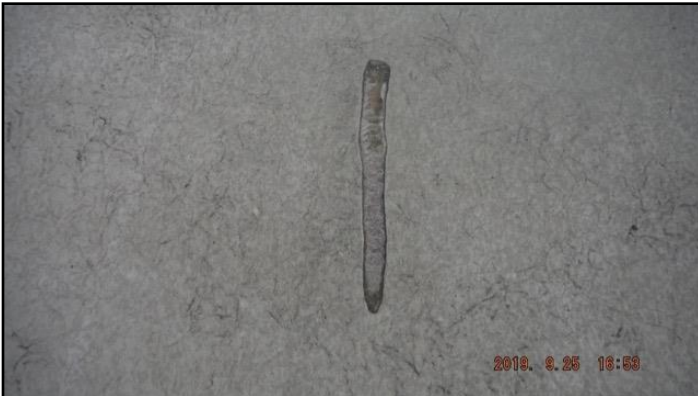
9. Condition: • Damaged membrane/Soft and or spongy areas noted by walking on deck

Damaged membrane

Task: Have a licensed contractor remove membrane to evaluate damage to structure and repair accordingly/Patching membrane would be a temporary repair

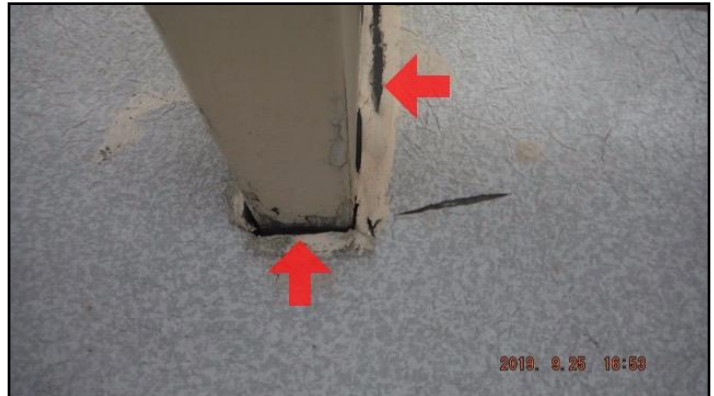
Caulking ineffective

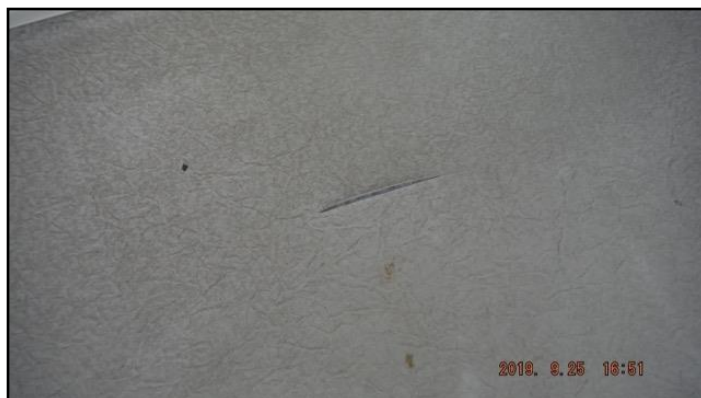
Damaged membrane

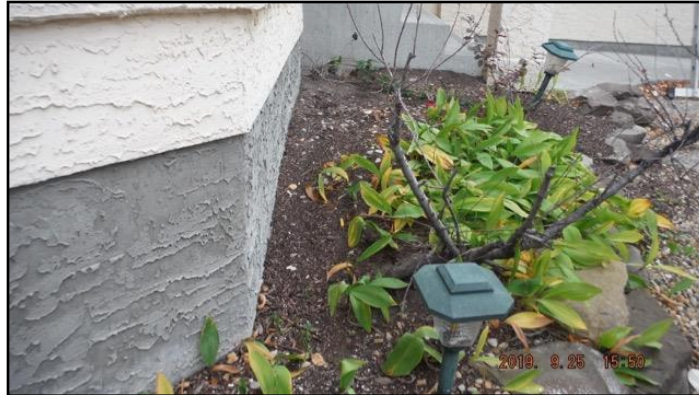
10. Condition: • Planters and gardens against walls

Planters and gardens against walls

Task: Remove planters or use plants that don't require water

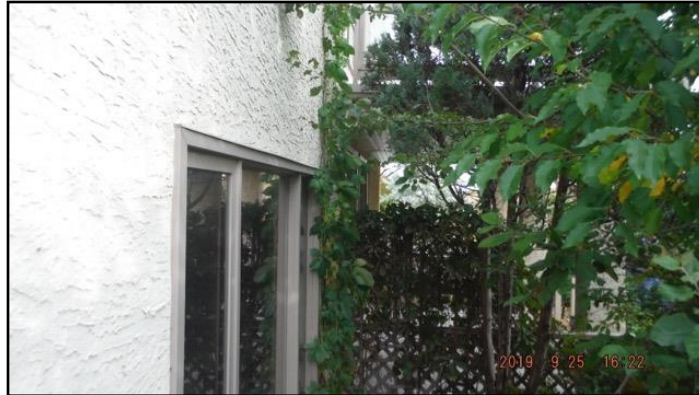
11. Condition: • Trees or shrubs too close to building

Trees or shrubs too close to building

Task: Prune shrubs and trees

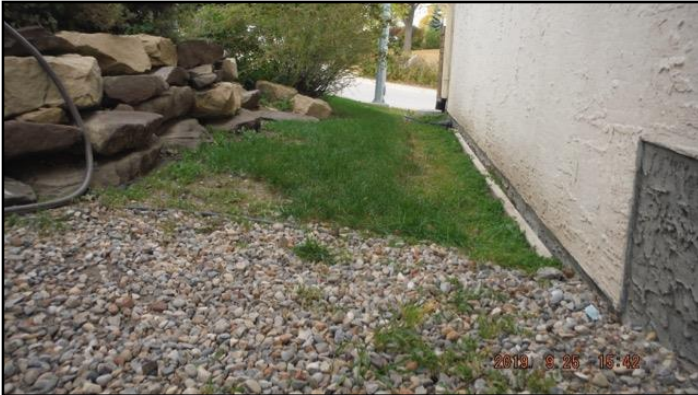
12. Condition: • Improper slope or drainage

Improper slope or drainage

Task: Have a landscaper create a swale/Valley

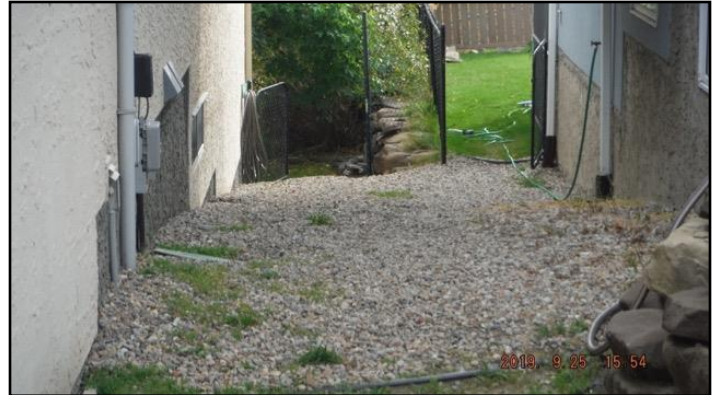
Improper slope or drainage

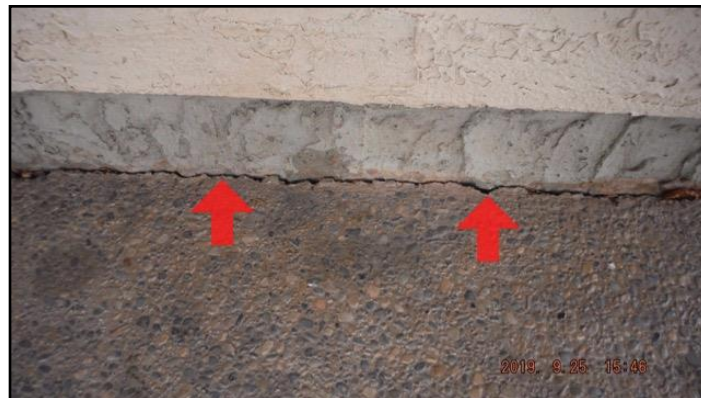
13. Condition: • Unsealed gap at building

Unsealed gap at building

Task: Apply elastomeric caulking to seal gap

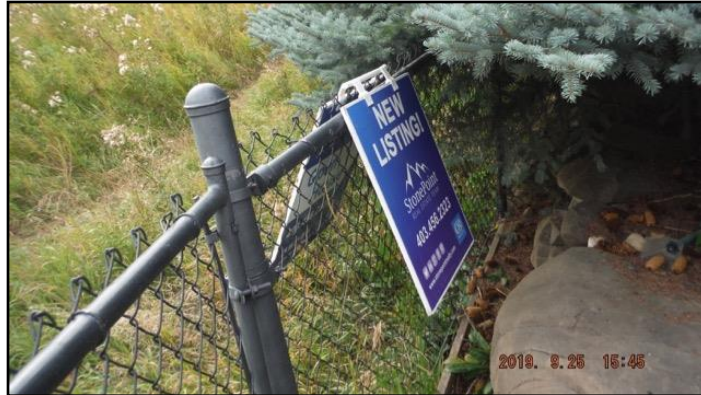
14. Condition: • Leaning

Leaning

Task: Have a licensed landscaper improve stone retaining wall and repair fence

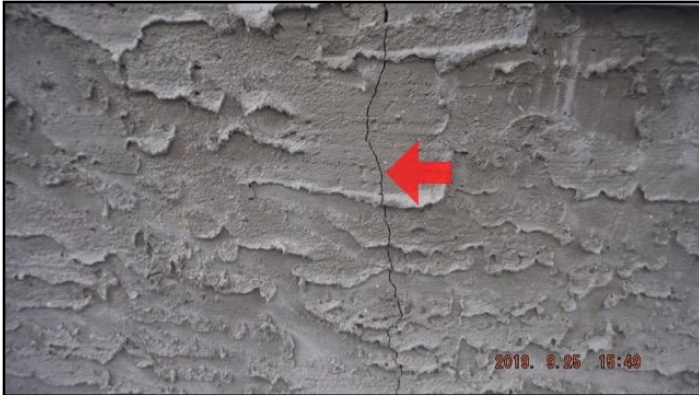
15. Condition: • Typical minor cracks

Typical minor cracks

Task: Monitor/Have a licensed contractor repair if necessary

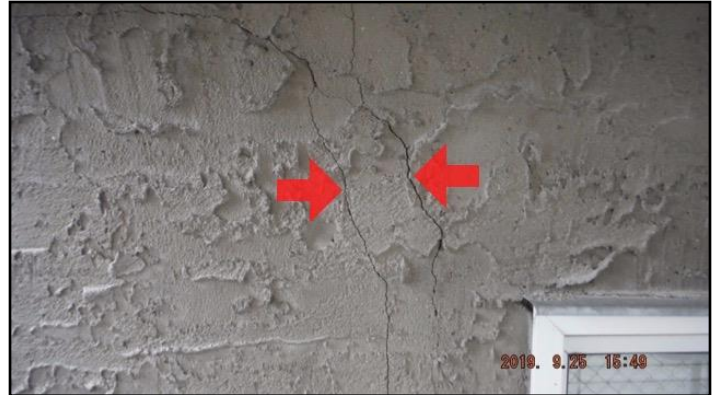
Typical minor cracks

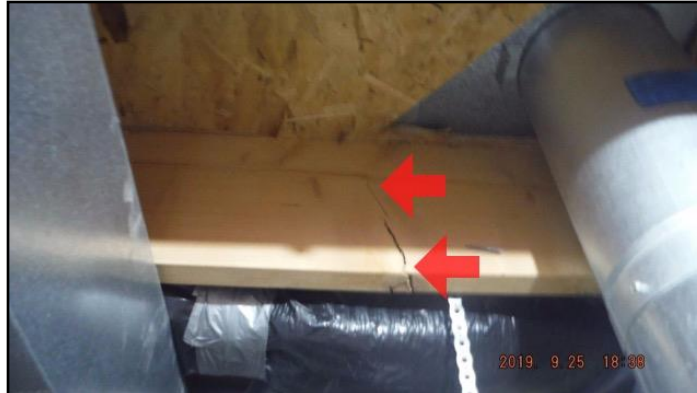
16. Condition: • Split or damaged

Split or damaged

Task: Have a licensed contractor repair

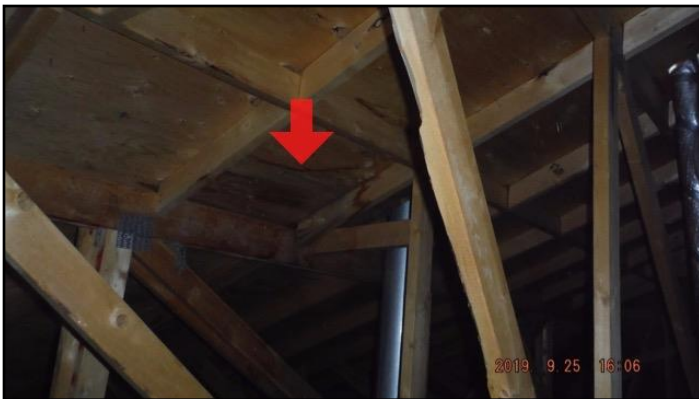
17. Condition: • Water stains

This condition may have been corrected with installation of newer shingles/Possibly an active leak caused by deteriorated stucco (mentioned in exterior section) on chimney chases.

Water stains

Task: Have a licensed stucco installer repair chimney/Monitor

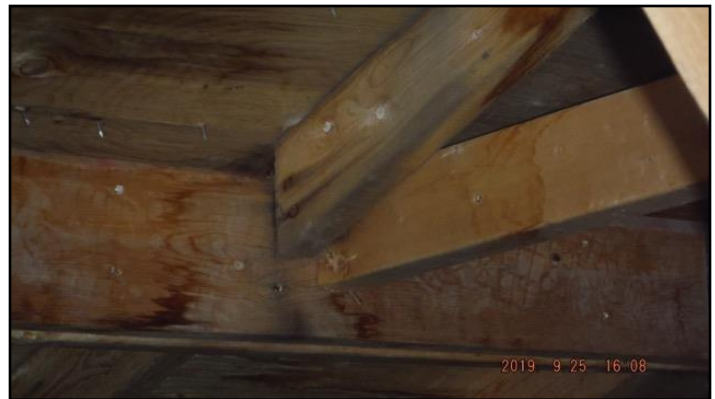
Water stains

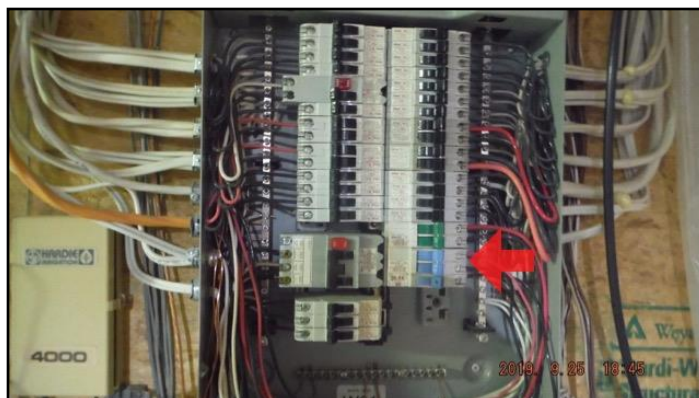
18. Condition: • Recalled breakers (Federal Pacific Stab-loc)

Implication(s): Failure to trip if overloaded/Fire hazard

Recalled breakers (Federal Pacific Stab-loc)

Task: Have a licensed electrician replace

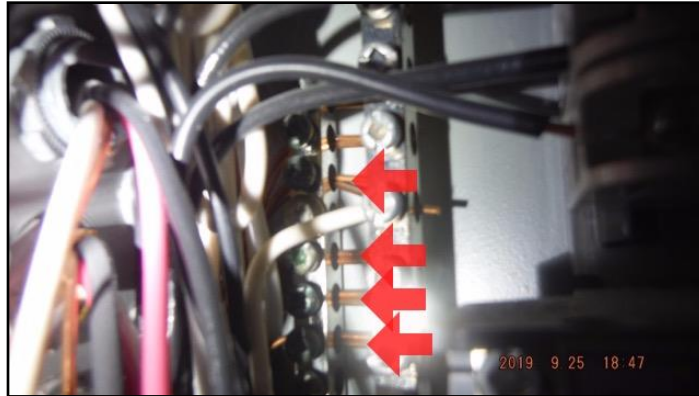
19. Condition: • Double taps

Double neutrals under single lug

Task: Have a licensed electrician correct

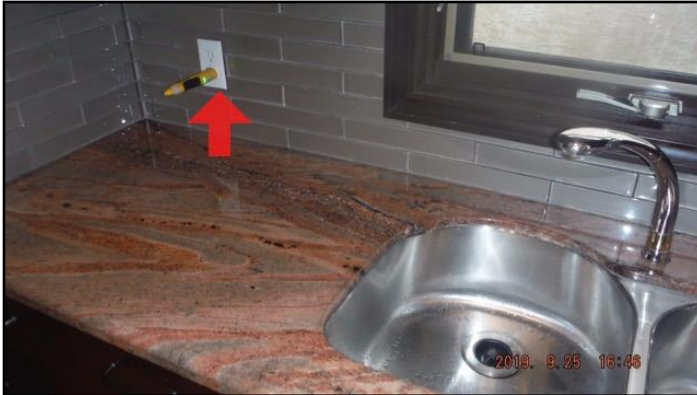
20. Condition: • No GFCI/GFI (Ground Fault Circuit Interrupter)

No GFCI

Task: Have a licensed electrician improve

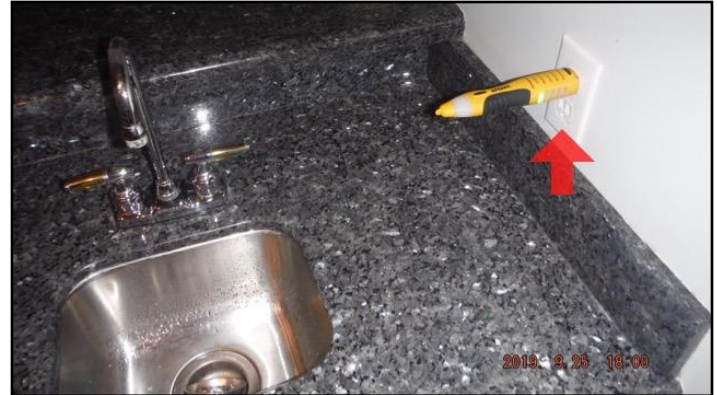
No GFCI

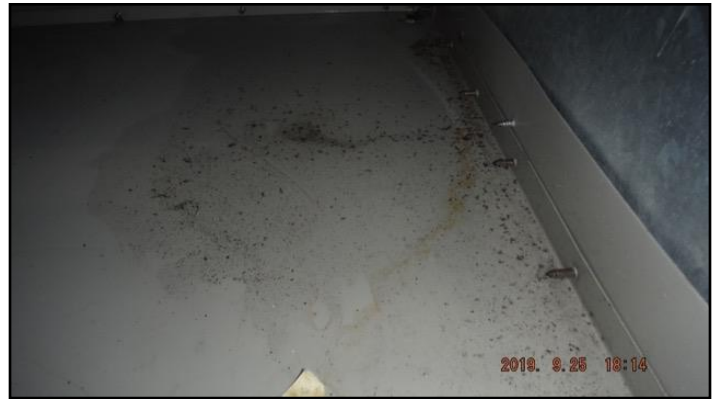
Due to dirty ducts, blower compartment, fan, and humidifier I believe this furnace has not been properly maintained.

Dirty blower compartment

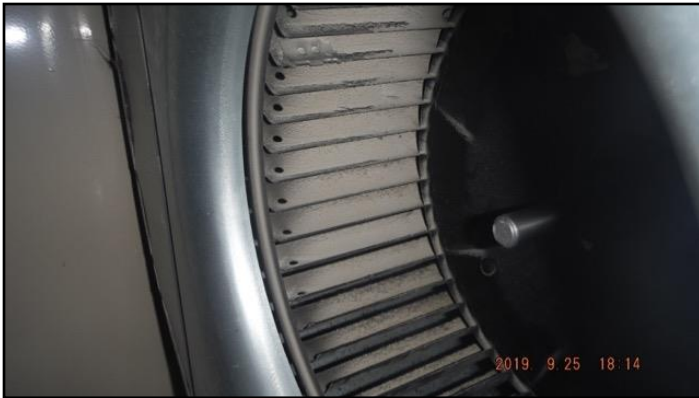
Dirty fan

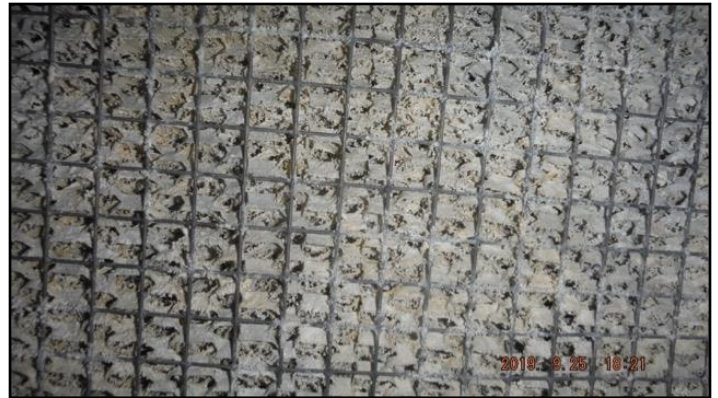
Clogged humidifier

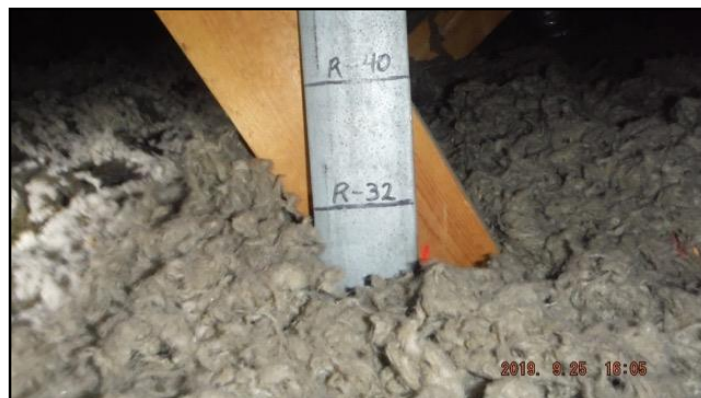
23. Condition: • Amount less than current standards

Approx. R-28

Task: Have a licensed insulation company add insulation

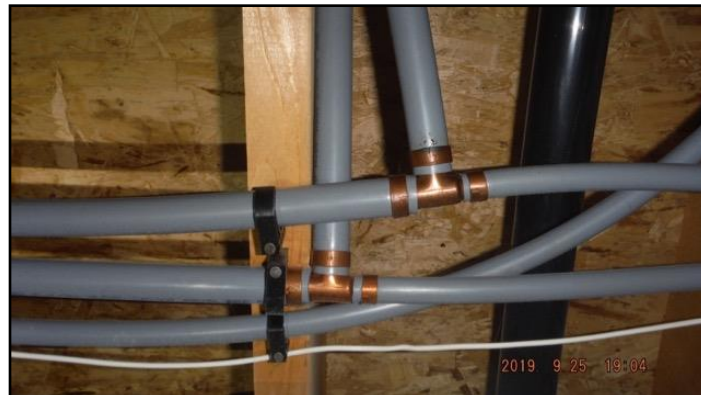
24. Condition: • Polybutylene

Polybutylene

Task: Monitor/Have a licensed plumber replace if necessary

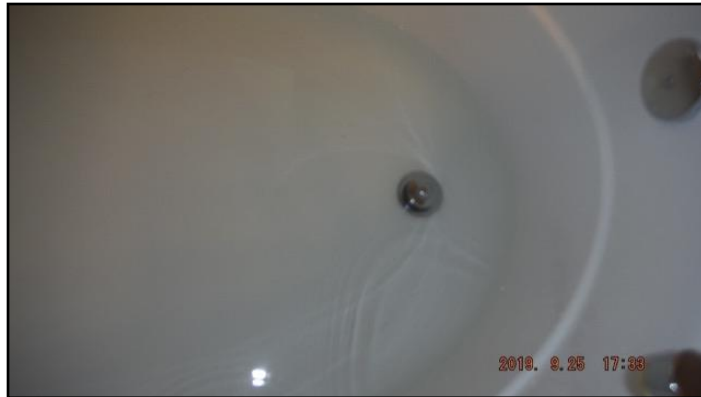
25. Condition: • Slow drains.

Slow drains

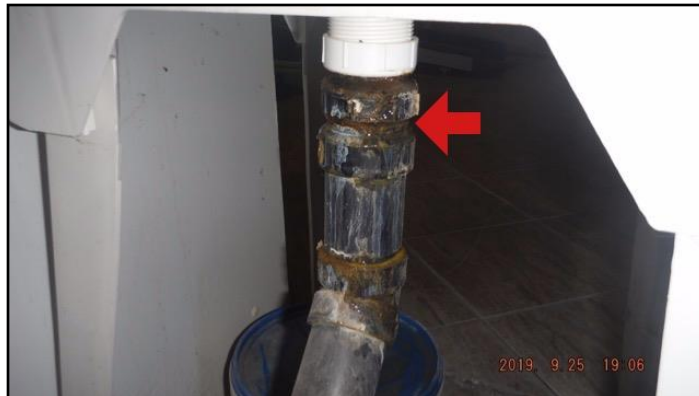
26. Condition: • Leak

Leak

Task: Have a licensed plumber repair

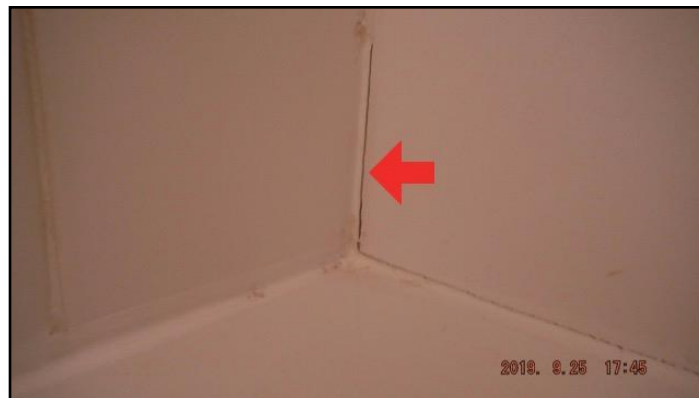
27. Condition: • Caulking loose, missing or deteriorated

Caulking loose, missing or deteriorated

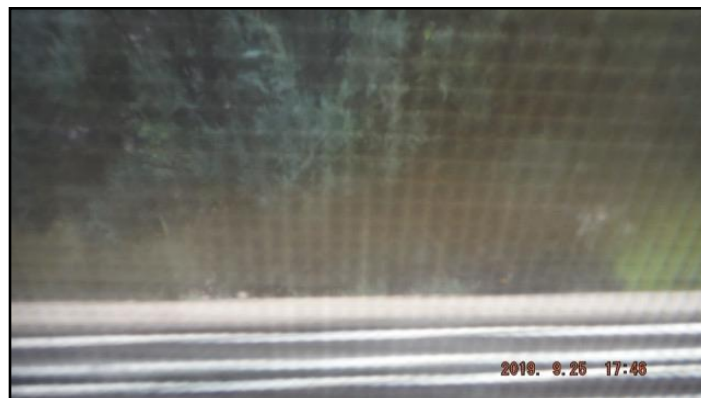
28. Condition: • Lost seal on double or triple glazing

Lost seal on double or triple glazing

Task: Monitor/Repair or replace if necessary

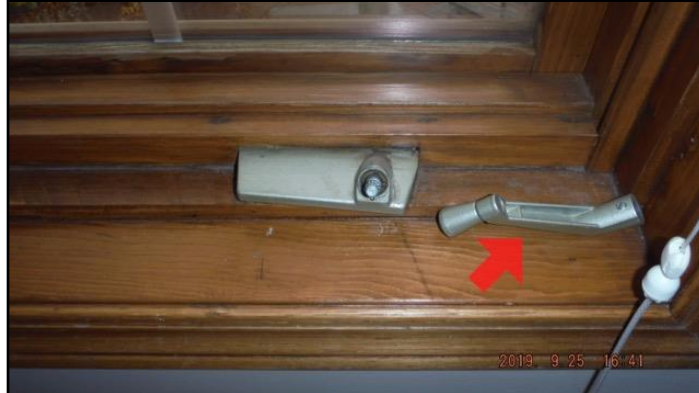
29. Condition: • Loose**Implication(s):** Equipment failure**Location:** Front Room**Task:** Reattach handle and tighten set screw

Loose

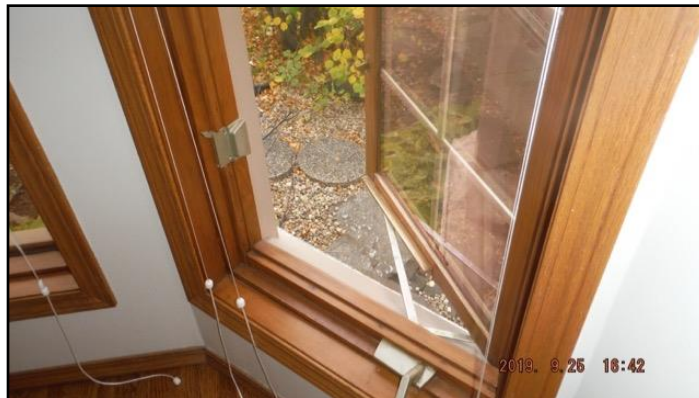
30. Condition: • Missing**Implication(s):** Chance of pests entering building | Increased heating costs | Reduced comfort**Location:** Front Room**Task:** Replace

Missing

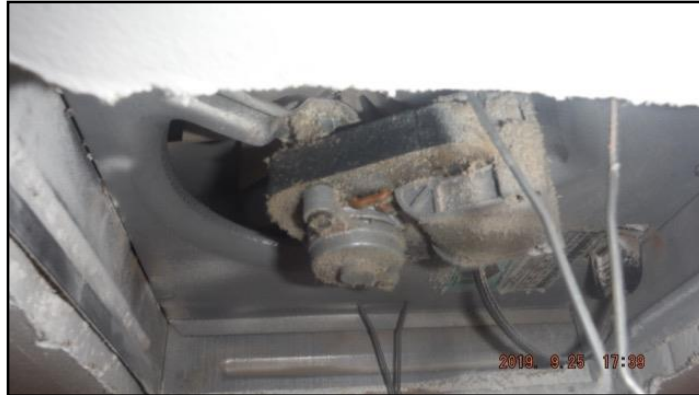
31. Condition: • Dirty**Implication(s):** Inadequate removal of humid air**Location:** Throughout Bathrooms**Task:** Clean with vacuum and damp cloth**Time:** Less than 1 year/Ongoing regular maintenance

Dirty

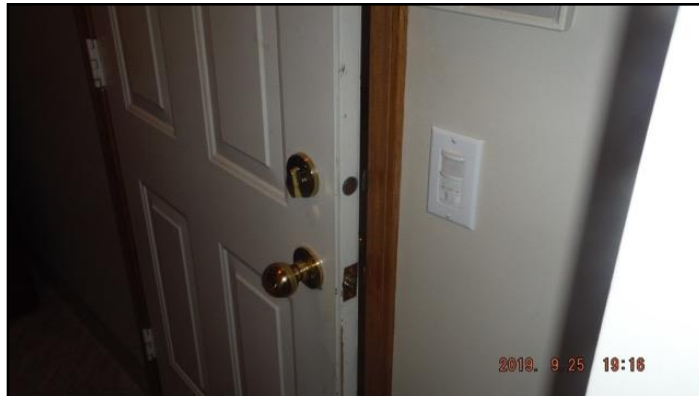
32. Condition: • Does not close door fully

Does not close door fully

Task: Have a licensed contractor adjust tension

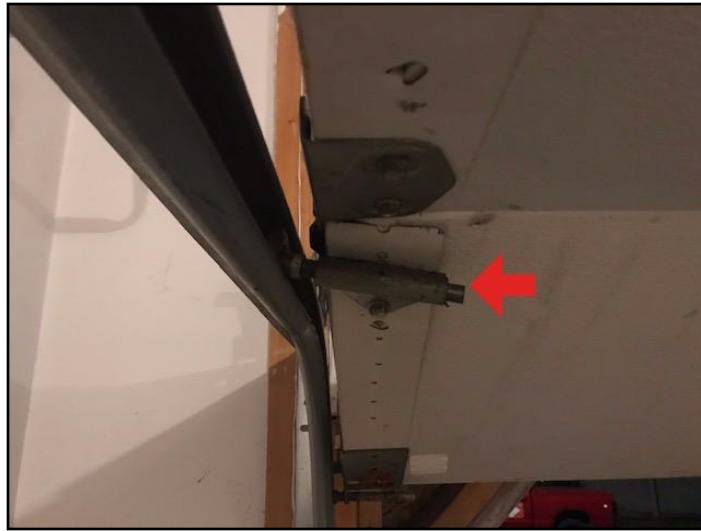
33. Condition: • Difficult to open or close

Mounting plate for roller is damaged.

Roller/Panel not attached properly

Task: Have a licensed overhead door company repair

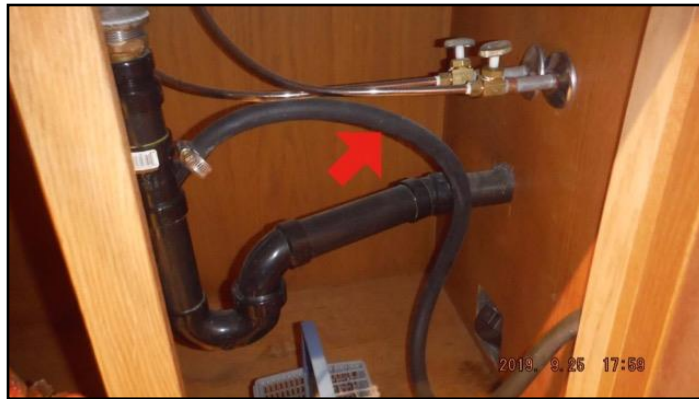
35. Condition: • Backflow prevention missing

Backflow prevention missing

Task: Attach drain line high under countertop

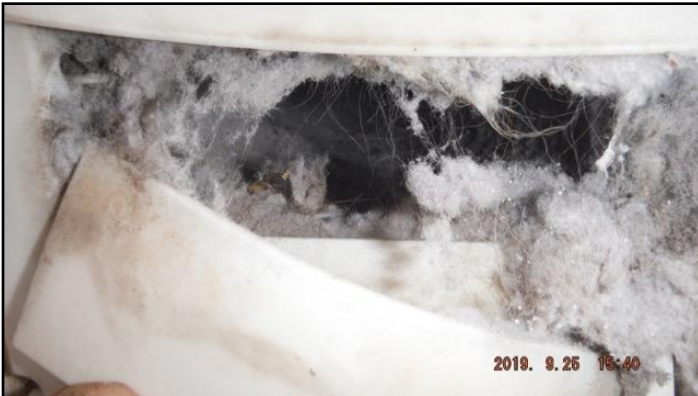
Clogged dryer vent

Task: Clean out vent duct/Reattach vent

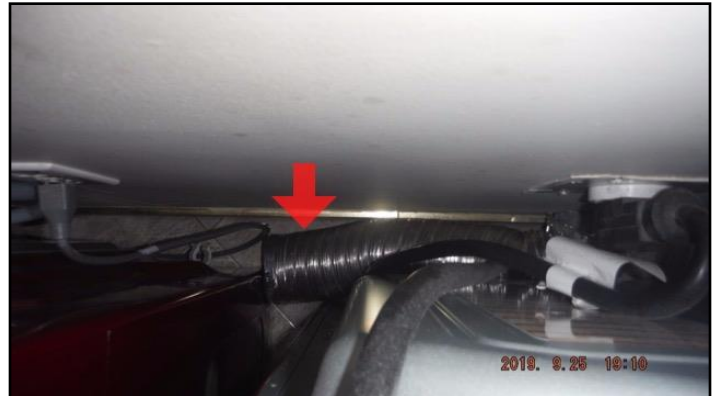
36. Condition: • Dryer vent disconnected

Dryer vent disconnected

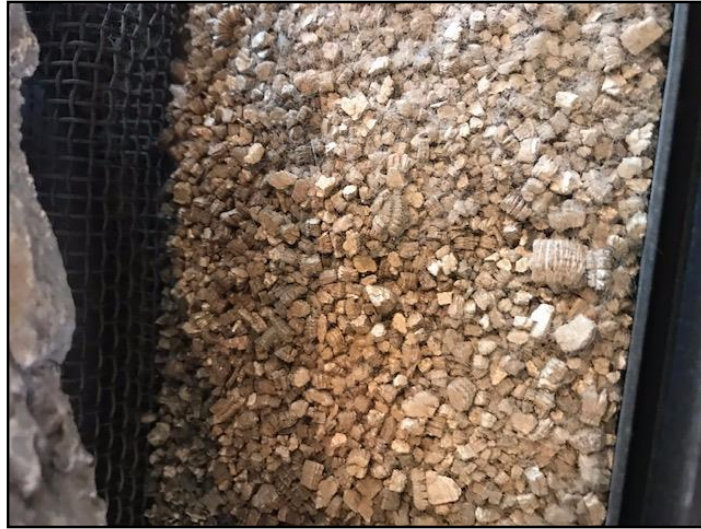
37. Condition: • Possible asbestos containing materials

Possible asbestos containing materials
