# YOUR INSPECTION REPORT

9 Fairview Avenue  
Toronto, ON M6P 3A2

INSPECTION DATE:  
Wednesday, April 7, 2021

RE: Report No. 2871  
9 Fairview Avenue  
Toronto, ON  
M6P 3A2

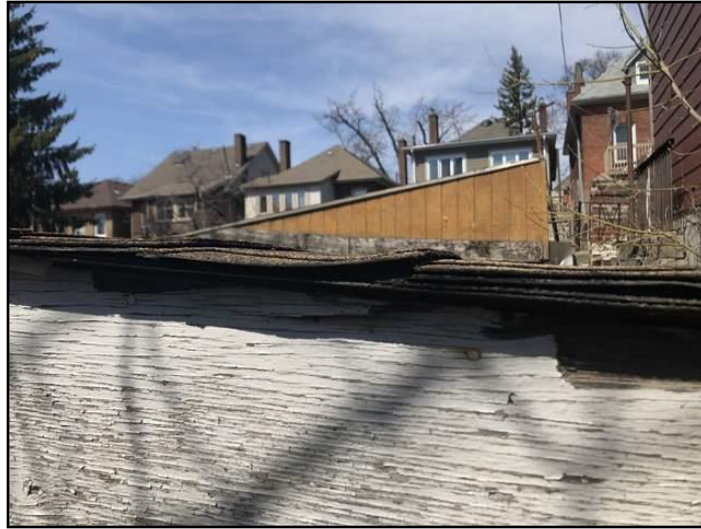
3. Multiple layers

**Condition:** • [Multiple layers](#)

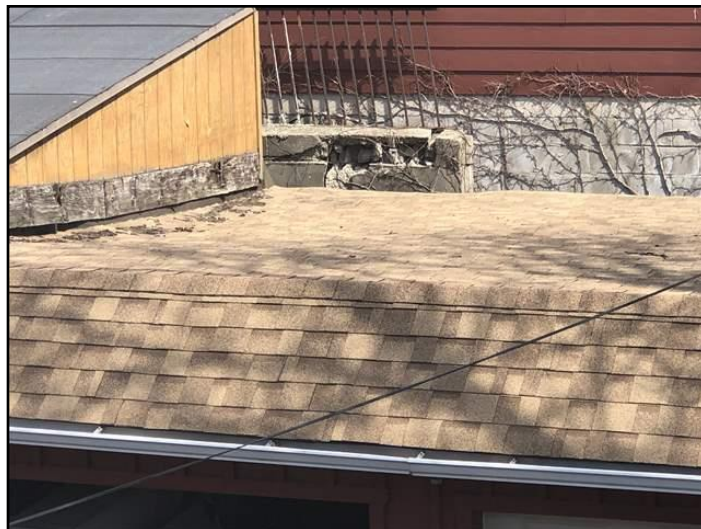
4. Debris/moss

**Condition:** • Debris/moss

**Task:** Clean

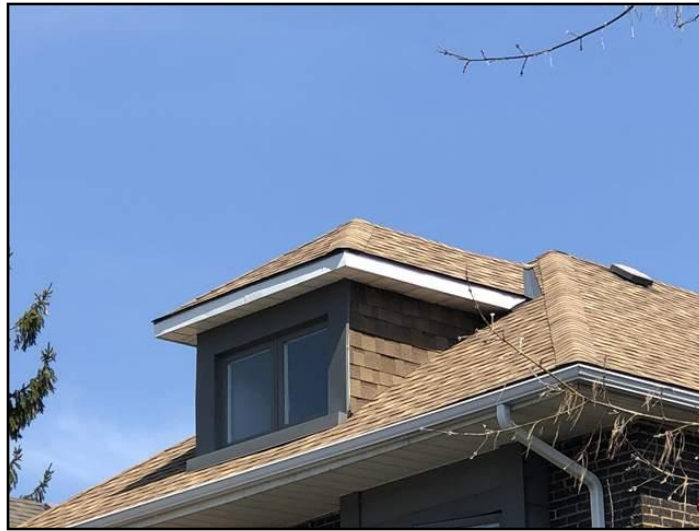
5. Missing

**Condition:** • [Missing](#)

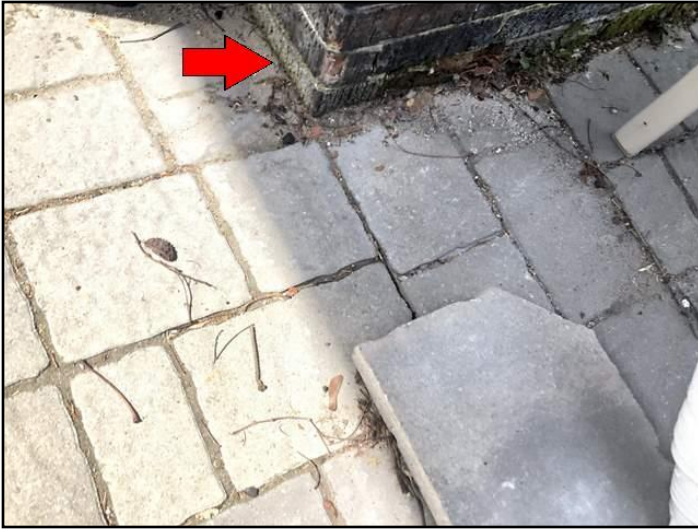
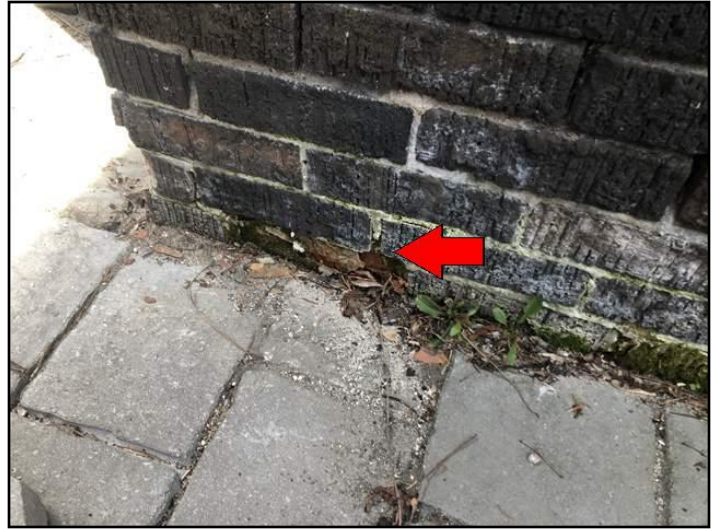
**Condition:** • [Spalling](#)

Spalling at various areas. Repair / Replace / Tuck point masonry and mortar. Most homes of this age will require routine masonry repairs. Photos show a sampling.

**Task:** Repair

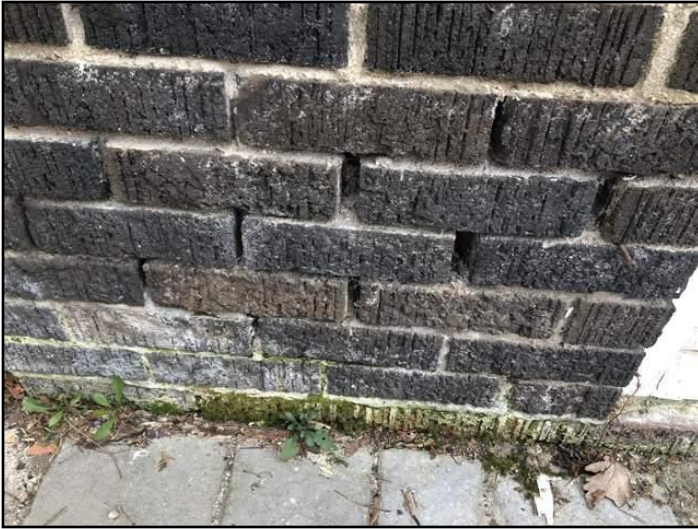
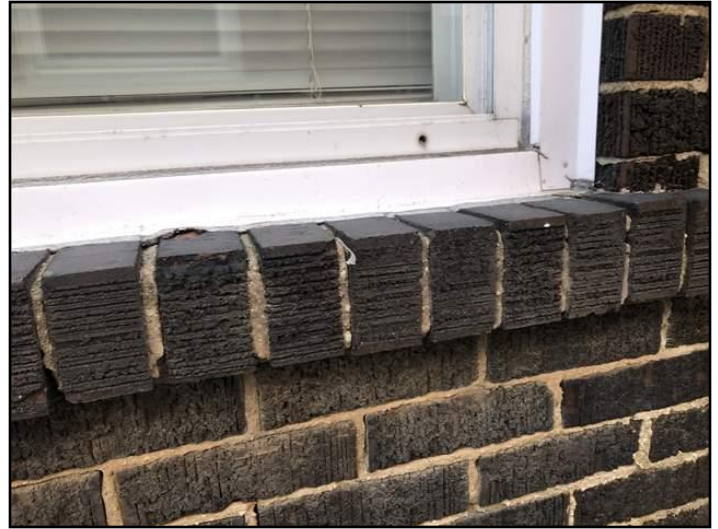
**Condition:** • [Mortar deterioration](#)

**Task:** Repair

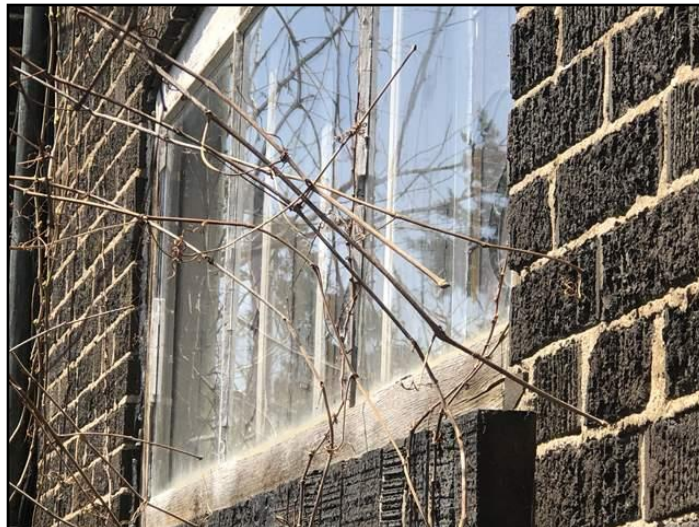
**Condition:** • [Paint or stain needed](#)

**Task:** Improve

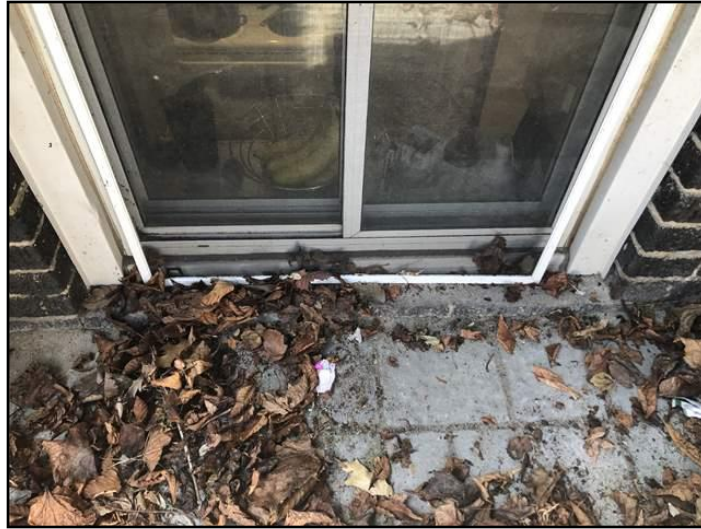
11. Sill - Near or at Grade Level

**Condition:** • Sill - Near or at Grade Level

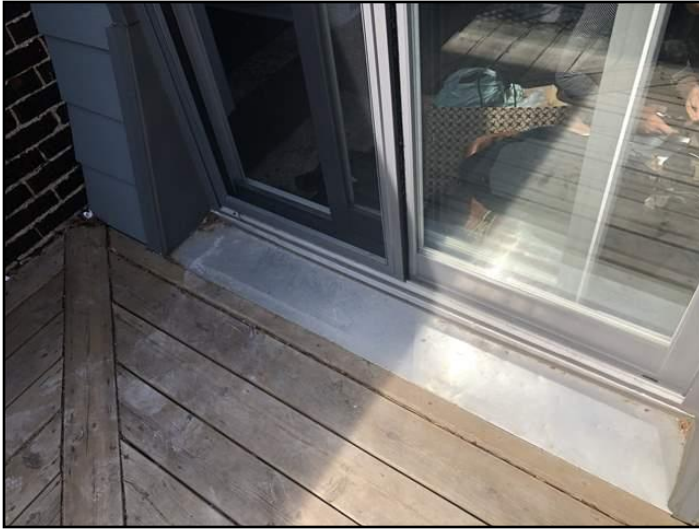
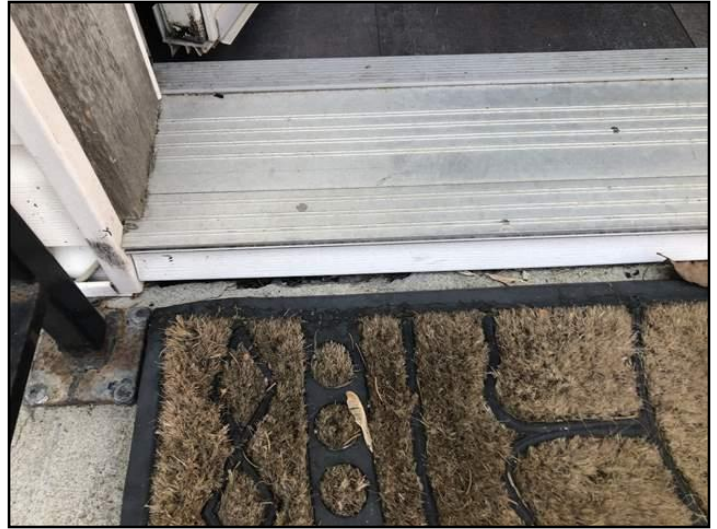
**Condition:** • Threshold too low

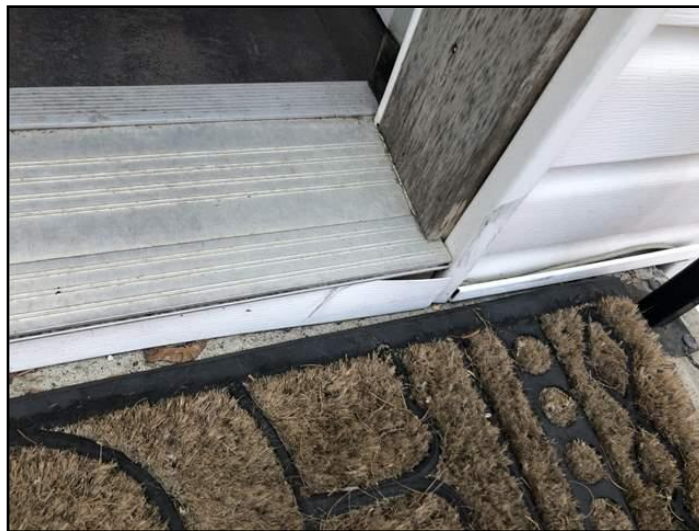
14. Damaged, cracked or loose

**Condition:** • [Damaged, cracked or loose](#)

**Task:** Improve

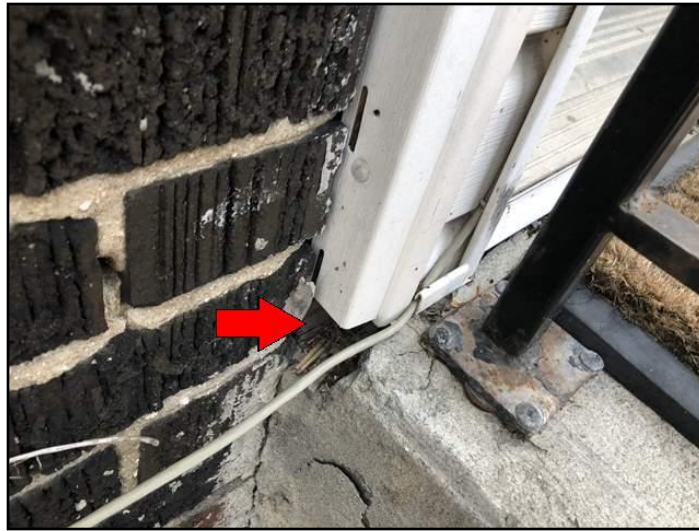
15.

**Condition:** • Gap at landing/wall

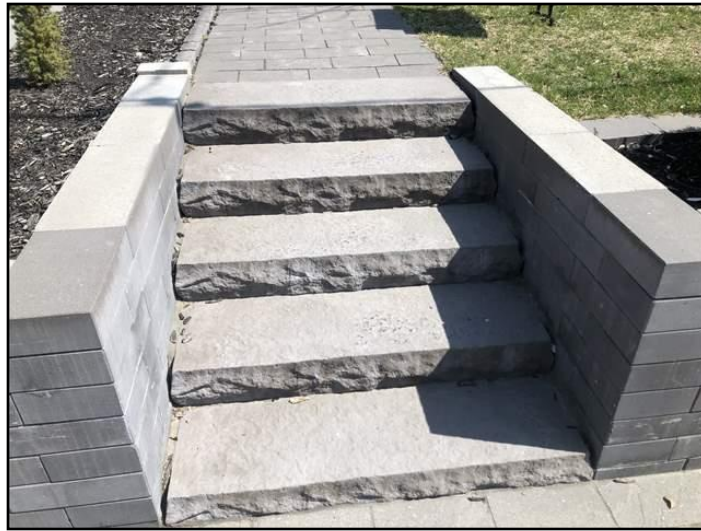
16. Missing

Condition: • [Missing](#)

Task: Provide

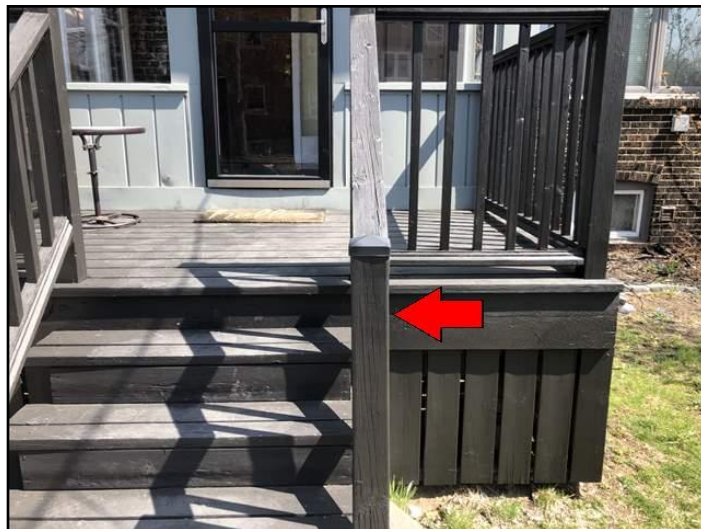
17. Loose

**Condition:** • [Loose](#)

**Task:** Improve

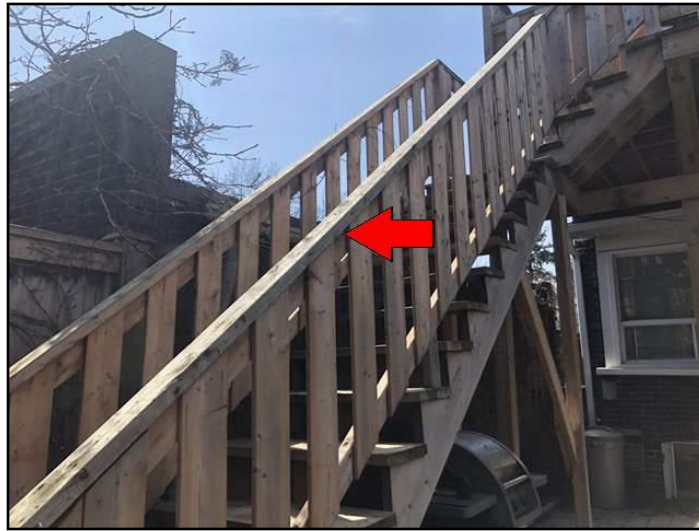
18. Weak

**Condition:** • [Weak](#)

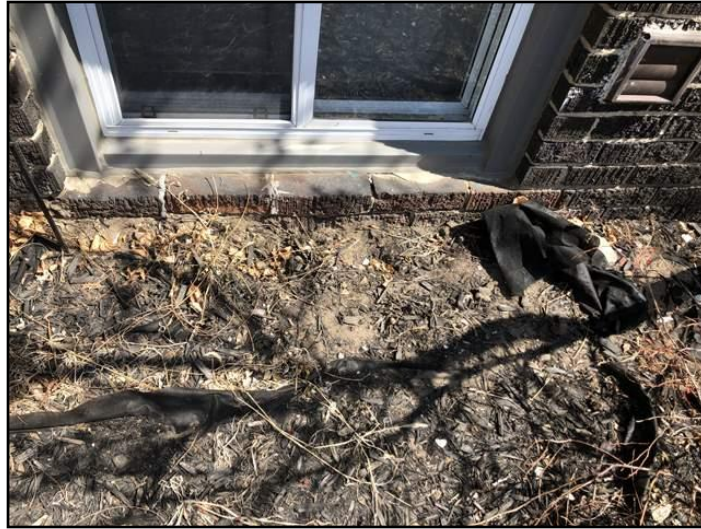
19. Low Areas

**Condition:** • Low Areas.

**Task:** Improve

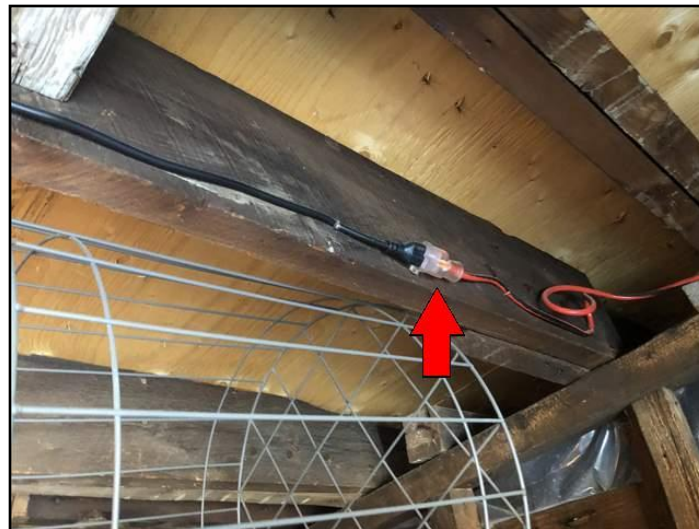
20. Extension cord for opener

**Condition:** • [Extension cord for opener](#)

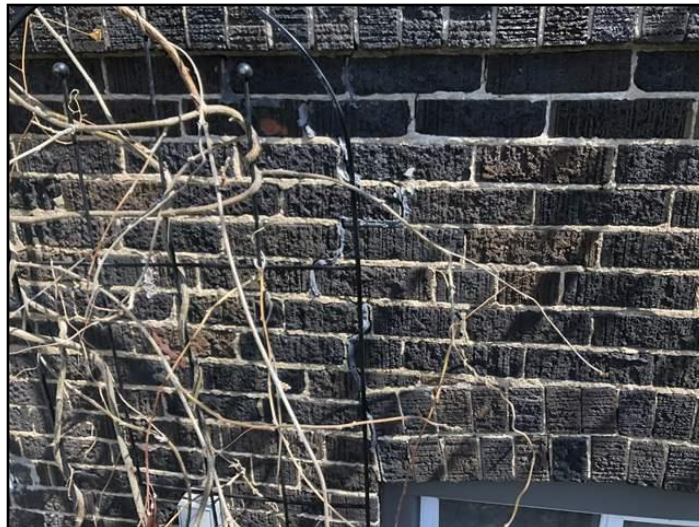
**Condition:** • [Prior repairs](#)

It is common to find a multitude of wall repairs on homes of this age

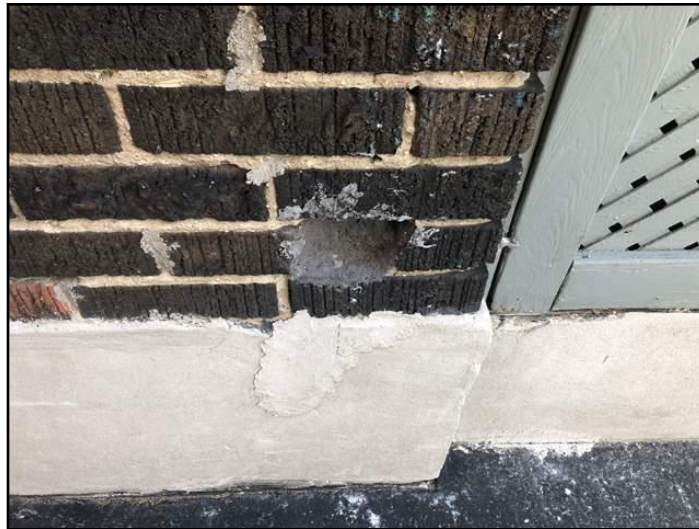
**22.** *Masonry missing*

**Condition:** • [Masonry missing](#)

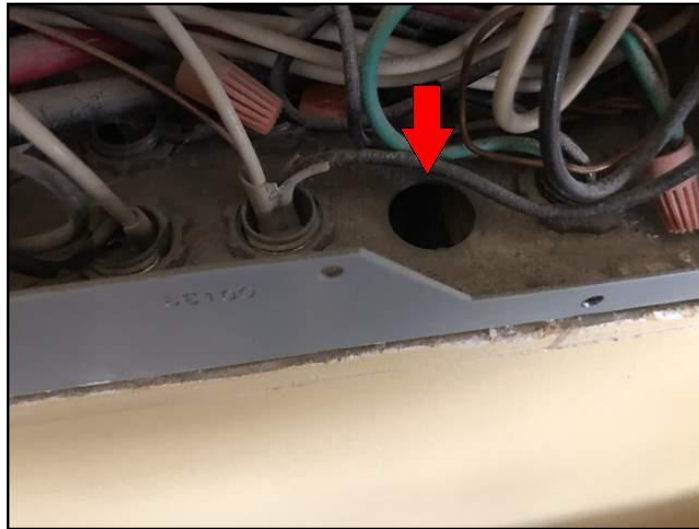
25. Openings in panel

**Condition:** • [Openings in panel](#)

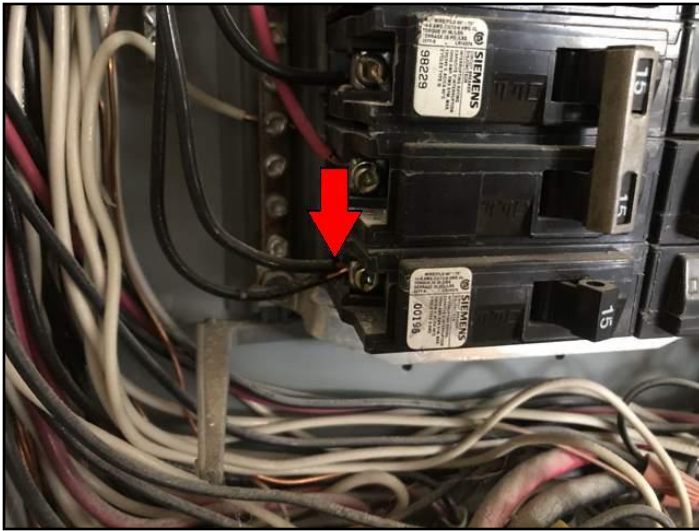
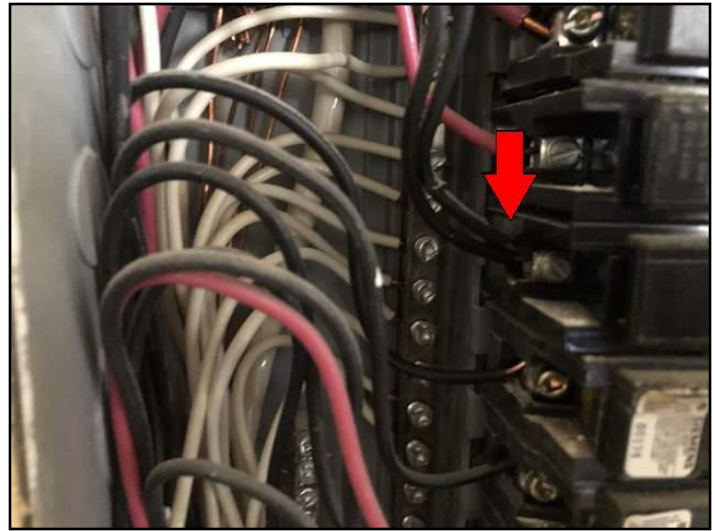
**Condition:** • [Double taps](#)

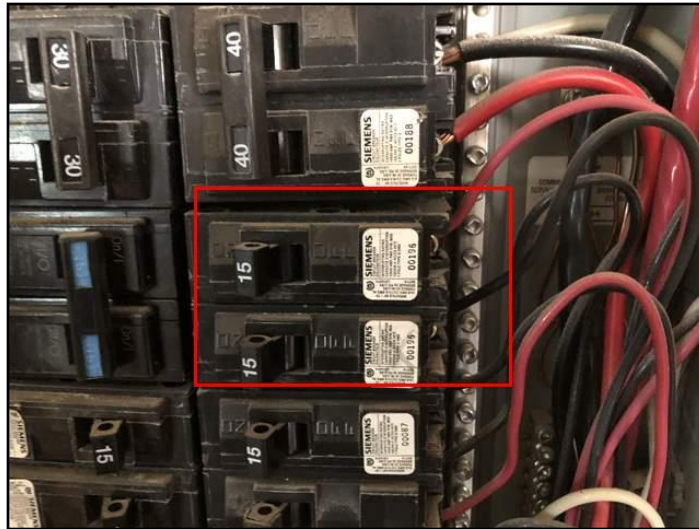
28. Breaker bridge missing

**Condition:** • [Breaker bridge missing](#)

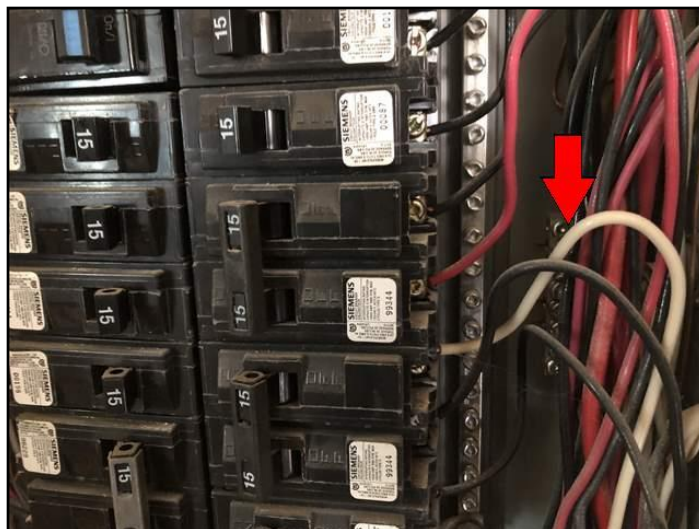
29. White wires connected to breakers not...

**Condition:** • White wires connected to breakers not identified as hot/live/ungrounded  
White wire used as hot wire not marked

**Task:** Correct

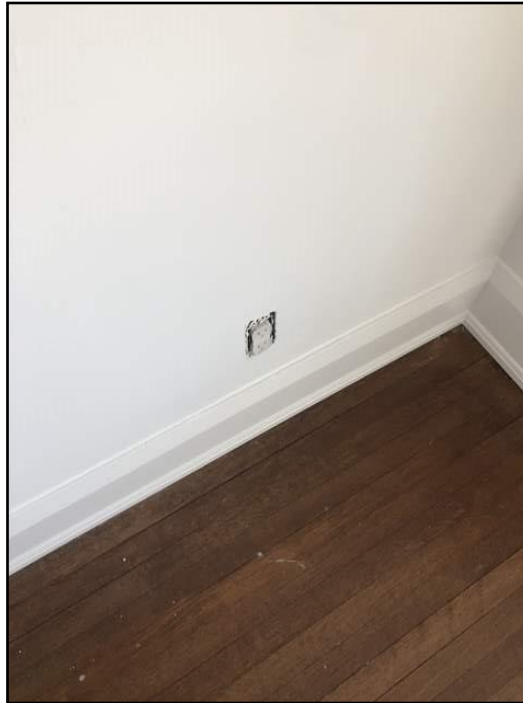
**Condition:** • For outlet (receptacle) is missing

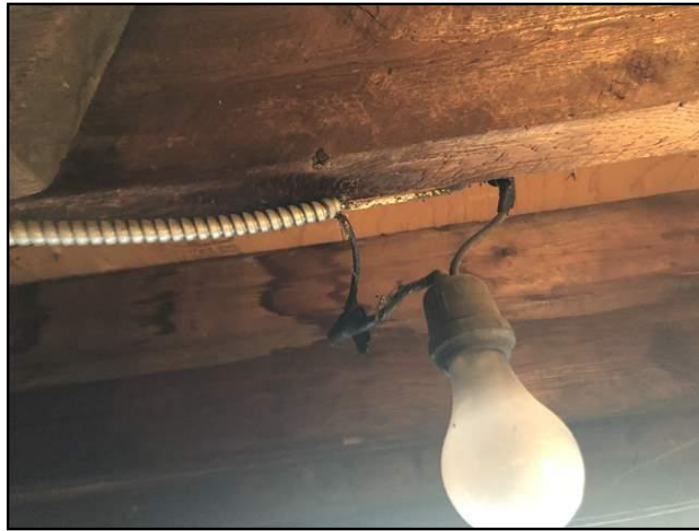
31.

**Condition:** • Light junction box missing

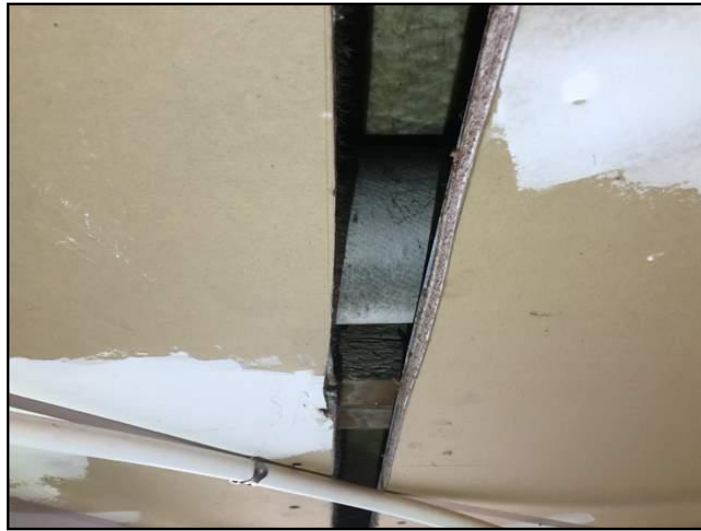
32. Observed in boiler room

\*\*hydronic piping exposed in basement was not wrapped. We observed one small area through ceiling of boiler room where we noticed pipe wrapping which may contain asbestos. That said, we cannot see areas behind wall/floors and there may be other areas where this insulation wrap is present. Take precautions when renovating/disturbing.

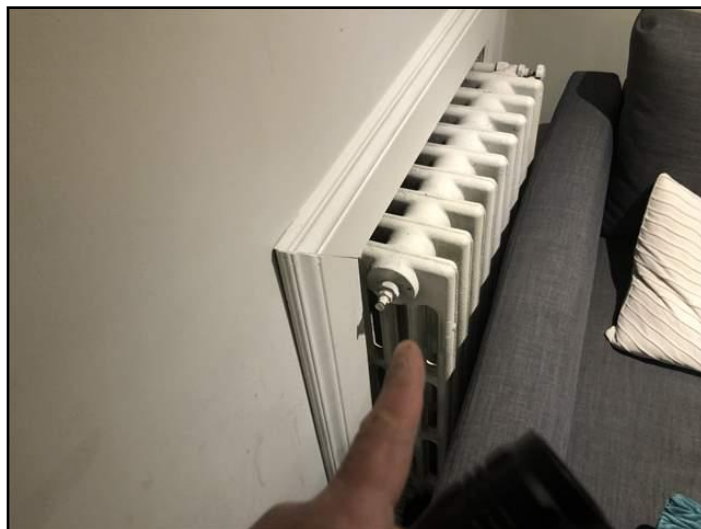
33. Cold

**Condition:** • [Cold](#)

**Task:** Replace or provide auxiliary heat

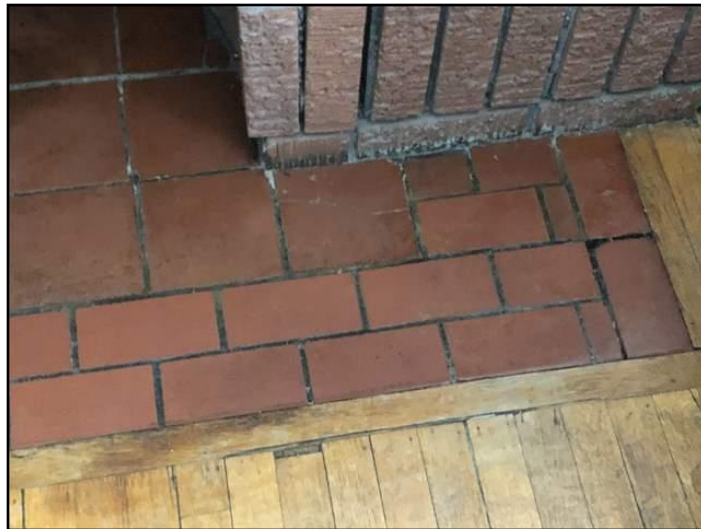
34. Too small

**Condition:** • [Too small](#)

**Task:** Correct

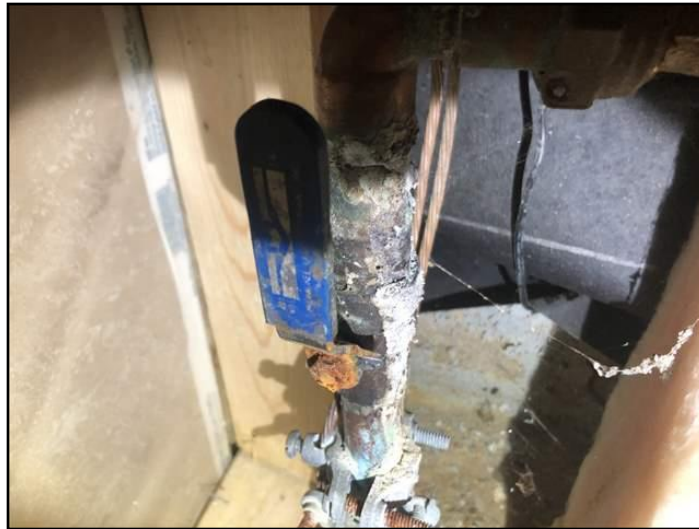
36. Corrosion

**Condition:** • Corrosion

**Task:** Repair

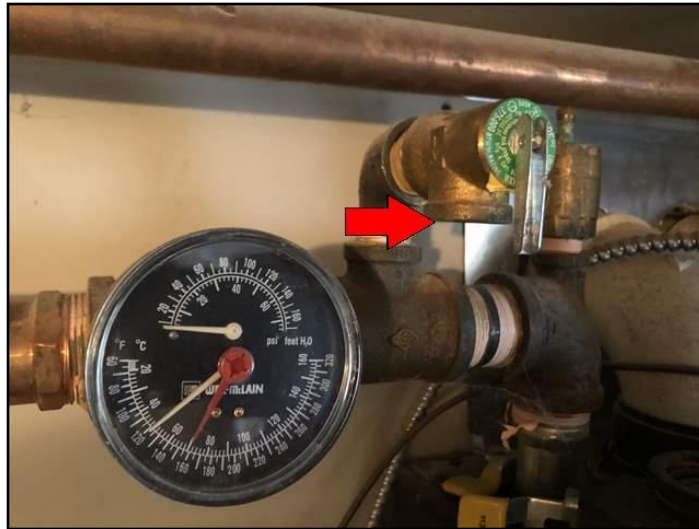
37. Discharge tube missing

**Condition:** • [Discharge tube missing](#)

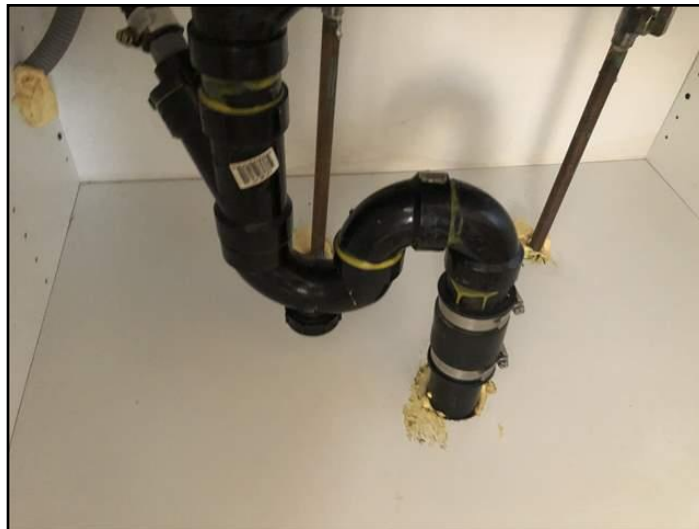
38. Nonstandard shape or material

**Condition:** • [Nonstandard shape or material](#)

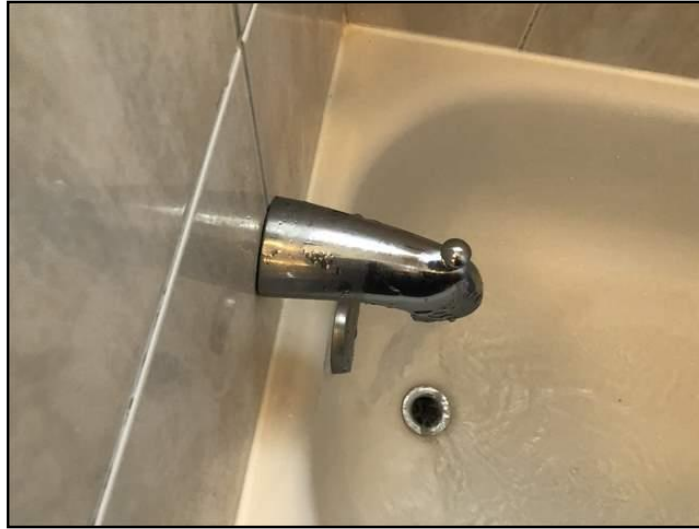
39. Loose

**Condition:** • [Loose](#)

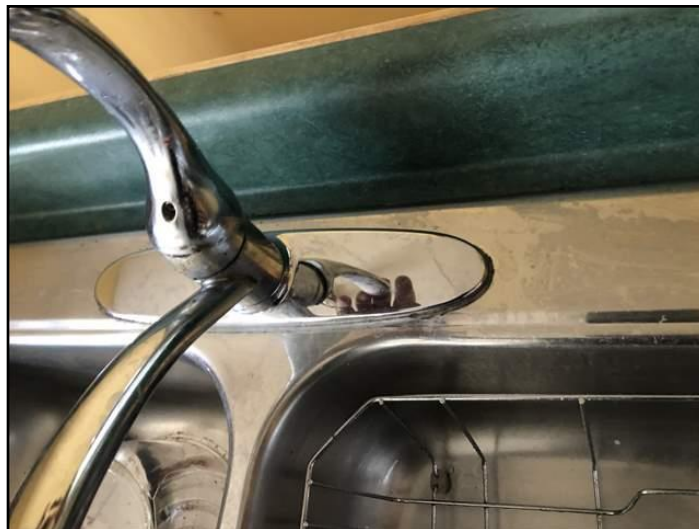
40. Loose

**Condition:** • [Loose](#)

**Task:** Repair / Replace

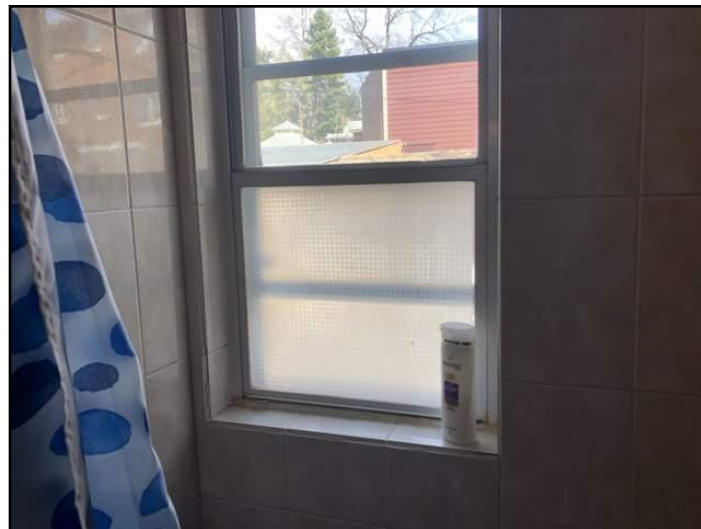
41. Unprotected window

**Condition:** • [Unprotected window](#)

**Task:** Protect

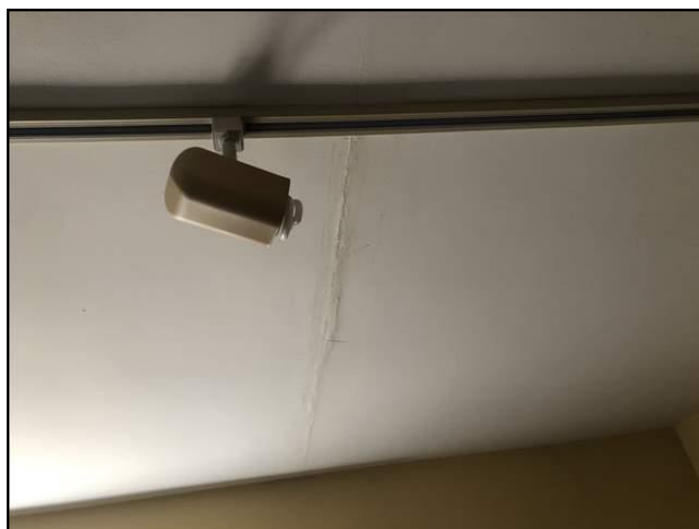
42. Patched

**Condition:** • [Patched](#)

Ceiling area is below bathroom. Prior leak approximately one year prior (as per tenant) and patchwork. Tested with a moisture meter. Dry at time of inspection.

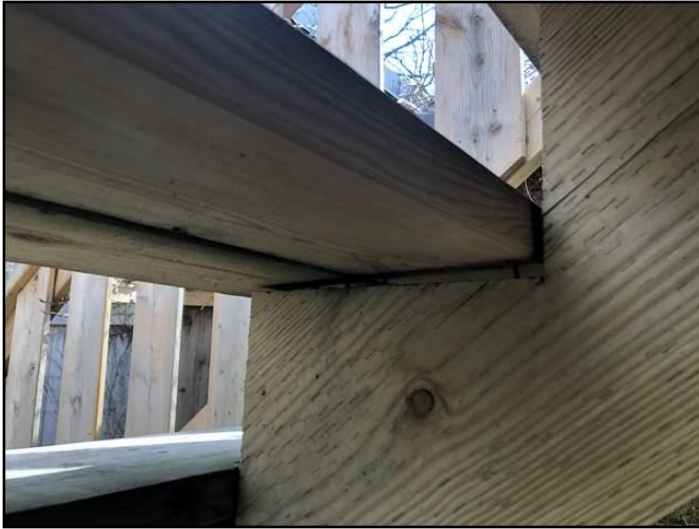
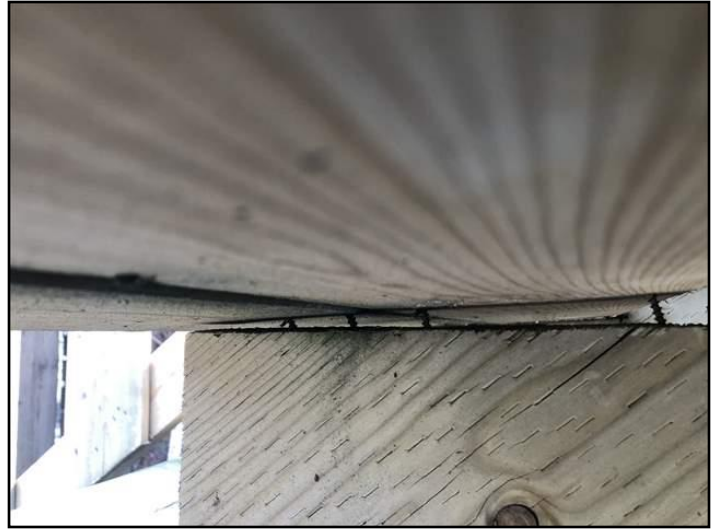
**Condition:** • [Loose](#)

**Task:** Repair

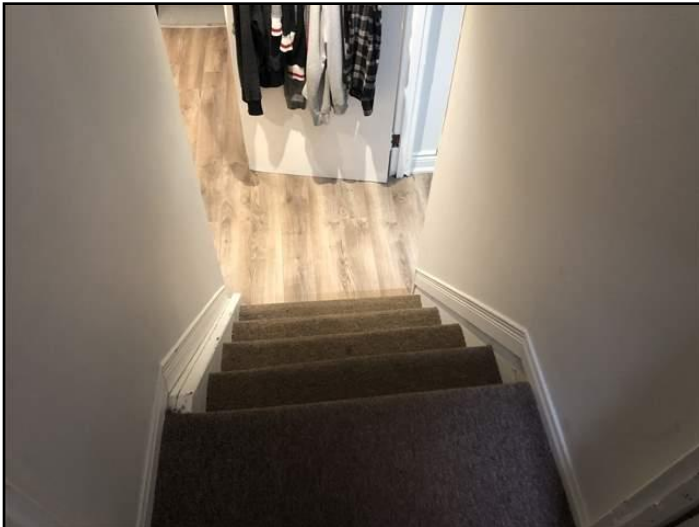
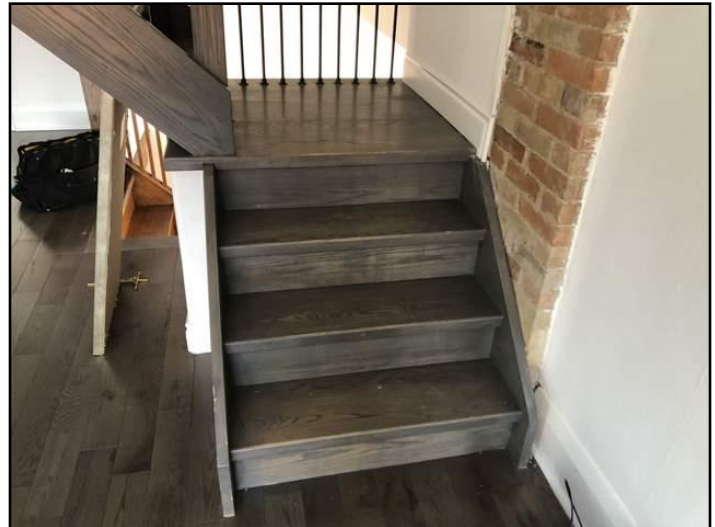
**Condition:** • [Missing](#)
