# Your Inspection Report

103 Longwater Chase  
Markham, ON L3R 4A9

Wednesday, August 19, 2026

RE: Report No. 11106  
103 Longwater Chase  
Markham, ON  
L3R 4A9

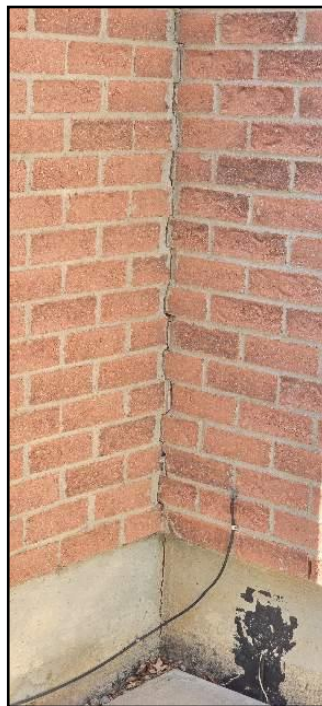
7.

**Condition:** • Minor settlement. Mortar should be patched as part of regular maintenance

**Task:** Repair/ Monitor

**Time:** Regular maintenance/ Ongoing

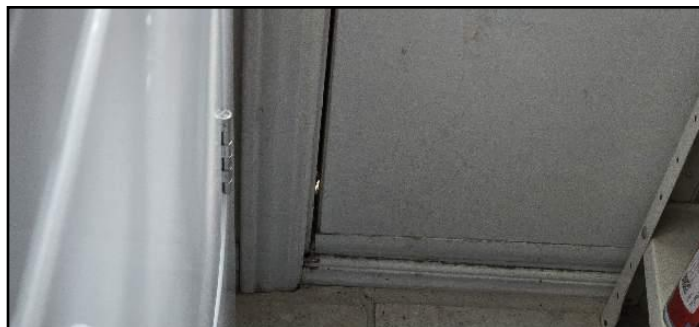
10.

**Condition:** • [Air leaks](#)

**Implication(s):** Chance of damage to finishes and structure | Increased heating and cooling costs

**Task:** Improve

**Time:** Regular maintenance

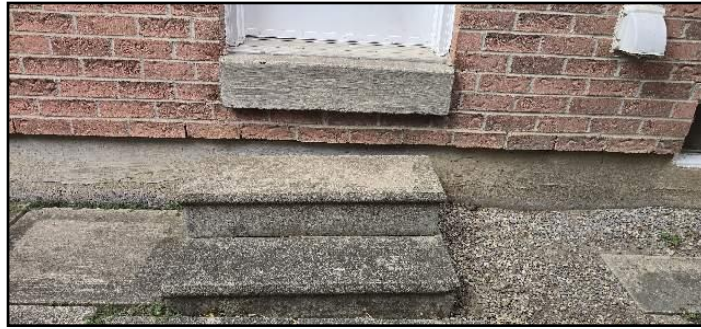
11.

**Condition:** • [Stair rise too big or not uniform](#)

**Implication(s):** Trip or fall hazard

**Task:** Correct

**Time:** Regular maintenance

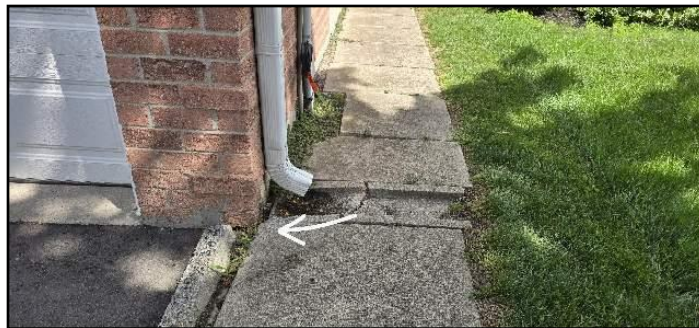
13.

**Condition:** • [Improper slope or drainage](#)

Concrete pad is cracked and one portion is sloping towards the garage

**Implication(s):** Chance of water damage to structure, finishes and contents

**Task:** Correct

**Time:** Regular maintenance

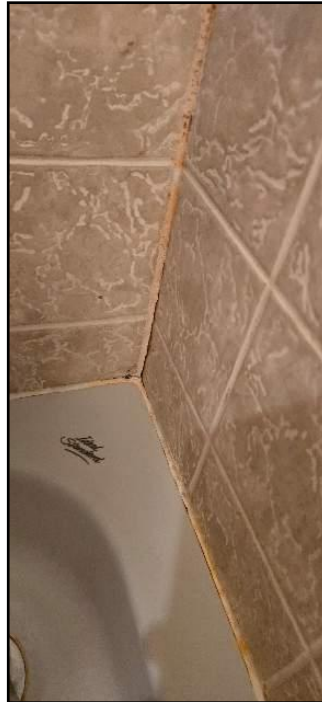
20.

**Condition:** • [Caulking loose, missing or deteriorated](#)

**Implication(s):** Chance of water damage to structure, finishes and contents

**Task:** Provide Replace

**Time:** Regular maintenance

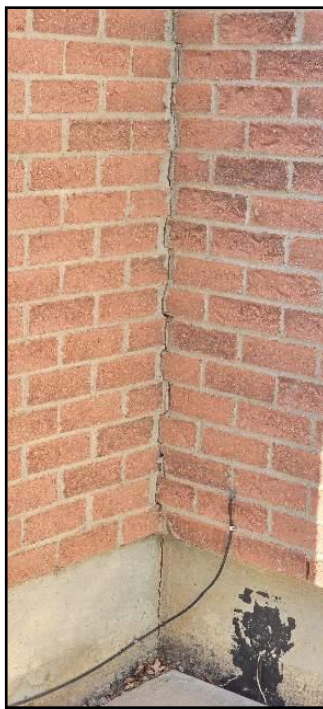
41.

**Condition:** • Minor settlement. Mortar should be patched as part of regular maintenance

**Task:** Repair/ Monitor

**Time:** Regular maintenance/ Ongoing

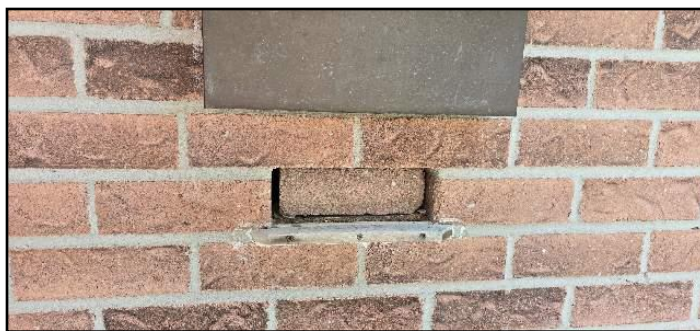
42.

**Condition:** • Unsealed entry point

**Task:** Correct

**Time:** As soon as practical

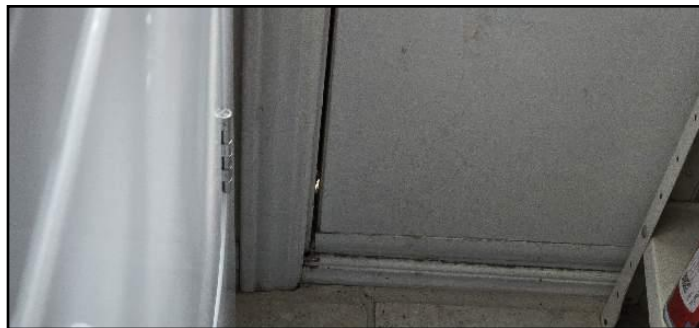
44.

**Condition:** • [Air leaks](#)

**Implication(s):** Chance of damage to finishes and structure | Increased heating and cooling costs

**Task:** Improve

**Time:** Regular maintenance

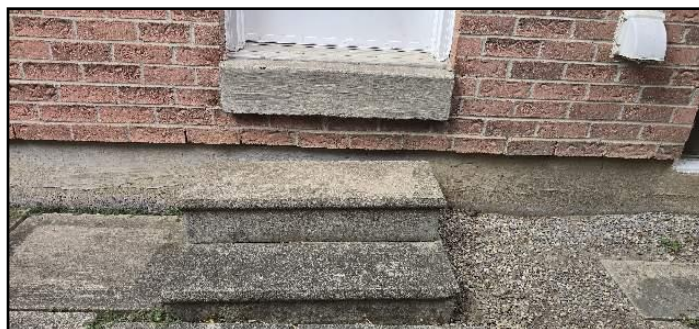
45.

**Condition:** • [Stair rise too big or not uniform](#)

**Implication(s):** Trip or fall hazard

**Task:** Correct

**Time:** Regular maintenance

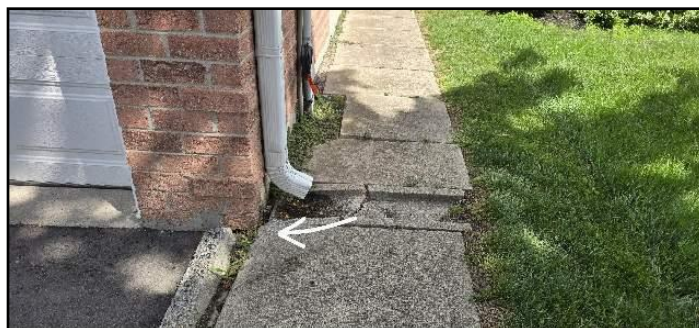
47.

**Condition:** • [Improper slope or drainage](#)

Concrete pad is cracked and one portion is sloping towards the garage

**Implication(s):** Chance of water damage to structure, finishes and contents

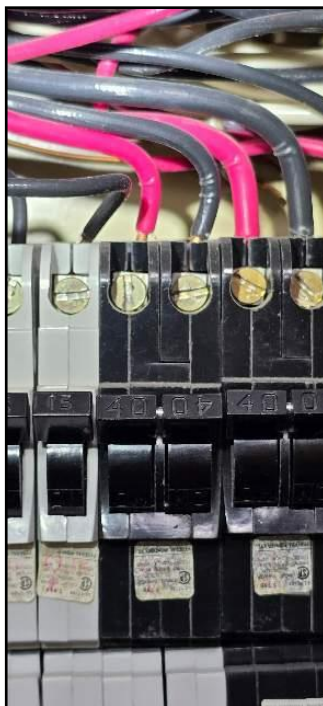
72.

**Condition:** • [Fuses or breakers too big](#)

**Implication(s):** Equipment overheating | Fire hazard

**Task:** Correct

**Time:** Immediate

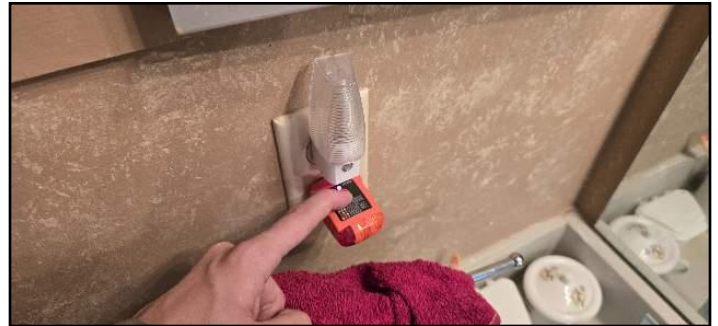
74.

**Condition:** • [GFCI/GFI needed \(Ground Fault Circuit Interrupter\)](#)

**Task:** Provide

**Time:** As soon as practical

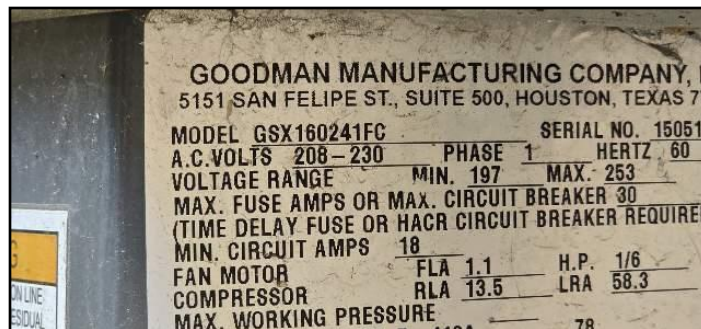
82.

- [2 Tons](#)

May be a bit weak for a 2800sqft home
