Your Inspection Report

505 Queen Street East
Toronto, ON

Friday, February 8, 2019

RE: Report No. 2685
505 Queen Street East
Toronto, ON

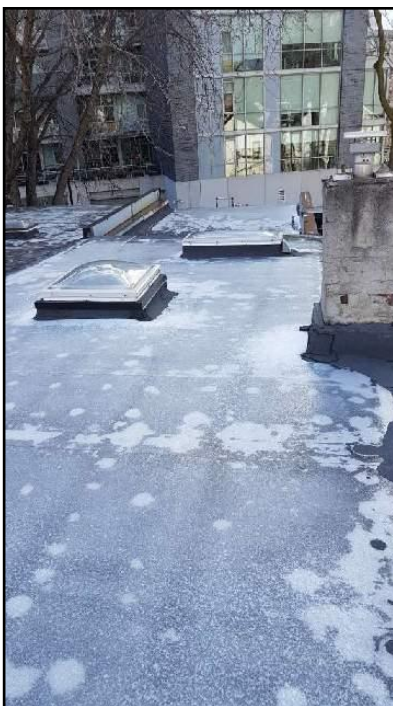
1. Modified bitumen membrane

Approximate age: • 12 years

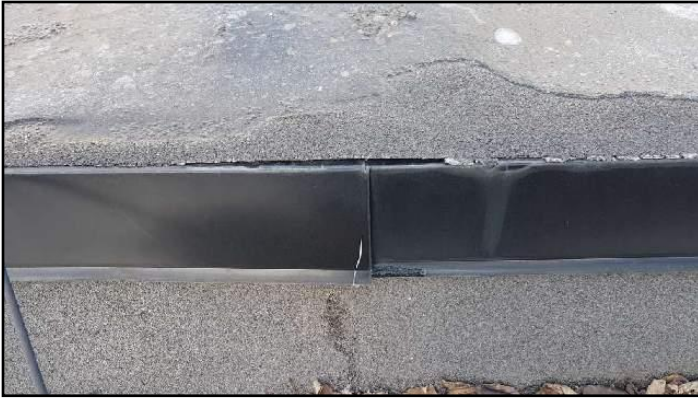
1. **Condition:** • Not visible

Majority of roof snow covered and not visible. Tune up / repair needed at some areas. Resecure flashings and lifting membrane. Inspect balance of roof when free of snow.

2. *Lifting membrane*

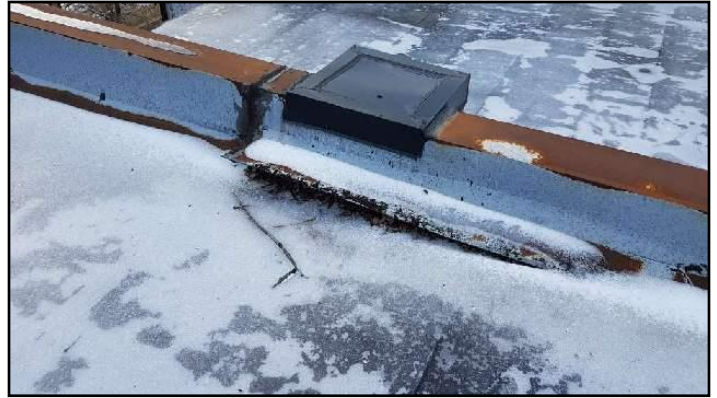
3. *Lifting flashing*

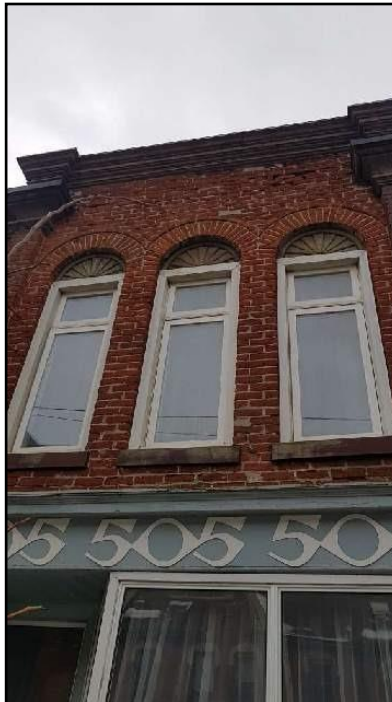
2. Condition: • [Masonry deterioration](#)

Implication(s): Weakened structure | Chance of structural movement

Location: North Second Floor

4. Masonry deterioration

Task: Repair

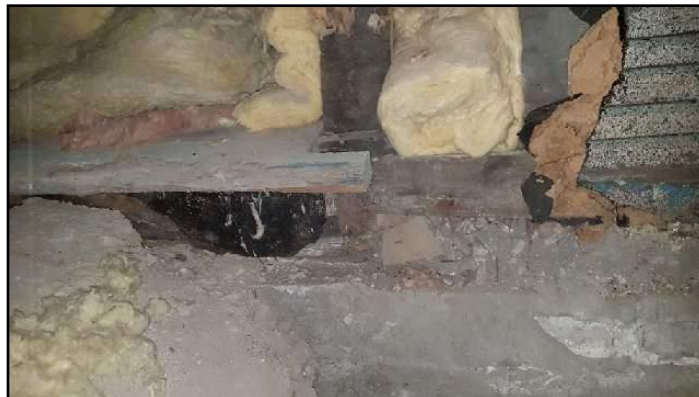
3. Condition: • [Wood too close to soil](#)

Implication(s): Weakened structure | Chance of structural movement

Location: North Crawl Space

5. Wood too close to soil

While not urgent, recommend replacement of original wood wall with beam above grade where original exterior wall meets crawl space.

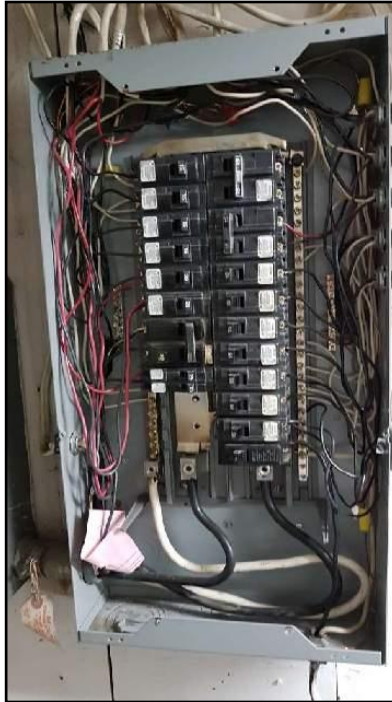
4. Condition: • [Double taps](#)

Implication(s): Fire hazard

Location: Basement Panel

7. Double taps

Split double taps at panel if nuisance tripping occurs.

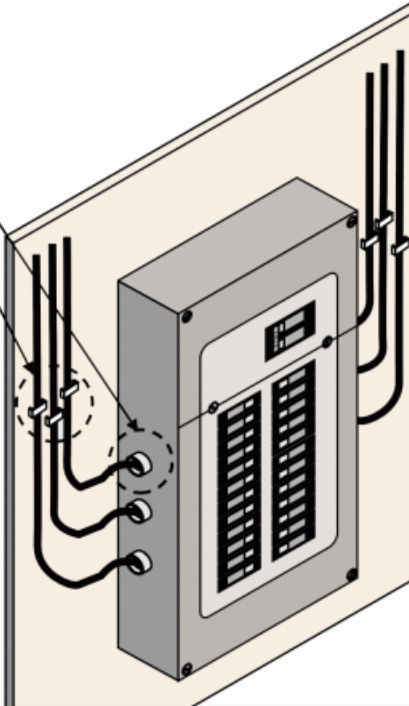
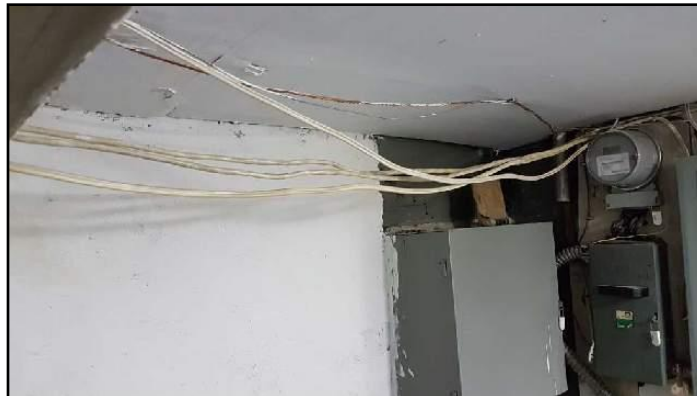
5. Condition: • [Not well secured](#)

Implication(s): Electric shock | Fire hazard

Location: Basement

8. Not well secured

Support loose wiring at basement.

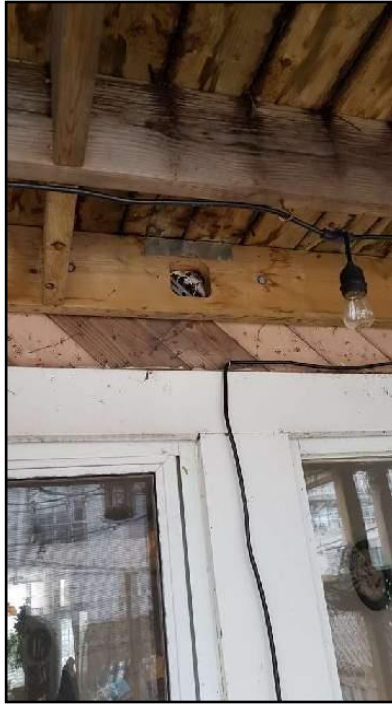
6. Condition: • [Cover loose or missing](#)

Implication(s): Electric shock | Fire hazard

Location: Various

9. Cover missing

Task: Add covers or fixtures

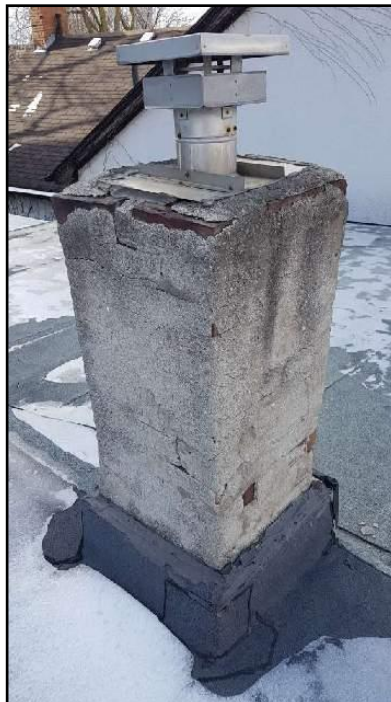
10. Condition: • [Spalling](#)

Implication(s): Material deterioration

Location: West Flat roof

Minor parging needed at chimney. Not urgent, complete in conjunction with roof repairs.
