YOUR INSPECTION REPORT

3 Sunnybrook Road
Toronto, ON M6S 1G3

INSPECTION DATE:
Friday, October 8, 2021

RE: Report No. 2952
3 Sunnybrook Road
Toronto, ON
M6S 1G3

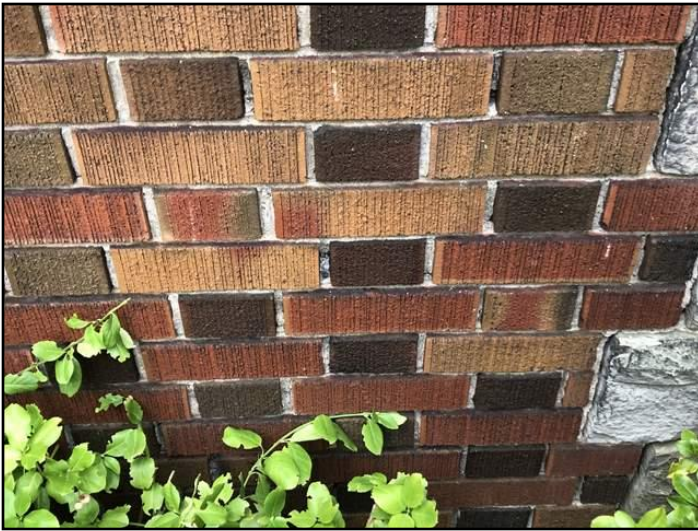
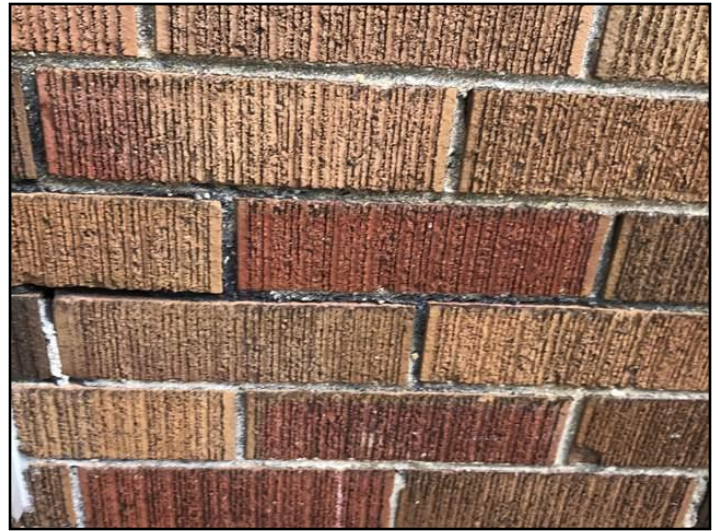
Condition: • [Mortar deterioration](#)

Provide mortar (Repointing, Tuck pointing) at various areas of the exterior brick or foundation. This is routine maintenance for homes of this age. Overall the brick and mortar is in good condition. photos show sampling.

5. Minor mortar deterioration

6. Minor mortar deterioration

Task: Repair

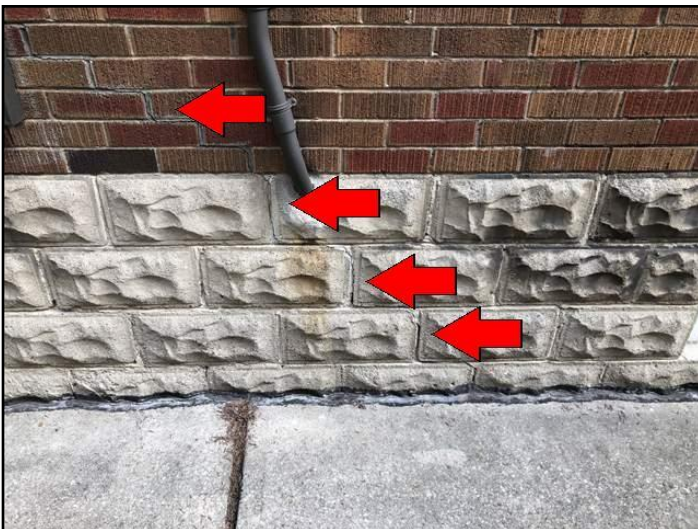
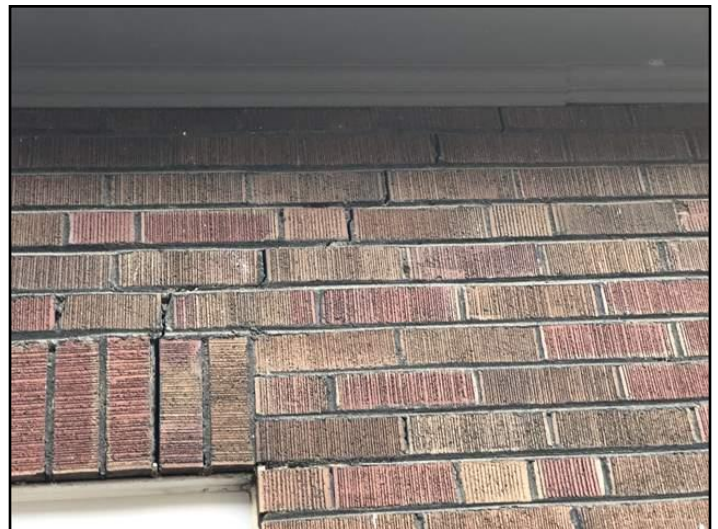
Condition: • Most masonry walls have small cracks due to shrinkage or minor settlement. These will not be individually noted in the report, unless leakage, building movement or similar problems are noted

7. Example of typical minor cracks

8. example

Task: Monitor / Repair when tuckpointing other masonry

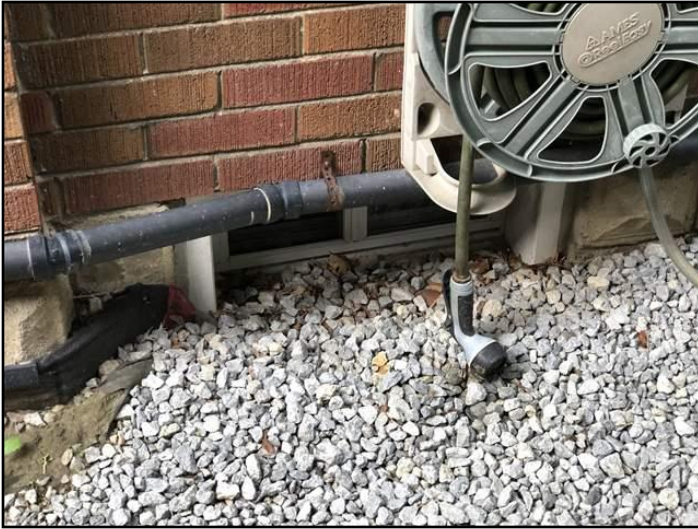
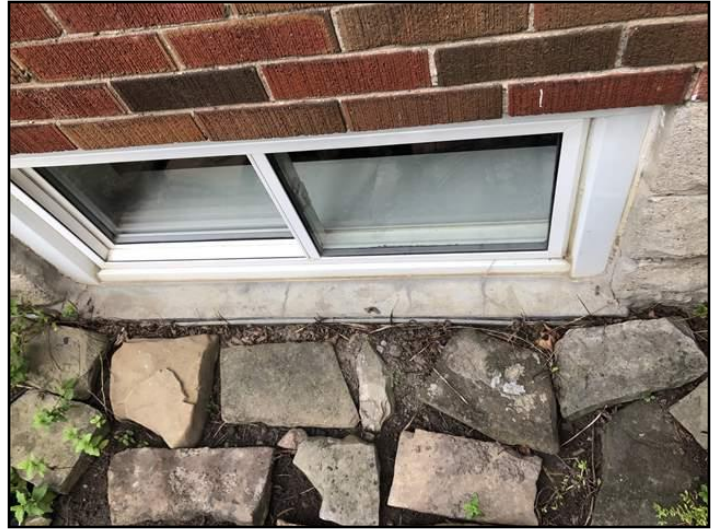
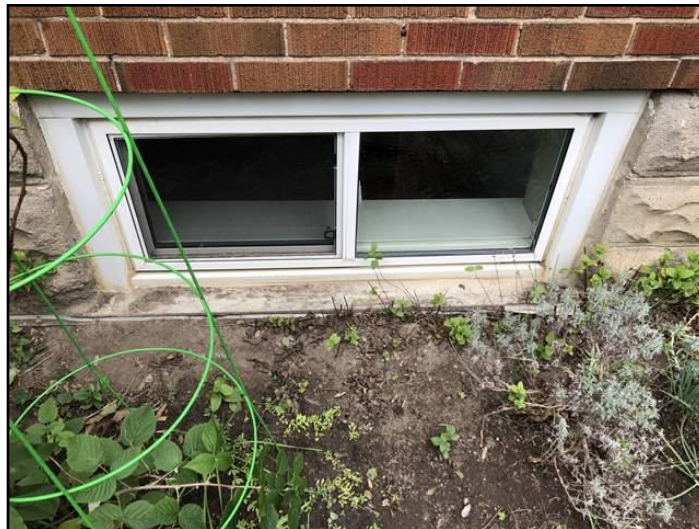
Condition: • Sill - Near or at Grade Level

9. Sill - Near or at Grade Level

10. Sill - Near or at Grade Level

11. Sill - Near or at Grade Level

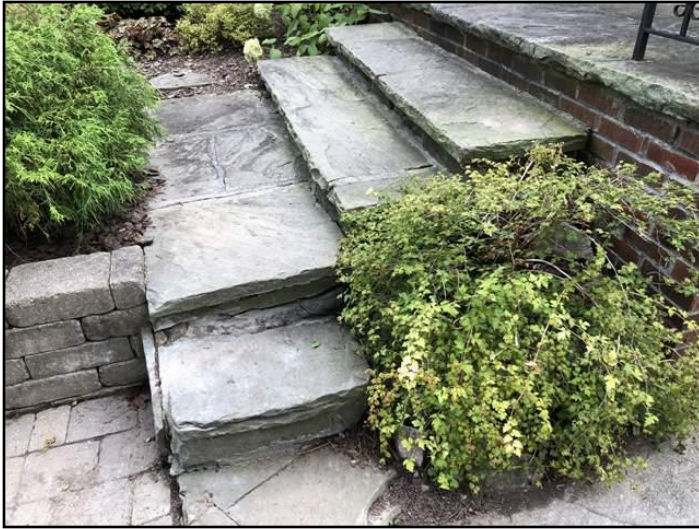
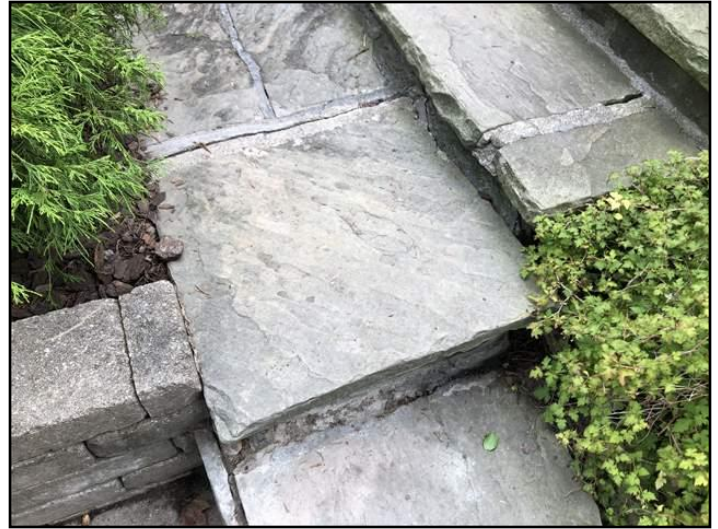
Condition: • [Steps springy, loose or sagging](#)

stone loose/not secure in some areas.

12. Steps loose

13. Steps loose

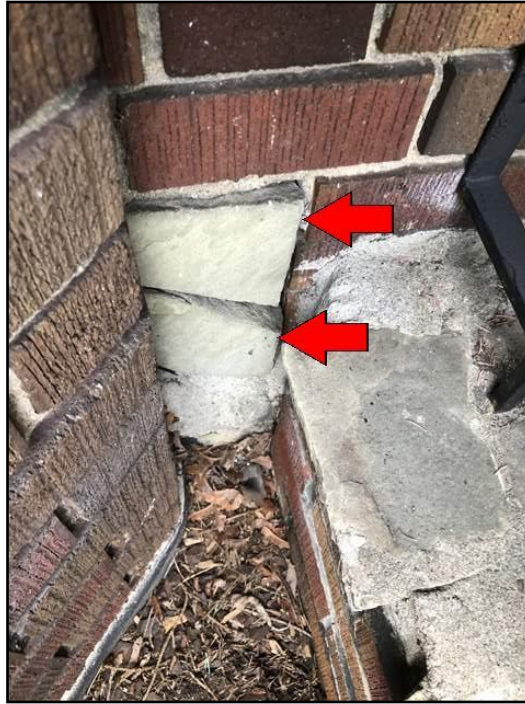
Condition: • [Masonry deteriorated](#)

14. Loose masonry

Task: Repair

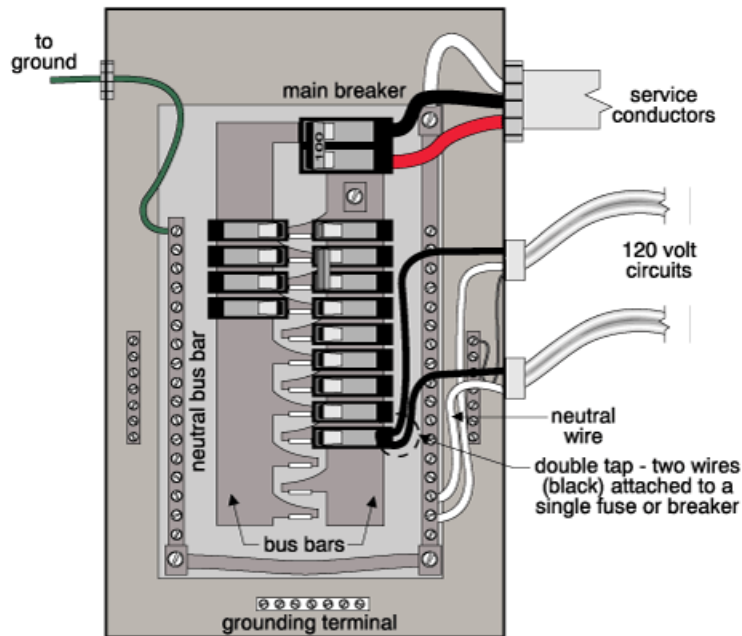
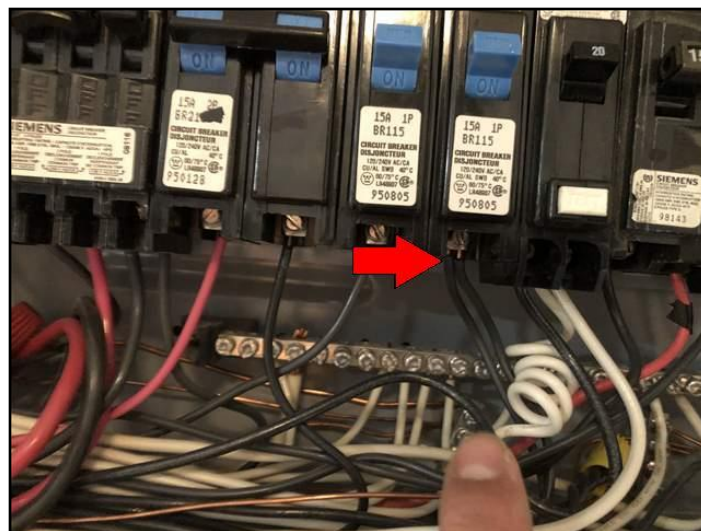
Condition: • [Double taps](#)

16. Double taps

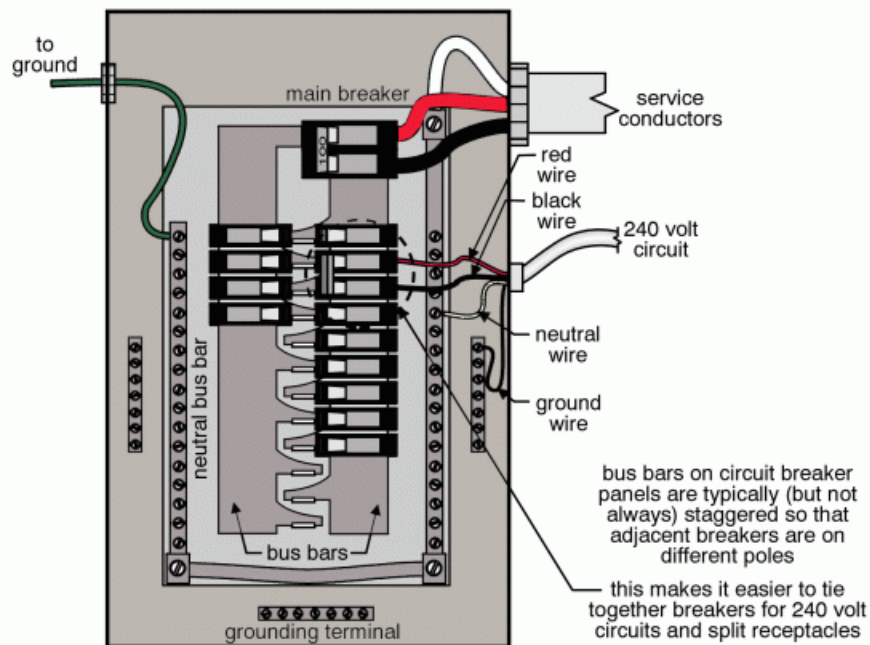
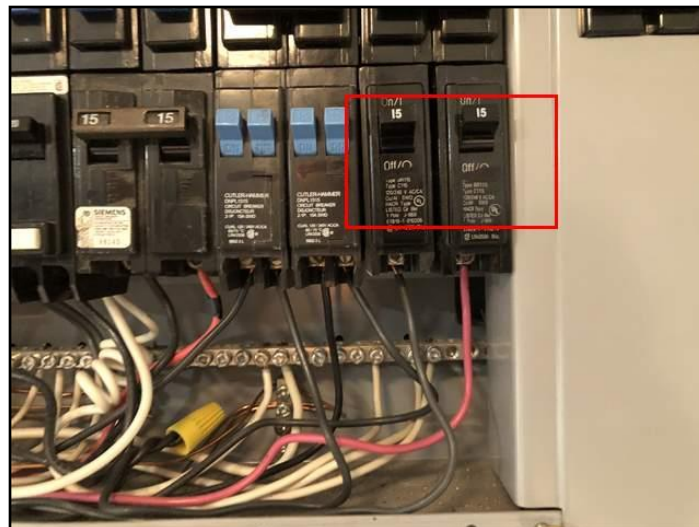
Condition: • [Breaker bridge missing](#)

17. Breaker bridge missing

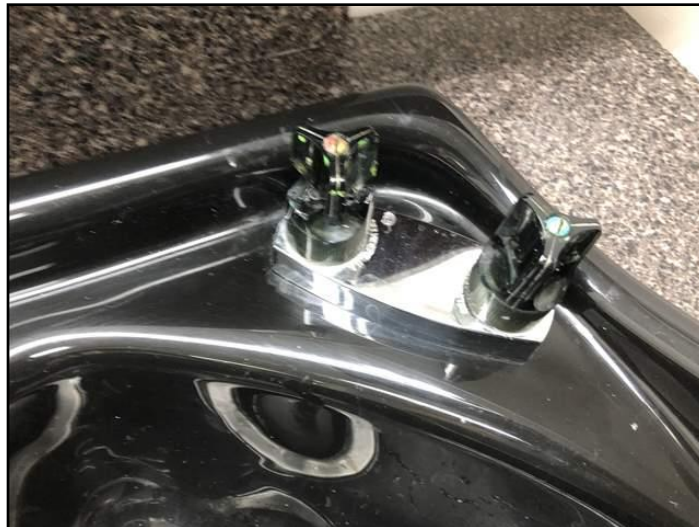
Condition: • [Loose](#)

20. Loose

Task: Repair

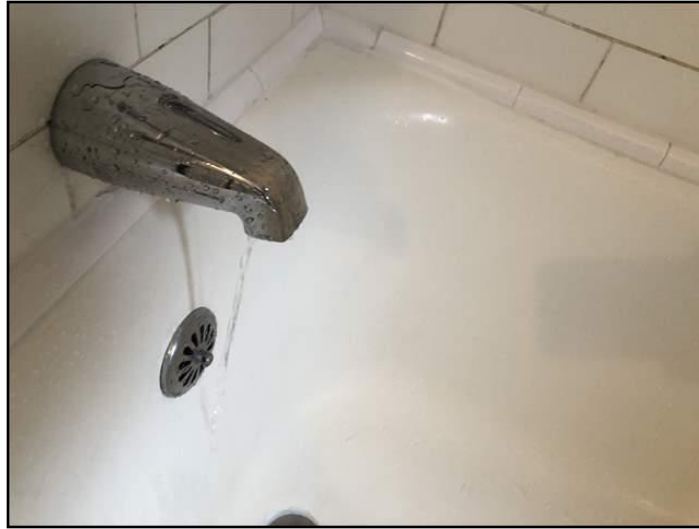
Condition: • [Shower diverter inoperative or defective](#)

21. Shower diverter inoperative or defective

Task: Clean or Replace

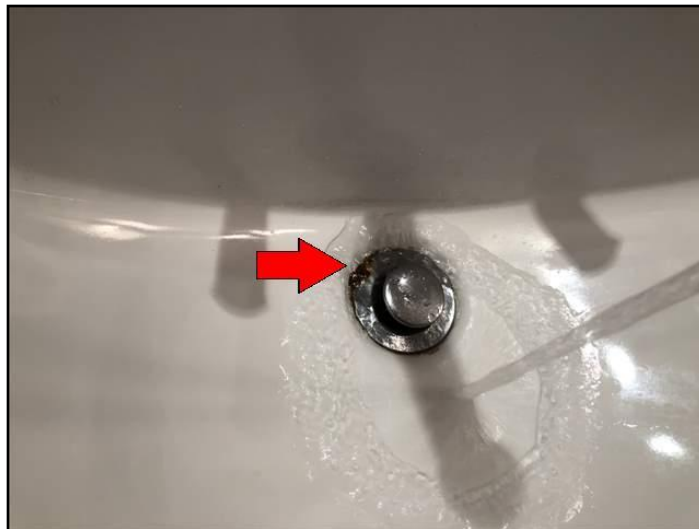
Condition: • [Rust](#)

22. Rust

Task: Replace

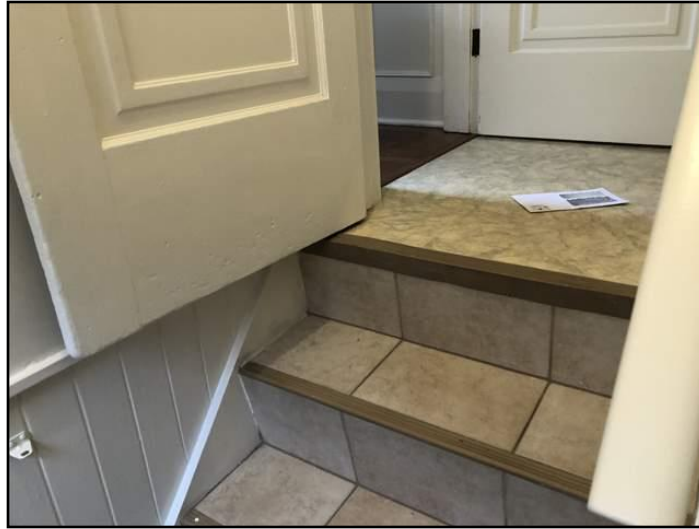
Condition: • [Installed backwards](#)

23. Installed backwards
