YOUR Inspection Report

Sample Home
My Town, ON

Monday, June 10, 2013

Rick Clayton CMI RHI WRT AMRT

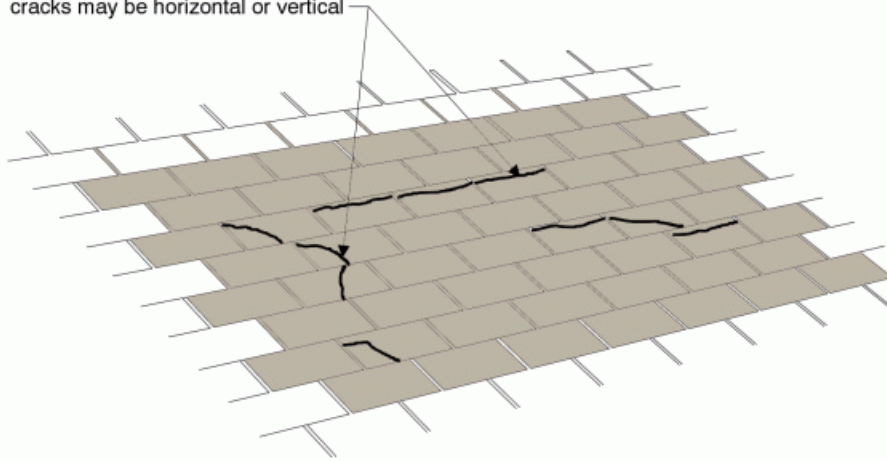
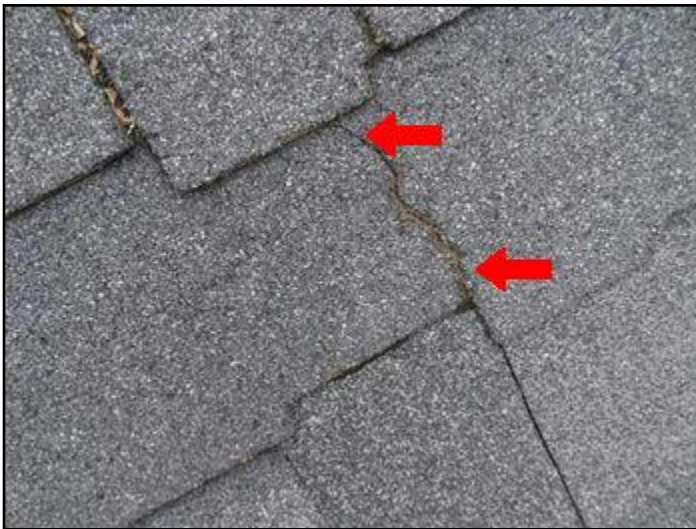
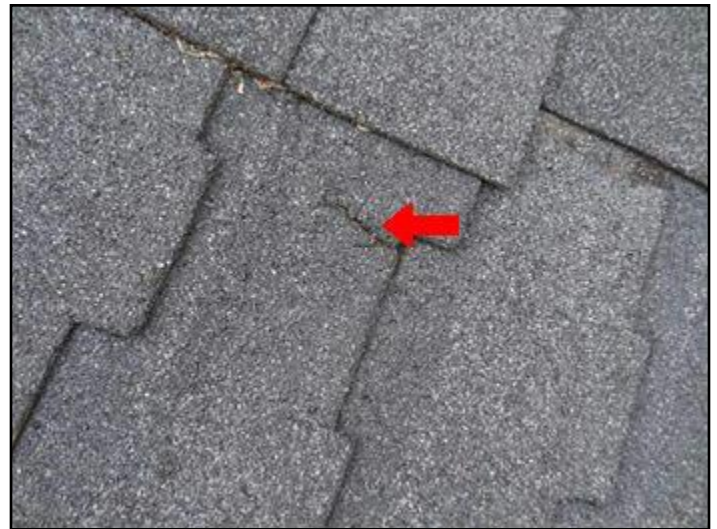
Condition: • Cracks

monitor and repair as needed. no moisture found in home

Implication(s): Chance of water damage to contents, finishes and/or structure

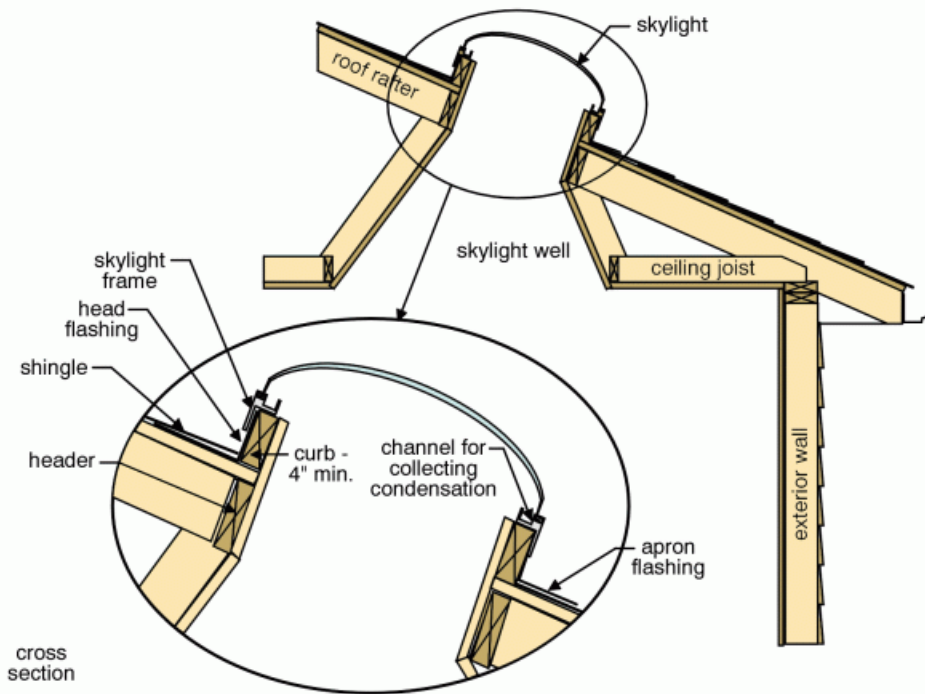
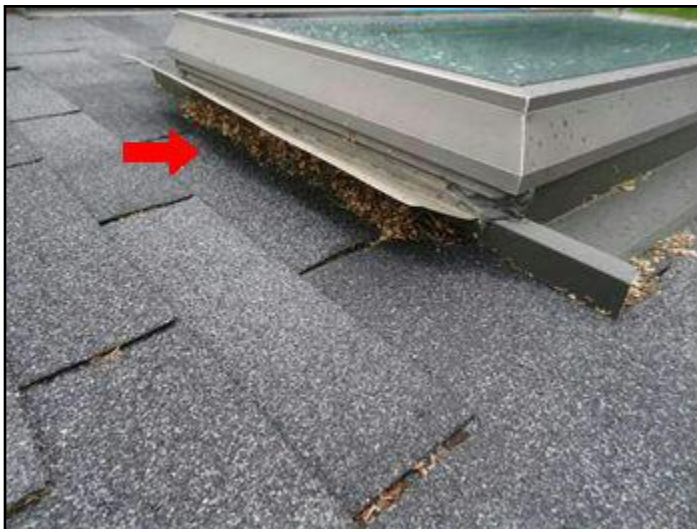
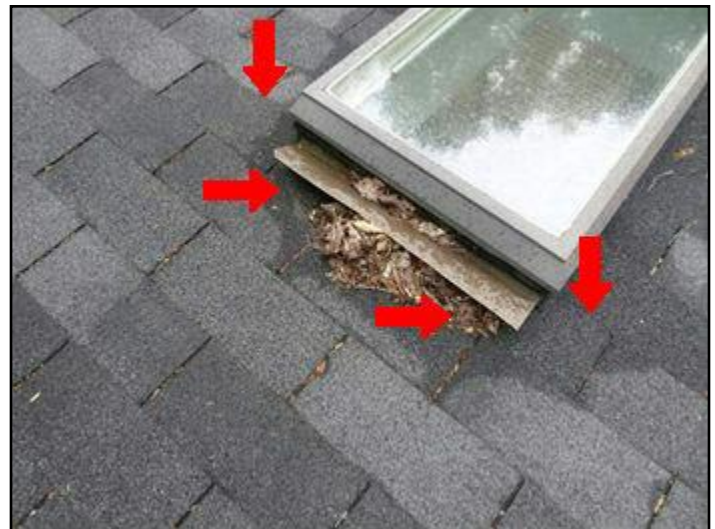
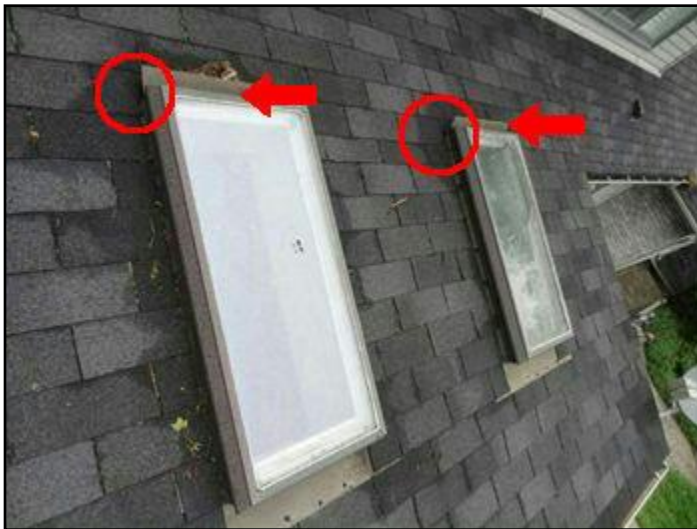
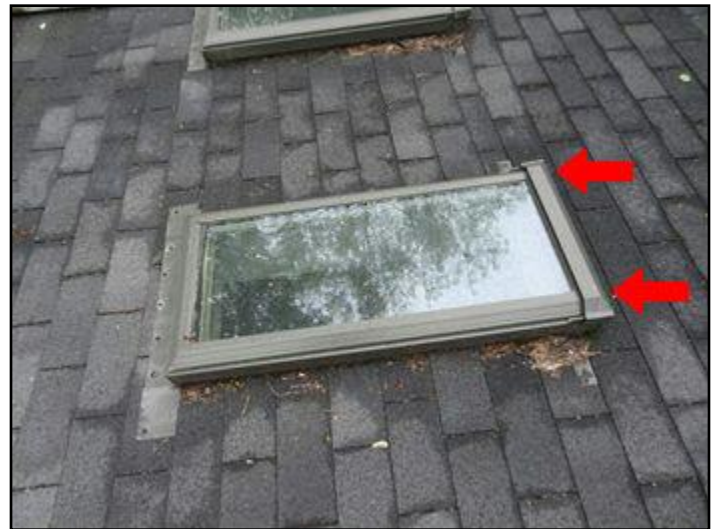
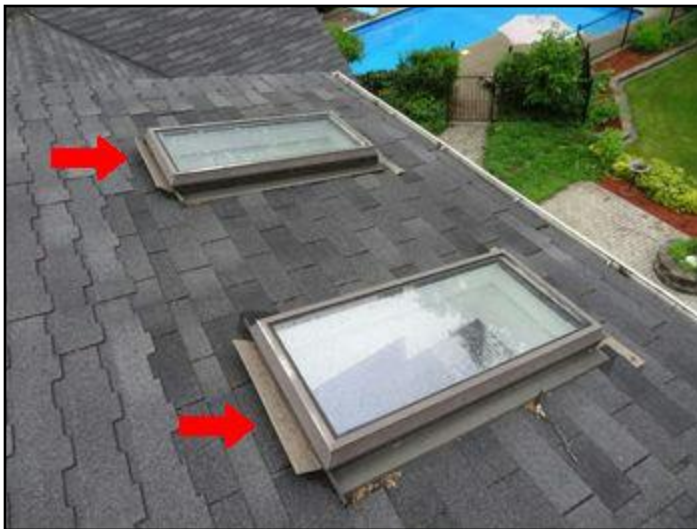
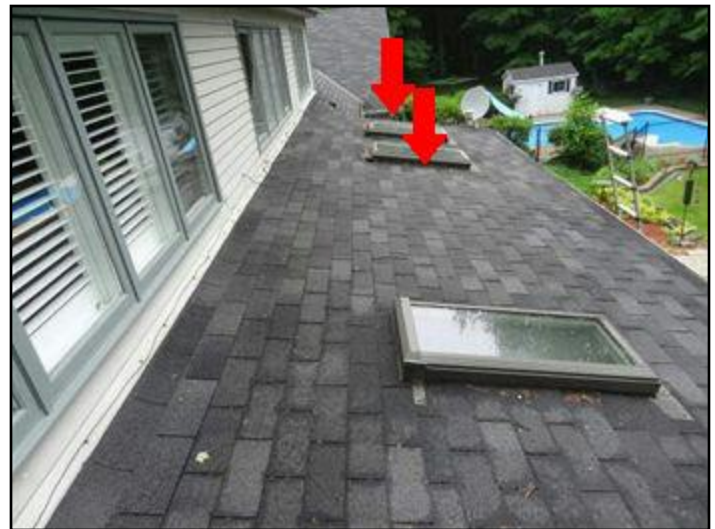
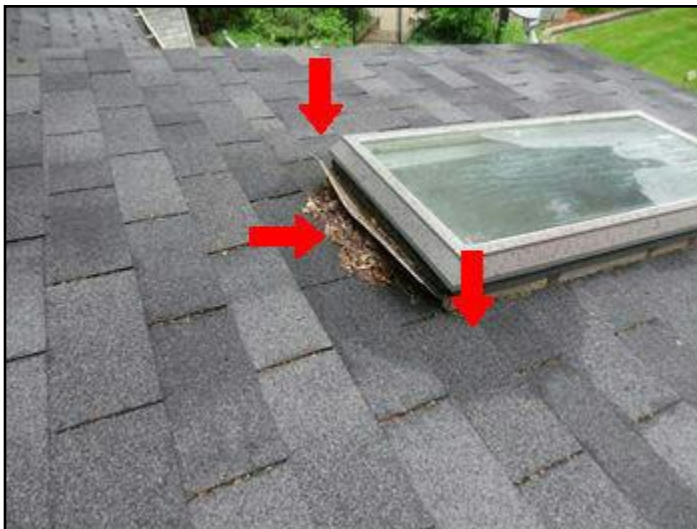
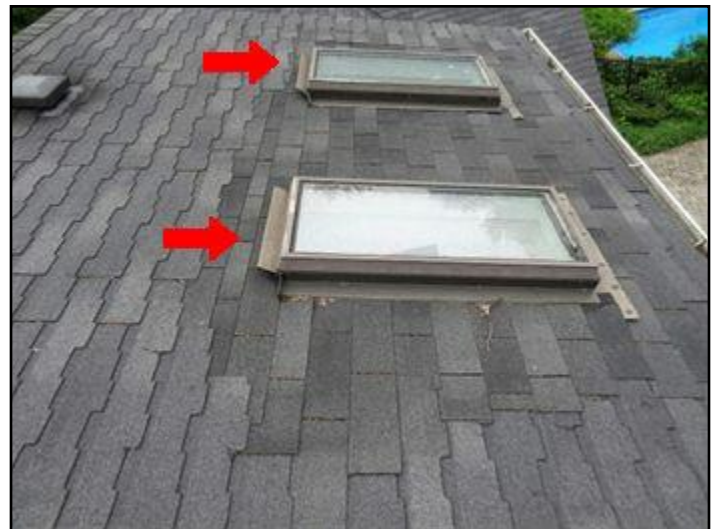
Condition: • Wrong, incomplete flashings

flashing at top of skylight is incomplete. New curb has been installed on upper sky lights but is missing on lower skylight. monitor for leakage. no moisture found during inspection. repairs and replacement of shingles noted in skylight areas.

Implication(s): Chance of water damage to contents, finishes and/or structure

Curb missing

proper installation of skylight.

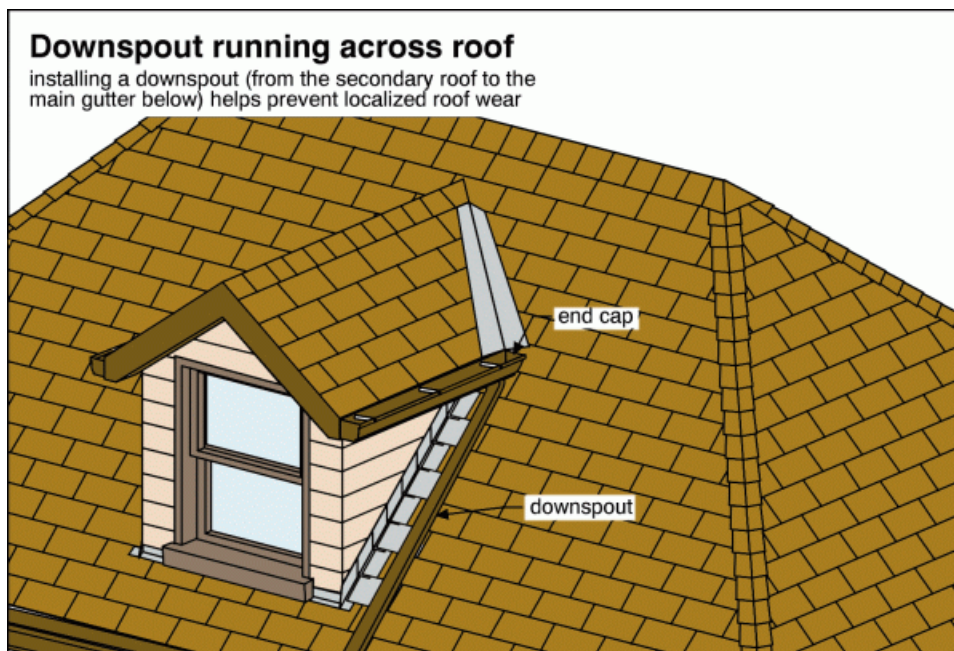
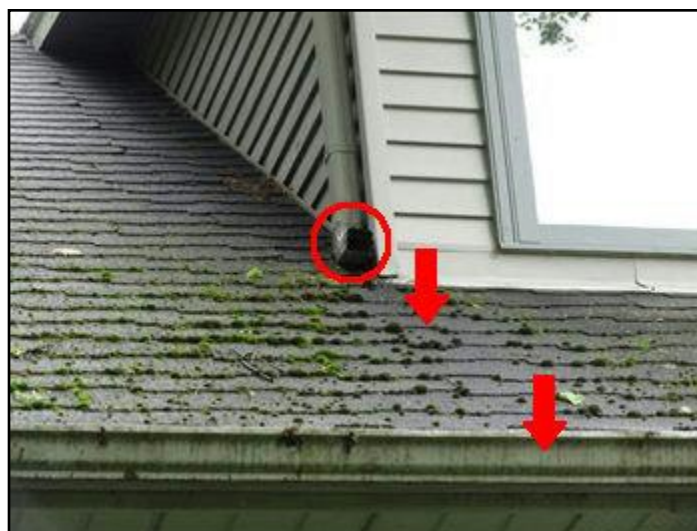
Condition: • Discharge onto roofs

Implication(s): Chance of water damage to contents, finishes and/or structure

extend down spout to lower trough to prevent further shingle wear.

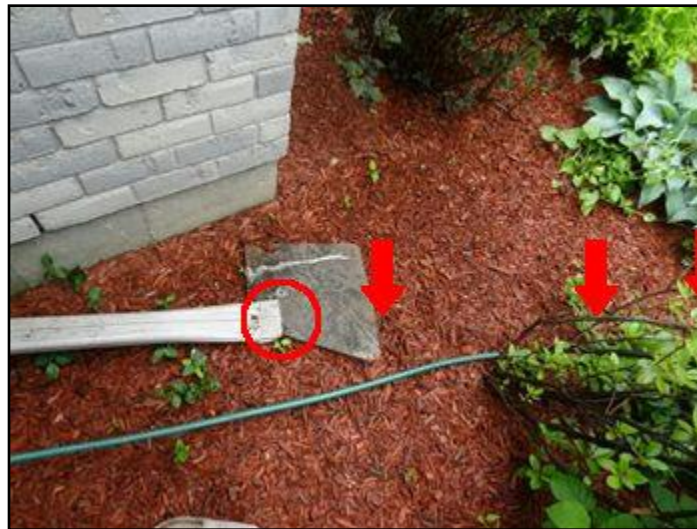
Condition: • Should discharge 6 feet from building
extend down spouts to reduce chances of water entering the basement

Implication(s): Chance of water damage to contents, finishes and/or structure

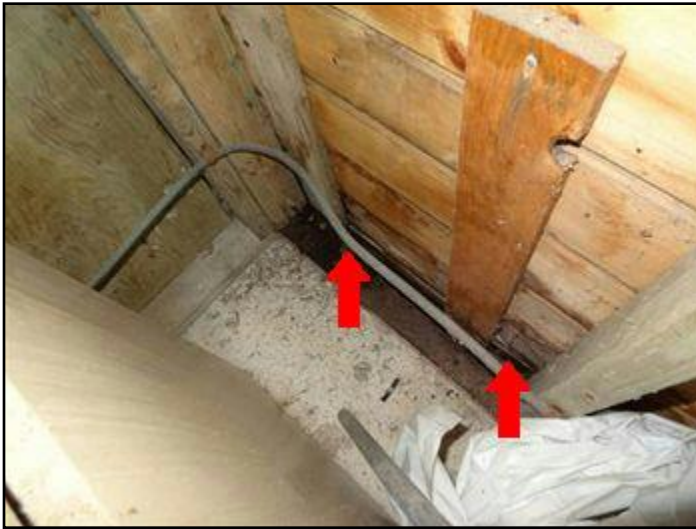
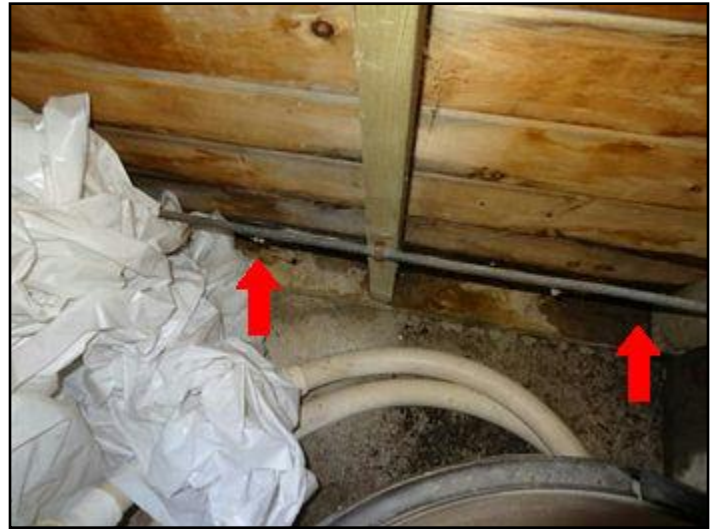
Condition: • Too close to grade
pool shed, rot noted at wall, correct as needed

Implication(s): Chance of water damage to contents, finishes and/or structure | Material deterioration | Rot | Insect damage

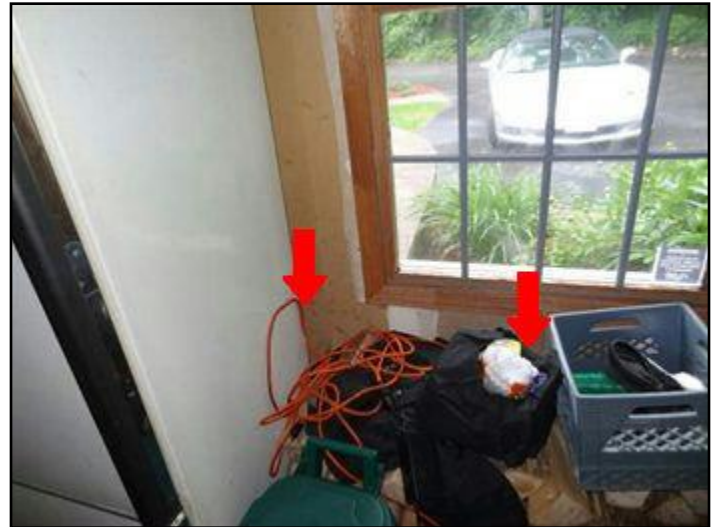
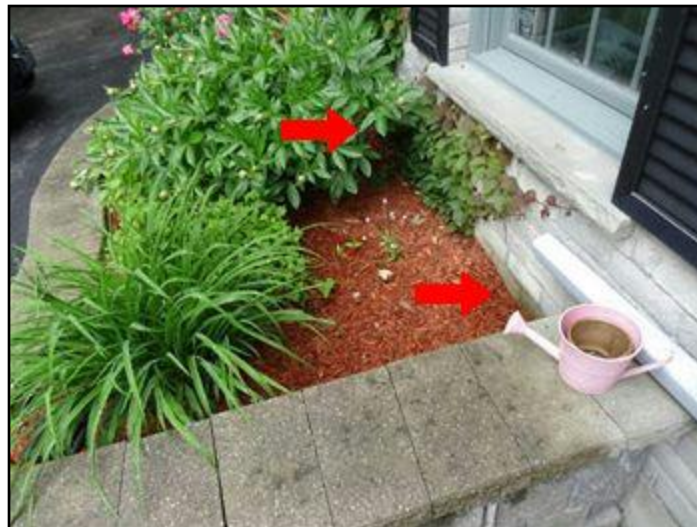
Condition: • Too close to grade

Soil is too high on brick work, should be 6 inches below bricks. signs of past repairs present in garage.

Implication(s): Chance of water entering building | Weakened structure | Rot

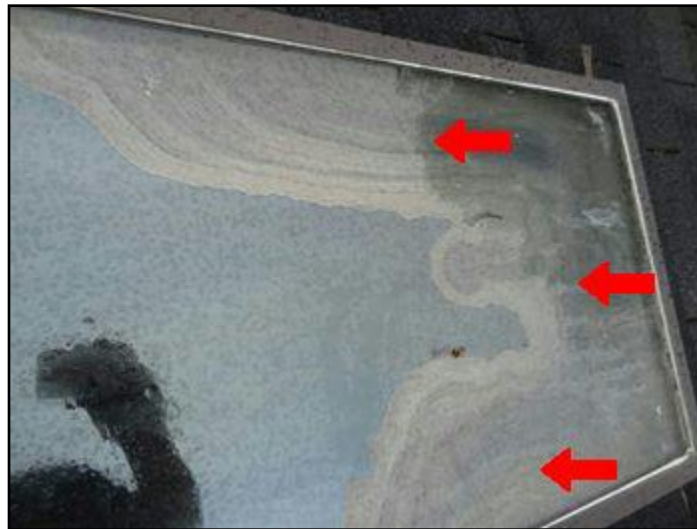
Condition: • Lost seal on double or triple glazing
seal lost on skylight, replace and needed

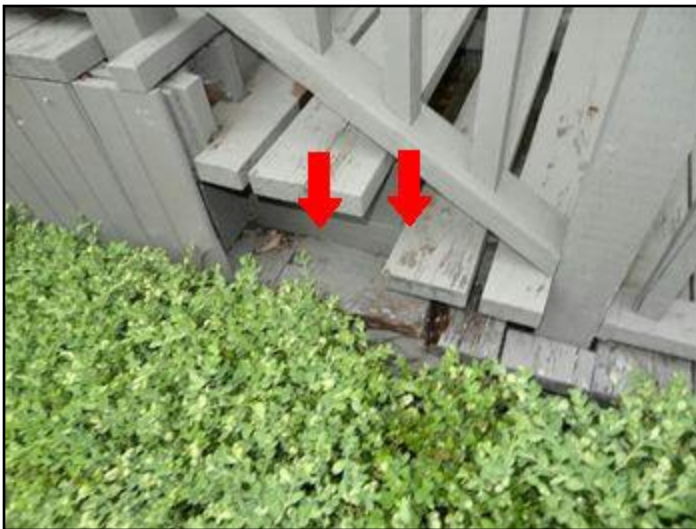
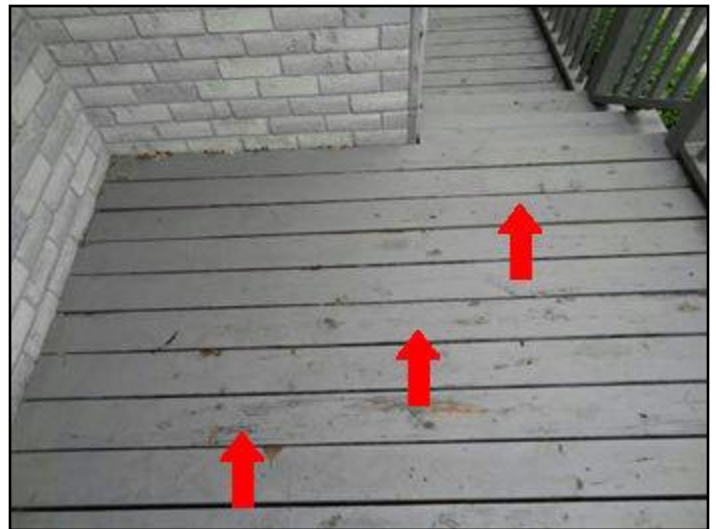
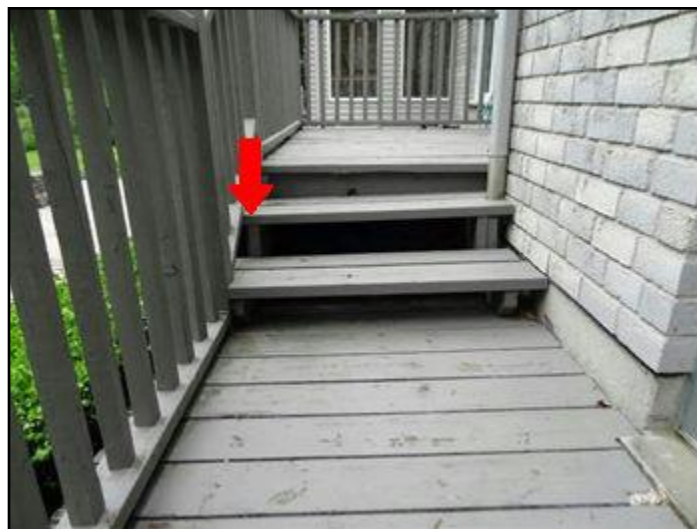
Condition: • Movement

movement noted at stairs of deck, correct downspout under stairs. correct stairs as needed. deck boards are loose

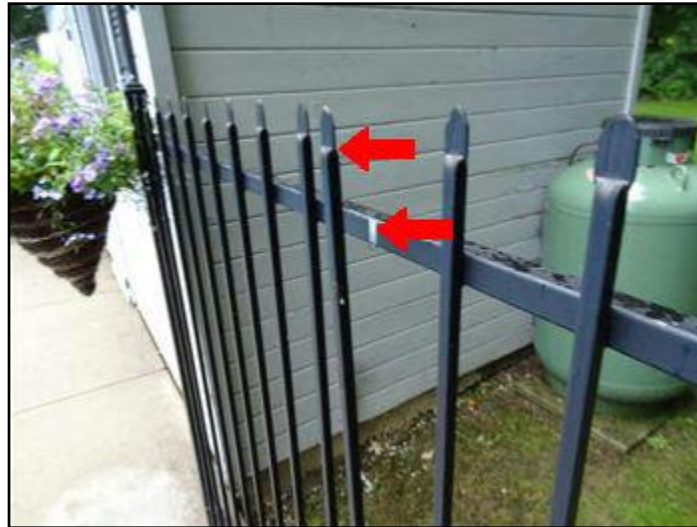
Condition: • Loose

loose spindle, correct

Implication(s): Fall hazard

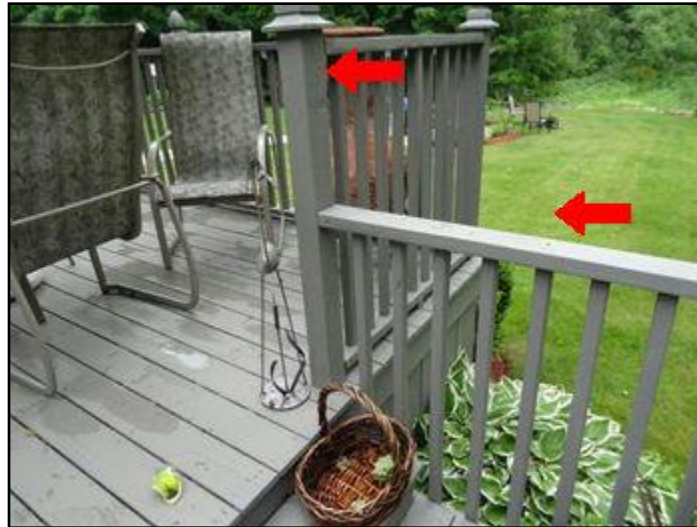
Condition: • Too low
increase the height of the railing

Implication(s): Fall hazard

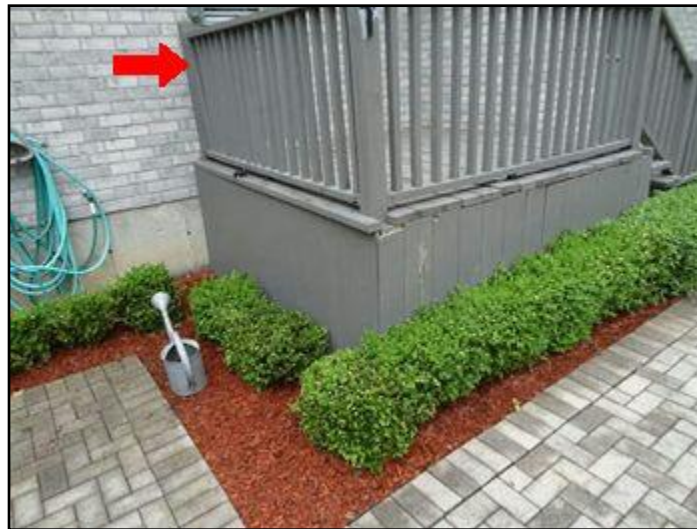
Condition: • Spindles (balusters) missing
loose spindle. correct as needed

Implication(s): Fall hazard

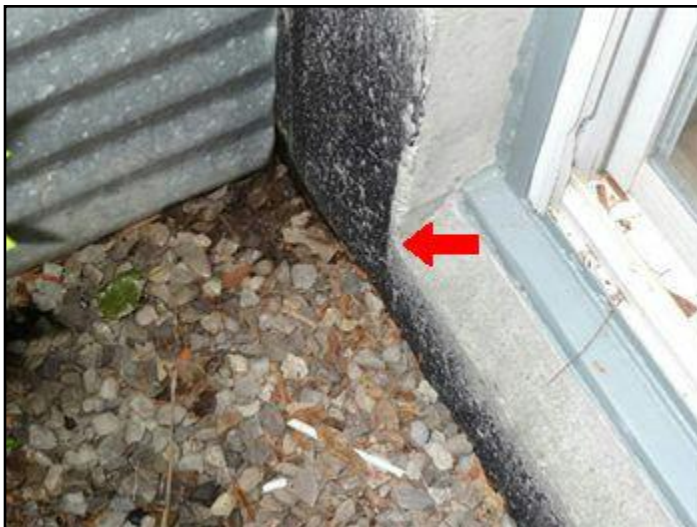
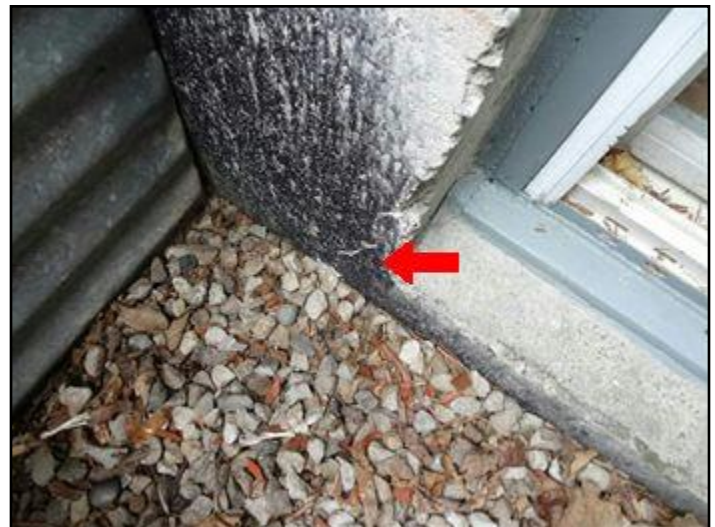
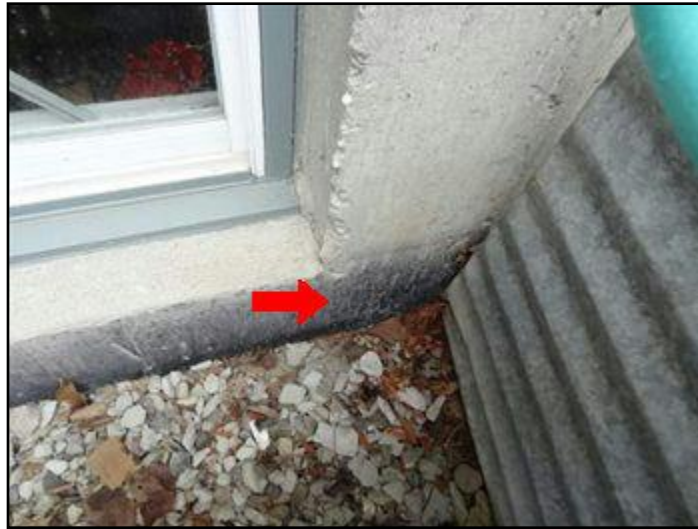
Condition: • Typical minor cracks
minor cracks in foundation, monitor for leakage and repair as needed.

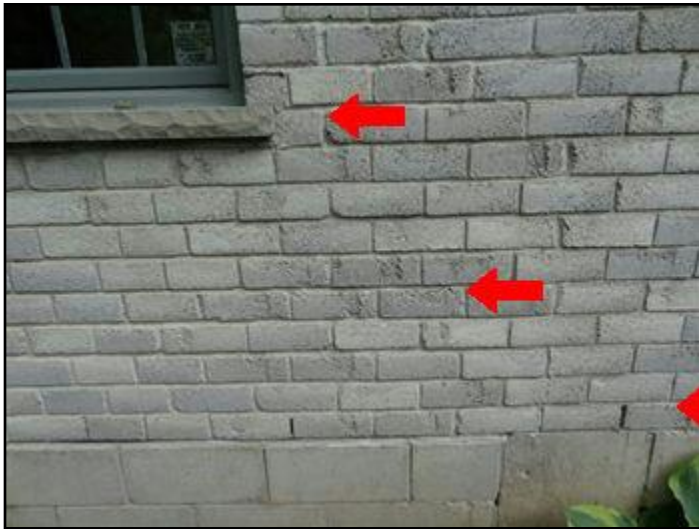
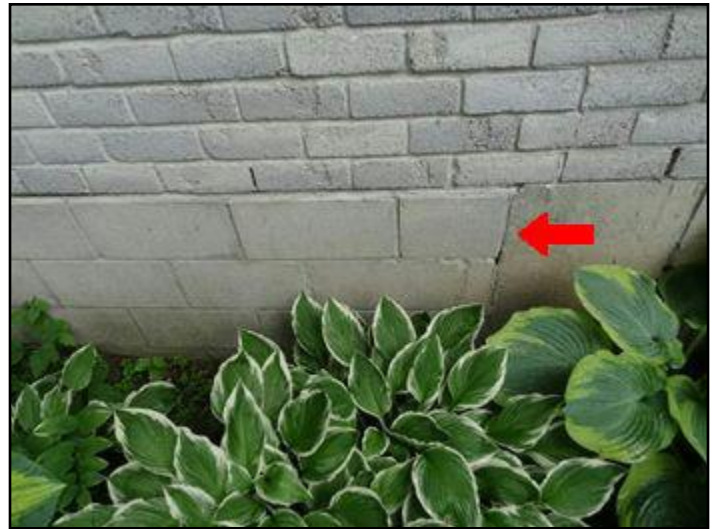
Condition: • Typical minor settlement
minor settlement, monitor for further movement.

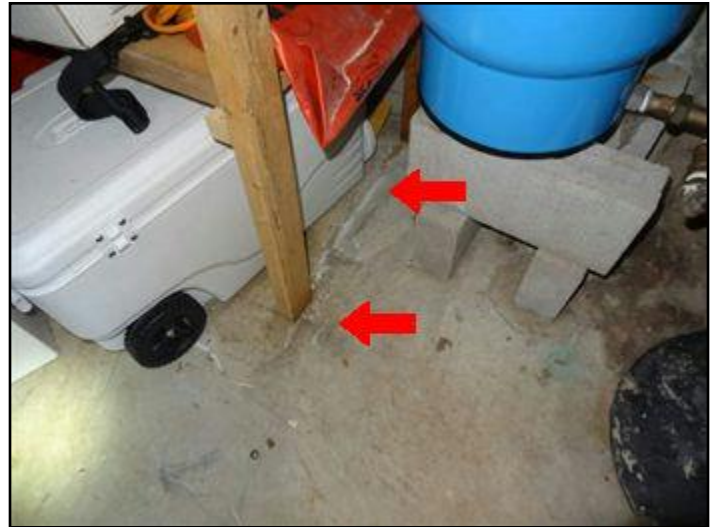
Condition: • Cracked

signs of past leakage noted at rear of the home, cracks below windows and at connection to well. monitor and correct as needed

Implication(s): Chance of water damage to contents, finishes and/or structure | Weakened structure

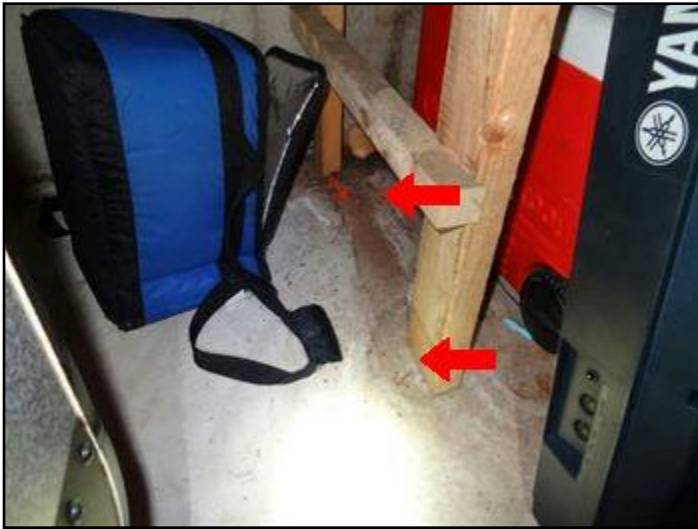
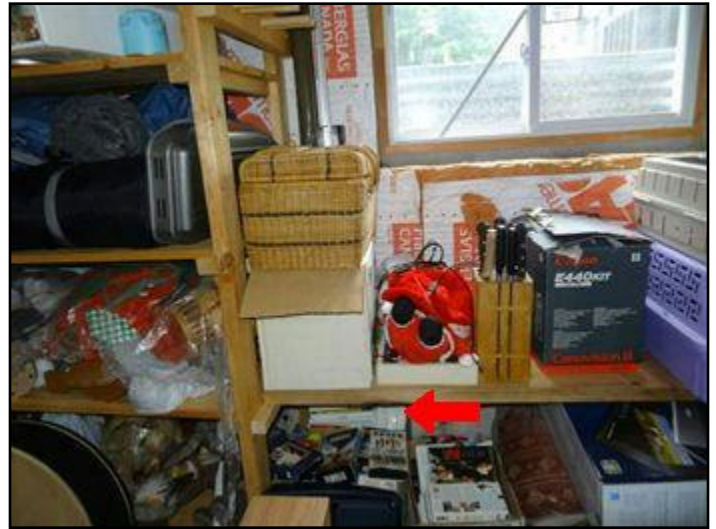
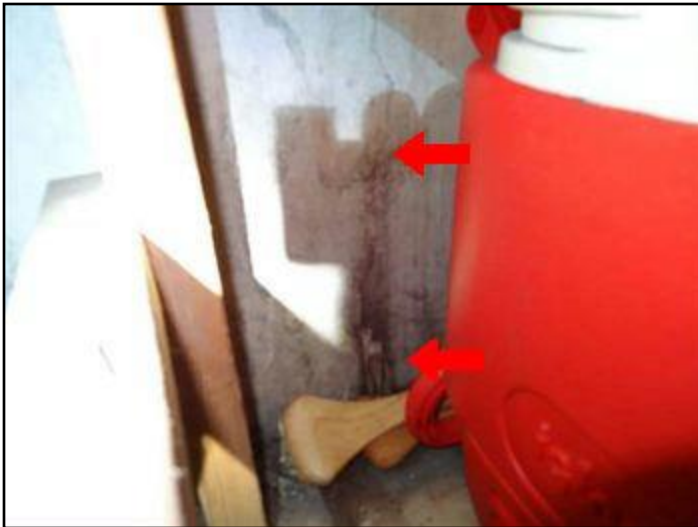
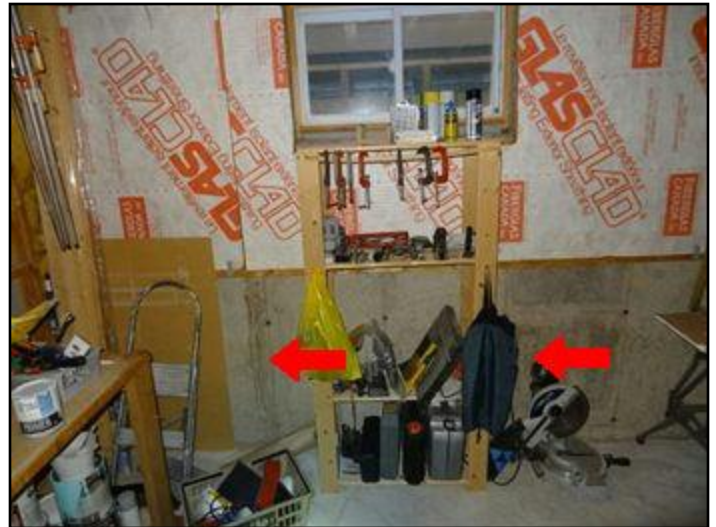
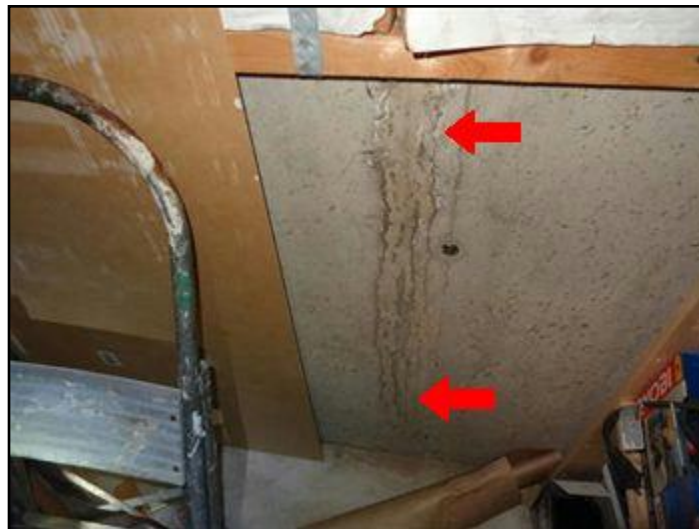
Condition: • Leaning

correct structure, loose and leaning.

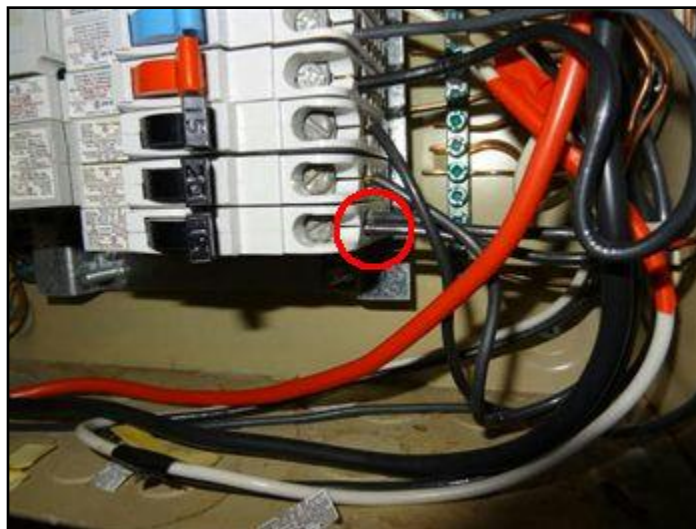
Condition: • Double taps

Implication(s): Fire hazard

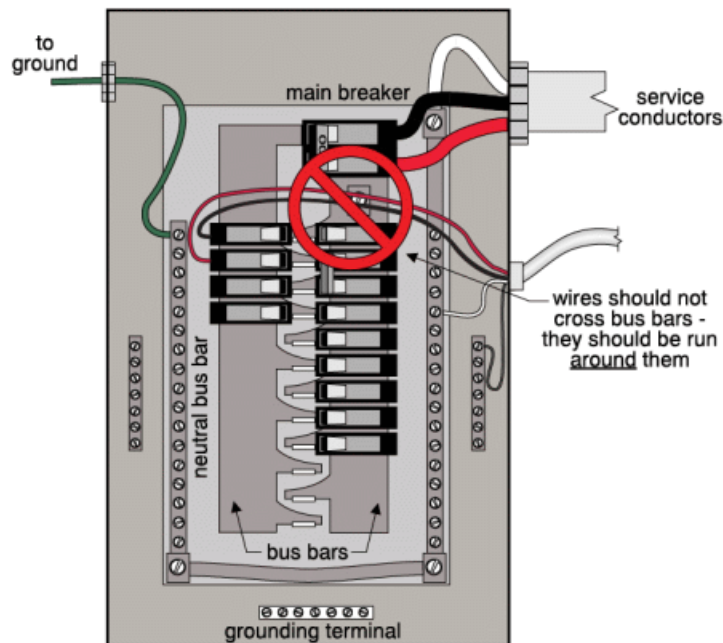
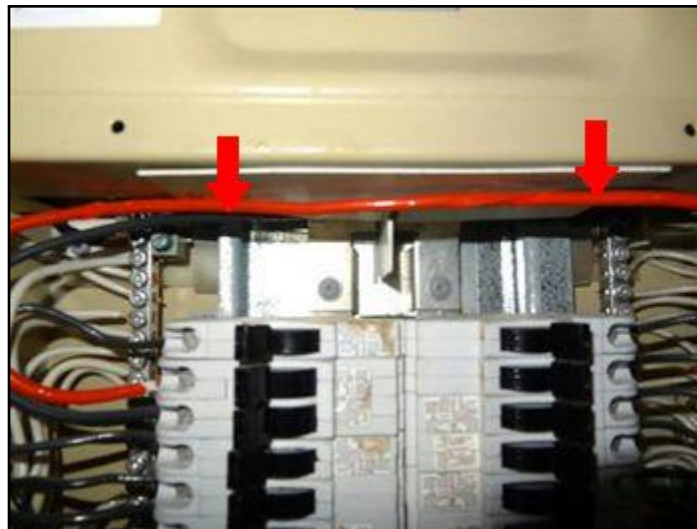
Condition: • Wire crossing bus connections

Implication(s): Electric shock | Fire hazard

Wires shouldn't cross bus bars

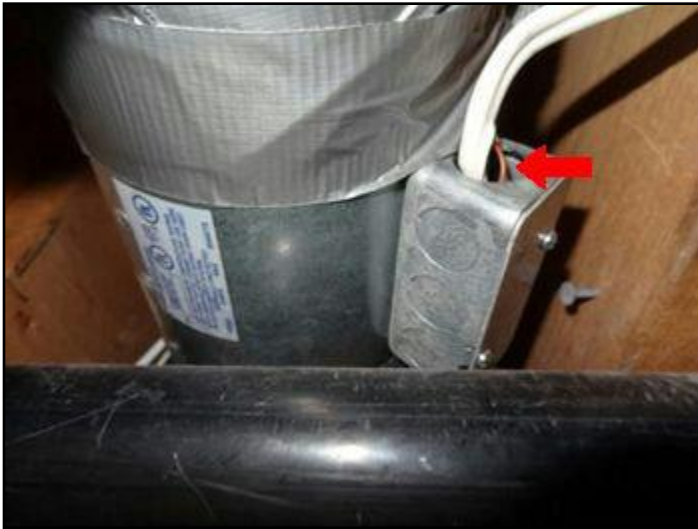
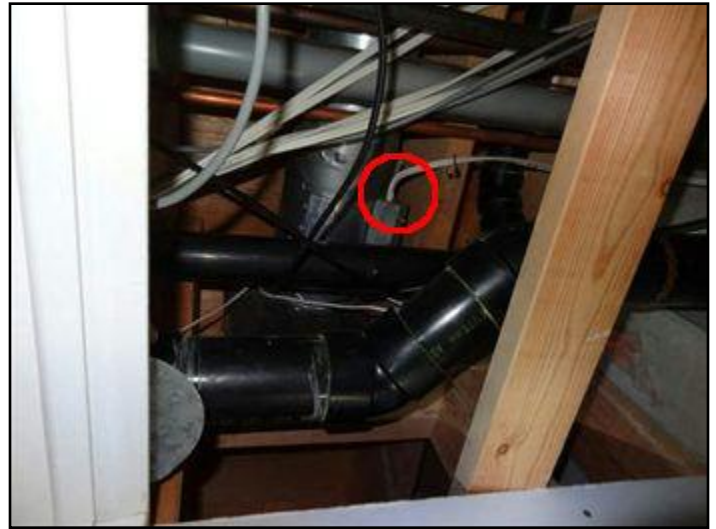
Condition: • Loose connections

wire connection at inline duct fan is loose at junction box.

Implication(s): Electric shock | Fire hazard | Interruption of electrical service

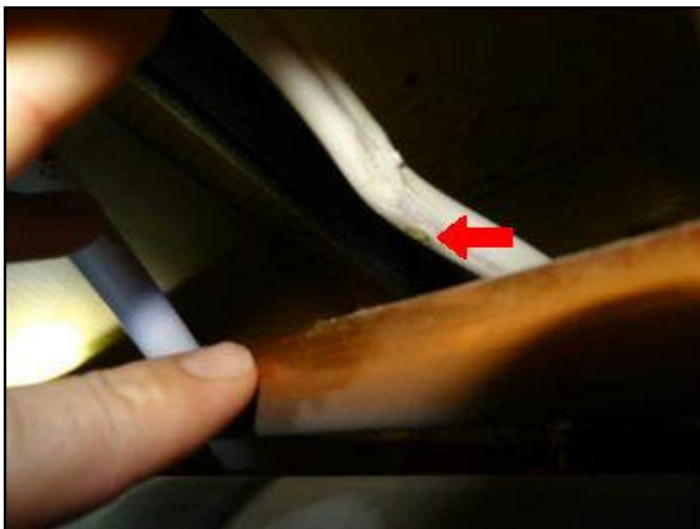
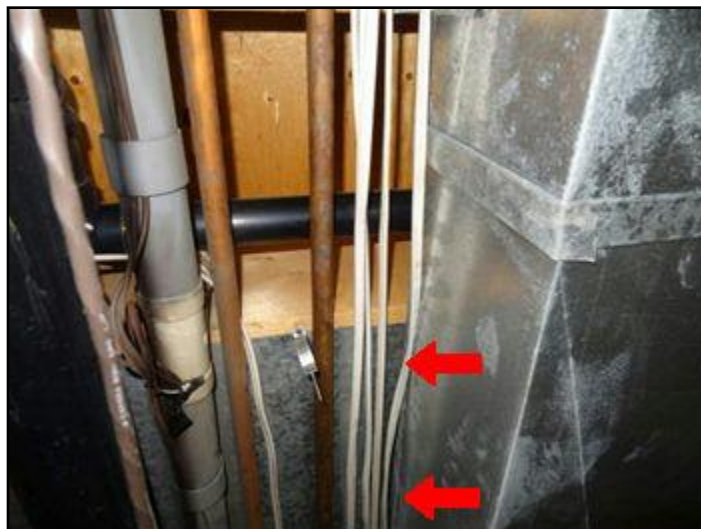
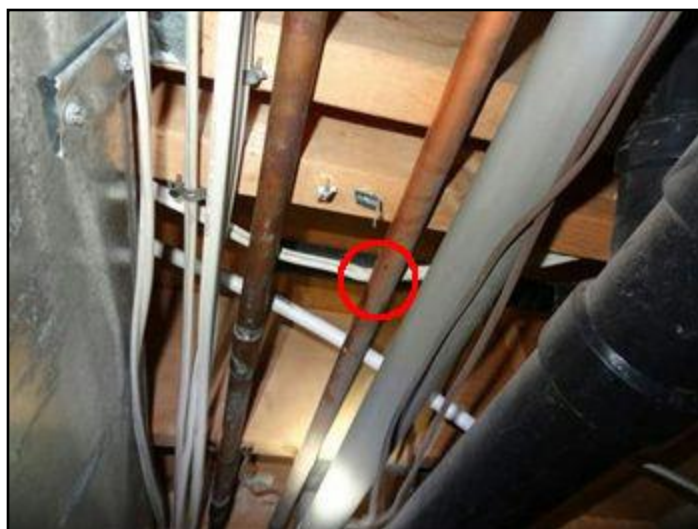
Condition: • Too close to duct, pipe, vent or chimney

Electrical wires can not touch water pipes, duct work or gas piping, correct

Implication(s): Electric shock | Fire hazard

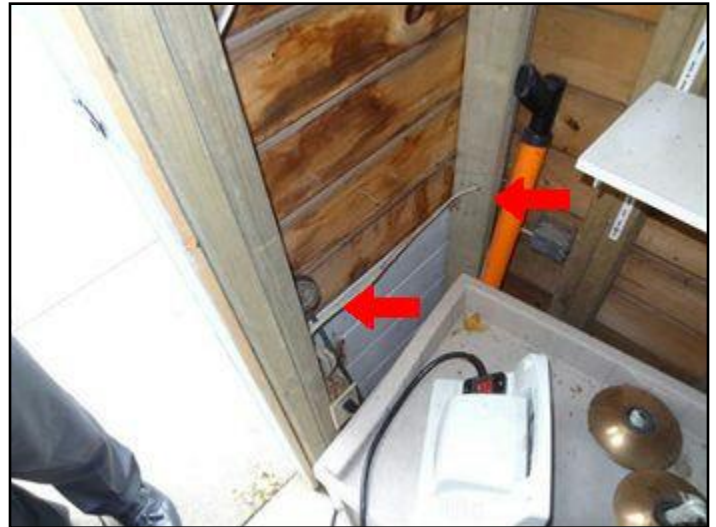
Condition: • Exposed on walls or ceilings

Protect wiring from possible damage.

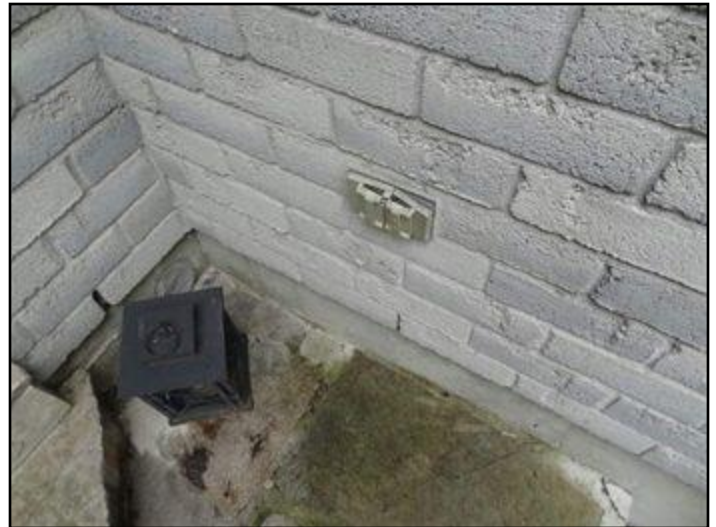
Condition: • Inoperative

outlets have no power, correct, source not found.

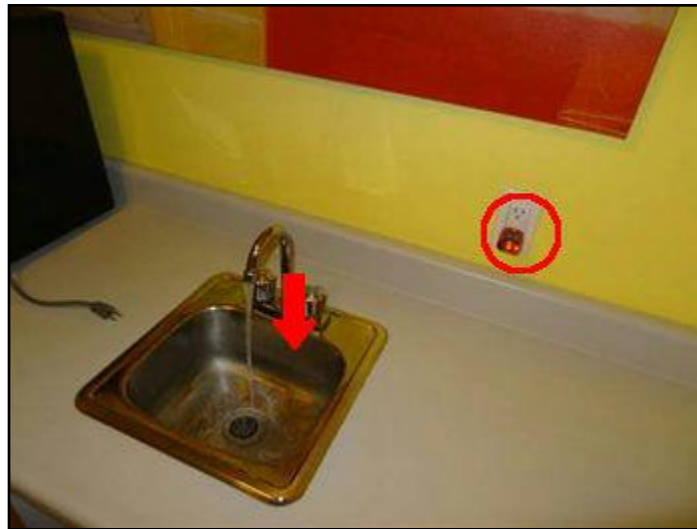
Condition: • GFCI/GFI needed (Ground Fault Circuit Interrupter)

Ensure Gfi receptacle is installed.

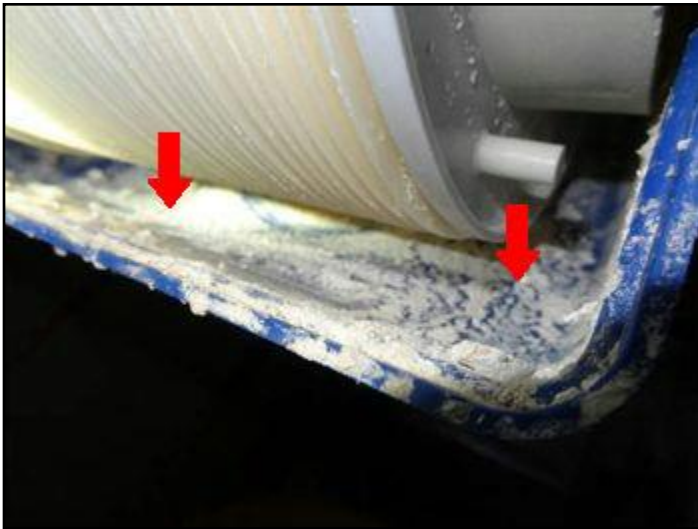
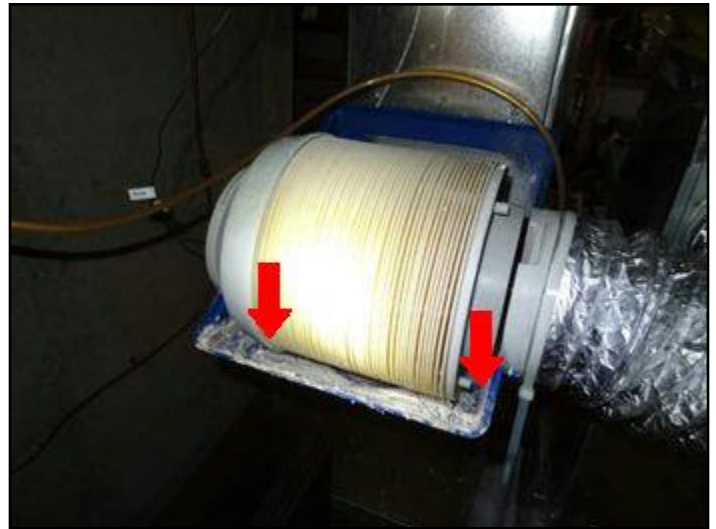
Condition: • Dirty

Clean or remove. monitor humidity in heating season. Maximum 50%RH

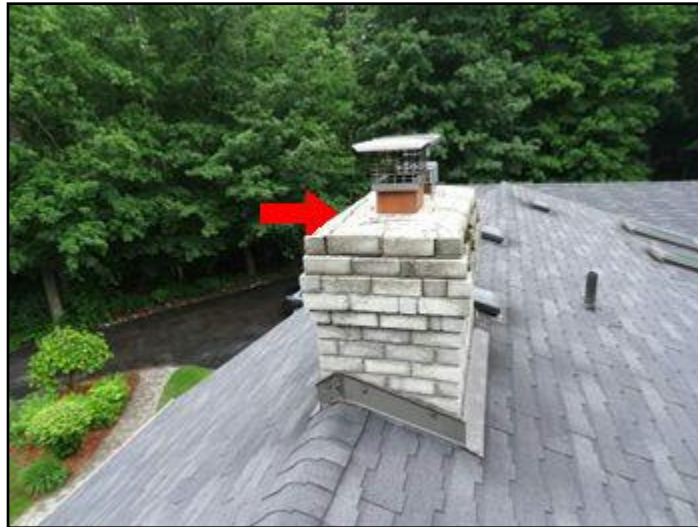
Condition: • Cracked

Seal Chimney cap to prevent leakage,

Implication(s): Chance of water damage to contents, finishes and/or structure | Shortened life expectancy of material

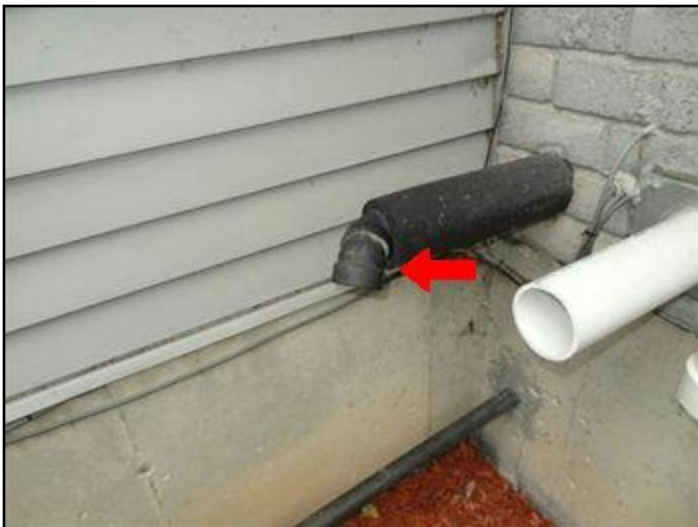
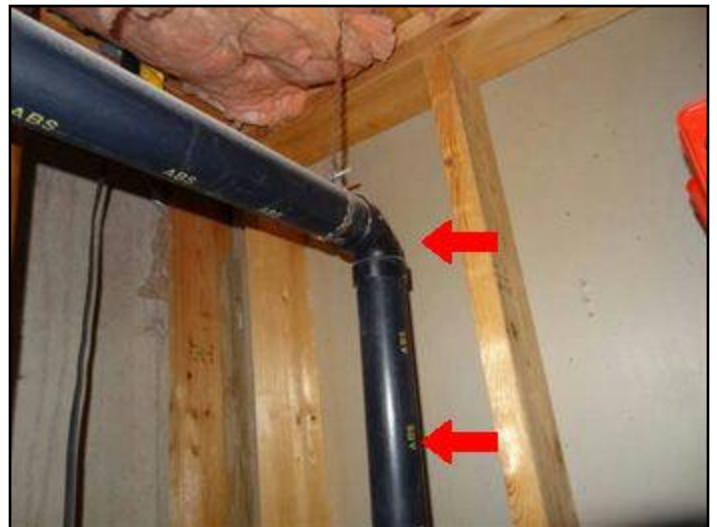
Condition: • Improper material

Replace abs vent pipe, been known to crack in the past. No cracks found during inspection.

Implication(s): Equipment not operating properly | Hazardous combustion products entering home

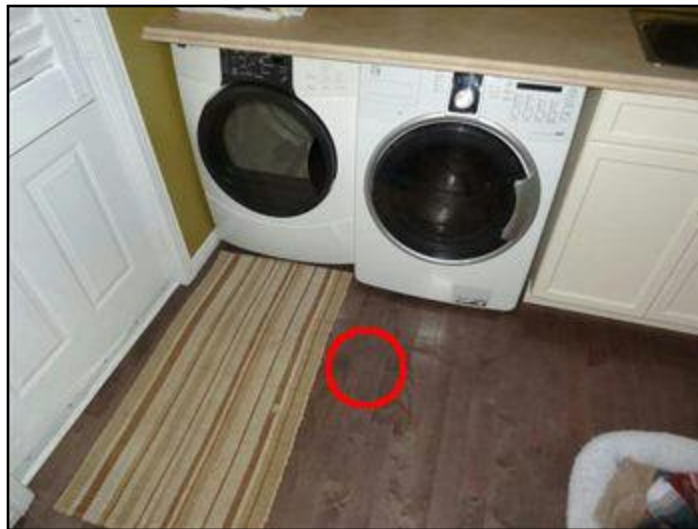
Condition: • Missing

There is no floor drain in laundry area, replace water lines with braided hoses.

Implication(s): Chance of water damage to contents, finishes and/or structure

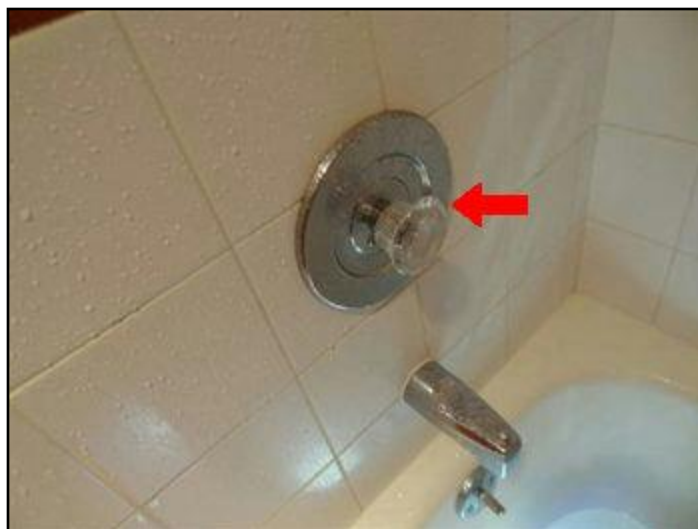
Condition: • Provide pressure balance for shower and bathtub,

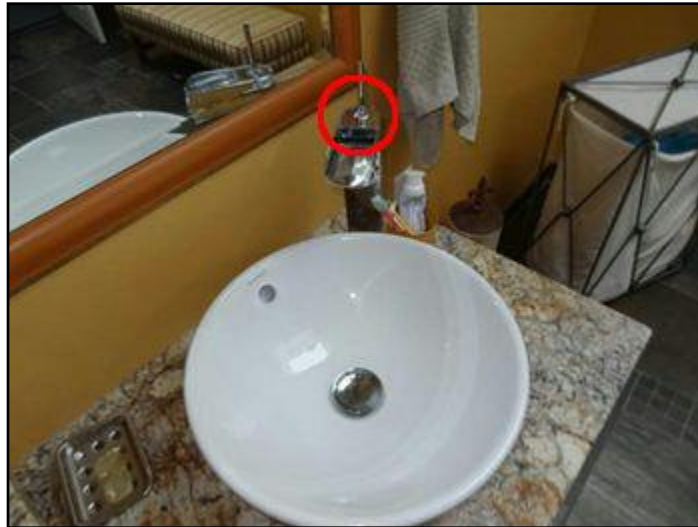
Condition: • Loose

properly secure faucet, loose

Implication(s): Equipment failure

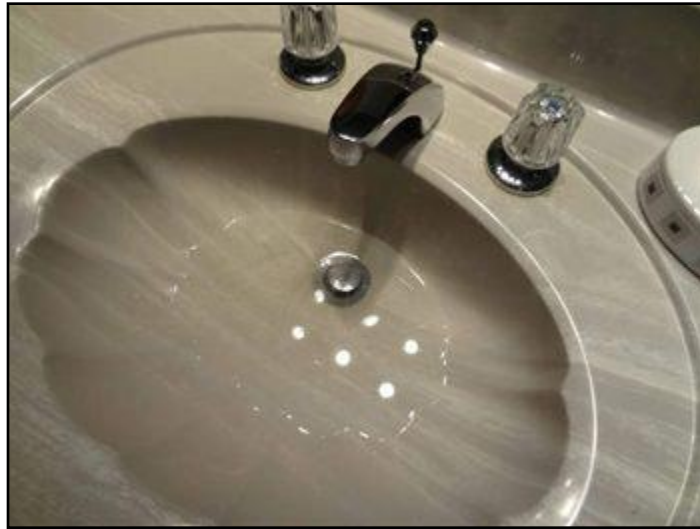
Condition: • Drain stop ineffective
repair drain stop as needed

Implication(s): Nuisance | Reduced operability
