#### FOR THE PROPERTY AT:

123 Sample Address Virginia Beach, VA 23455

Friday, June 9, 2017

RE: Report No. 1319, v.5 123 Sample Address Virginia Beach, VA 23455

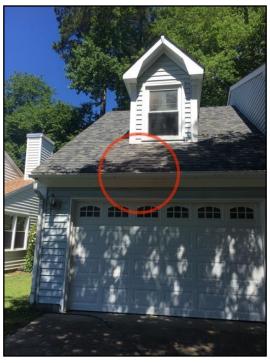
Condition: • Clogged

Implication(s): Chance of water damage to contents, finishes and/or structure

1. Clogged

**Location**: Throughout Exterior **Task**: Repair or replace

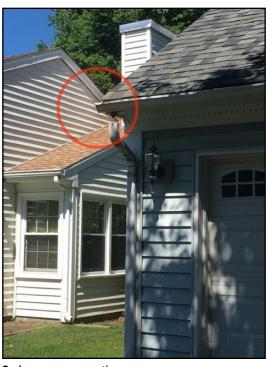
# **ROOF DRAINAGE \ Downspouts Condition:** • Loose connections

Implication(s): Leakage

Location: Front Left First Floor Exterior

3. Loose connections

Task: Repair or replace

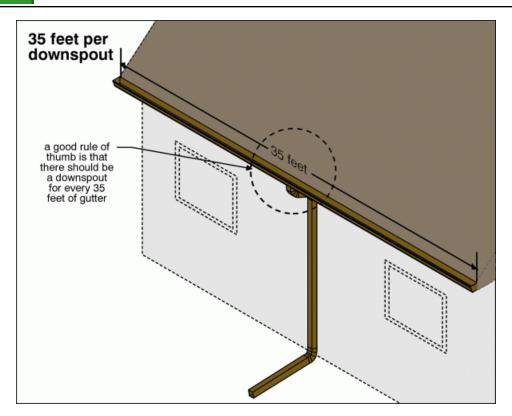
Condition: • Missing

Implication(s): Chance of water damage to contents, finishes and/or structure

4. Missing

Task: Repair or replace

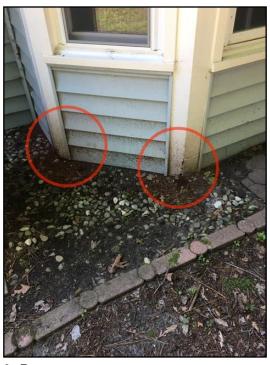
Condition: • Rot

Beside Air conditioning unit

Implication(s): Chance of water damage to contents, finishes and/or structure | Material deterioration

6. Rot

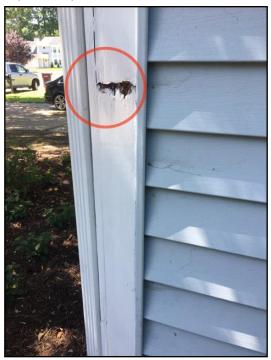
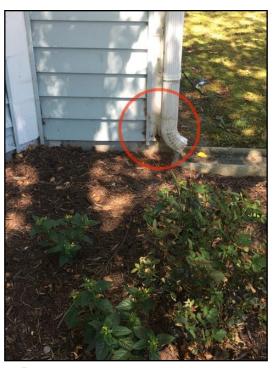
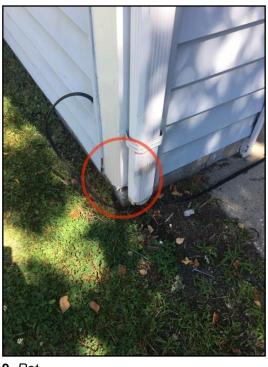
Condition: • Rot

Implication(s): Material deterioration | Chance of water damage to contents, finishes and/or structure

Location: Front Left and Right Corners Exterior

**7.** Rot

8. Rot

9. Rot

Task: Repair or replace

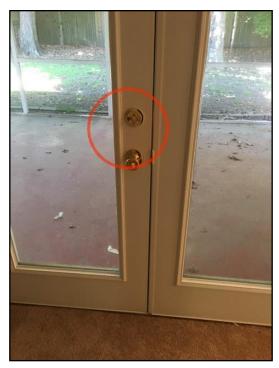
10.

**Condition:** • Bolt lock does not work **Location**: Rear First Floor Exterior

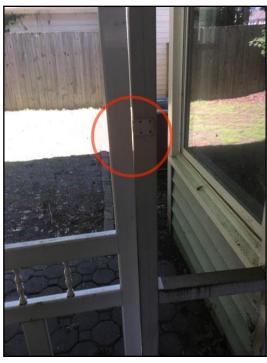
**Condition:** • Inoperable
Screen door hinges missing

Implication(s): Chance of damage to finishes and structure

11. Inoperable

**Location**: Rear Exterior **Task**: Repair or replace

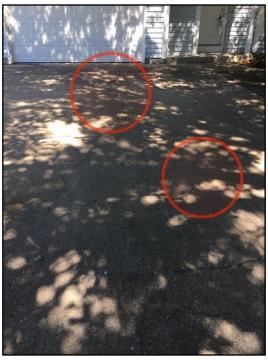
**Condition:** • Cracks in concrete driveway need to be sealed/repaired to prevent further moisture penetration/damage.

13. Cracks in concrete driveway need to be...

Task: Needs Sealing/Caulking

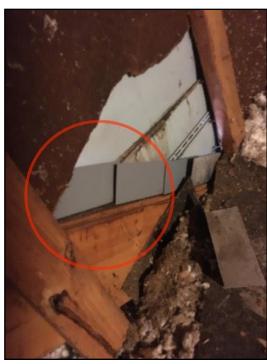
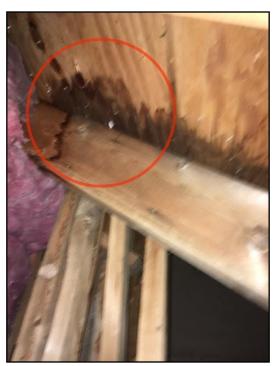
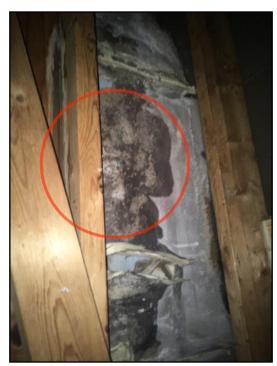
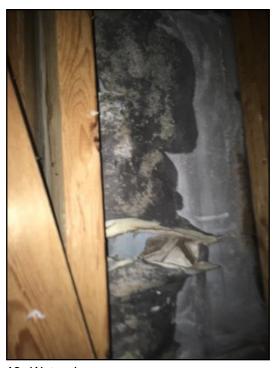
Condition: • Water damage

Water stain on sheathing and drywall at chimney **Location**: Left Side Second Floor in attic at chimney

16. Water damage

17. Water damage

18. Water damage

Task: Repair Replace

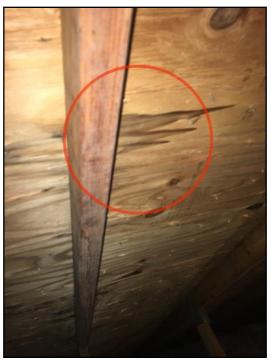
Condition: • Water stains

Small water stain right of pipe stack Implication(s): Material deterioration

Location: Rear Left Attic Task: Further evaluation

19. Water stains

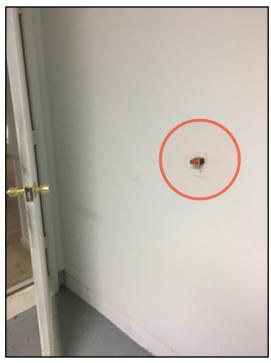
**Condition:** • Inoperative

**Location**: Front Left Garage **Task**: Repair or replace

23. Inoperative

Time: Immediate

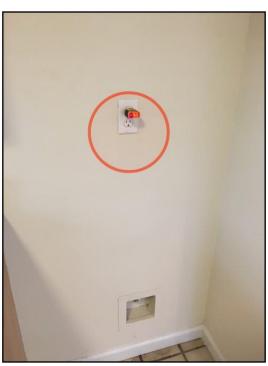
**Condition:** • Reversed polarity

Implication(s): Electric shock Location: Rear Right Kitchen Task: Repair or replace

24. Reversed polarity

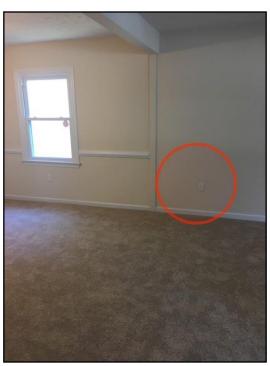
Condition: • Reversed polarity
Middle outlet on outside wall
Implication(s): Electric shock

25. Reversed polarity

Task: Repair or replace

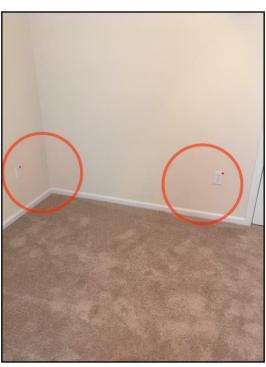
Condition: • Reversed polarity

26. Reversed polarity

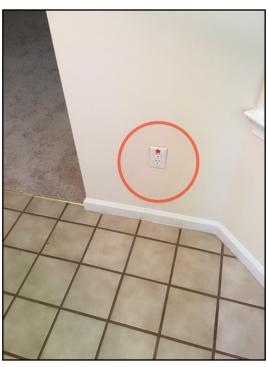
Condition: • Ungrounded Marked with red sticker

27. Ungrounded

Task: Repair or replace

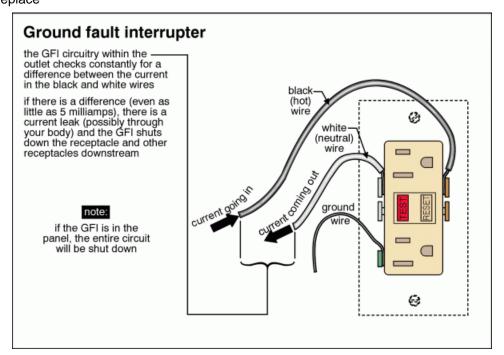
Condition: • No GFCI/GFI (Ground Fault Circuit Interrupter)

Implication(s): Electric shock Location: Front Left Garage Task: Repair or Replace

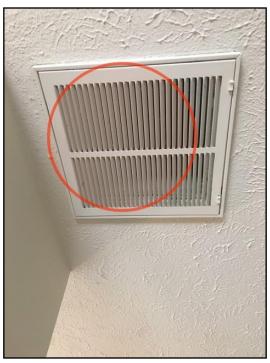
Condition: • Missing

28. Missing

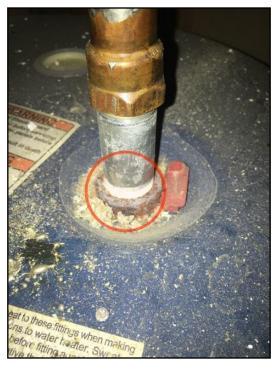
Condition: • Rust

Implication(s): Leakage

30. Rust

Task: Monitor Time: ongoing

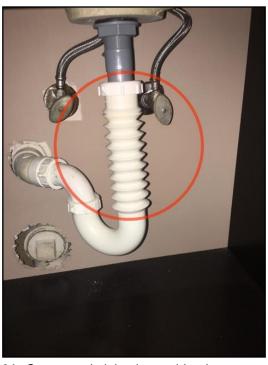
Condition: • Corrugated piping is not ridged nor recommended for household plumbing.

**31.** Corrugated piping is not ridged nor...

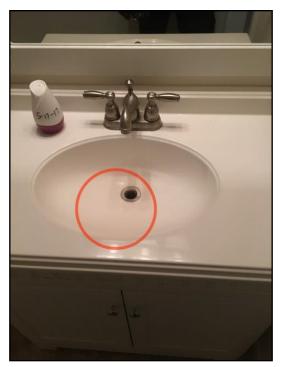
**Condition:** • Drain stop missing **Implication(s)**: Reduced operability **Location**: Second Floor Bathroom

32. Drain stop missing

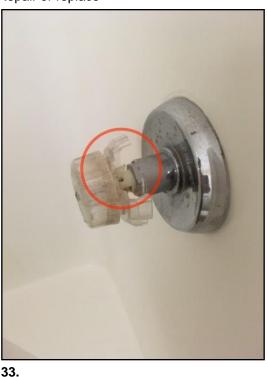
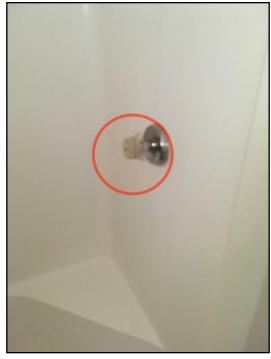
34.

Condition: • Handle is cracked

Location: Front Right Second Floor Master Bathroom

Task: Repair or replace

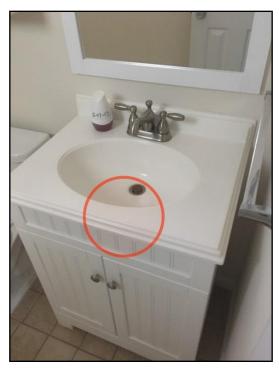
Condition: • Loose or missing pieces

Loose

38. Loose or missing pieces

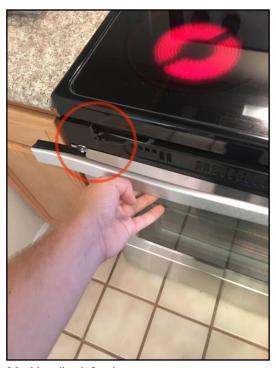
Condition: • Handle defective

Implication(s): System inoperative or difficult to operate

**Location**: Kitchen **Task**: Repair or replace

39. Handle defective

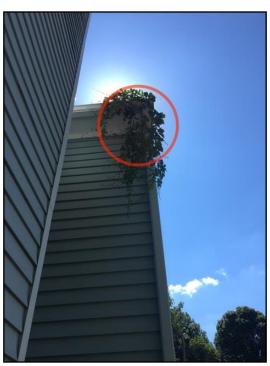
10. Condition: • Vines on building

Implication(s): Chance of pests entering building | Chance of damage to finishes

59. Vines on building

**Location**: Left Side Exterior **Task**: Repair or replace

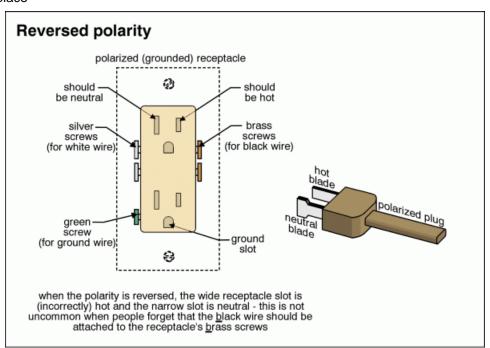
19. Condition: • Reversed polarity

Refrigerator outlet

Implication(s): Electric shock Location: Rear Right Kitchen Task: Repair or replace

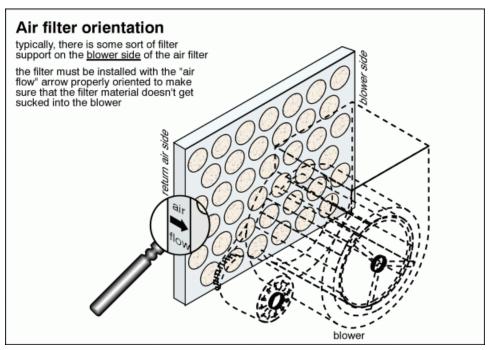
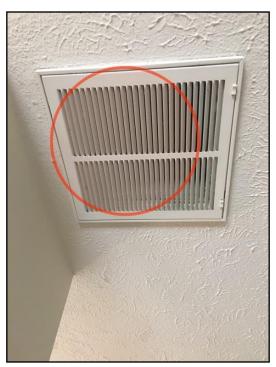
25. Condition: • Missing

Location: Middle First Floor Living Room

88. Missing

Task: Repair or replace

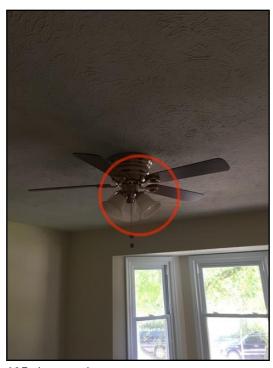
**34. Condition:** • Inoperative **Implication(s)**: Reduced comfort

Location: Right Side Second Floor Bedroom

105. Inoperative

Task: Repair or replace

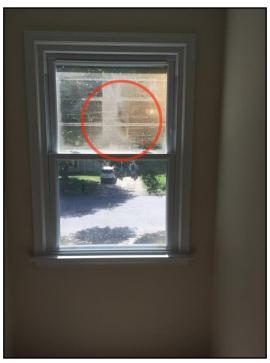
35. Condition: • Lost seal on double or triple glazing

106. Lost seal on double or triple glazing

Task: Repair or replace
