Your Inspection Report

XXX Sample street
Calgary, AB

INSPECTION DATE:
Tuesday, March 11, 2008

Hawkeye Property Services
426 21 ave NE
Calgary, AB T2E 1S6

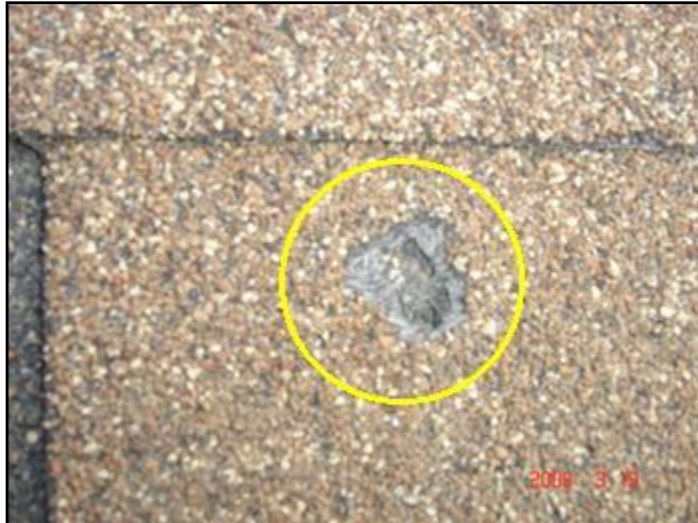
1.

Condition: • [Damage](#)

one spot of burn though

Implication(s): Chance of water damage to contents, finishes and/or structure

Location: lower edge east side

Task: Replace

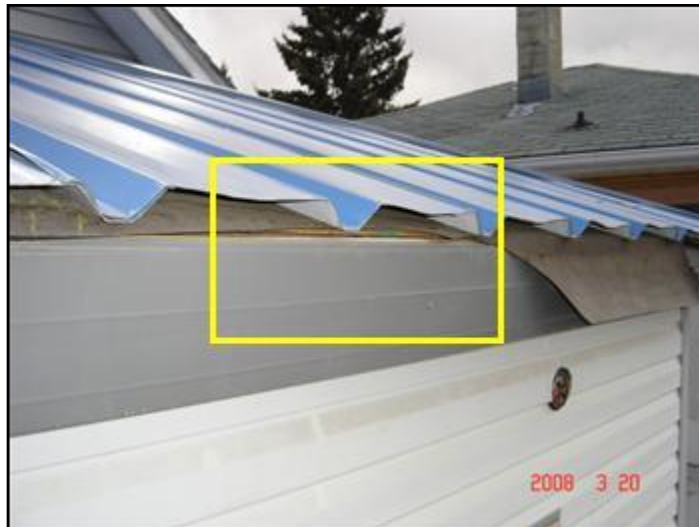
Condition: • [Overhangs too big or small](#)

Implication(s): Chance of water damage to contents, finishes and/or structure

Task: Replace

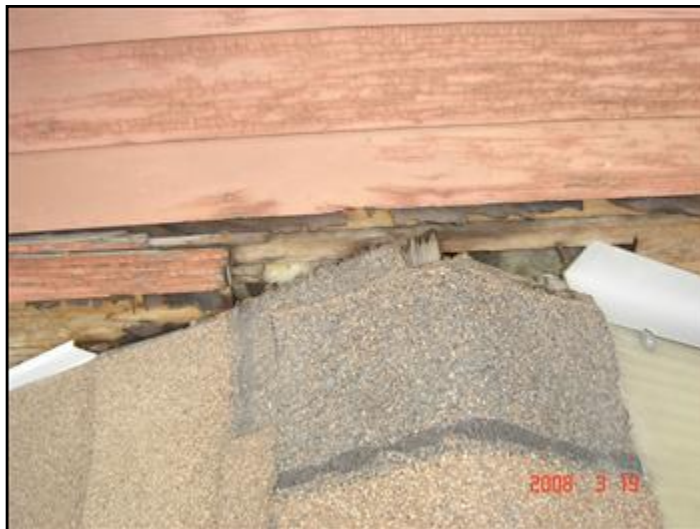
Condition: • Incomplete flashing

Implication(s): leakage, structural damage

Task: Replace

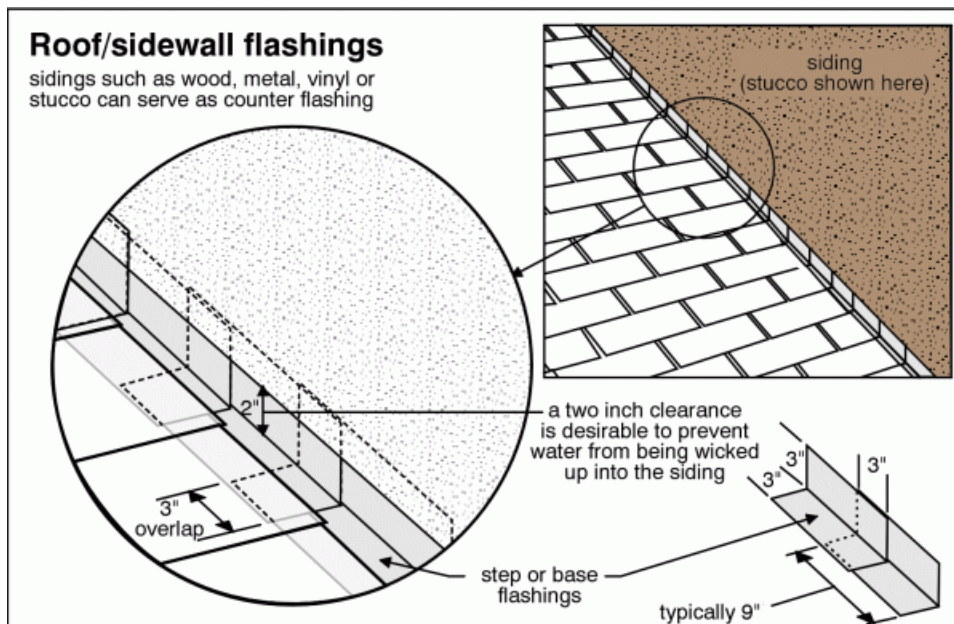
6.

Condition: • [No step or counter flashings](#)

Implication(s): Chance of water damage to contents, finishes and/or structure

Task: Replace

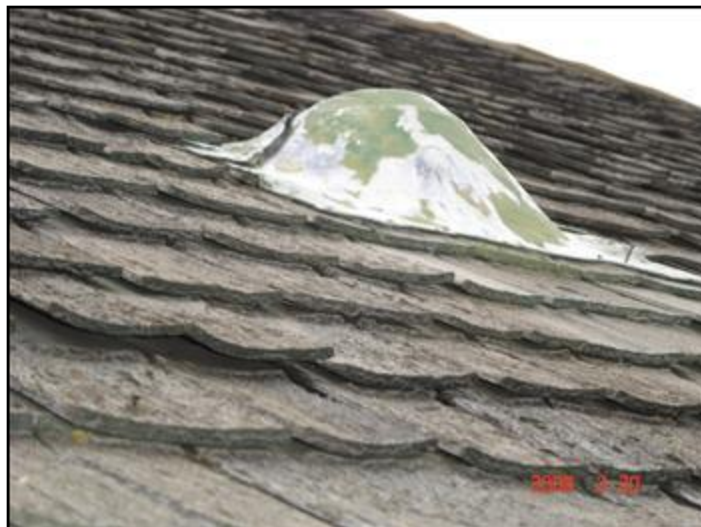
Condition: • Very old plumbing stack flashing, likely failed, replace when re-roofing.

Implication(s): Leakage

Task: Replace

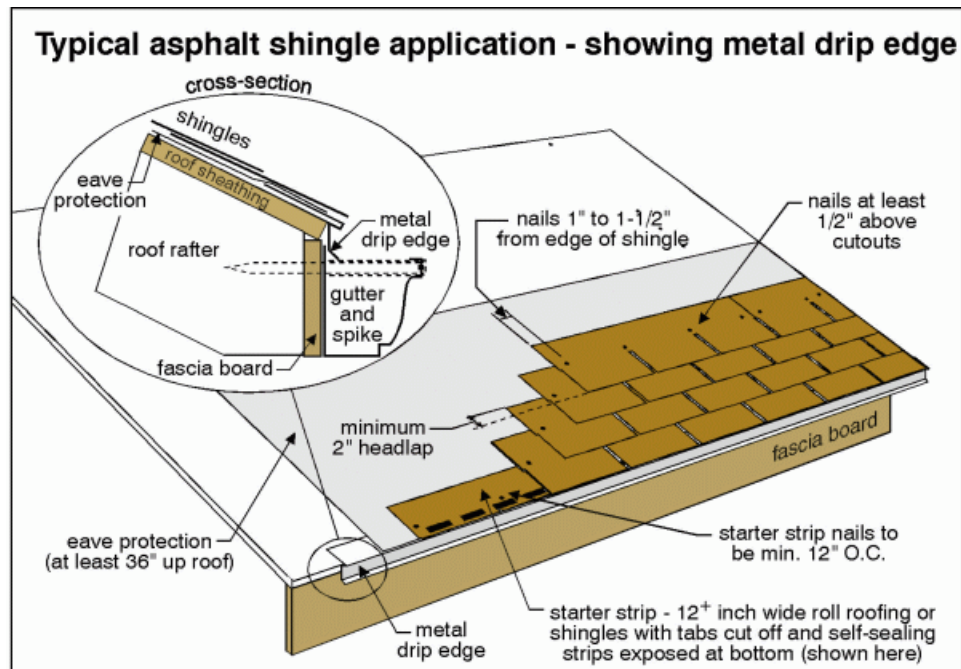
Condition: • [Missing](#)

Implication(s): Chance of water damage to contents, finishes and/or structure

Task: Improve

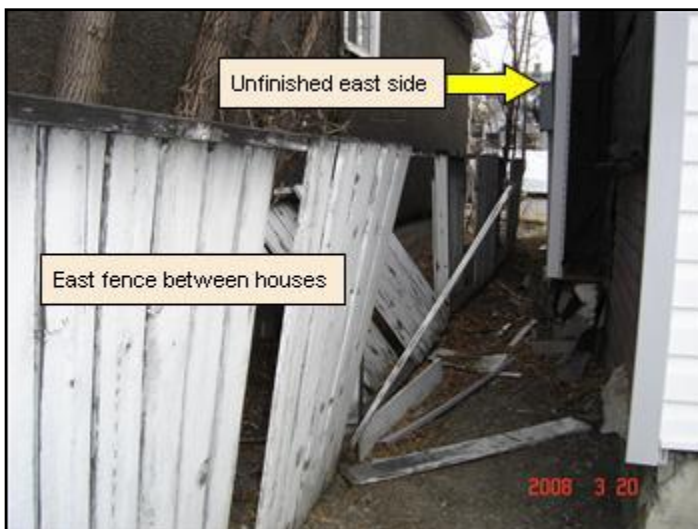
Fence in very poor condition, several trees growing on both fence lines.

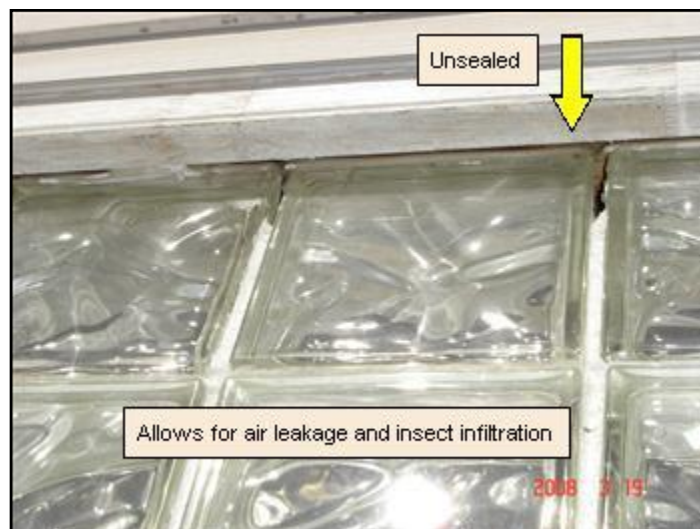
Condition: • [Caulking missing, loose or deteriorated](#)

Implication(s): Chance of water damage to contents, finishes and/or structure

Task: Repair or replace

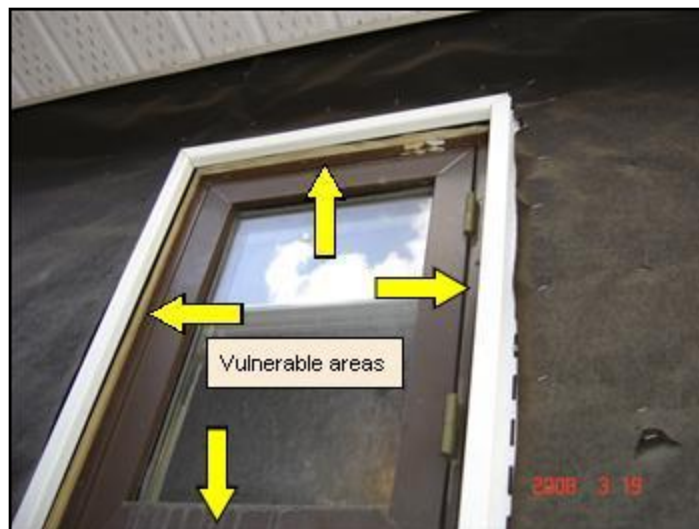
Condition: • [Missing or loose pieces](#)

Implication(s): Cosmetic defects | Chance of water damage to contents, finishes and/or structure

Task: Provide appropriate finish

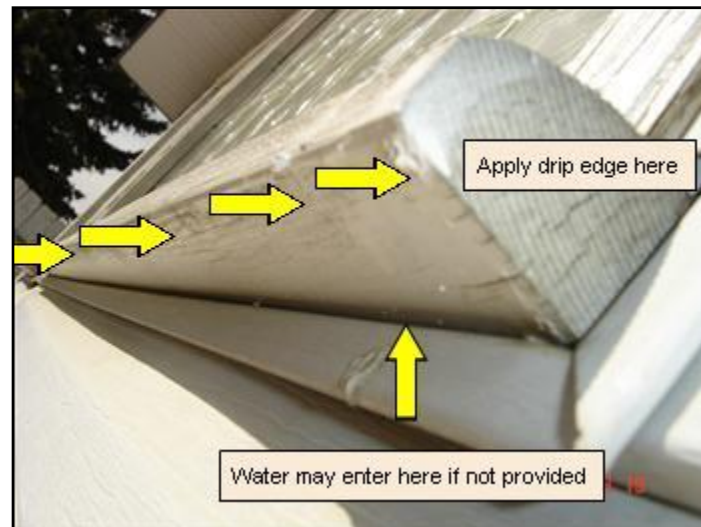
Condition: • [No capillary break \(drip edge\) on sill](#)

Implication(s): Chance of water damage to contents, finishes and/or structure

Task: Repair or replace

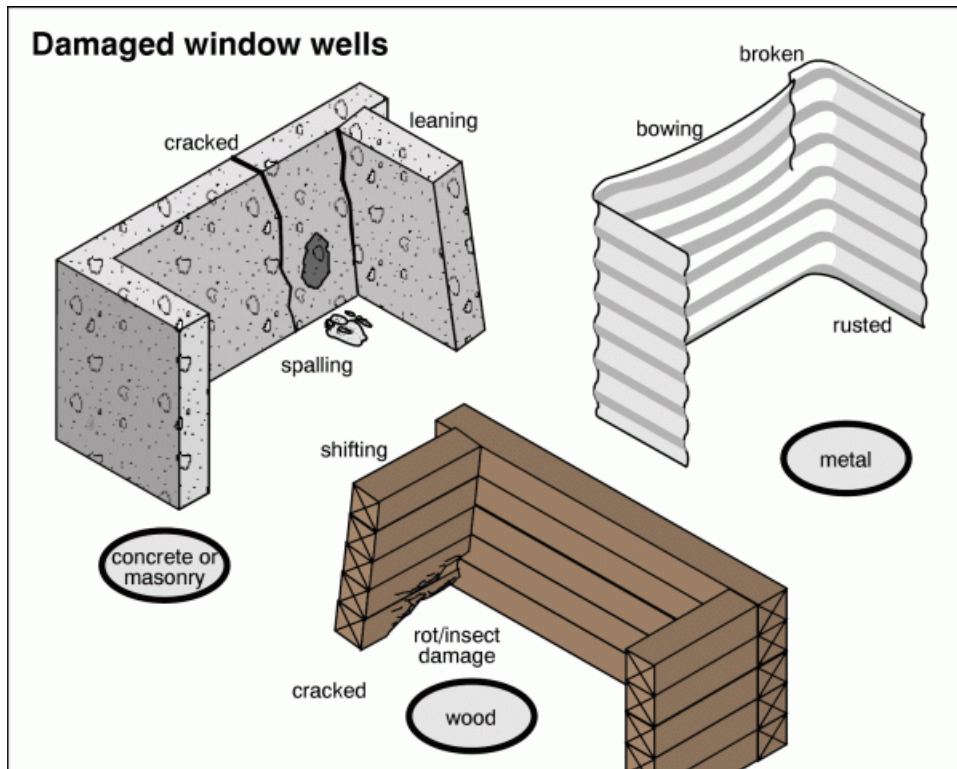
Condition: • [Wood/soil contact](#)

Proper roof drainage will go a long way to slowing deterioration of this window well, loose screen used to prevent pest entry needs repair.

Implication(s): Rot

Task: Improve

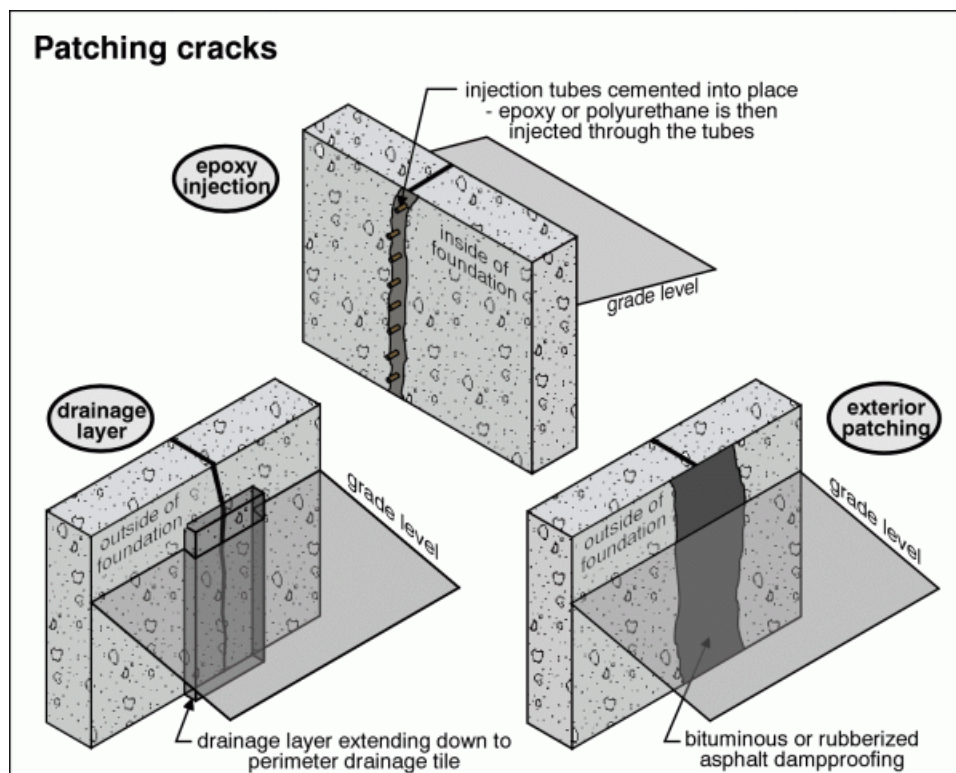
Condition: • [Exposed foundations - cracked or spalled](#)

Correct roof drainage and monitor cracks for movement, if movement continues professional involvement recommended.
See structural section.

Implication(s): Chance of water entering building | Chance of damage to structure | Chance of structural movement

Task: Monitor

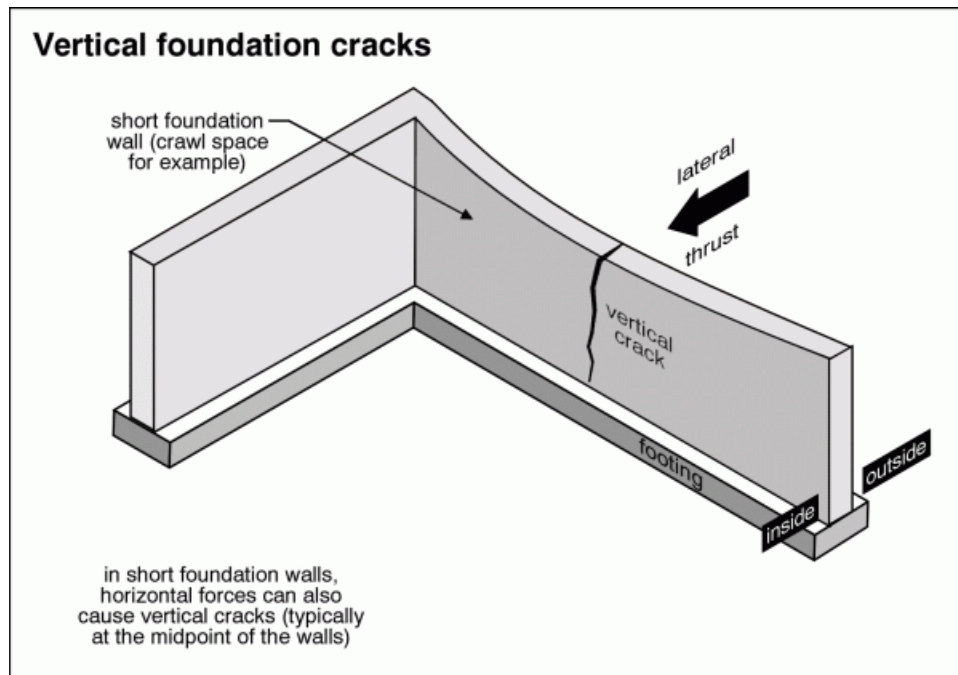
Condition: • [Cracked](#)

Prior repair to vertical crack by hose bib reopened, corresponds with cracked parging on exterior.

Implication(s): Chance of water damage to contents, finishes and/or structure | Weakened structure

Task: Monitor

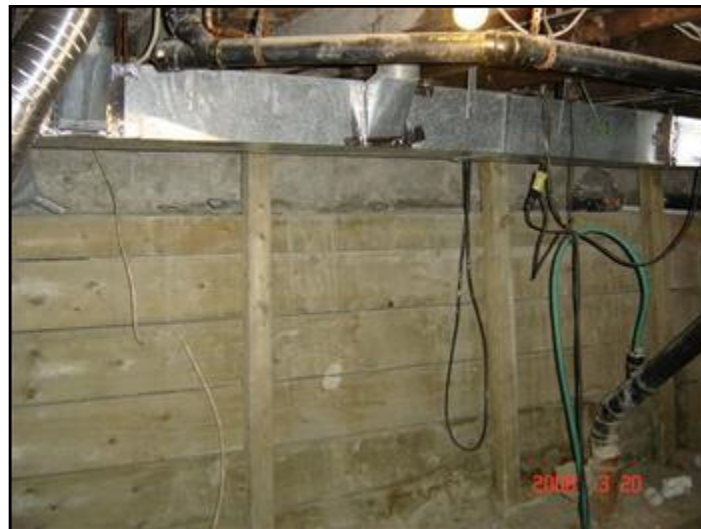
Condition: • [Prior repairs](#)

Foundation wall shored up by wood structure, columns buried at bottom and attached to joist at top to prevent lateral movement, no clues of further movement noted. Repair starts on the north side next to furnace and extends around the perimeter terminating on west wall. Approximately 65% of foundation supported in this manner, cracks and evidence of movement visible on unsupported sections. Correct roof drainage situation and monitor for further movement, consult specialist if movement continues.

Task: Monitor

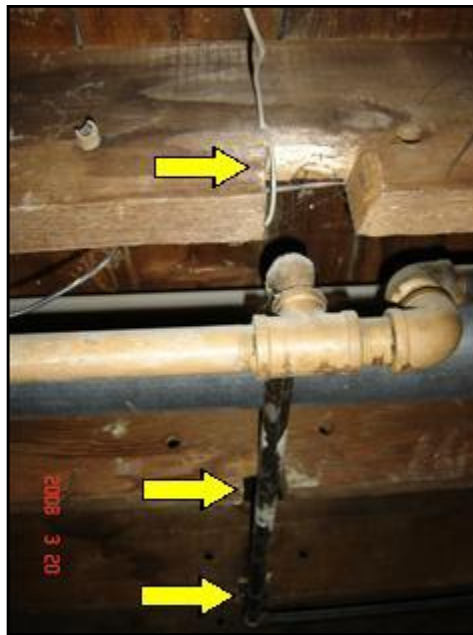
49.

Condition: • [Poor end bearing, joist hanger connections](#)

Existing joist at repaired area unsupported, provide joist hanger (easy fix) as soon as possible. Notched end bearing of joist may be prone to splitting under excessive loads, no condition currently noted.

Task: Repair/ Monitor

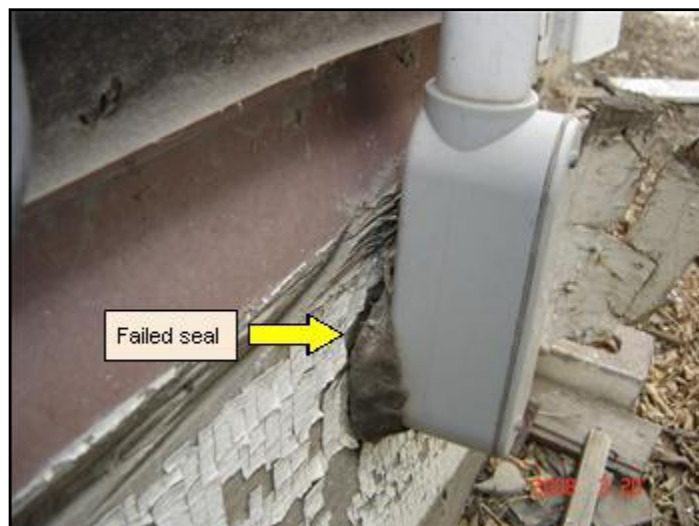
Condition: • Failed seal on conduit penetration.**Location:** Northeast Exterior wall**Task:** Improve**Time:** Less than 1 year

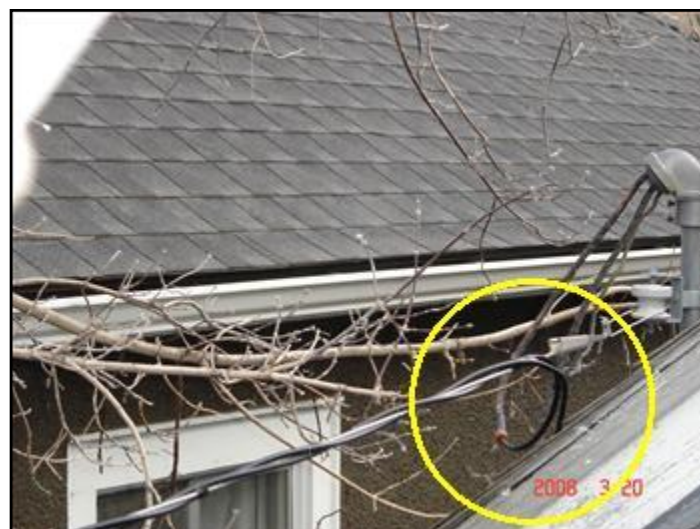
Condition: • [Drip loop too low \(touching roof\)](#)

Task: Further evaluation

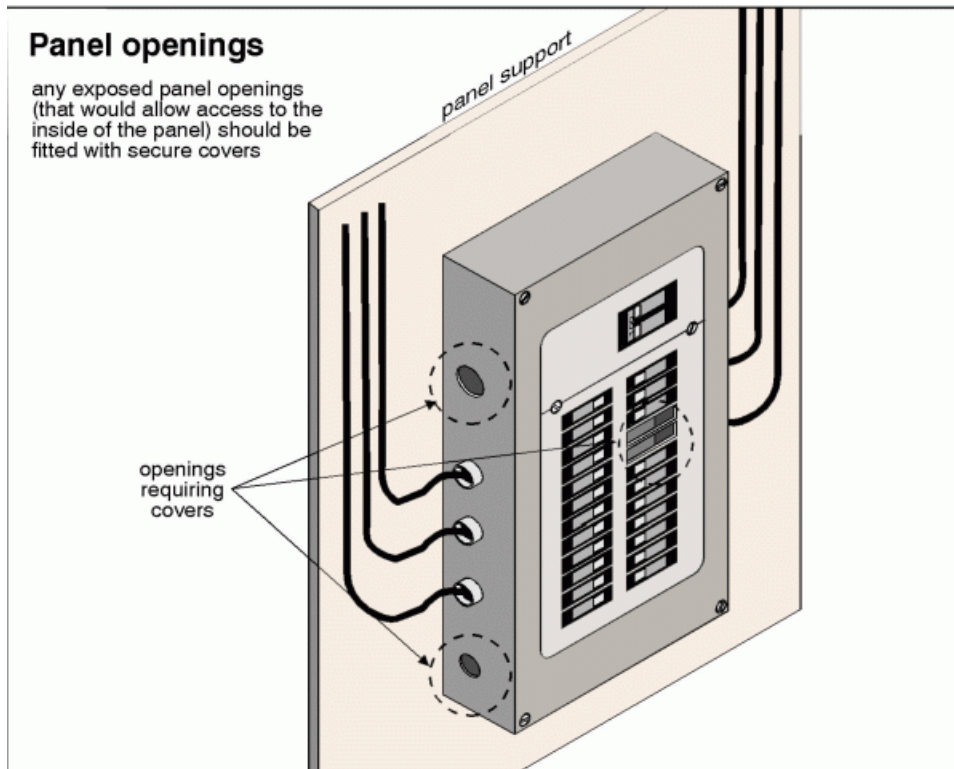
Condition: • [Openings in panel](#)

Implication(s): Electric shock | Fire hazard

Task: Provide

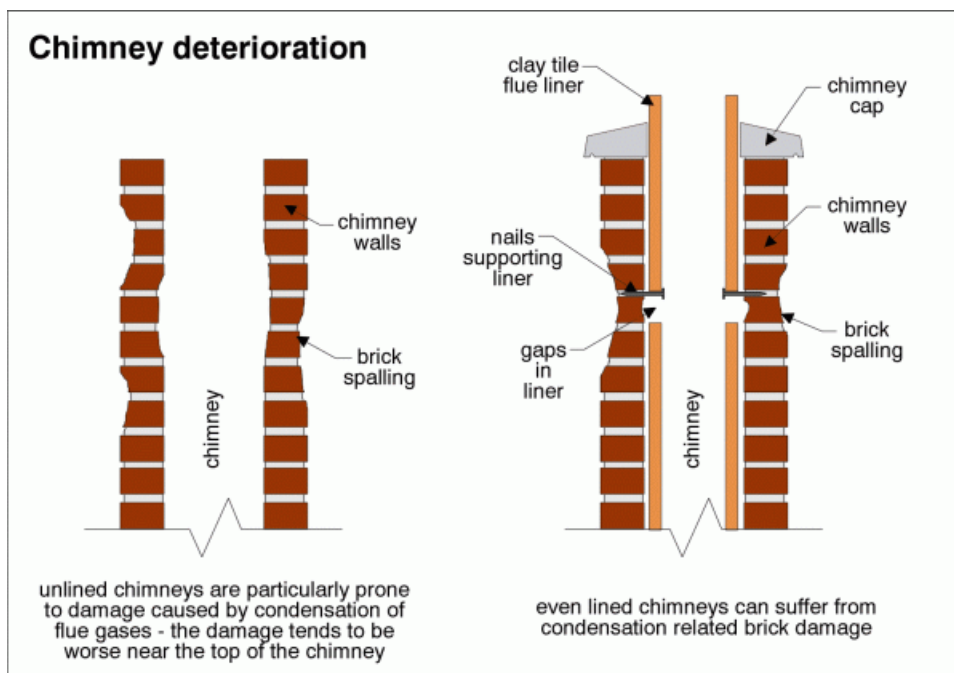
Condition: • [Loose, missing or deteriorated masonry](#)

Portion of masonry chimney above roof line in very poor condition, pieces may fall off and cause damage or injury, remove when re-roofing. Provide adequate flashing for active metal flue serving furnace and hot water heater

Implication(s): Material deterioration

Task: Remove

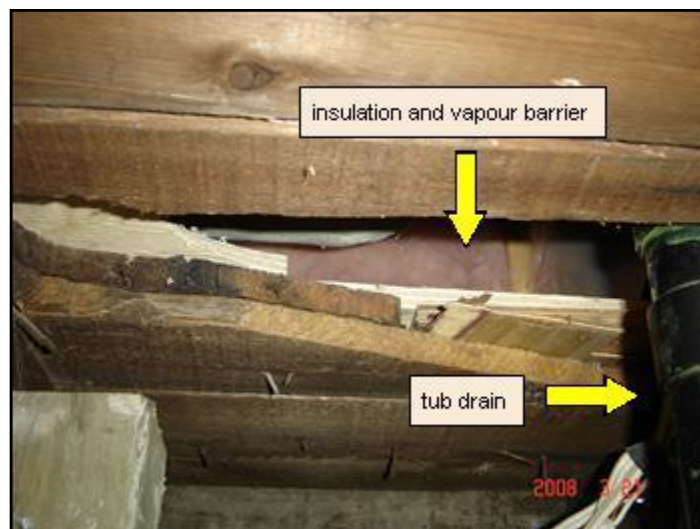
Condition: • [Evidence insulation has been added](#)

south side

Location: West Crawl space

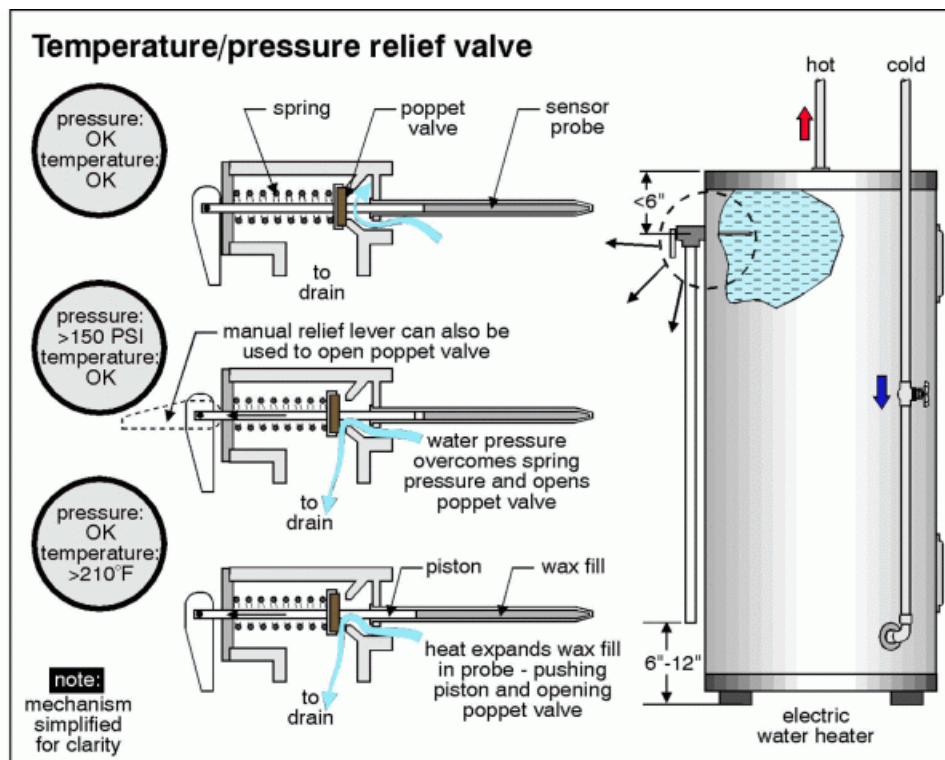
Condition: • [Discharge tube missing](#)

Task: provide

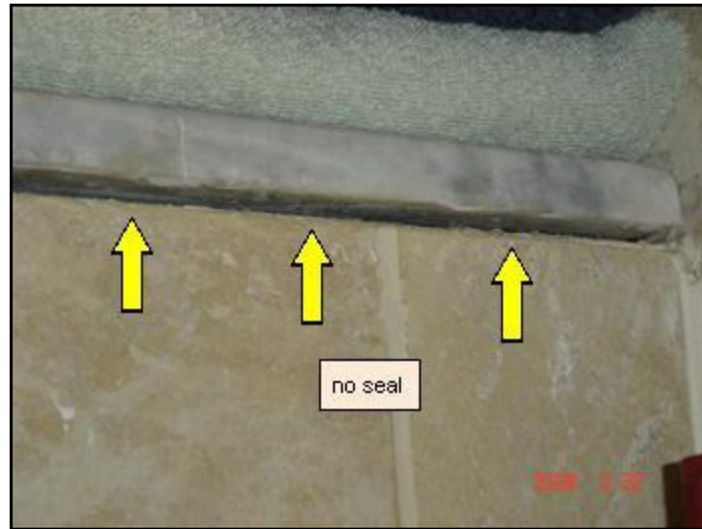
Condition: • [Caulking loose, missing or deteriorated](#)

Several areas around tub have no or failed caulking. Do not use as shower until corrected.

Implication(s): Chance of water damage to contents, finishes and/or structure

Task: Repair or replace

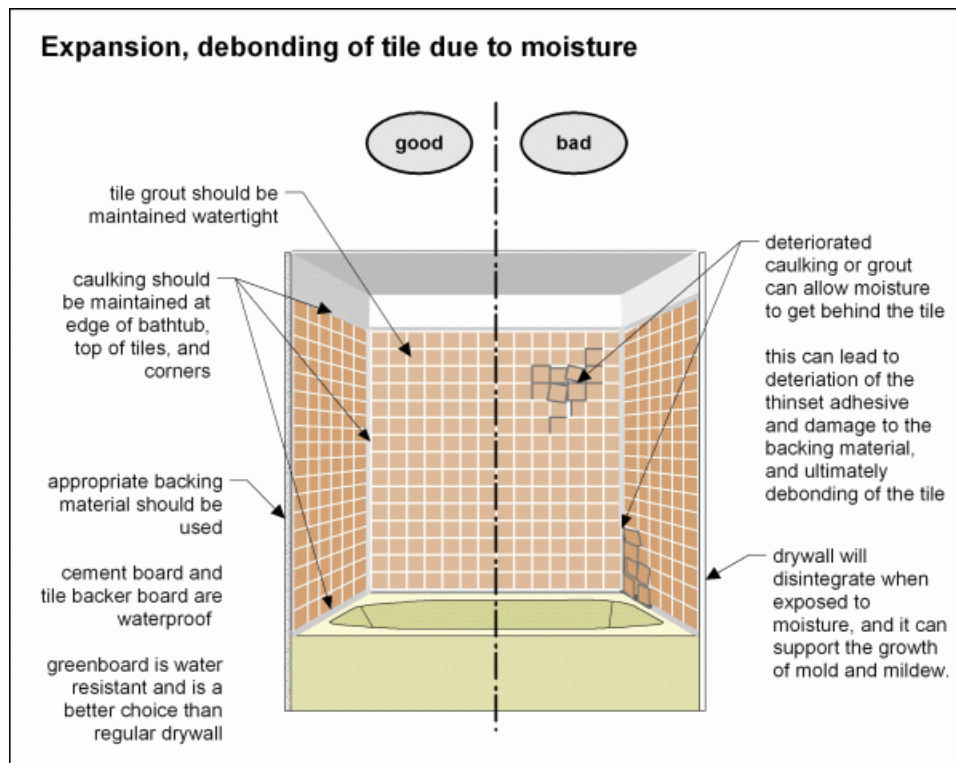
Condition: • [Caulking loose, missing or deteriorated](#)

No seal from wall to floor, water could infiltrate structure if floor becomes wet.

Implication(s): Chance of water damage to contents, finishes and/or structure

Task: Improve

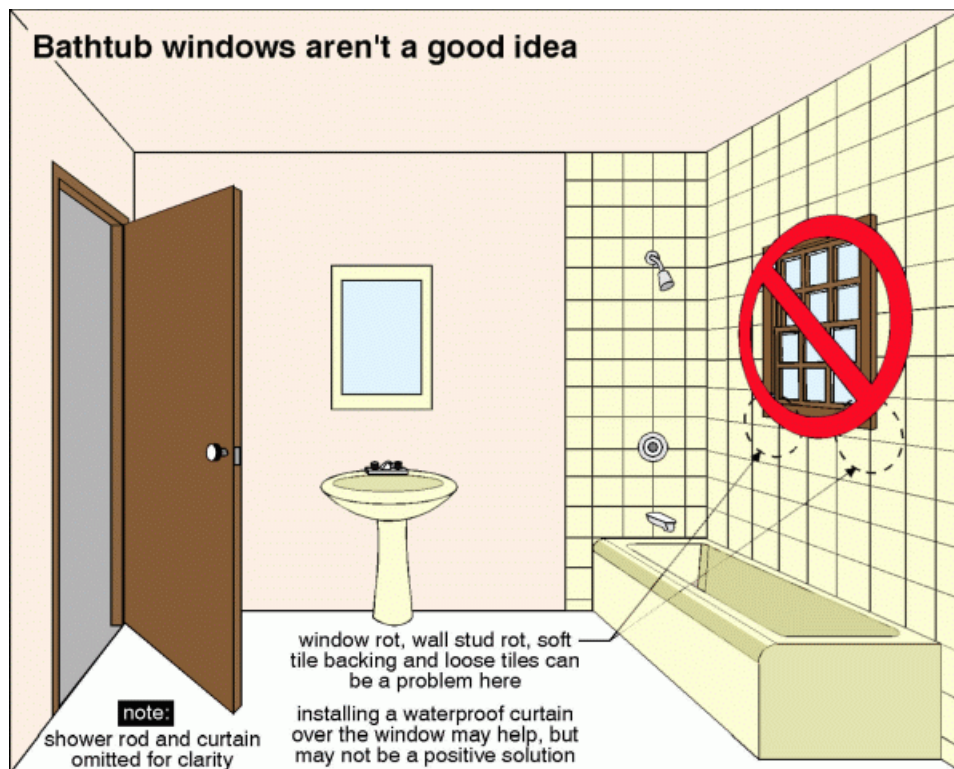
Condition: • [Unprotected window](#)

Missing trim on wooden window frame, protection will need to be provided if shower is used.

Implication(s): Chance of damage to finishes and structure

Task: Improve

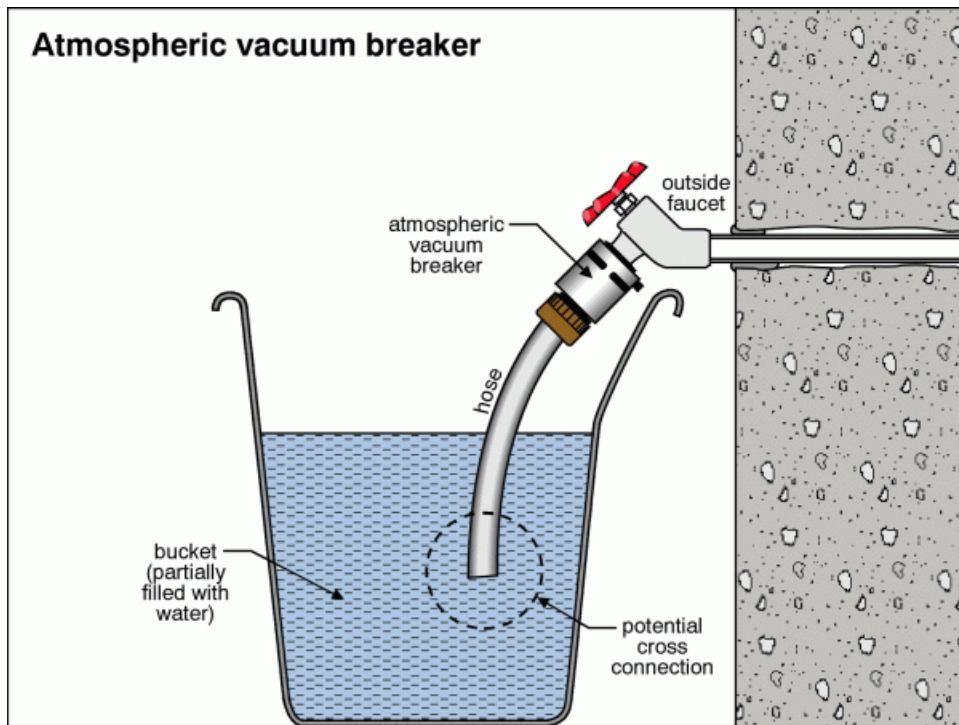
Condition: • [Backflow prevention missing](#)

Task: Provide
