INSPECTION REPORT

For the Property at:
3570 LOCHMILL DR
LOGANVILLE, GA 30052

Prepared for: CUSTOMER SAMPLE
Inspection Date: Saturday, November 3, 2018
Prepared by: John Watson

Report No. 1009, v.4

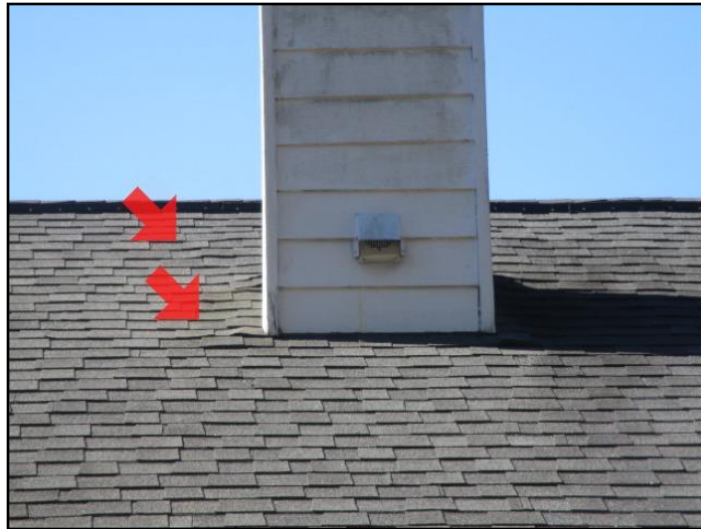
1. Condition: • Missing, loose or torn

Identified loose shingles near chimney chase. Recommend contacting a qualified contractor to replace loose shingles.

Missing, loose or torn

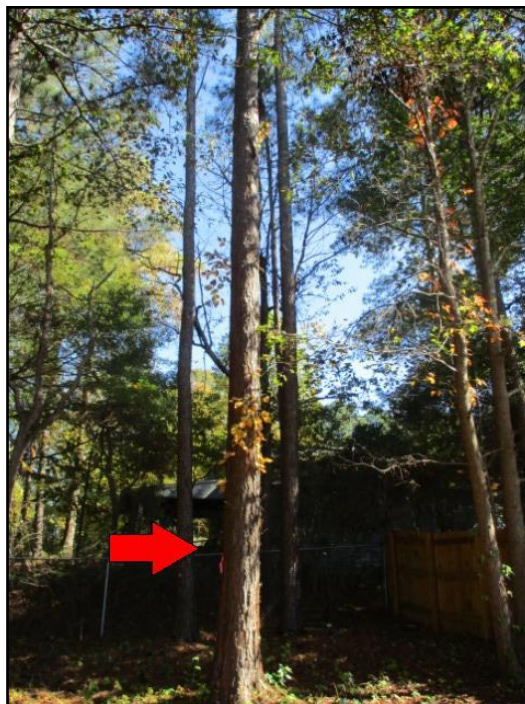
Recommend that large dead tree at rear of property be removed by a qualified contractor. Tree is in excess of 60 feet tall and could potentially rot further, uproot and fall on fence or property. A measurement was taken from base of tree to rear of home and the distance was 77 feet, but the tree is direct in the sight line of the property.

Dead Tree

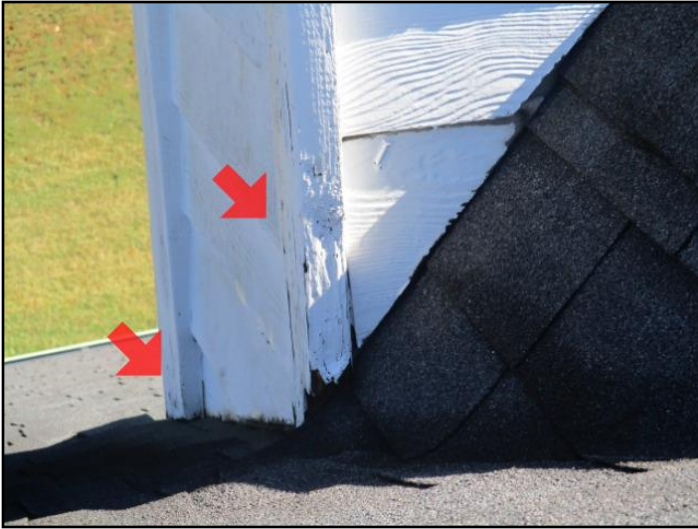
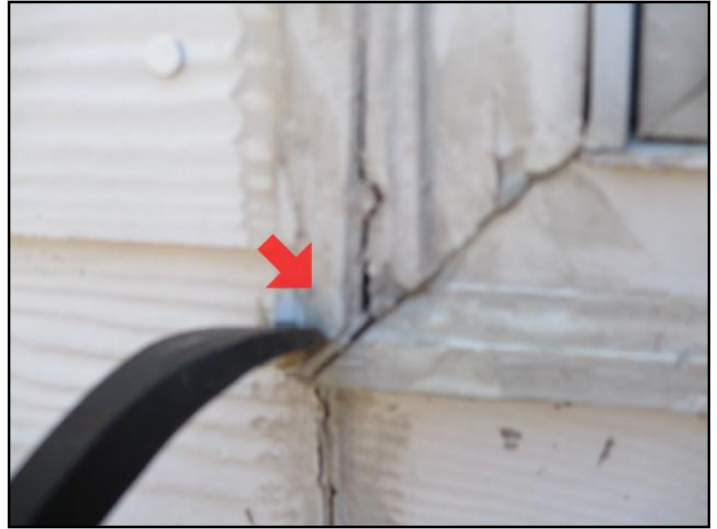
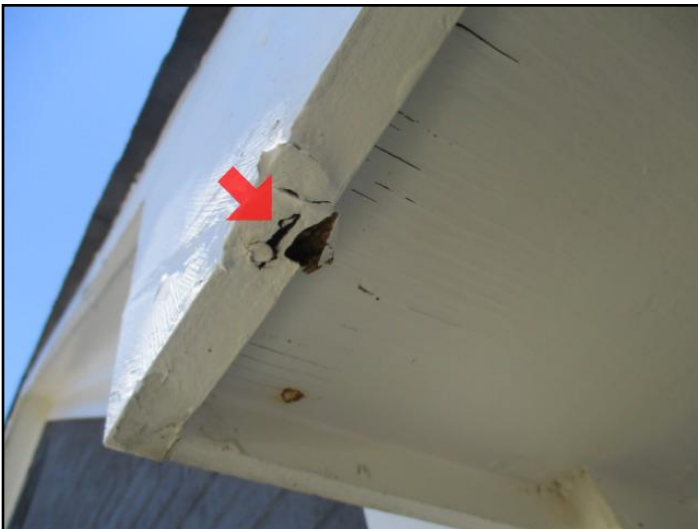
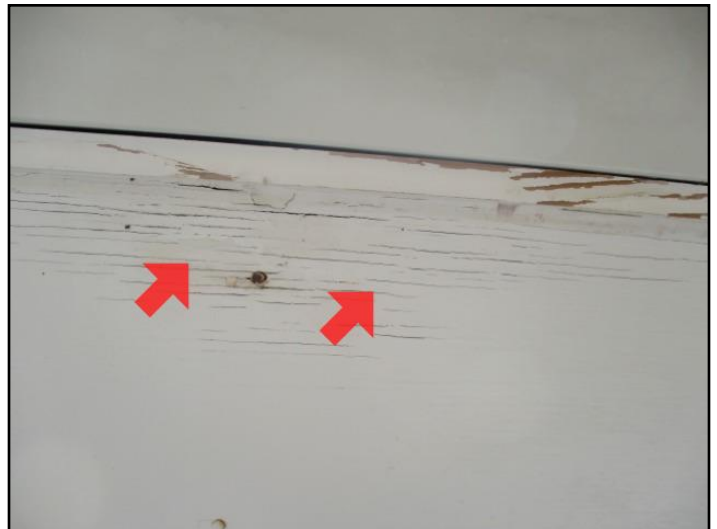
Various areas of siding and trim contain dry rot. Specifically the chimney chase, fascia board and window trim

Rot

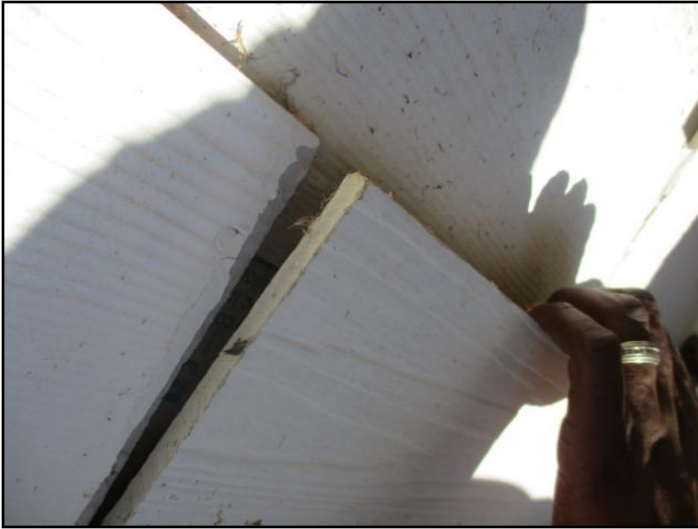
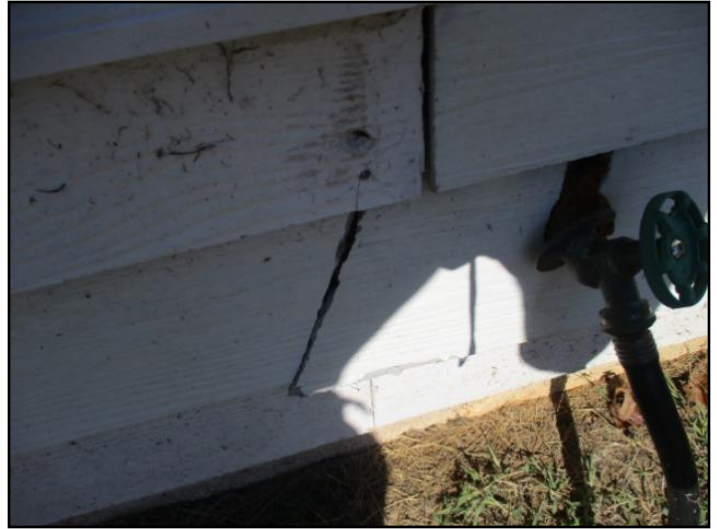
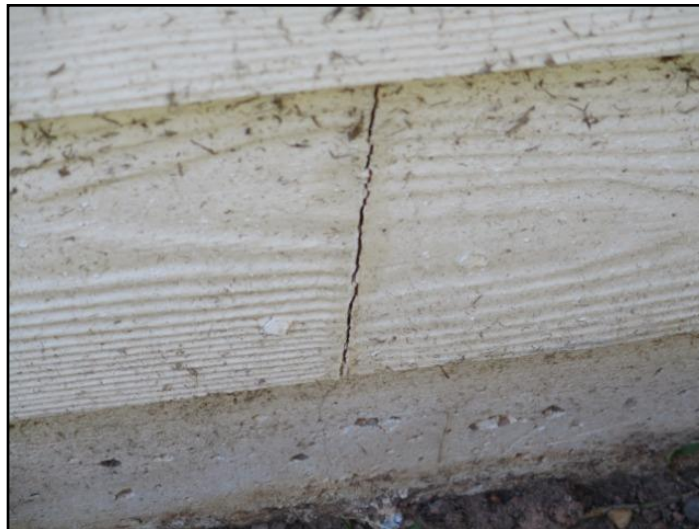
Loose, cracked or missing siding on exterior of home needs to be replaced with fiber cement siding, using proper fastener type and painted for protection

Loose or missing pieces

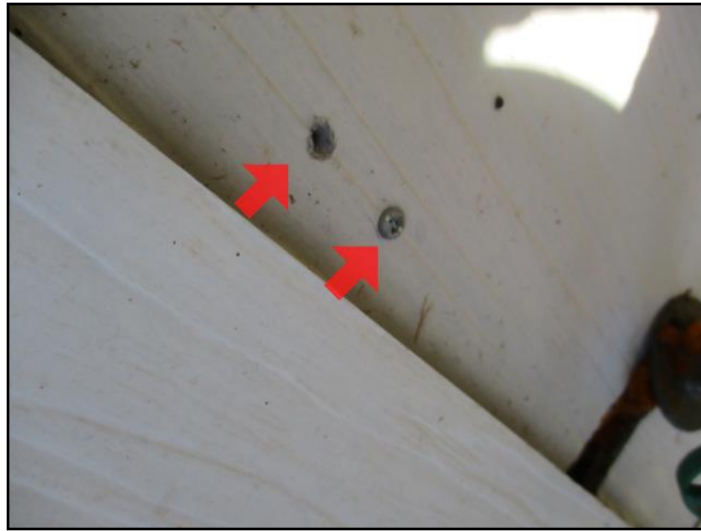
Repair attempted with incorrect fastener type. Recommend that a qualified contractor replaces screws with proper fastener type and paint for protection.

Nailing problems

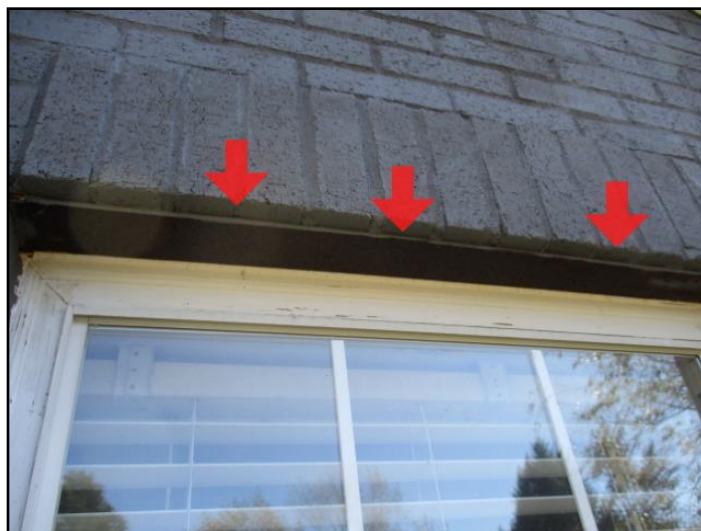
Absence of weep holes resulted in the moisture having no where to travel (over the lintel) it has started to rust the lintel. Recommend hiring a qualified contractor to treat the surface rust then maintain the exterior of the home moving forward. Further investigation shows that weep holes have been drilled into the exterior cladding at the bottom of the home, but not above the window.

Lintel rusting

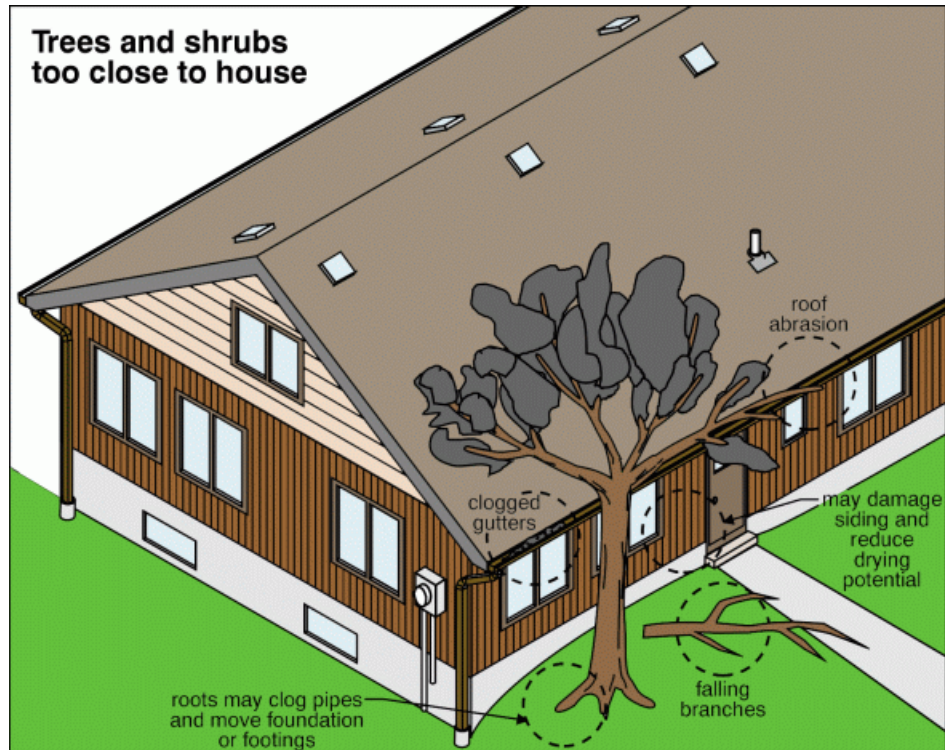
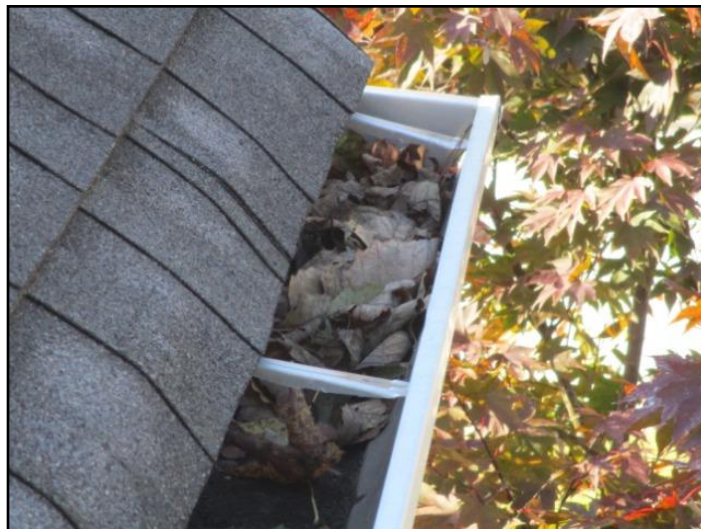
7. Condition: • Trees or shrubs too close to building

Trees or shrubs too close to building

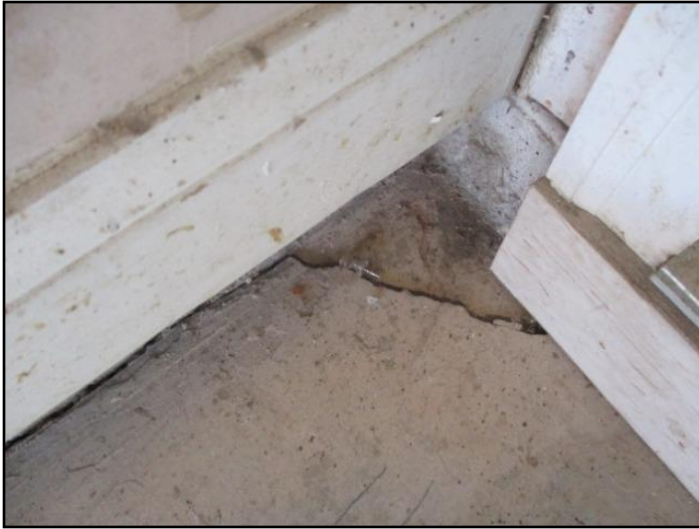
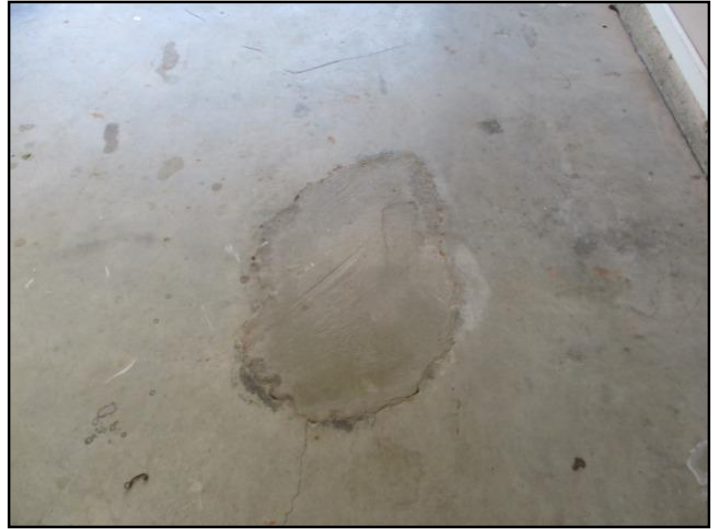
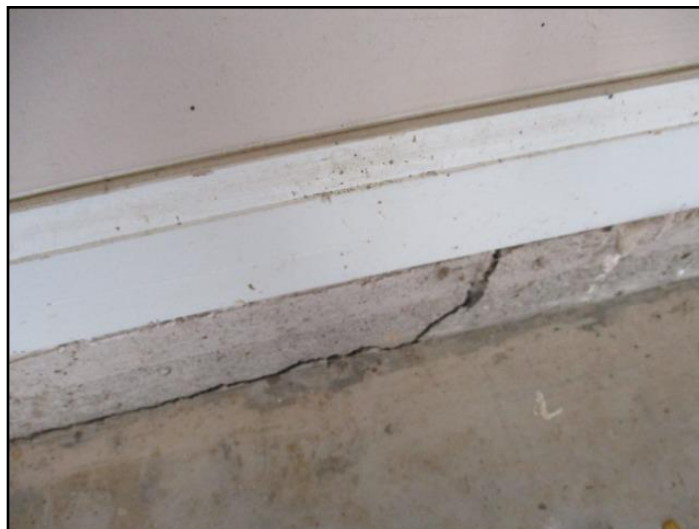
Recommend that garage floor is monitored over time to determine if shifting occurs where cracks are present then contact a qualified contractor to fill cracks and in garage floor.

Cracked

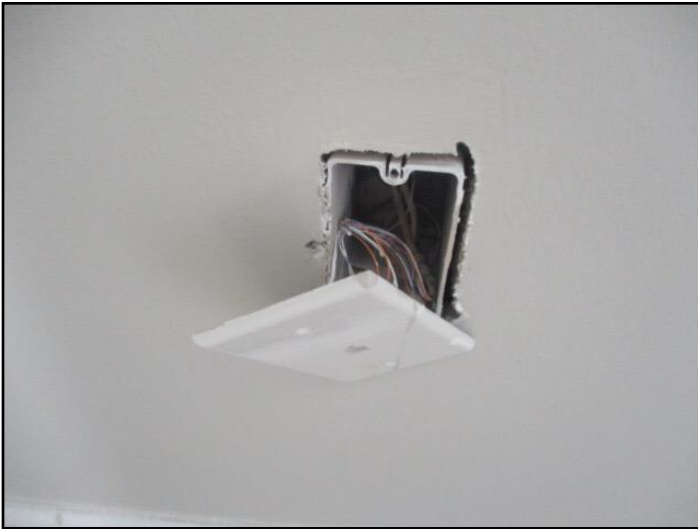
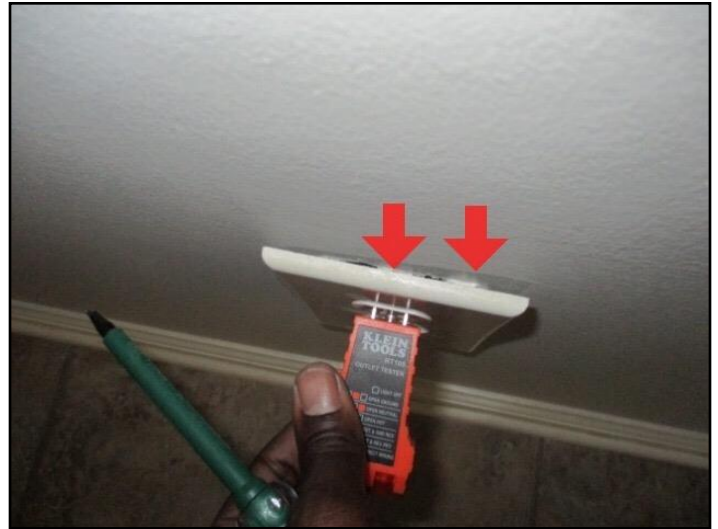
Recommend tightening the outlet plates to improve connection at outlet. Outlet could potentially pull from wall when unplugging small devices or appliances and cause electrical shock.

For outlet (receptacle) is loose

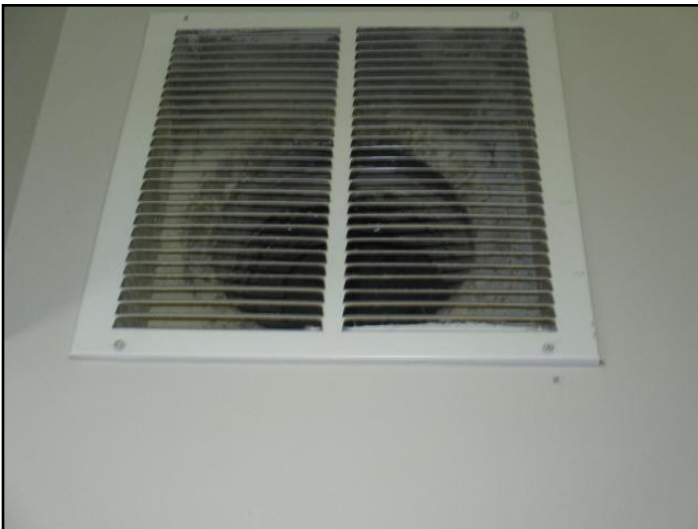
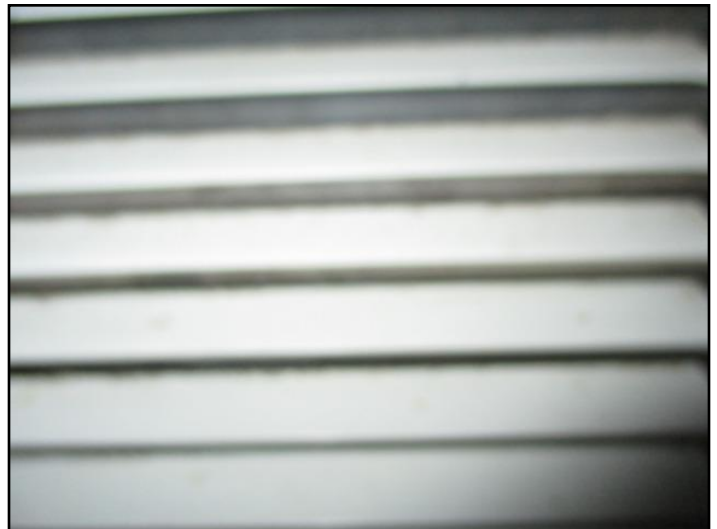
While furnace was serviced recently, the duct work was not cleaned or cleaned properly. Recommended a qualified HVAC contractor clean all duct work, registers and returns.

Dirty

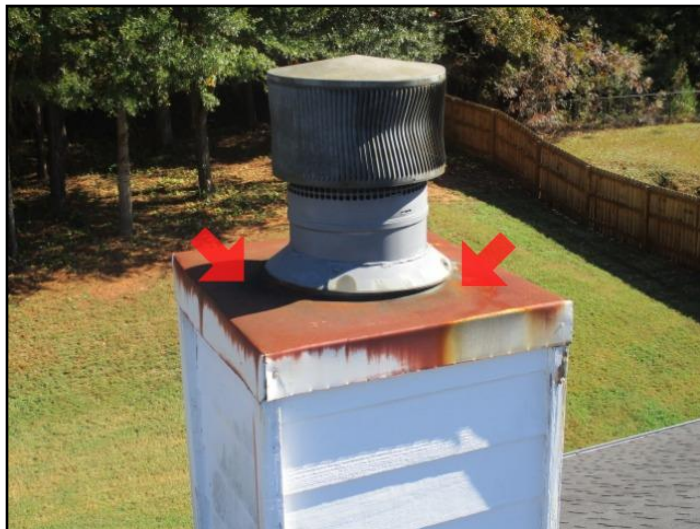
13. Condition: • Rust

Rusted Chase Cover

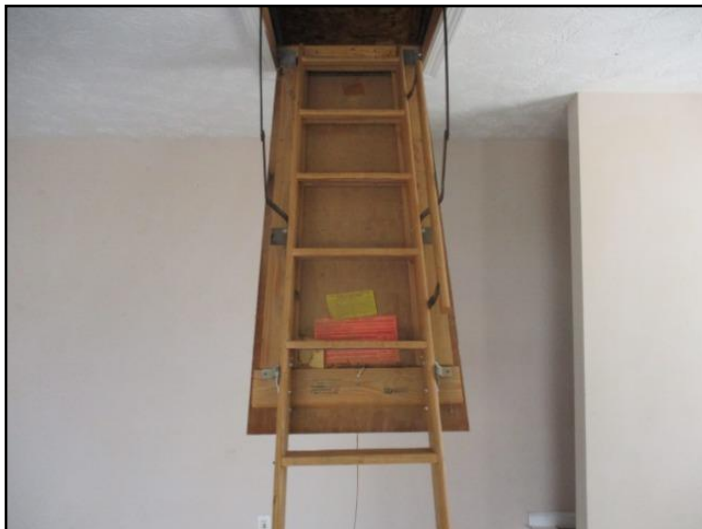
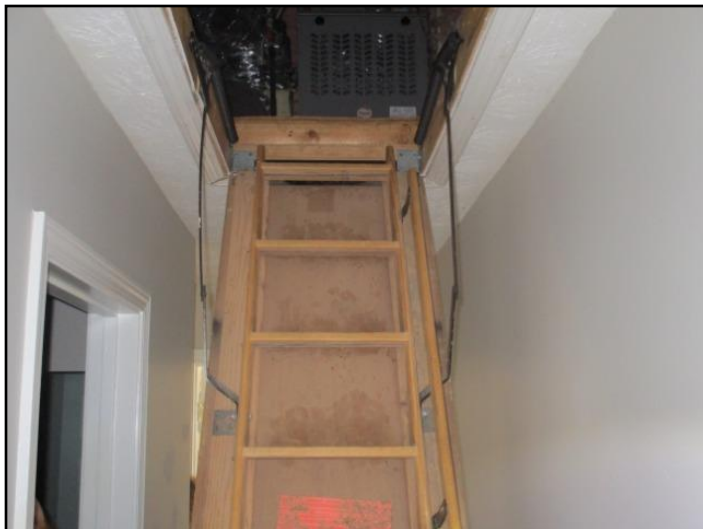
Home has 2 attic entry ways, neither of which have been insulated. It is recommended that both attic hatches be insulated to improve overall energy costs.

Not insulated

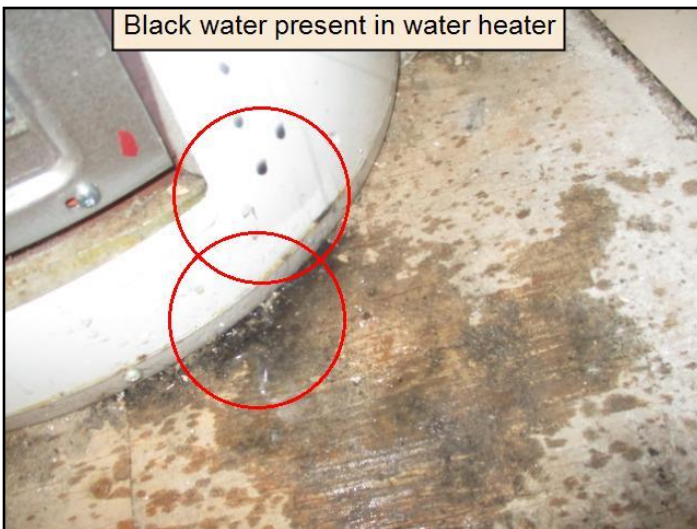
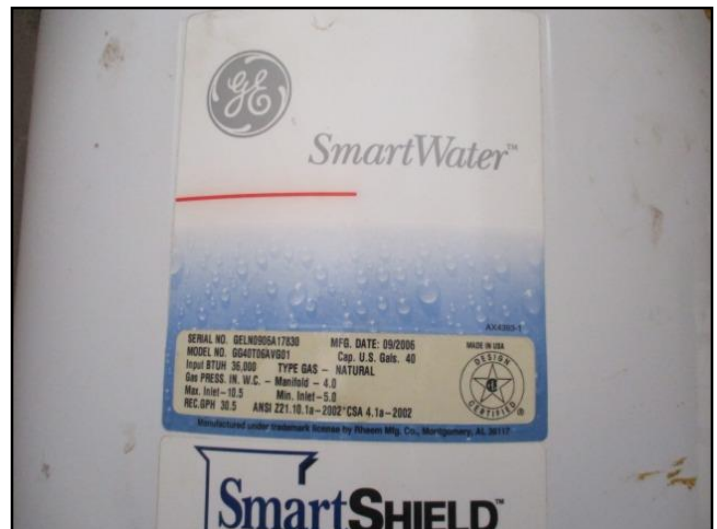
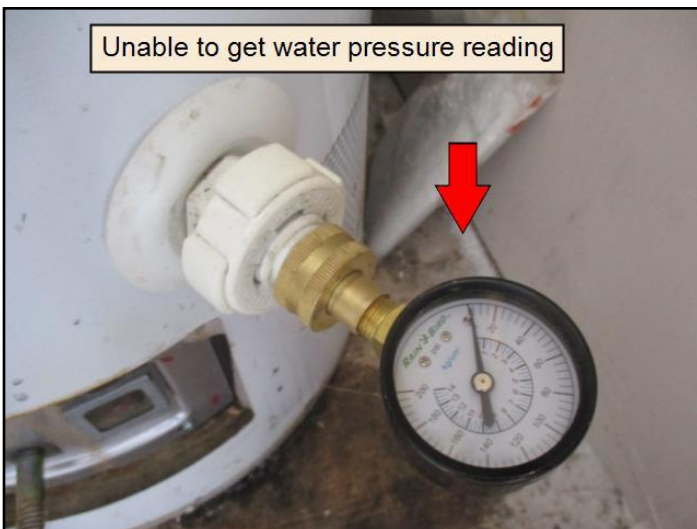
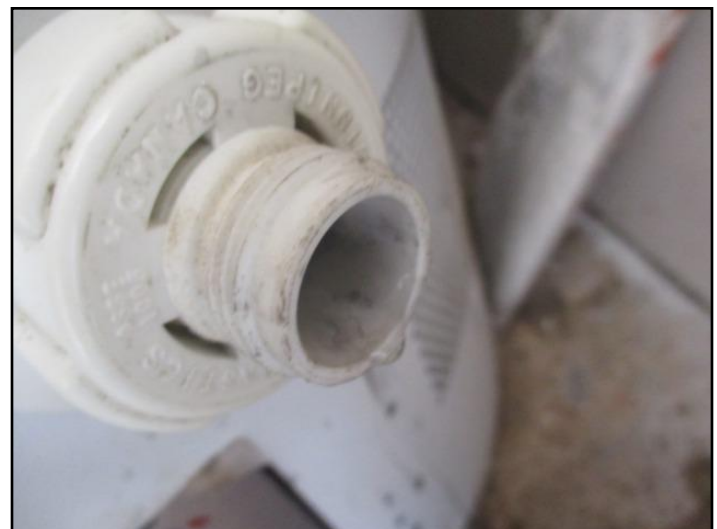
Recommended that water heater be replaced by a qualified contractor as it was unable to be tested due to having no fuel source and seemed to be inoperable for a lengthy period of time. Black water spilled from the tank when attempting to get a pressure reading. Pilot light was unable to be lit. The bottom section of the tank appeared to be rusted through, indicating that the water heater was beyond its usable life and needs to be replaced.

Inoperative

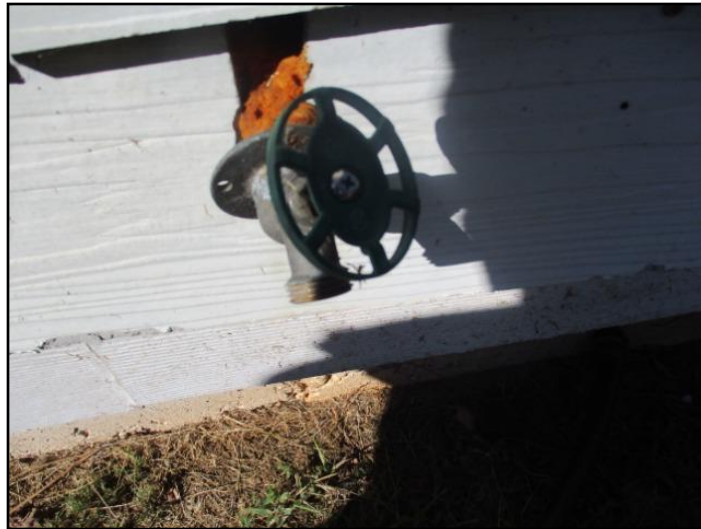
Secondary outdoor hose bib was found to be inoperative. Recommend a qualified contractor further investigate the plumbing and correct the water flow to exterior hose bib.

Inoperative

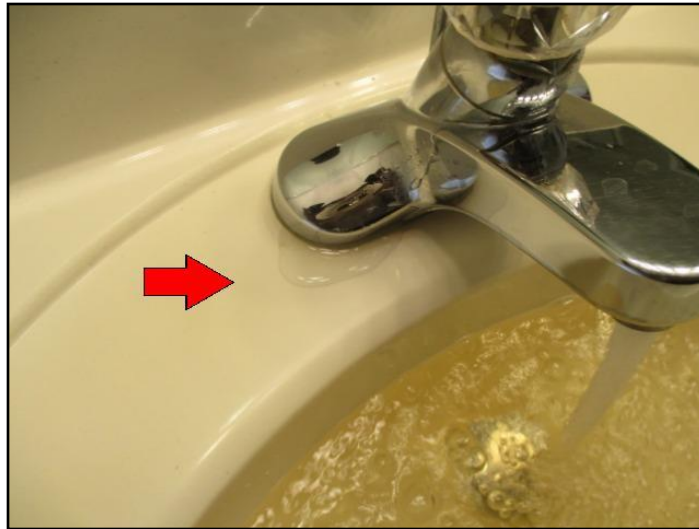
Found leaky faucet in bathroom. Recommend a qualified contractor tighten and caulk the fixture to prevent leaks.

Leaky Faucet

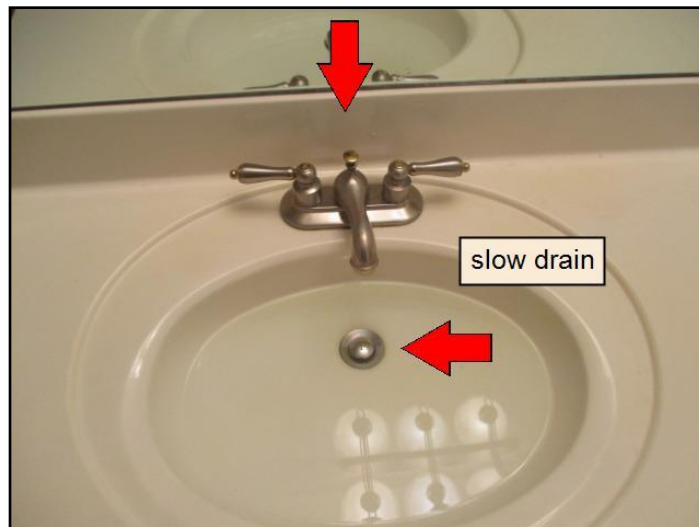
Recommend unclogging sink drain for better performance

Slow drains

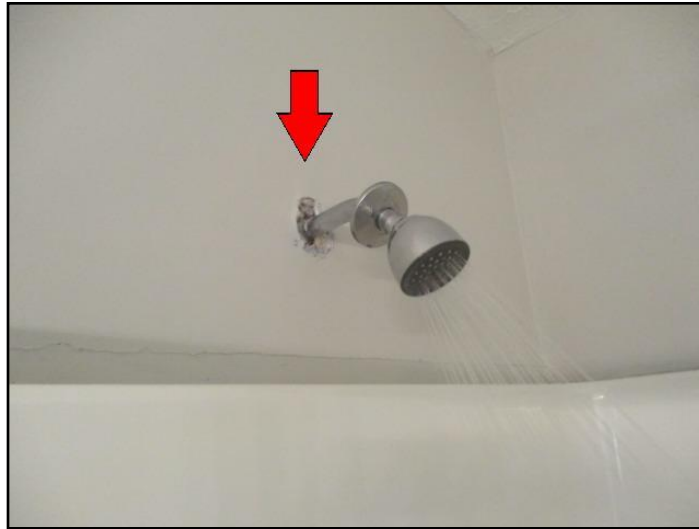
20. Condition: • Caulking loose, missing or deteriorated

Caulking loose, missing or deteriorated

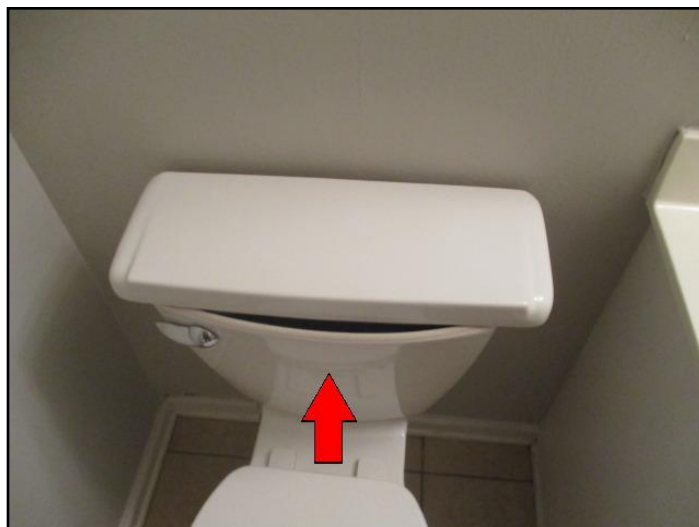
Incorrect tank cover installed on toilet. Recommended that tank cover is replaced with proper sized tank cover to prevent foreign matter from getting into opening at top of tank and causing plumbing issues in the future.

Surface defects

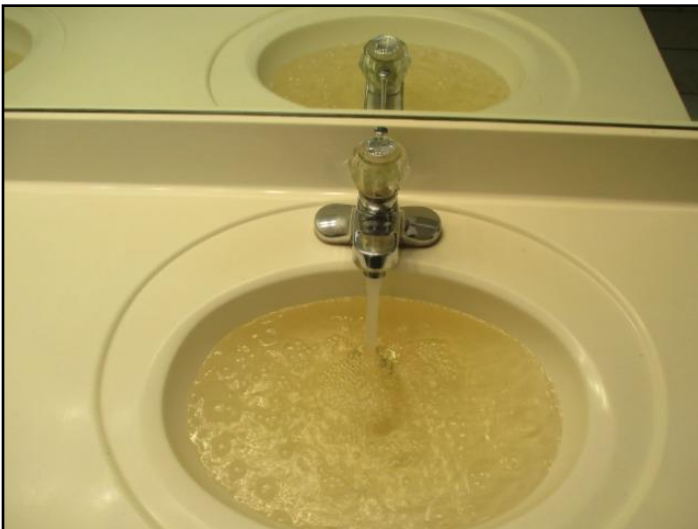
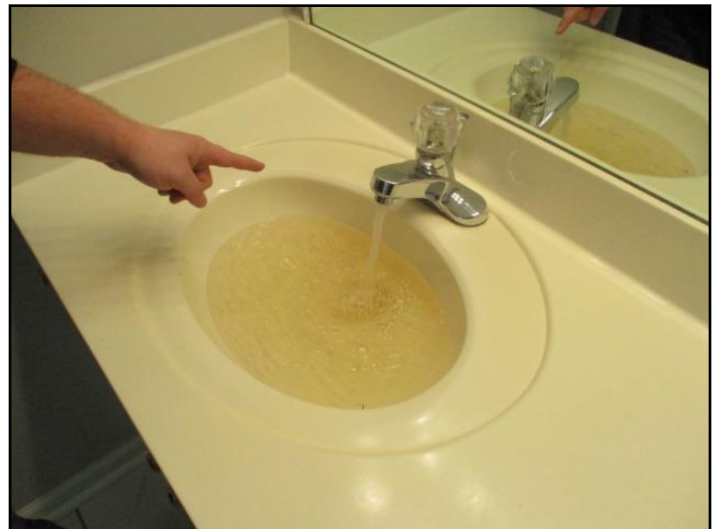
22. Condition: • Multiple faucets dispensed brown dirty water. It is expected that the property has been vacant for a period of time with no usage, causing this issue. With the hot water tank being inoperative, this could be the cause of the tinted water. It is recommended that a qualified contractor further evaluate the plumbing lines to better understand if the water can quickly be flushed out the system prior to occupying the property. It is expected that once the water tank is replaced and all faucets are open for a period of time, the water discoloration will correct itself.

Dirty Water

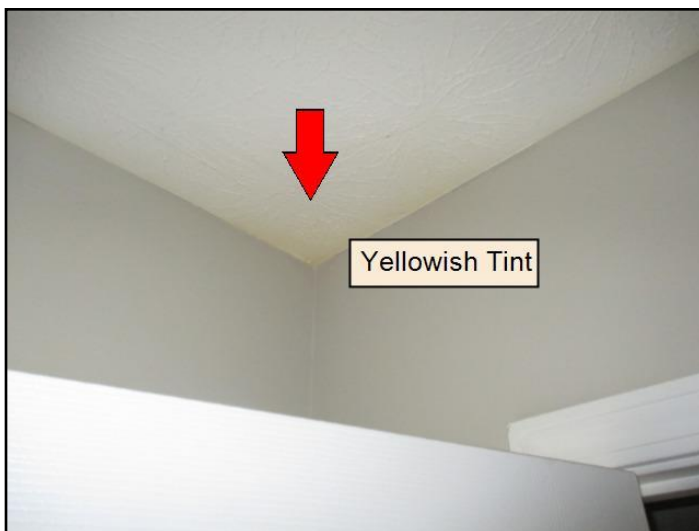
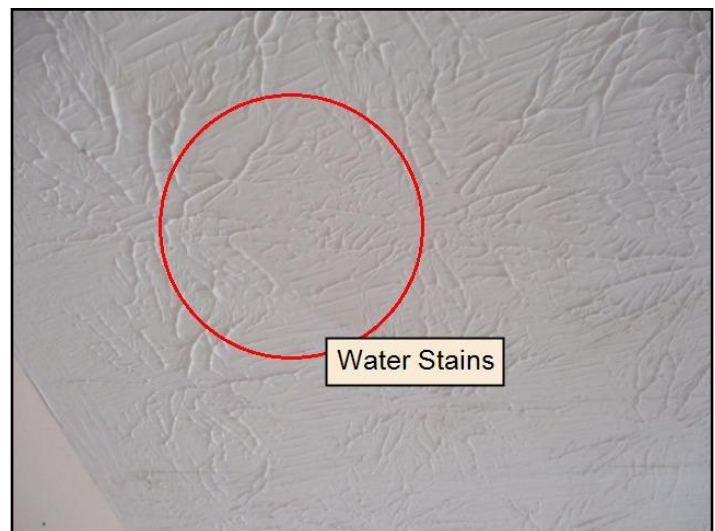
Typical nail pops and paint tinting of ceiling. Evidence of water leak present in garage ceiling, tested for saturation and found to be dry, proving that leak stain is old and not recent. Recommended correcting nail pops and painting ceiling during next remodel.

Typical flaws

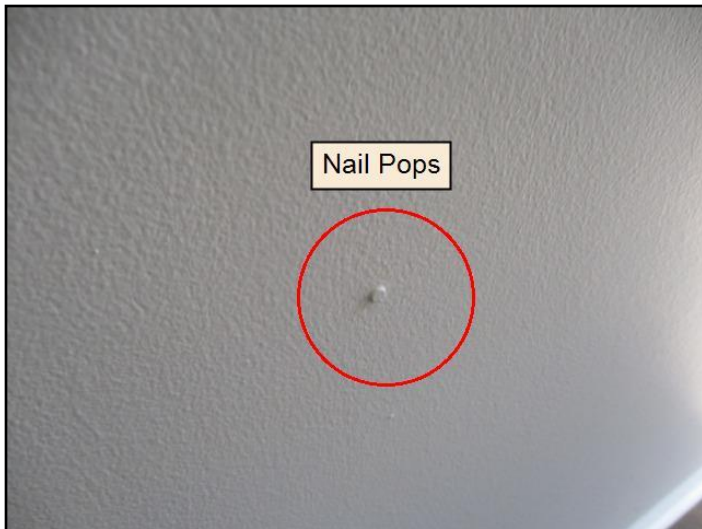
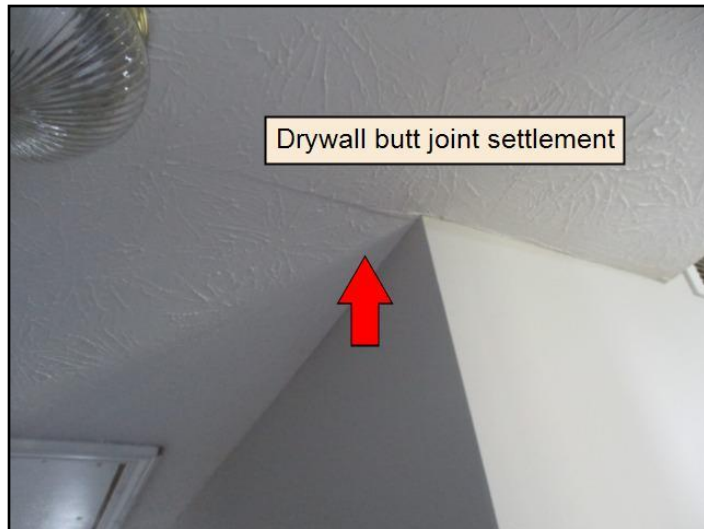
Typical nail pops and drywall shifting has occurred. Recommend correcting during next remodel.

Typical flaws

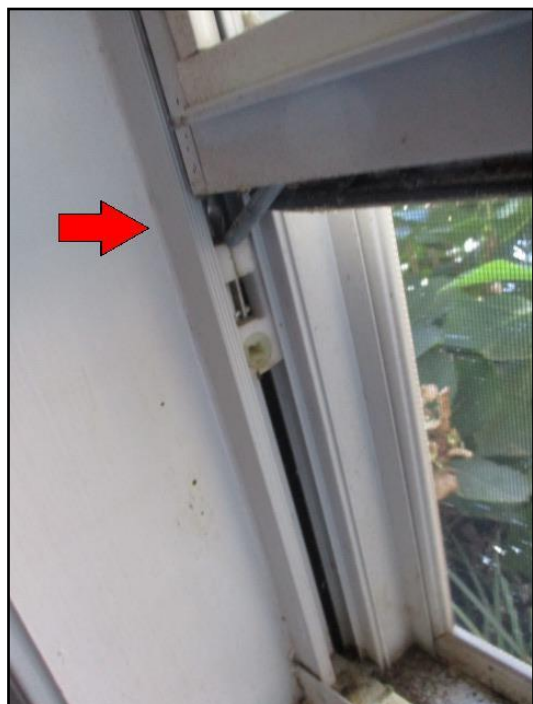
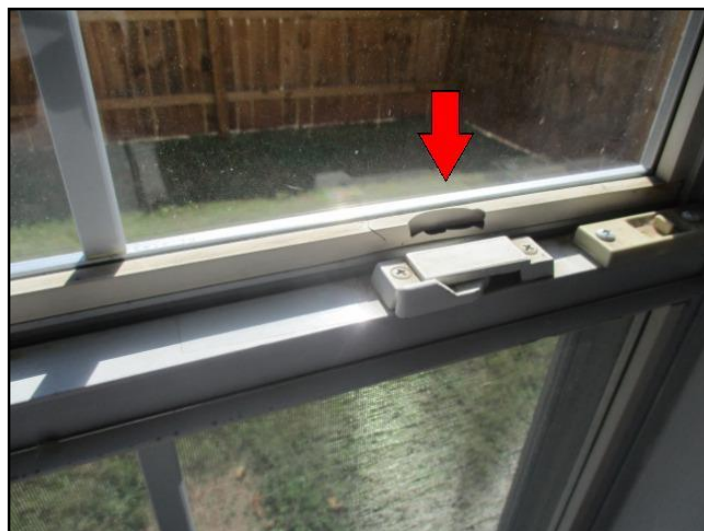
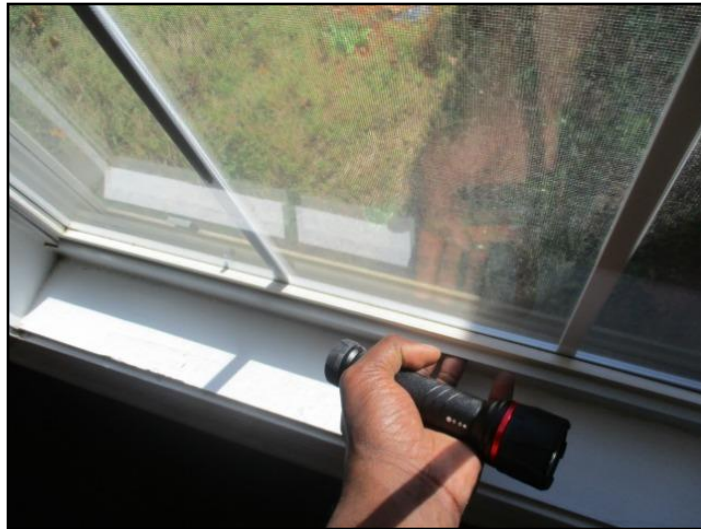
Multiple windows throughout property were either inoperable, broken or damaged. Recommend a qualified contractor provide estimate on replacing all broken windows.

Broken sash and spring

Damage

Difficult to operate

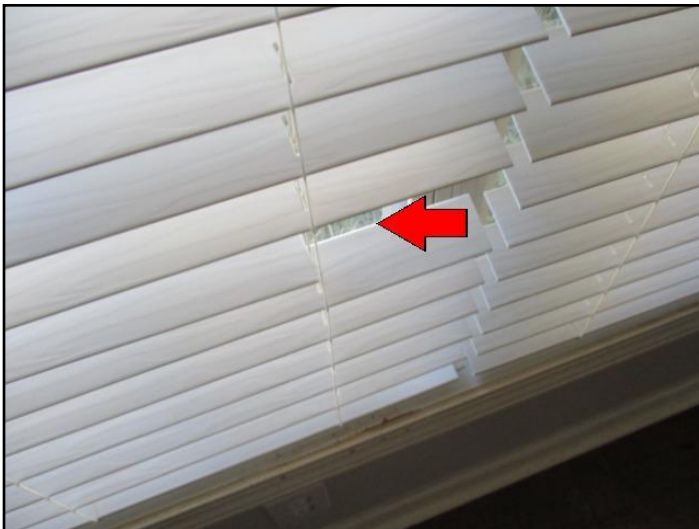
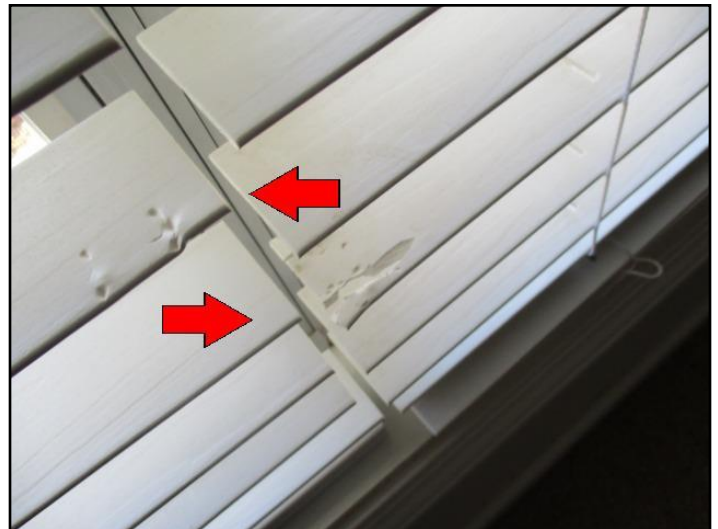
Multiple blinds throughout various rooms contain broken blinds. Recommend replacing blinds when remodeling.

Damaged

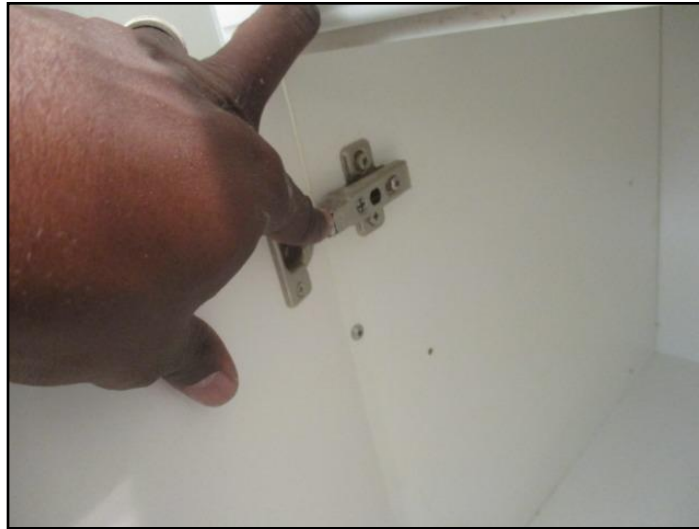
Several kitchen cabinet doors have loose hardware. Recommend tightening all hardware for better door open/closing performance.

Doors or drawers missing or loose

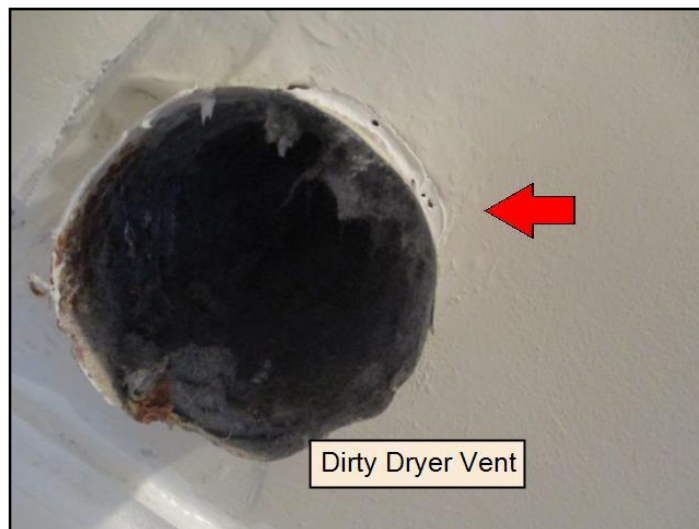
Recommend cleaning dryer vent when duct work is cleaned to improve operation of dryer and to reduce the risk of fire.

Dryer vent obstructed
