YOUR INSPECTION REPORT

6 Mountview Avenue
Toronto, ON M6P 2L3

INSPECTION DATE:
Tuesday, September 5, 2017

RE: Report No. 2159, v.2
6 Mountview Avenue
Toronto, ON
M6P 2L3

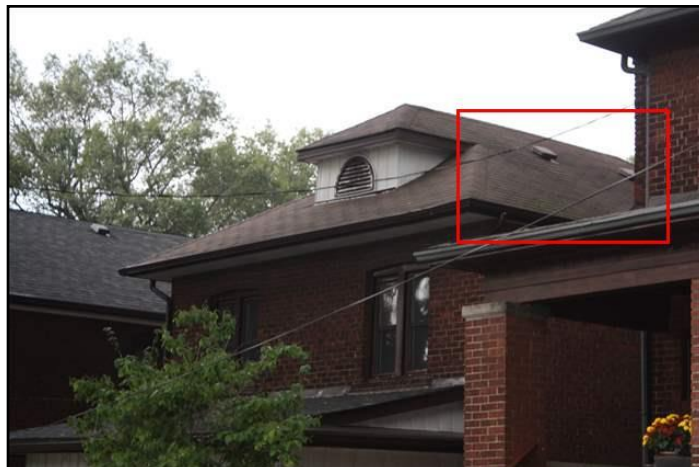
1. moss

Condition: • Debris/moss

Implication(s): Shortened life expectancy of material

Location: North Exterior Roof

Task: Click link to read more information / Clean

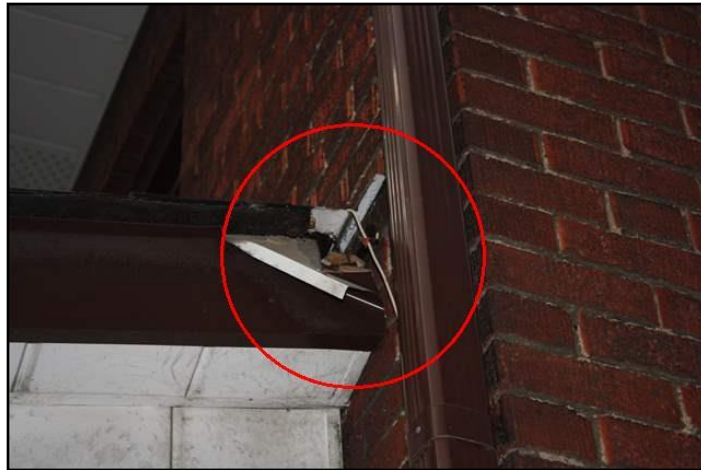
2. Damage

Condition: • [Damage](#)

Implication(s): Chance of water damage to contents, finishes and/or structure

Location: North Exterior

Task: Repair

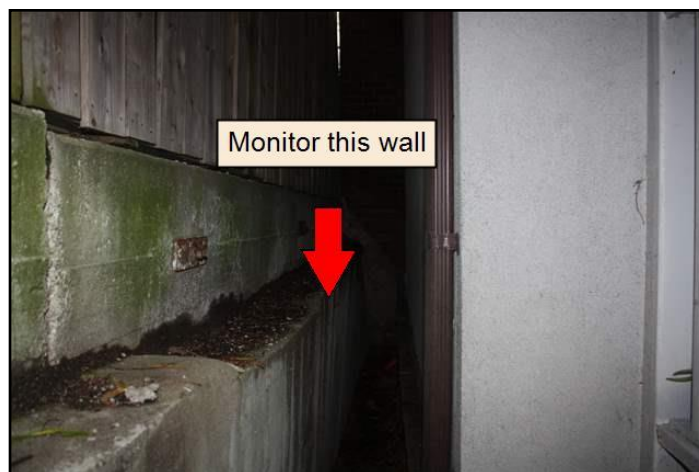
3.

Condition: • Very minor lean noted at bottom portion of retaining wall at the north (near rear) of the home. It's possible the wall was built this way. Prudent to monitor (as is recommended for all retaining walls.)

Location: North Exterior

Task: Monitor

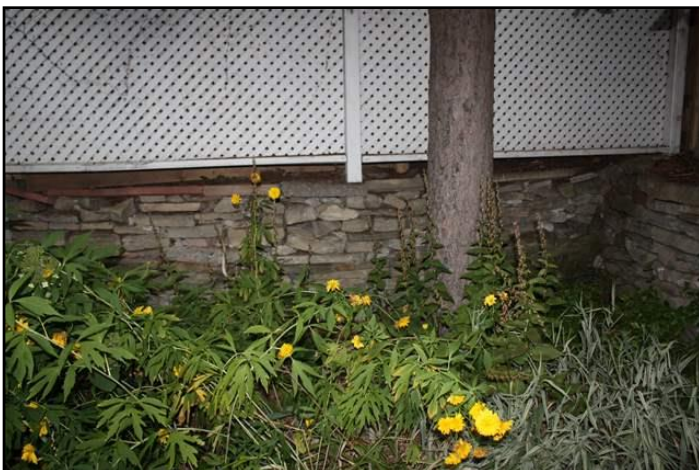
4. Bowing or bulging

Condition: • [Bowing or bulging](#)

At rear yard we noted a stone retaining wall that is bulging. We cannot determine from a one-time visit if the wall is moving and at what rate. Also, we cannot determine what side of the property the wall was built. Sometimes these walls are shared. Maintenance with yard retainers are very common in this neighbourhood.

Implication(s): Weakened structure | Chance of movement

Location: Rear Exterior Yard

Task: Improve/Repair

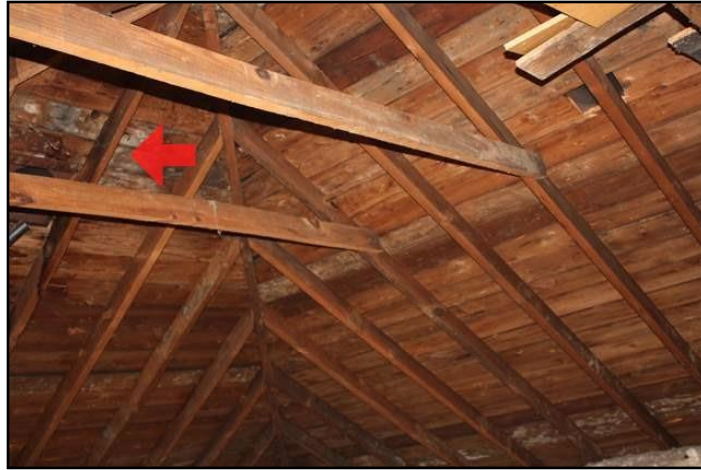
6. Water stains

Condition: • [Water stains](#)

Water stains noted on attic sheathing. These water stains may have been present for some time. Unable to determine if this is an active leak. No active water stains were noted on interior ceilings. Also, there was heavy rainfall during the inspection and we did not observe any water leaking from where the area of the stains.

Implication(s): Material deterioration

Location: Attic

Task: Monitor

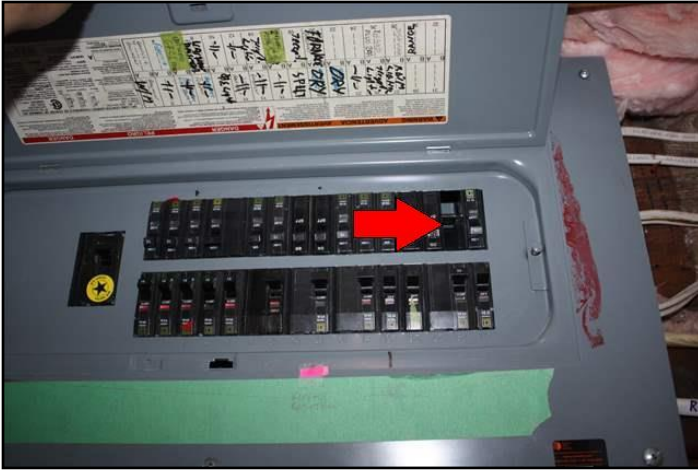
7. Openings in panel

Condition: • [Openings in panel](#)

Implication(s): Electric shock | Fire hazard

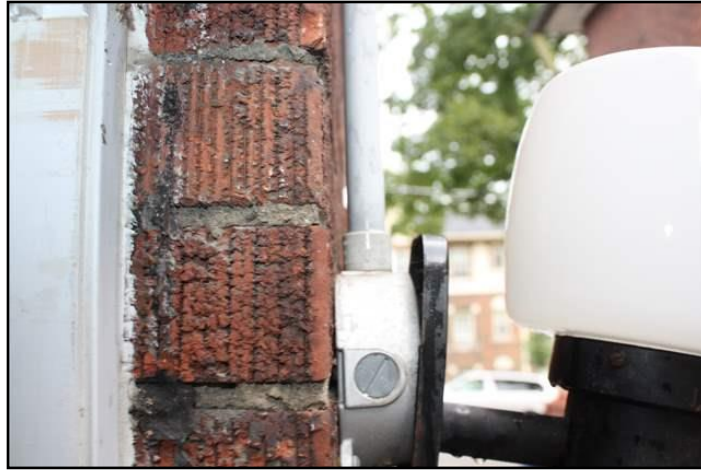
11. Loose

Implication(s): Nuisance | Potential problem when obtaining home insurance**Task:** Replace if ever found.**DISTRIBUTION SYSTEM \ Lights****Condition:** • [Loose](#)**Implication(s):** Electric shock | Fire hazard**Location:** Exterior Wall**Task:** Improve**Time:** Regular maintenance**Cost:** Regular maintenance item

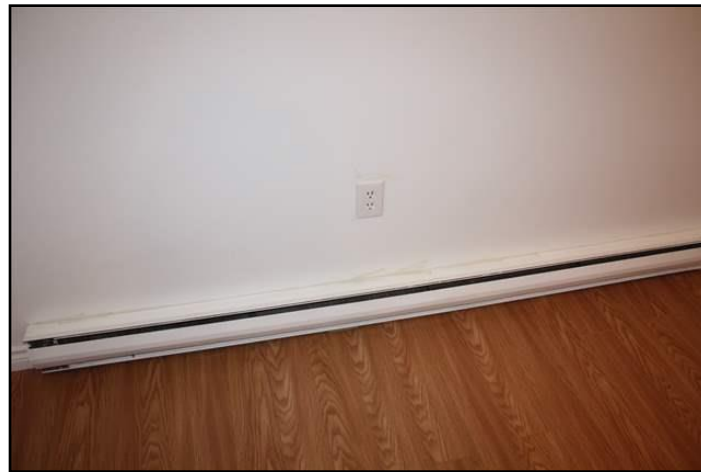
12. Above electric baseboard heaters

Condition: • [Above electric baseboard heaters](#)

Implication(s): Increased fire hazard

cords plugged into outlets above electric baseboard heaters could overheat if accidentally draped over the heater

outlets should be located at either end of the heater

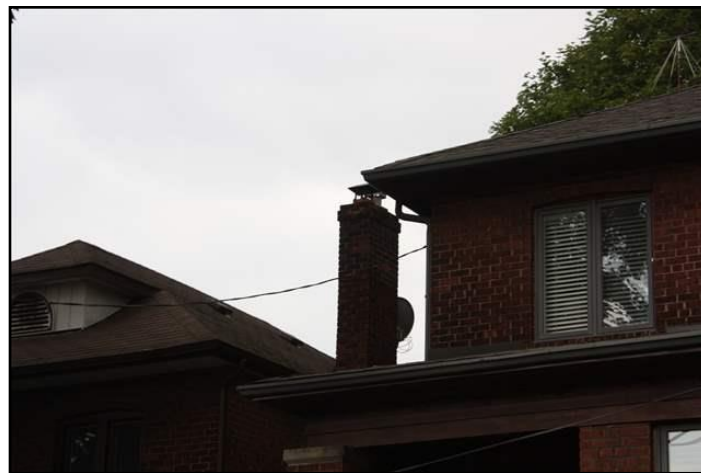
13. Loose, missing or deteriorated masonry

Condition: • [Loose, missing or deteriorated masonry](#)

Implication(s): Material deterioration

Tuckpoint mortar and Repair or replace spalled bricks

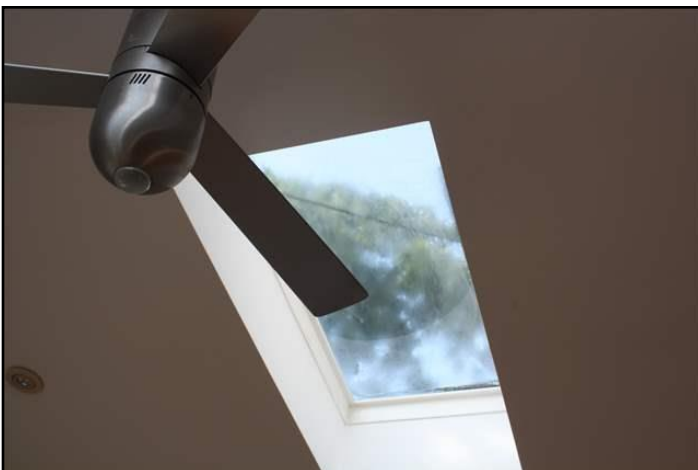
16. Lost seal on double or triple glazing

Condition: • [Lost seal on double or triple glazing](#)

Task: Replace
