YOUR INSPECTION REPORT

11 Palisades
Toronto, ON M6S 2W9

INSPECTION DATE:
Thursday, May 18, 2023

RE: Report No. 7199, v.2
11 Palisades
Toronto, ON
M6S 2W9

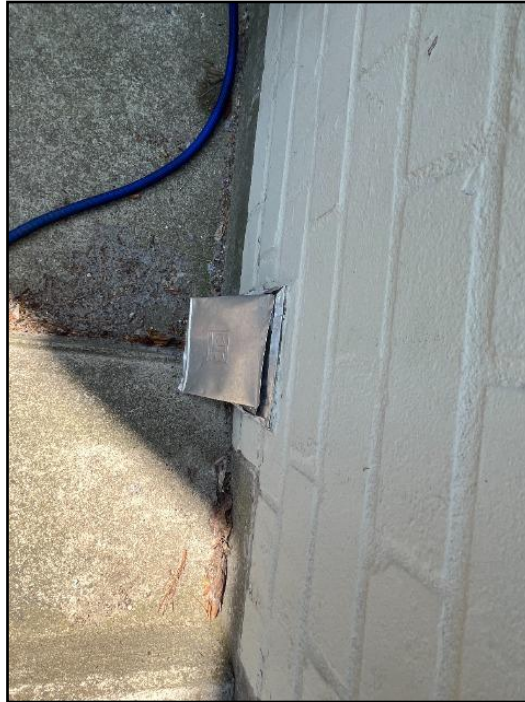
Condition: • [Caulking missing or ineffective](#)

3. Caulking missing or ineffective

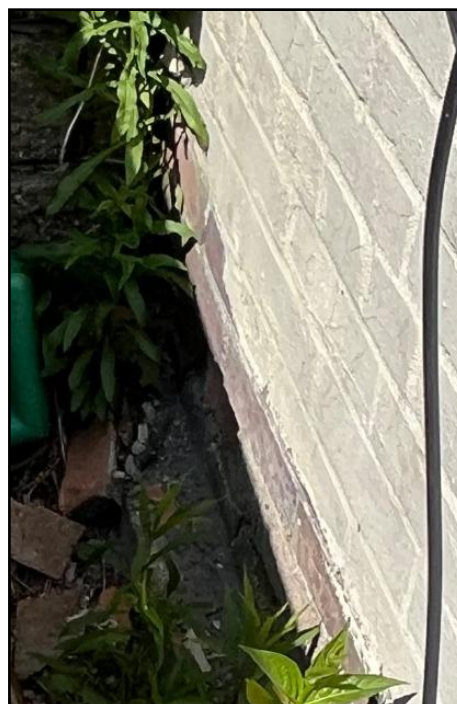
Condition: • [Spalling](#)

4. Spalling

Task: Repair

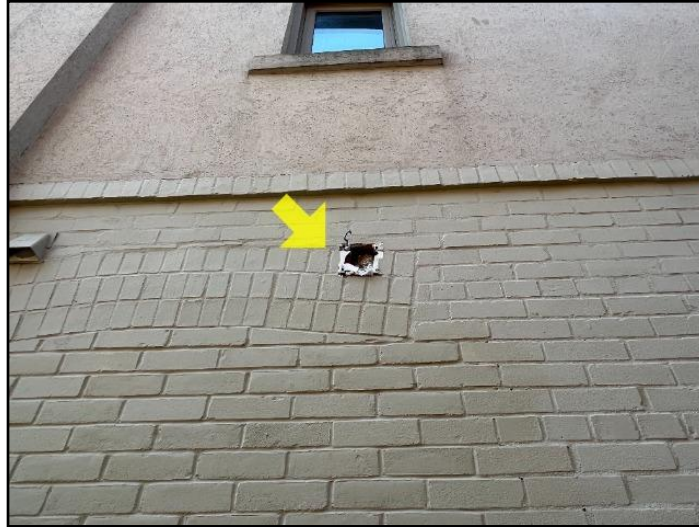
Condition: • Cover missing

5. Cover missing

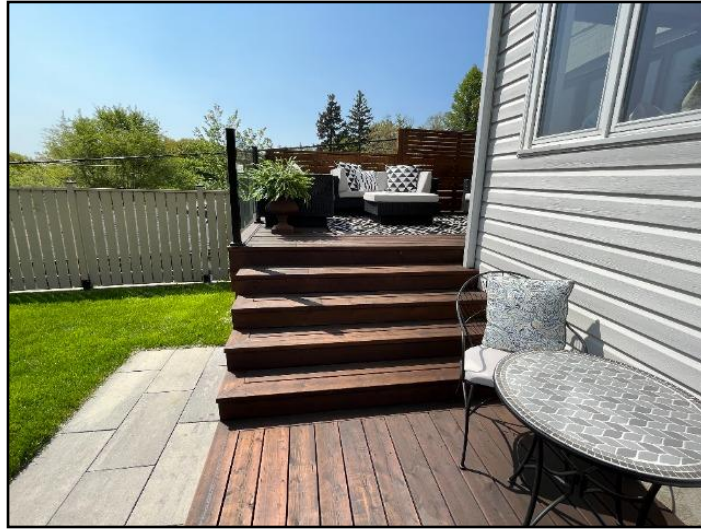
Condition: • [Missing](#)

8. Missing

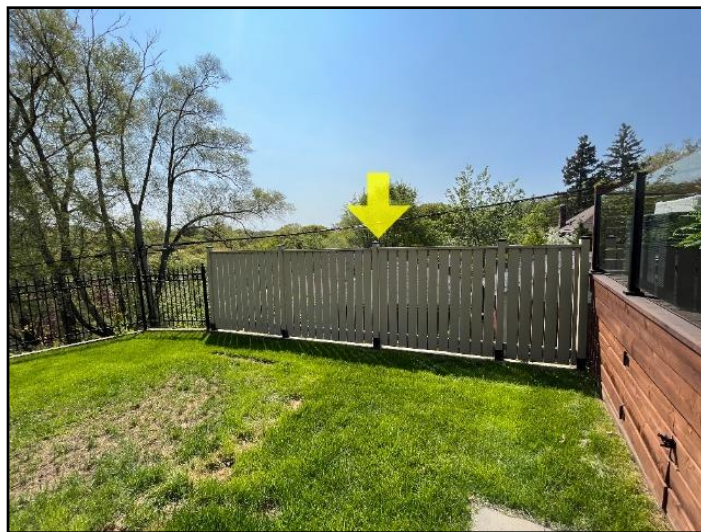
Condition: • [Weak](#)

9. Weak

Task: Improve stability

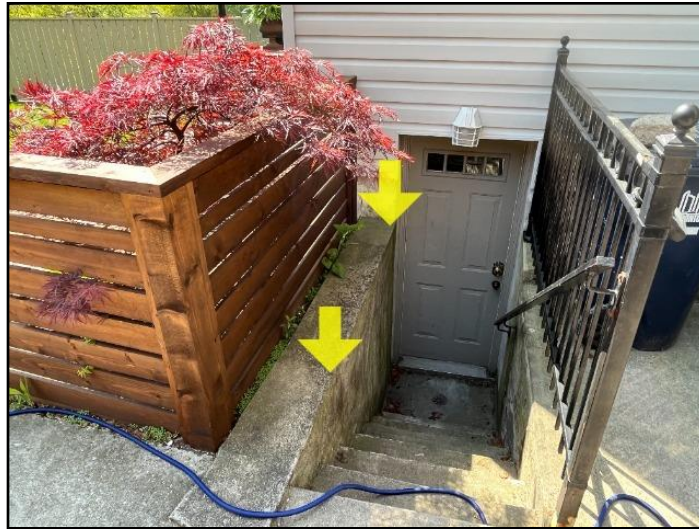
Condition: • [Guard and handrail problems](#)

10. Guard

Task: Provide Guard at left side wall

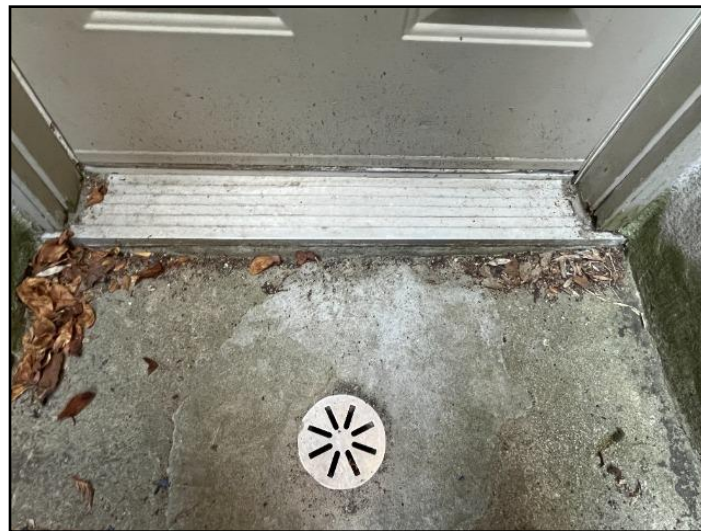
Condition: • [Door threshold missing, too low, not watertight](#)

11. Door threshold low

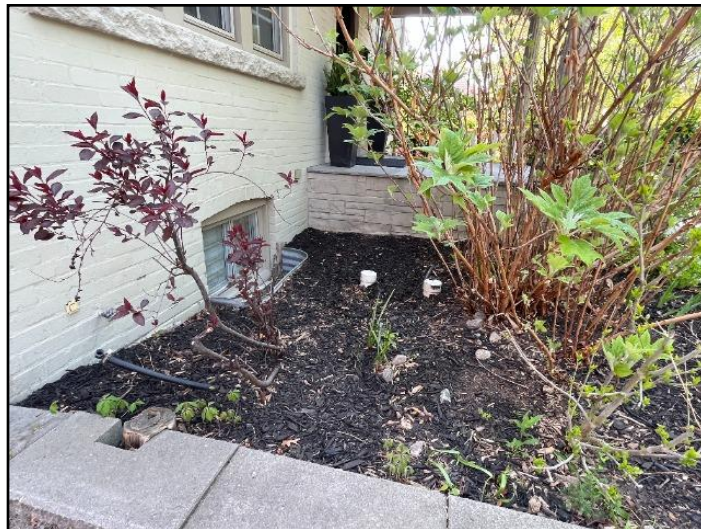
Condition: • [Improper slope or drainage](#)

A very important factor in preventing basement leakage is to maintain the grading that is nearest the home to promote good drainage away from the home for at least 6 feet. "Water management" is an important role for homeowners.

12. Improper slope or drainage

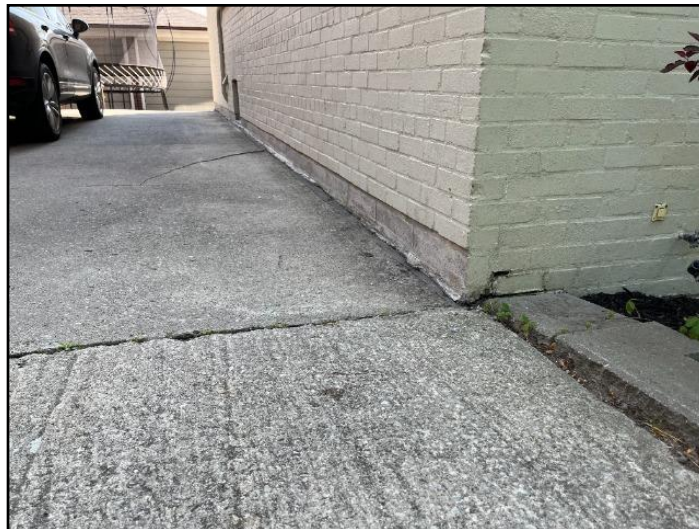
Condition: • [Improper slope or drainage](#)

Crack / Settlement at one area of driveway. Keep wall /driveway intersection well sealed.

13. Improper slope or drainage

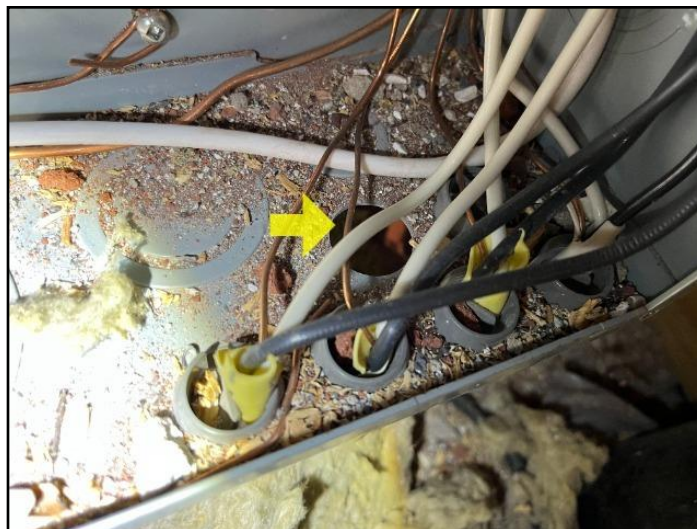
Condition: • [Openings in panel](#)

15. Openings in panel

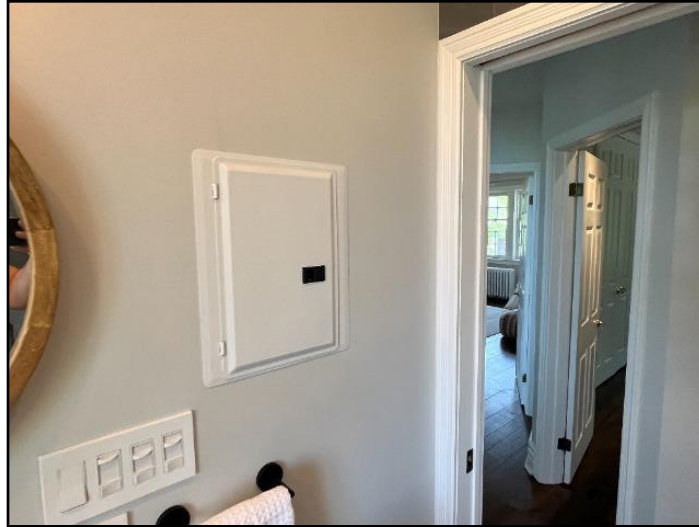
Condition: • [Poor location](#)

(This rule is in place due to shower steam causing condensation / moisture at the panel which is a fire hazard)

16. *Sub panel at bathroom*

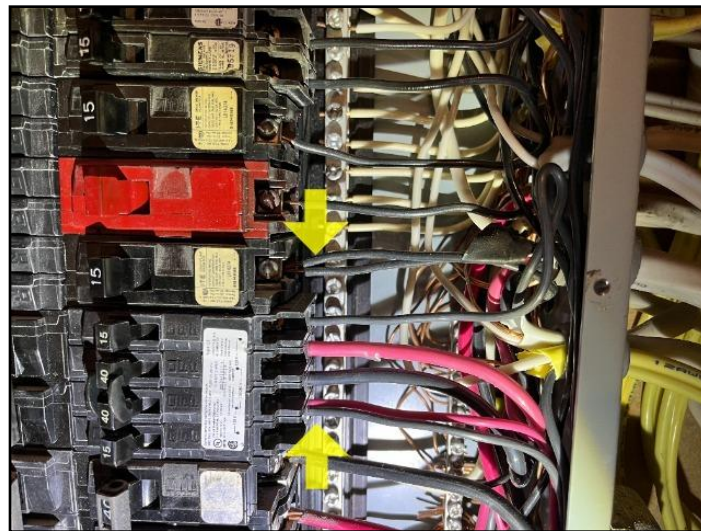
Condition: • [Double taps](#)

17. Double taps

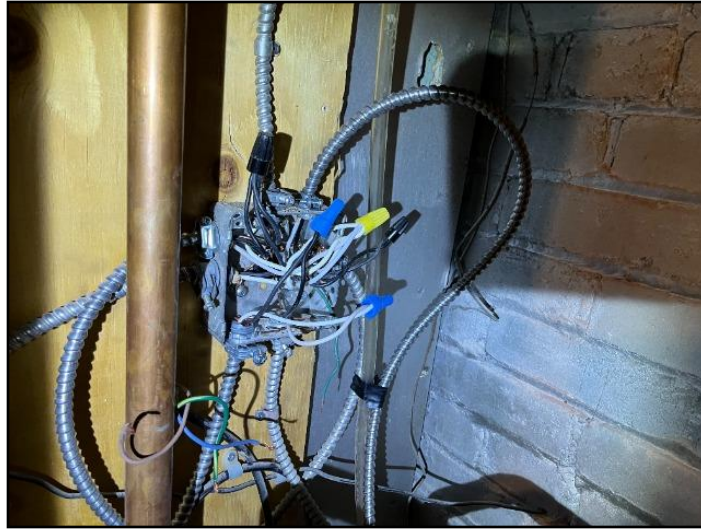
Condition: • [Cover loose or missing](#)

18. Cover loose or missing

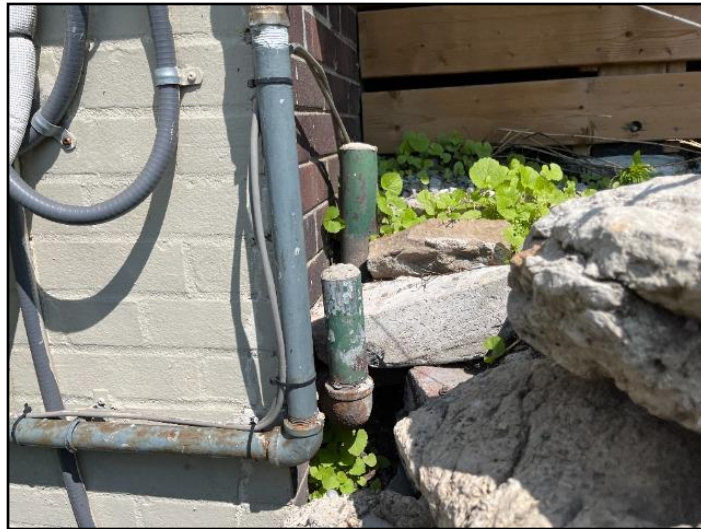
Condition: • [Abandoned](#)

When old abandoned oil fill and vent pipes are found routed below grade, we typically would recommend further evaluation for a possible buried oil tank. A prior assessment was performed in 2005 for a previous homeowner and no tank was found. As a courtesy, we provide the document supplied by the sellers agent in the APPENDIX tab of this report.

19. Abandoned

Task: For Your Information / See Appendix tab / Consult sellers representative for more information
