Your Inspection Report

231 Ashdale Avenue
Toronto, ON M4L 2Y8

Tuesday, May 26, 2020

RE: Report No. 3046, v.3
231 Ashdale Avenue
Toronto, ON
M4L 2Y8

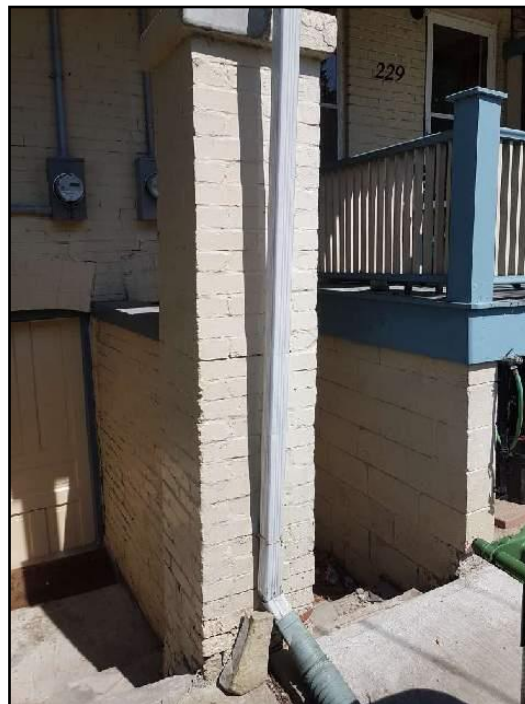
1. Leaning

3. Condition: • [Leaning](#)

While sound at present, porch column has been undermined by creation of basement entrance and will require eventual rebuild.

Implication(s): Chance of movement | Weakened structure

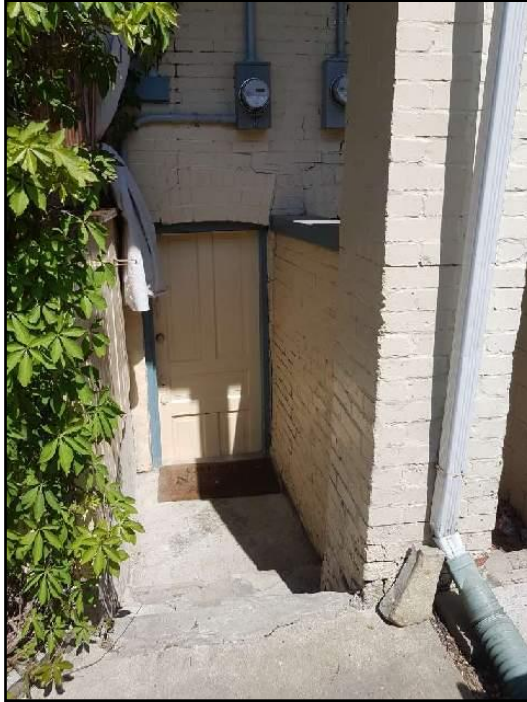
2.

4. Condition: • Basement entrance poorly constructed without drain or step up into basement, undersized door, cracked

stairs and no handrail. Rebuild if this is to be used as a primary entrance or finishing basement.

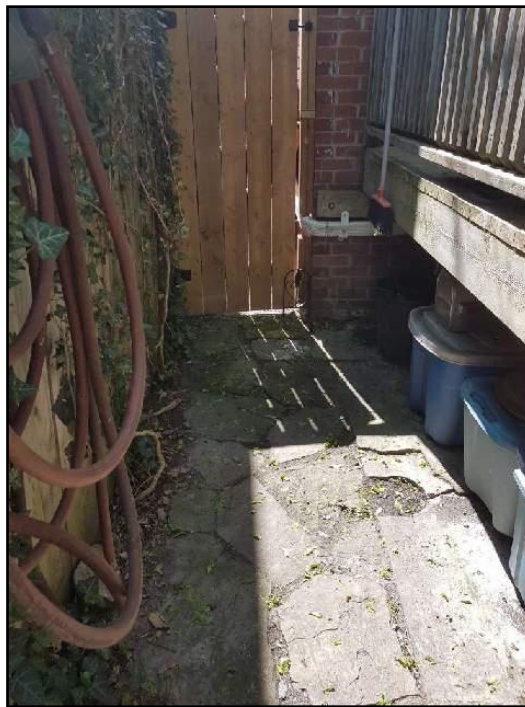
4. Improper slope or drainage

5. Condition: • [Improper slope or drainage](#)

Implication(s): Chance of water damage to contents, finishes and/or structure

Improve drainage to lessen potential for basement leakage.

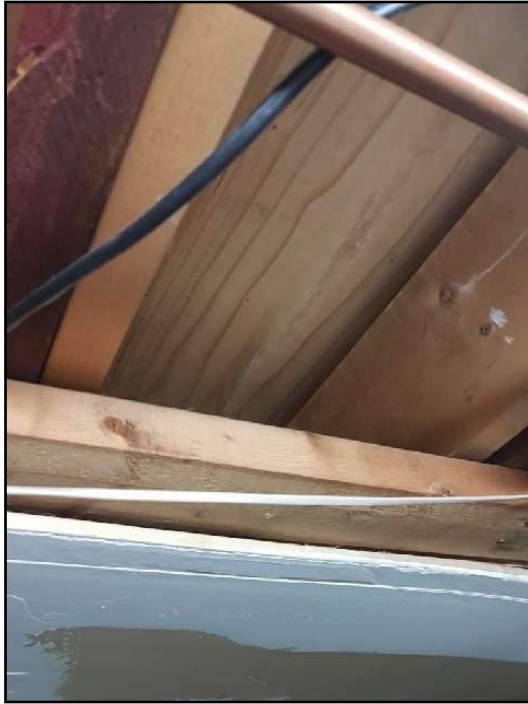
5. Repairs

6. Condition: • Evidence of previous termite activity and structural repairs to kitchen. No current activity found.

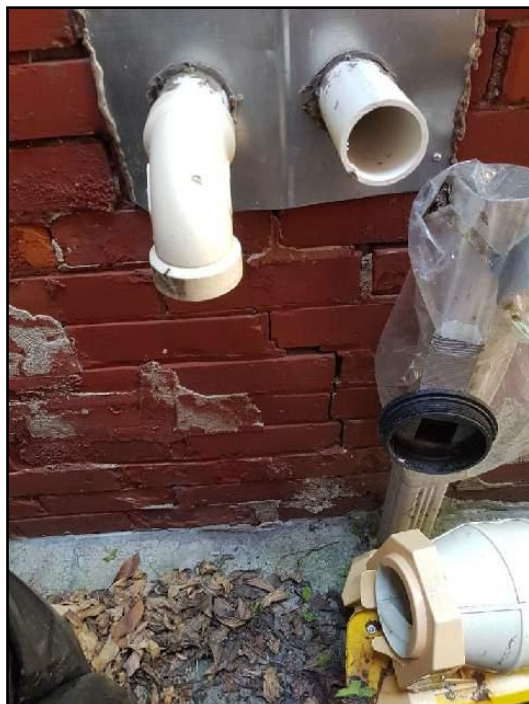
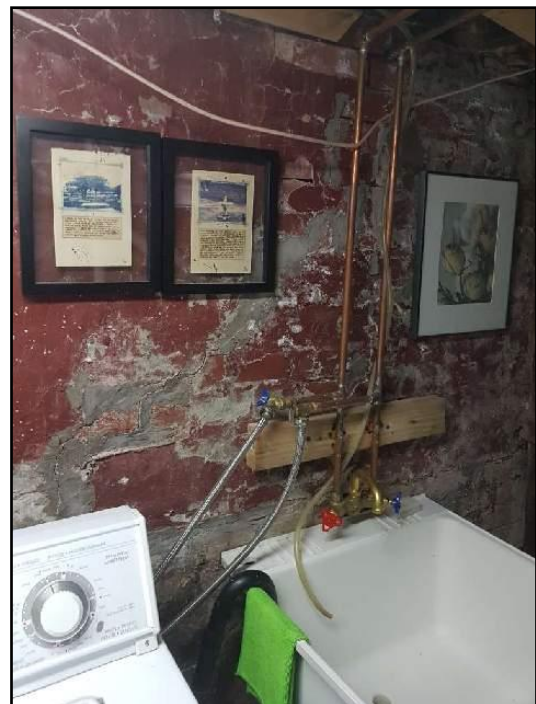
7. Condition: • [Cracked](#)

Crack at foundation has high probability of leakage, repair if renovating or finishing basement.

Implication(s): Chance of water damage to contents, finishes and/or structure | Weakened structure

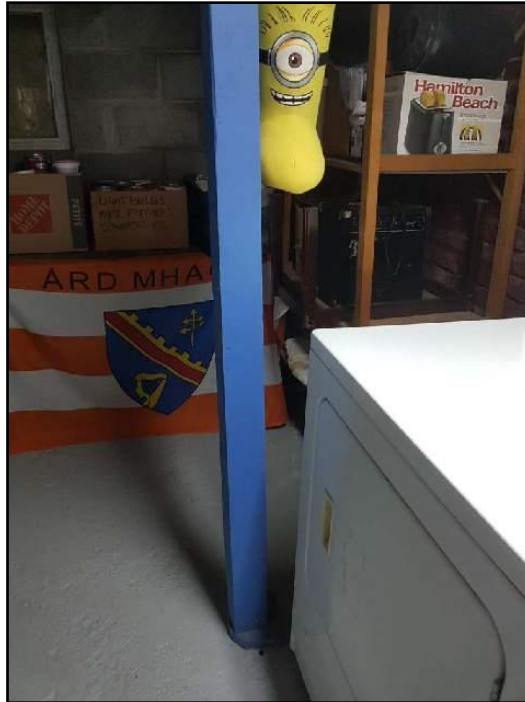
9. No footing

8. Condition: • [No footing](#)

Implication(s): Chance of structural movement

Replace temporary columns if renovating basement or areas above.

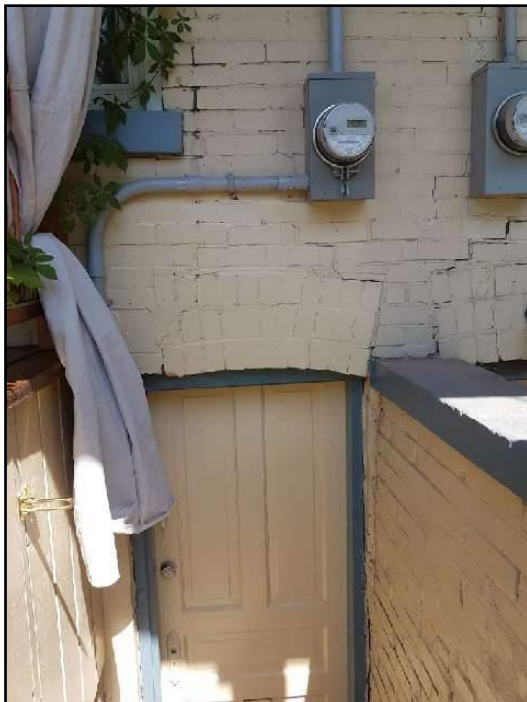
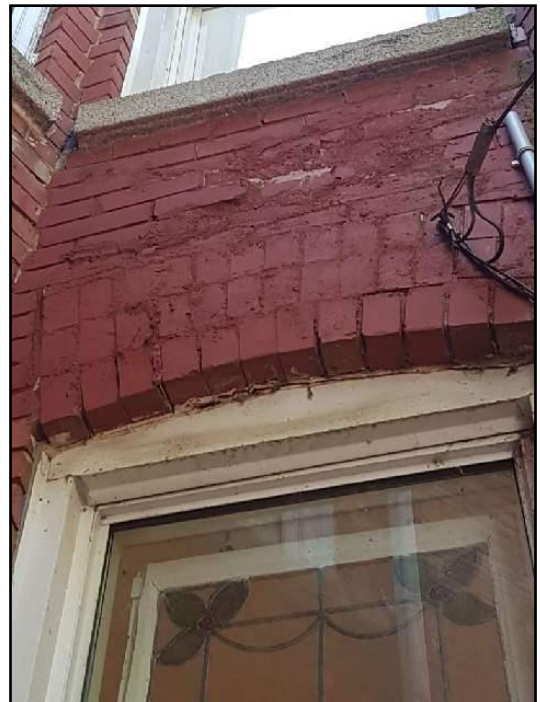
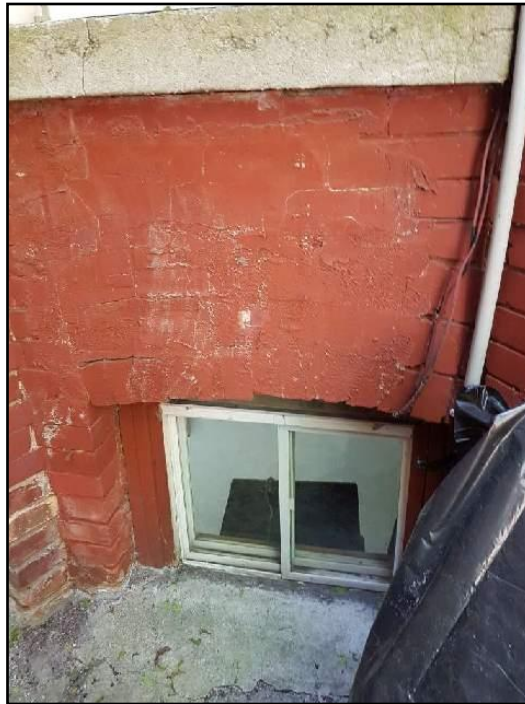
9. Condition: • [Cracked](#)

Several arches are in poor condition and will require eventual rebuild or replacement with steel lintels.

Implication(s): Weakened structure | Chance of structural movement

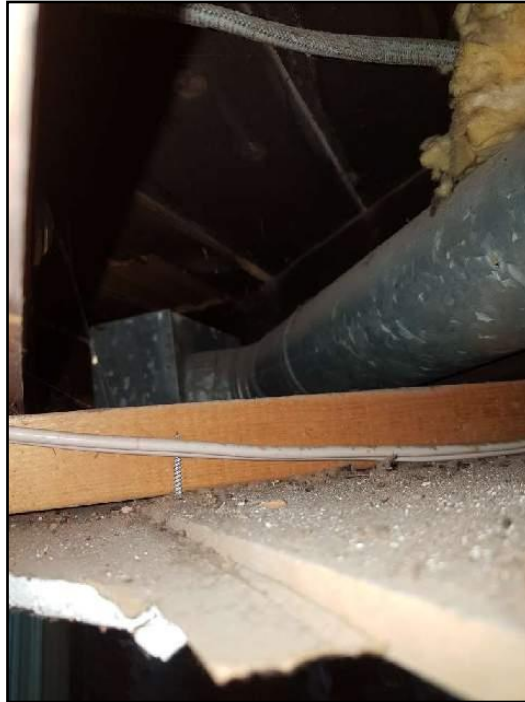
13. Leaky joints

12. Condition: • [Leaky joints](#)

Implication(s): Reduced comfort | Increased heating costs

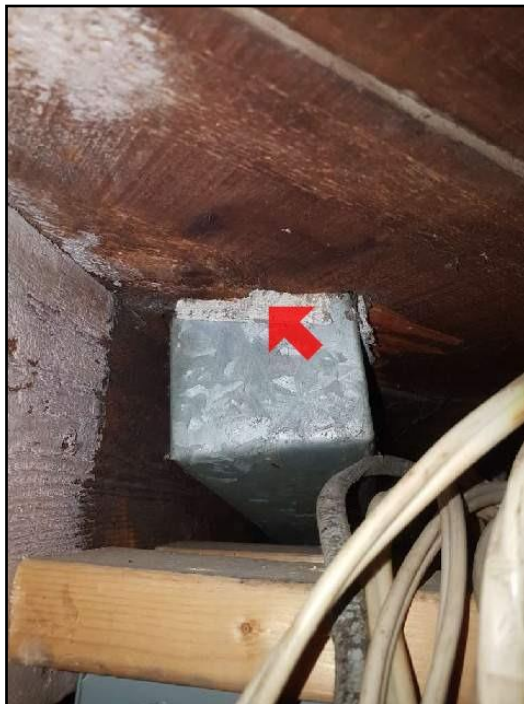
14. Asbestos

13. Condition: • Some asbestos present at ducting, remove if necessary to disturb. Typical for this era of construction ducting within walls is asbestos wrapped.

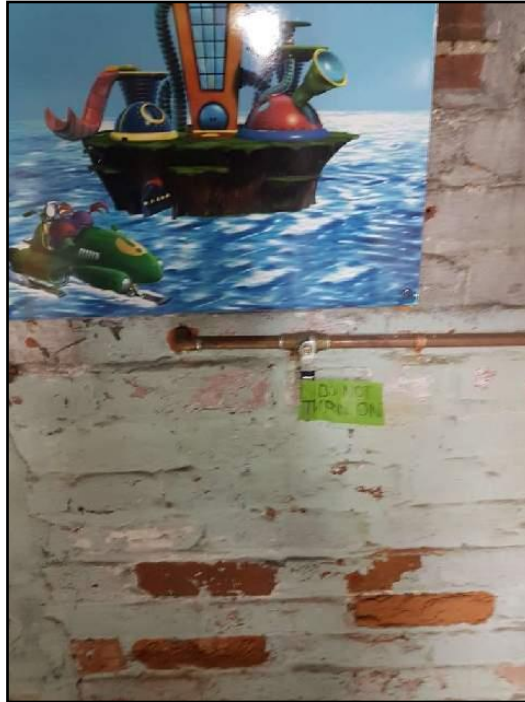
15. Leak or drip

15. Condition: • [Leak or drip](#)

Implication(s): Chance of water damage to contents, finishes and/or structure

Vendor to repair leak at west outdoor hose piping.

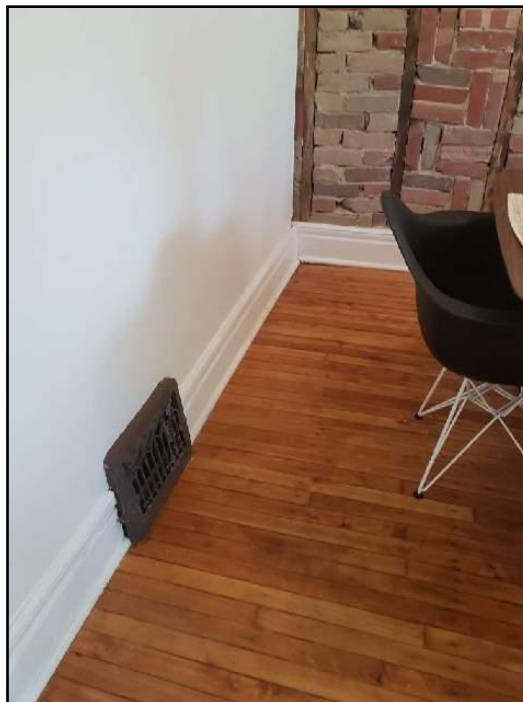
16. Sloped

16. Condition: • Sloped

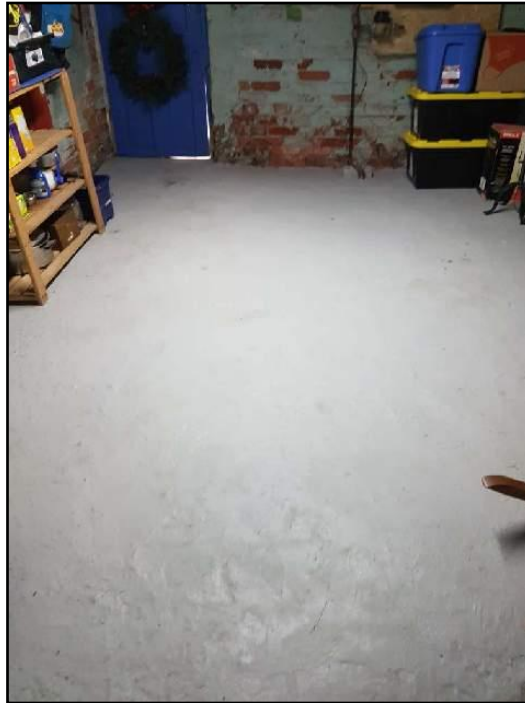
17. Heaved

17. Condition: • [Heaved](#)

Implication(s): Trip or fall hazard | Difficult access

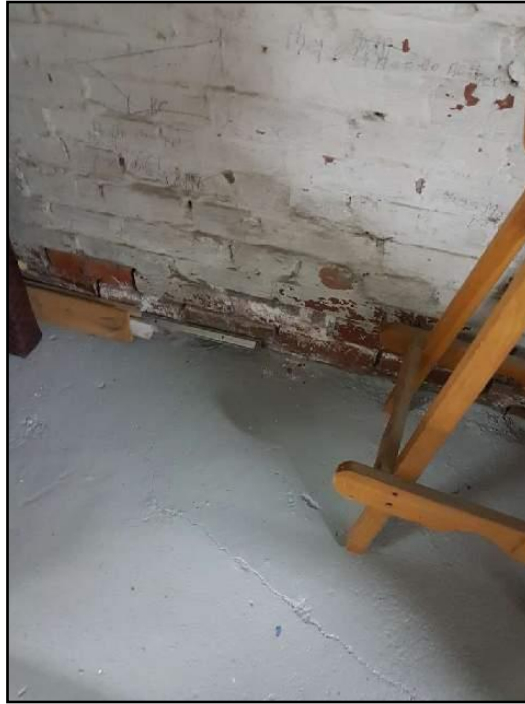
18. *Efflorescence*

18. Condition: • [Efflorescence](#)

Implication(s): Chance of water damage to contents, finishes and/or structure
