YOUR Inspection Report

2730 Ferol Ln
Lynn Haven, FL 32444

Wednesday, August 5, 2020

RE: Report No. 1010
2730 Ferol Ln
Lynn Haven, FL
32444

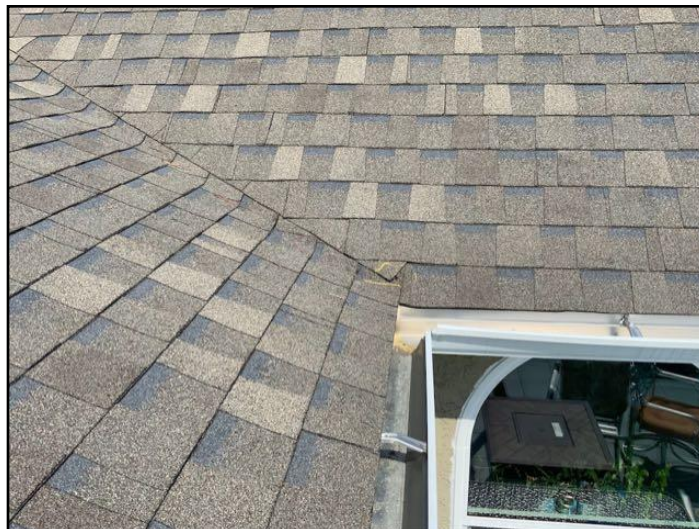
Condition: • [Exposed fasteners](#)

Implication(s): Chance of water damage to contents, finishes and/or structure

9. *Exposed fasteners*

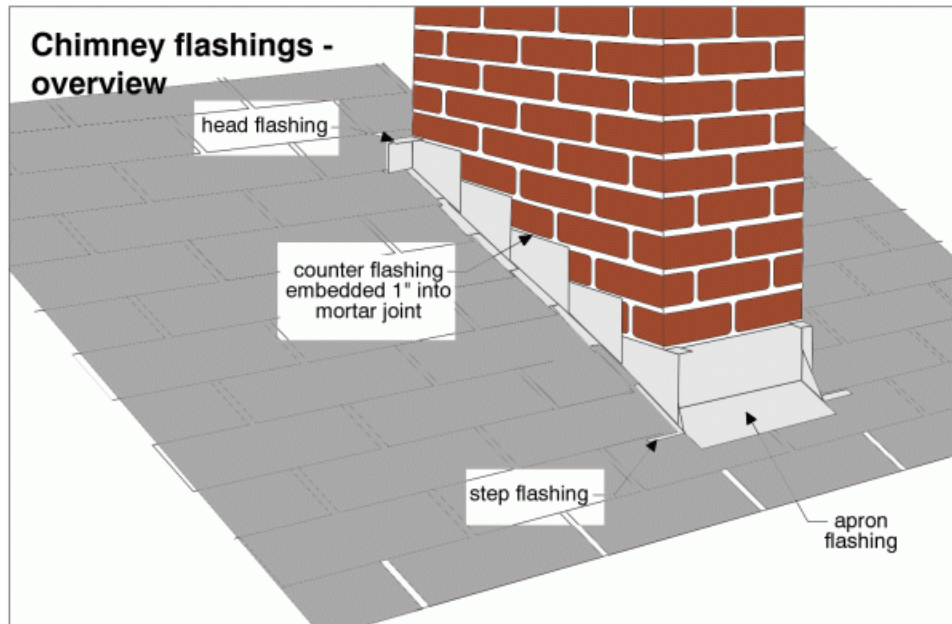
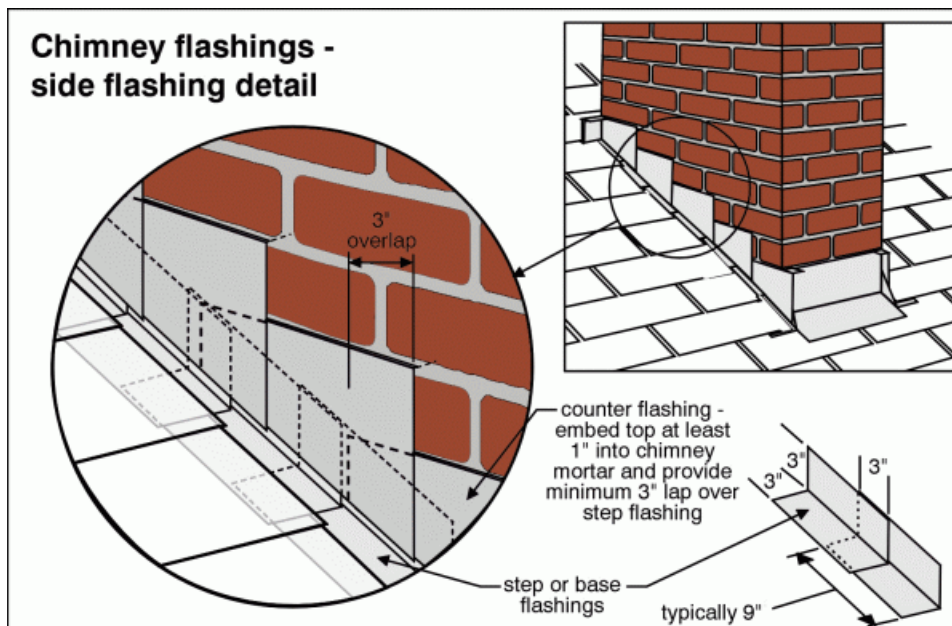
Condition: • [Missing top, bottom, side flashings](#)

Implication(s): Chance of water damage to contents, finishes and/or structure

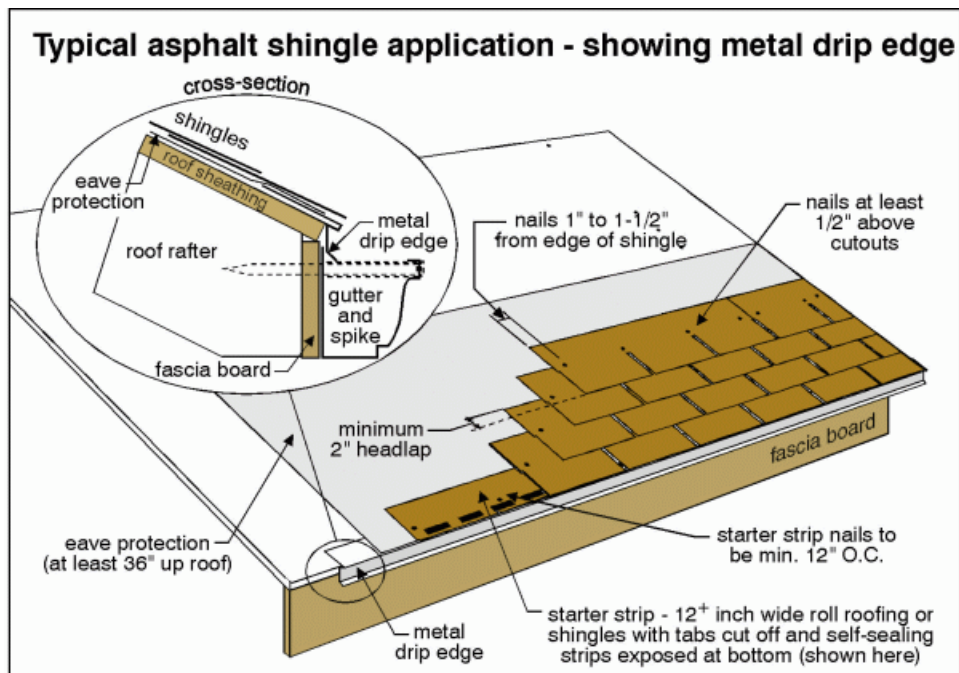
Condition: • [Above underlayment](#)

Implication(s): Chance of water damage to contents, finishes and/or structure

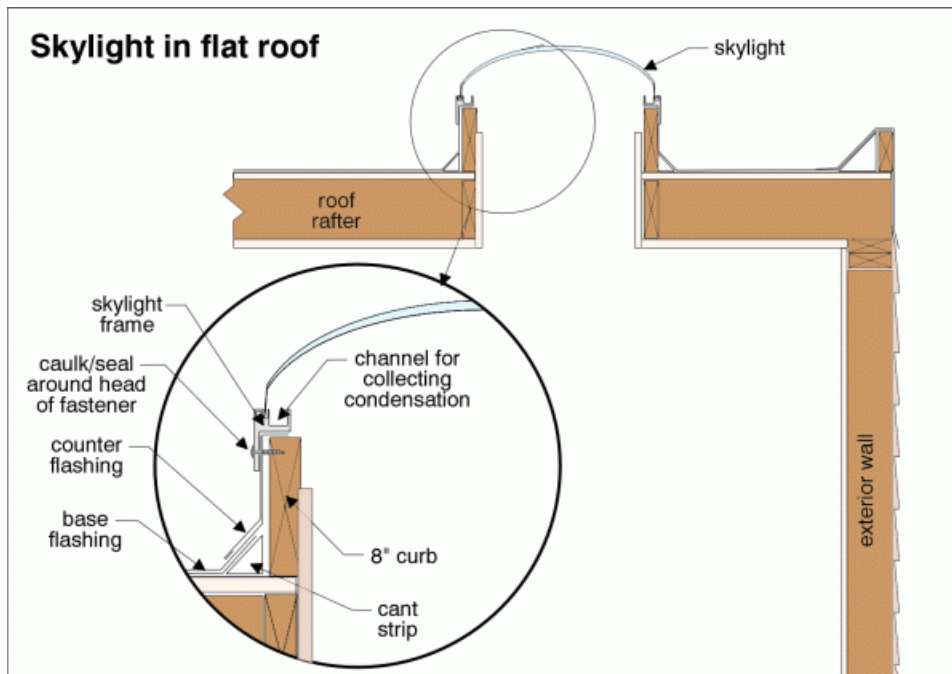
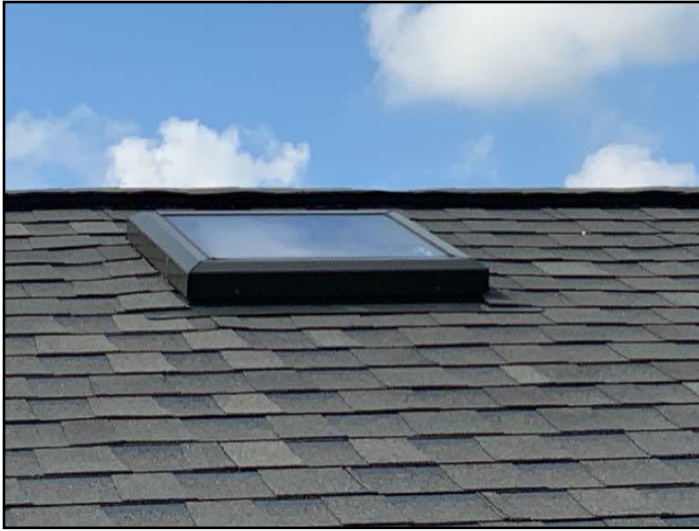
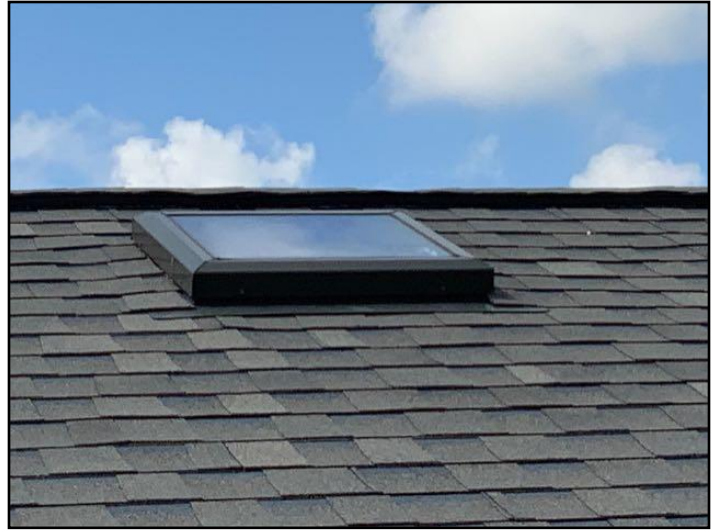
Condition: • [Skylight not well secured](#)

Implication(s): Chance of water damage to contents, finishes and/or structure

10. Skylight not well secured

11. Skylight not well secured

Task: Repair

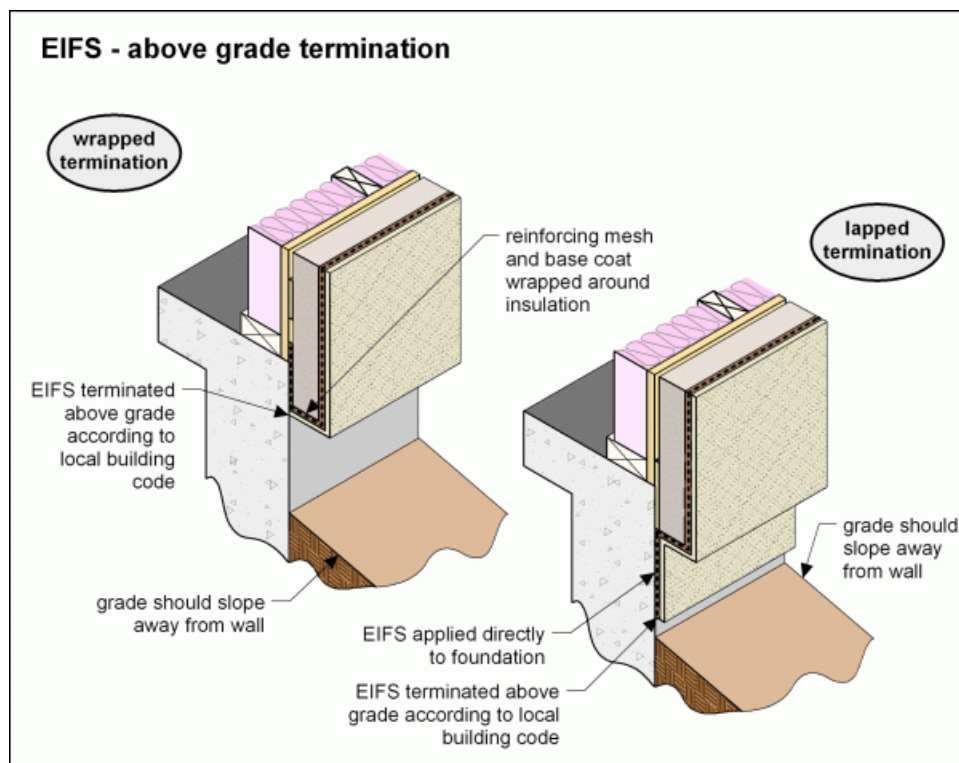
Condition: • [Too close to grade](#)

Implication(s): Chance of water damage to contents, finishes and/or structure | Material deterioration

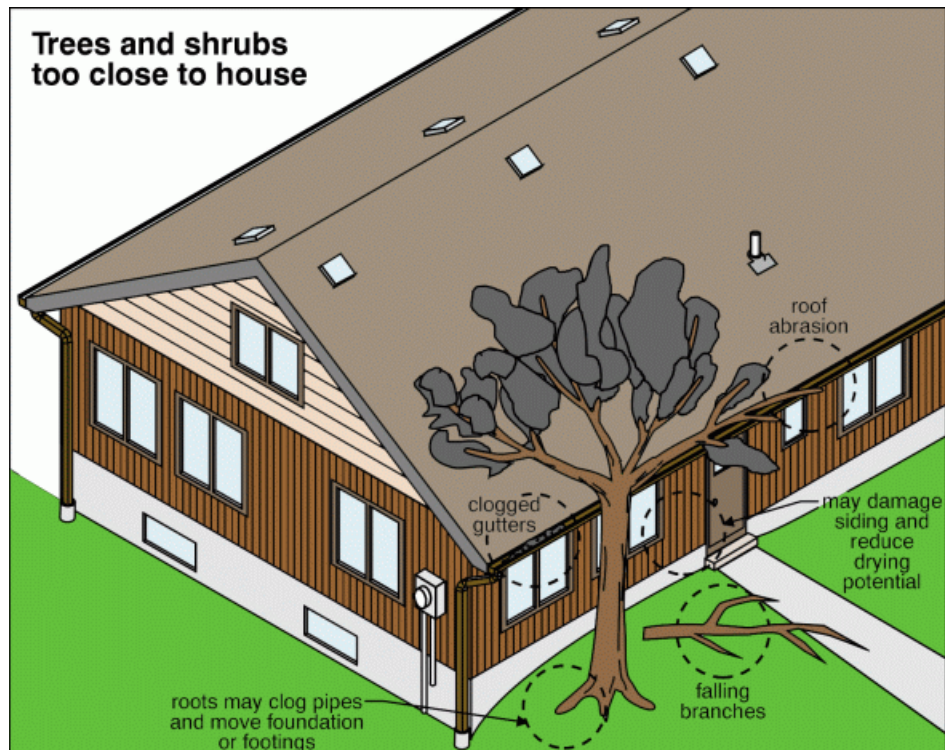
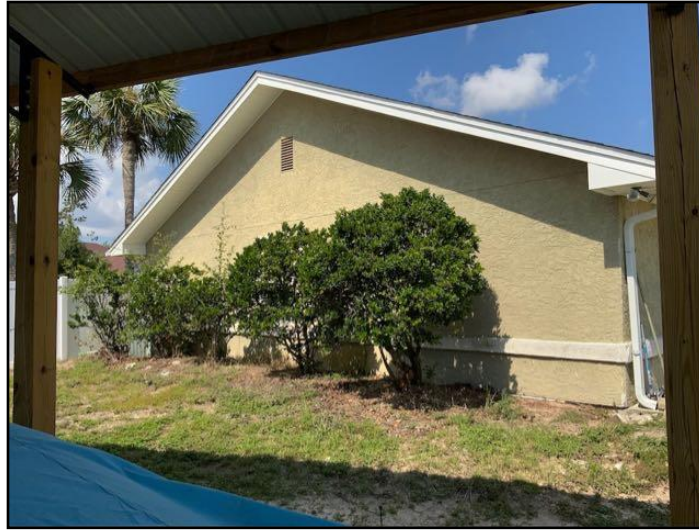
Condition: • [Trees or shrubs too close to building](#)

Implication(s): Chance of water damage to contents, finishes and/or structure | Chance of pests entering building | Material deterioration

19. Trees or shrubs too close to building

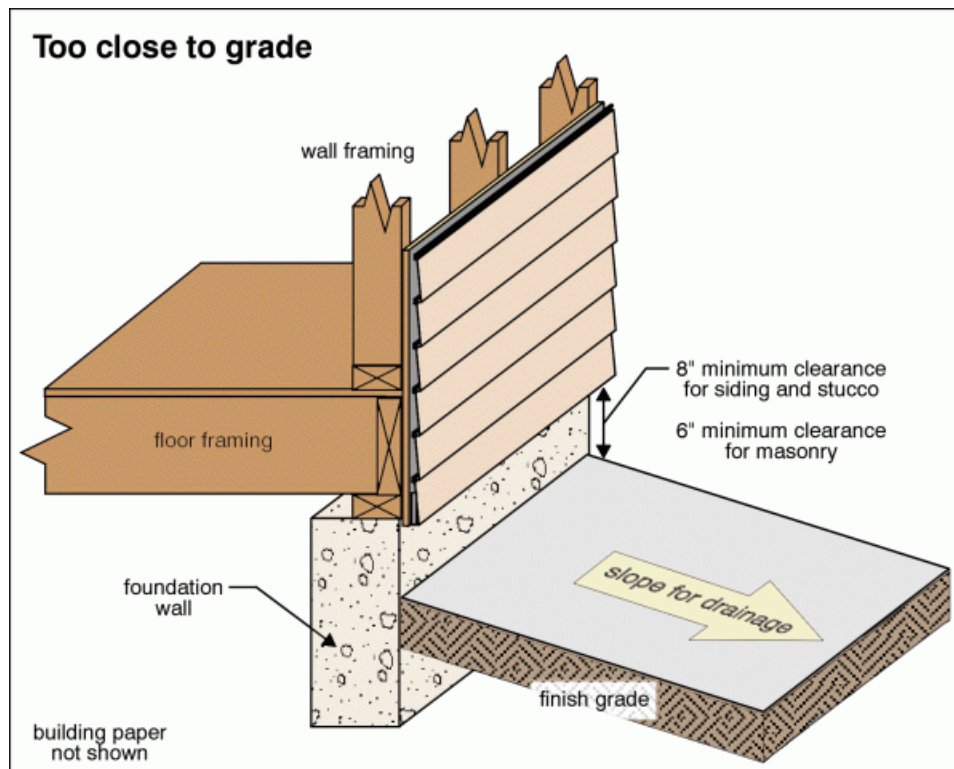
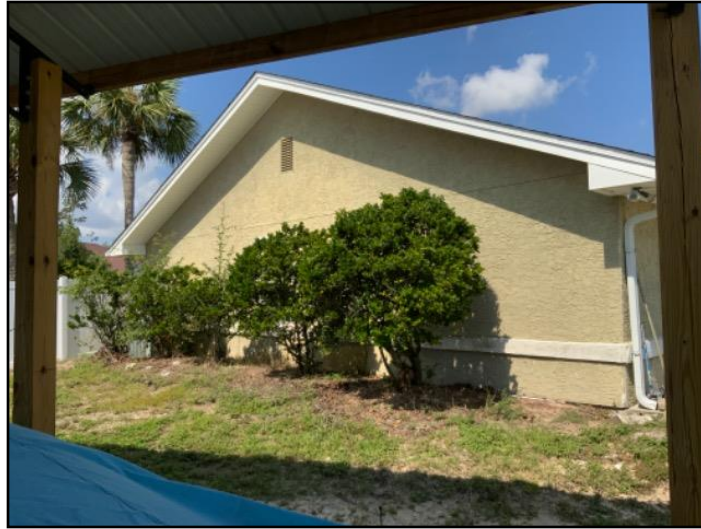
Condition: • [Siding too close to grade](#)

Implication(s): Chance of water entering building | Weakened structure | Rot | Insect damage

20. Siding too close to grade

Task: Repair

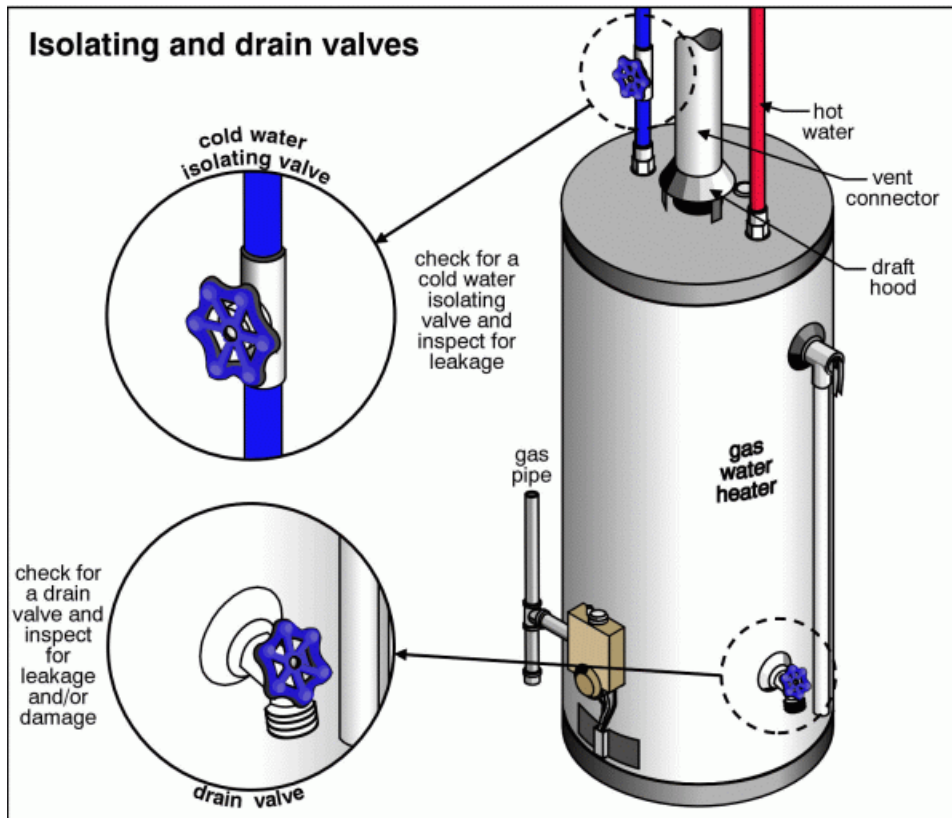
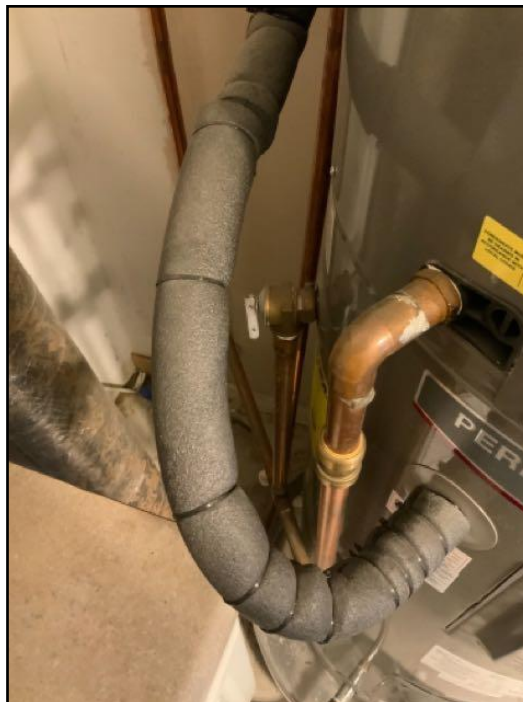
Condition: • [Problems](#)

Implication(s): Chance of water damage to contents, finishes and/or structure

53. Problems

Task: Repair or replace
