Report No. 1021, v.5

777 Runningbrook Drive, Mississauga, ON December 4, 2019

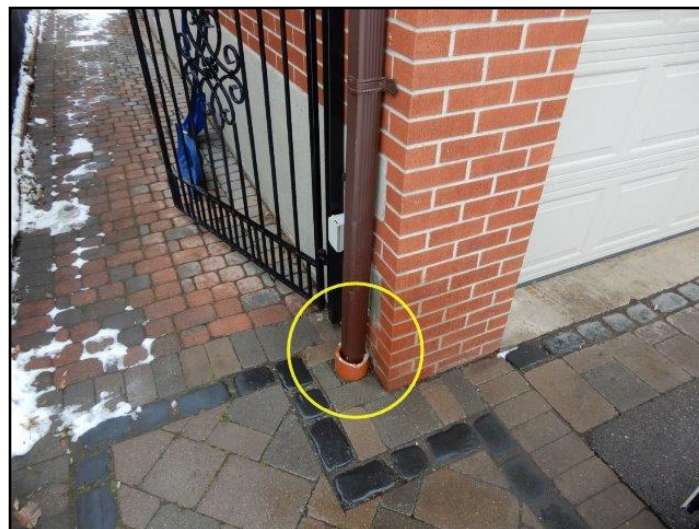
1. Discharge below grade

1. Condition: • [Discharge below grade](#)

Homes of this age with downspouts that discharge below grade are more likely to cause basement leakage or foundation damage due to clogged or deteriorated pipes. Having your downspouts to discharge above grade is a preventative measure to reduce the risk of foundation leakage and structural damage. Please note that depending on the age and installation, concealed water damage may have already occurred.

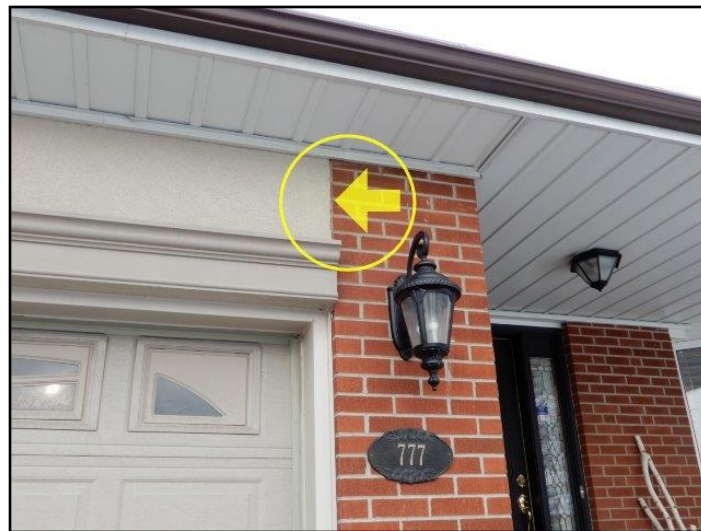
2. Cracked

2. Condition: • [Cracked](#)

crack noted, repairs required in order to prevent water damage be hide the interior wall

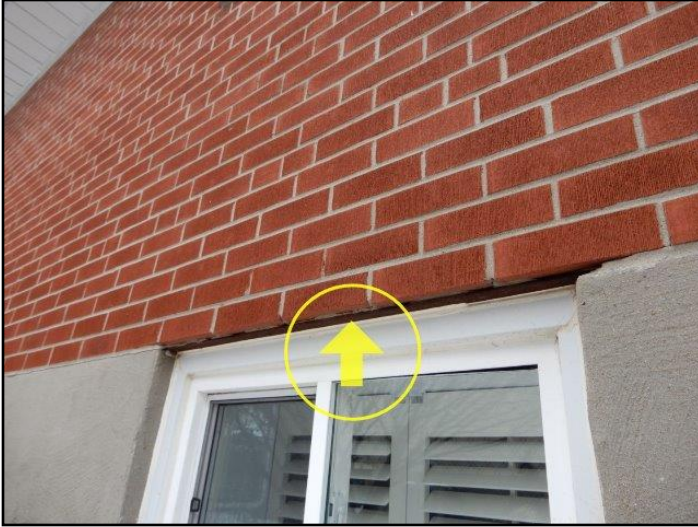
3. Lintel rusting

3. Condition: • [Lintel rusting](#)

Paint and protect steel lintel in order to prevent further rusting

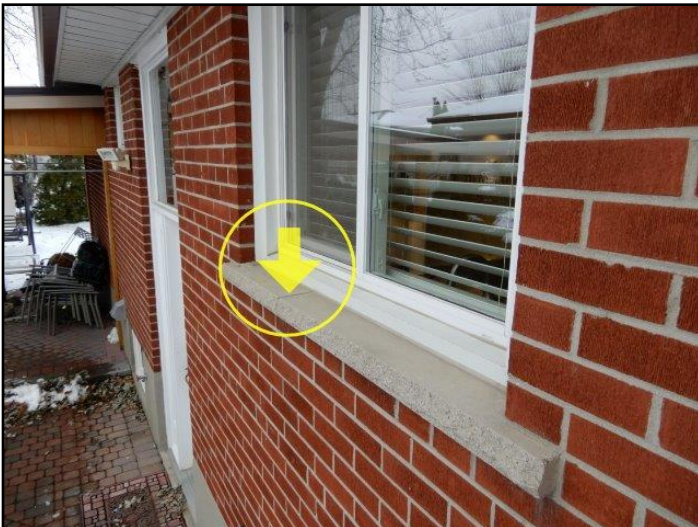
5. Caulking loose, missing or deteriorated

4. Condition: • [Caulking loose, missing or deteriorated](#)

caulk all window ledges in order to prevent water damages to interior finishes

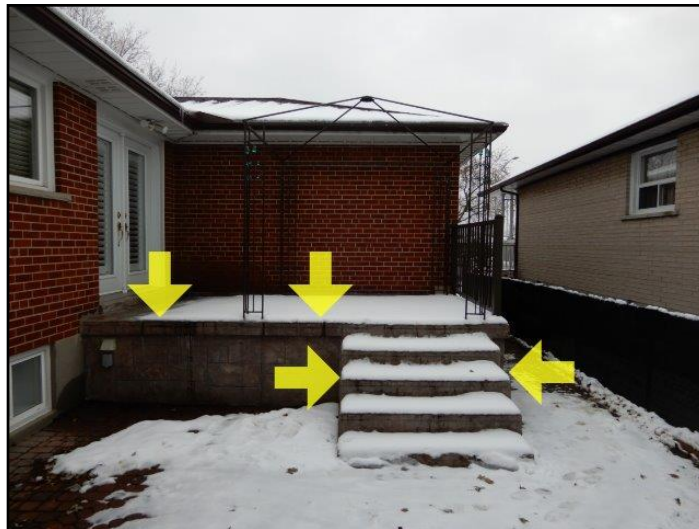
8. Missing

5. Condition: • [Missing](#)

Handrails, guard and posts are required at this deck height, recommend improving immediately in order to prevent a serious fall hazard

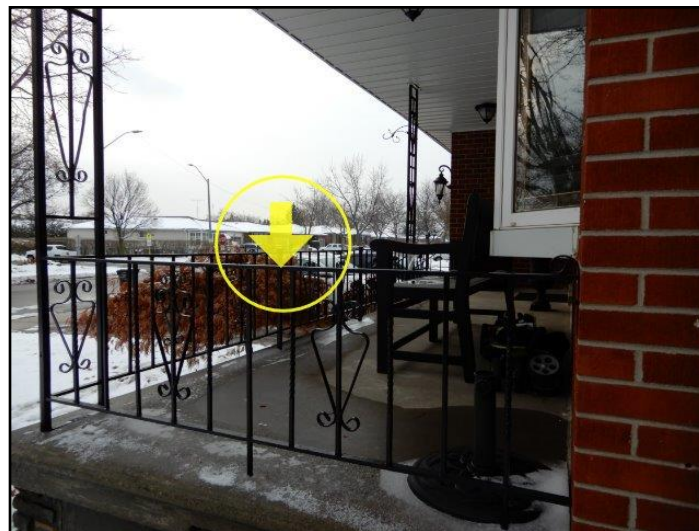
9. Too low

6. Condition: • [Too low](#)

handrails are too low, this may result in a fall hazard, recommend replacing or improving the railing height

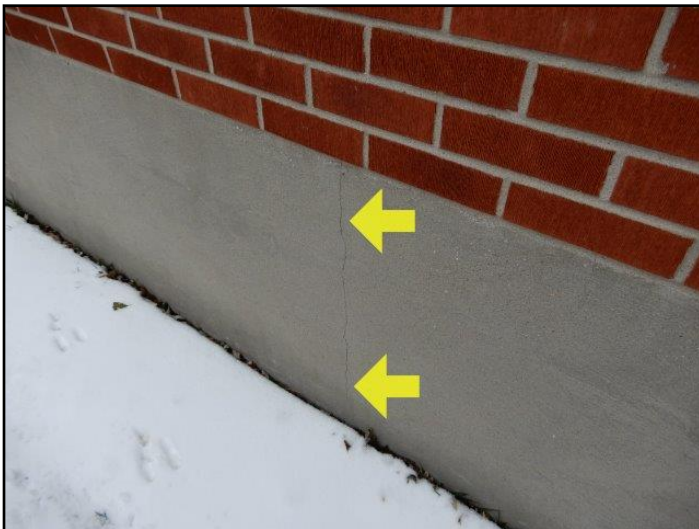
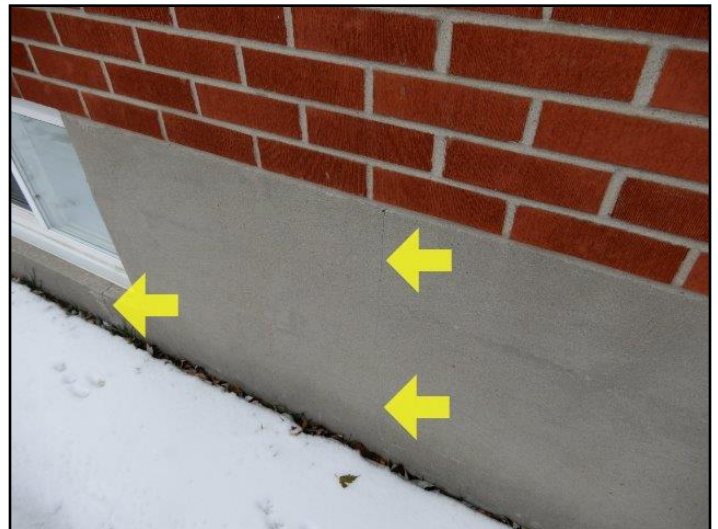
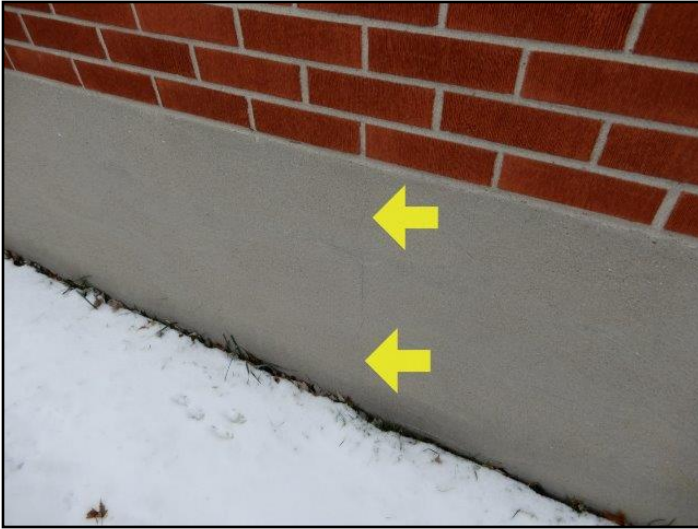
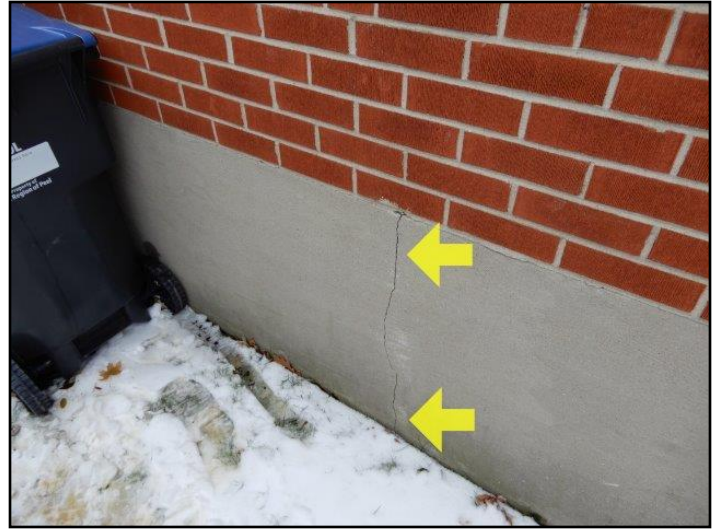
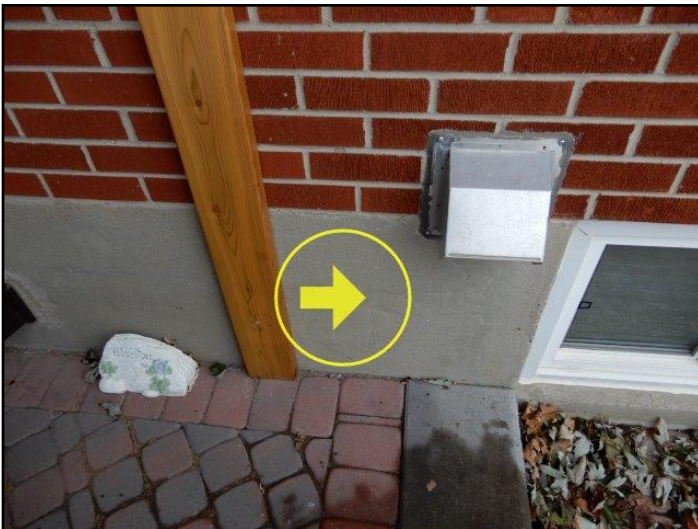
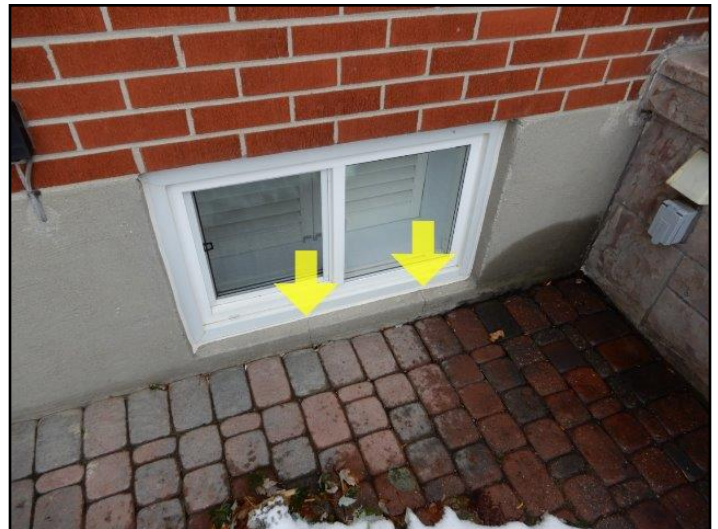
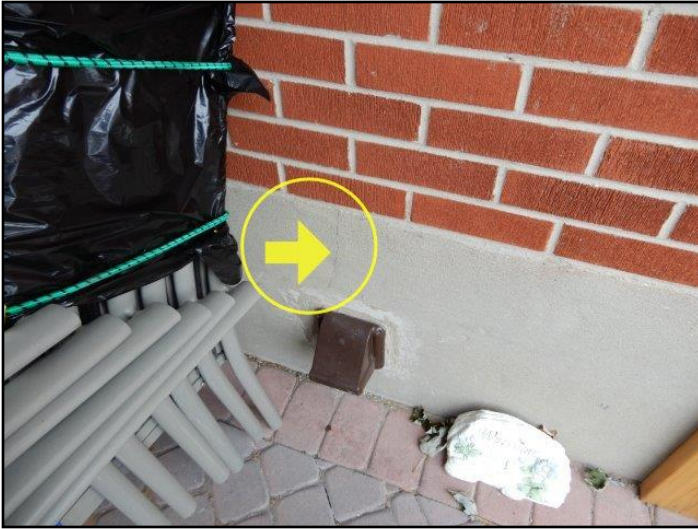
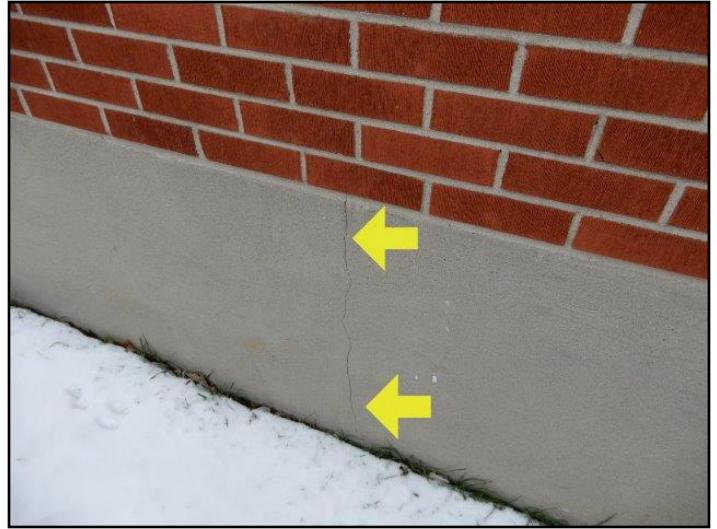
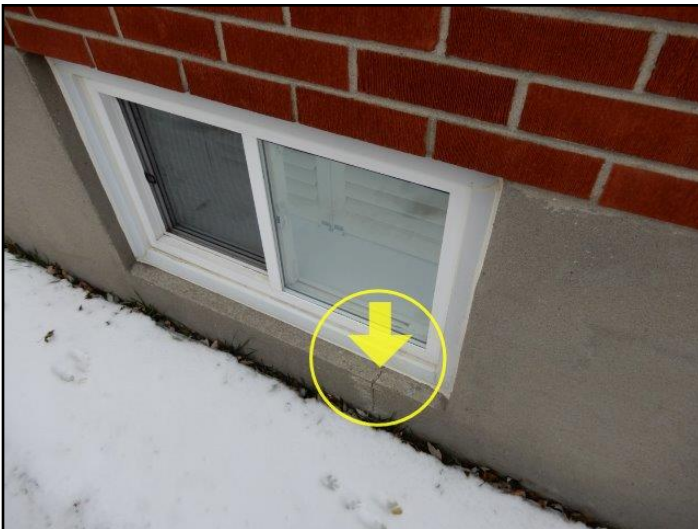
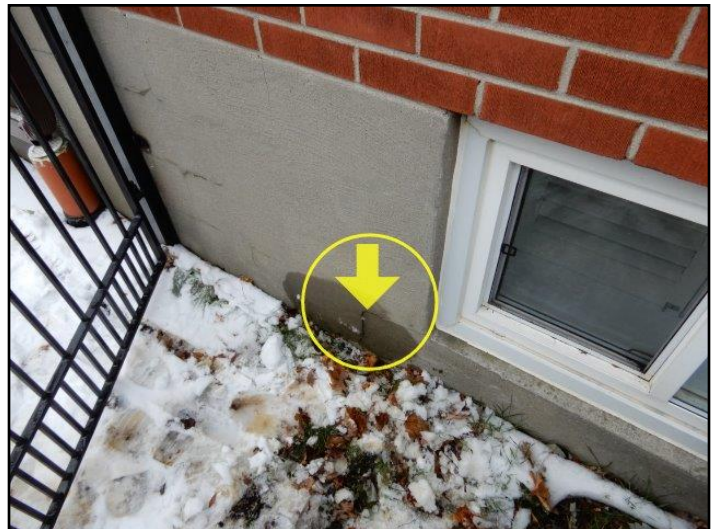
7. Condition: • [Cracked](#)

Foundation cracks noted throughout, this appears not to pose a structural concern. In order to protect the interior finishes from water infiltration recommend patching from the exterior, consult with a foundation expert on the approach and material required. Homes of this age do not have a water tight membrane protecting the foundation walls, ensure the lot grading is kept away from the foundation walls, all downspouts at least 4to6 feet away from the house.

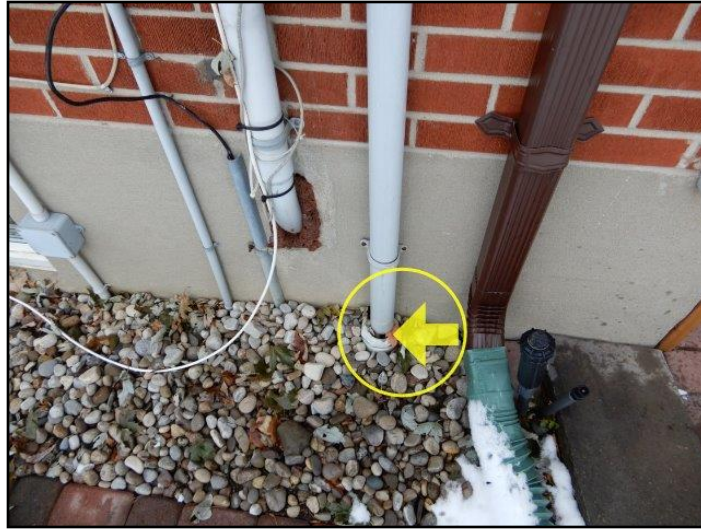
20. Conduit or cable not weather-tight

8. Condition: • [Conduit or cable not weather-tight](#)

Conduit not weather tight, recommend to seal the opening to prevent water infiltration

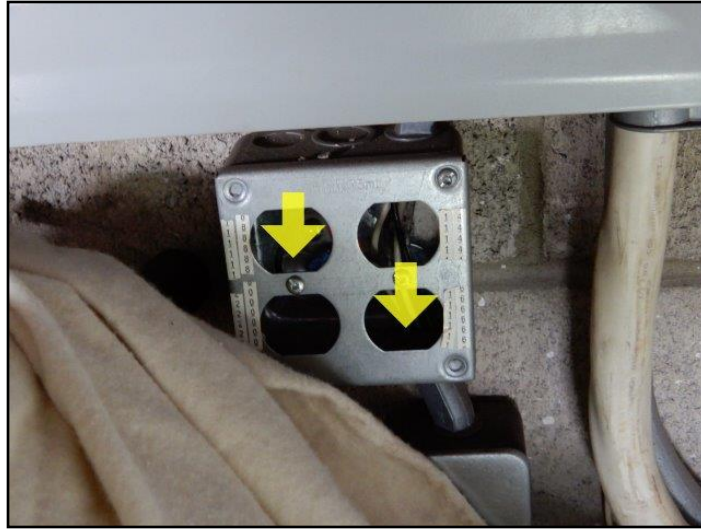
21. Unprotected openings

9. Condition: • [Unprotected openings](#)

open receptacle, repairs required immediatly

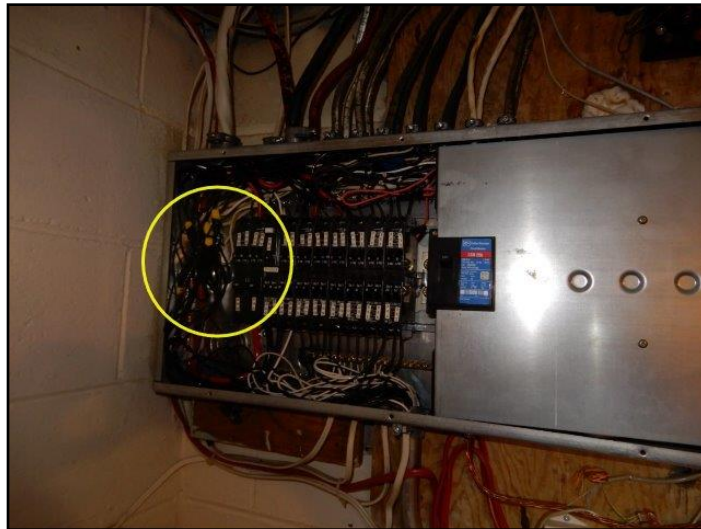
22. Crowded

10. Condition: • [Crowded](#)

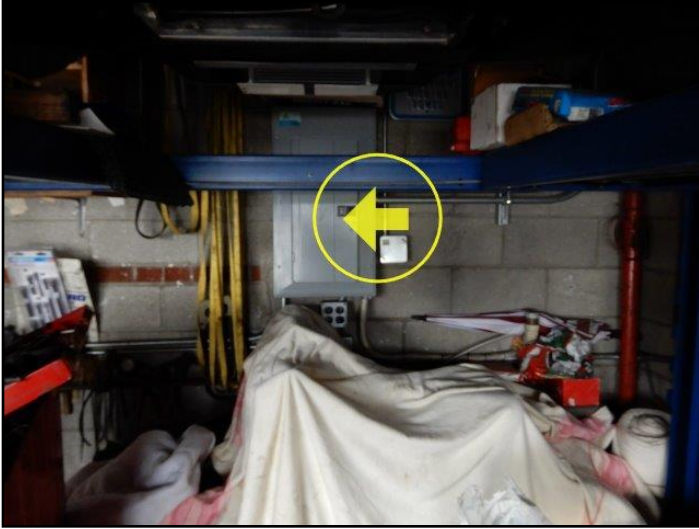
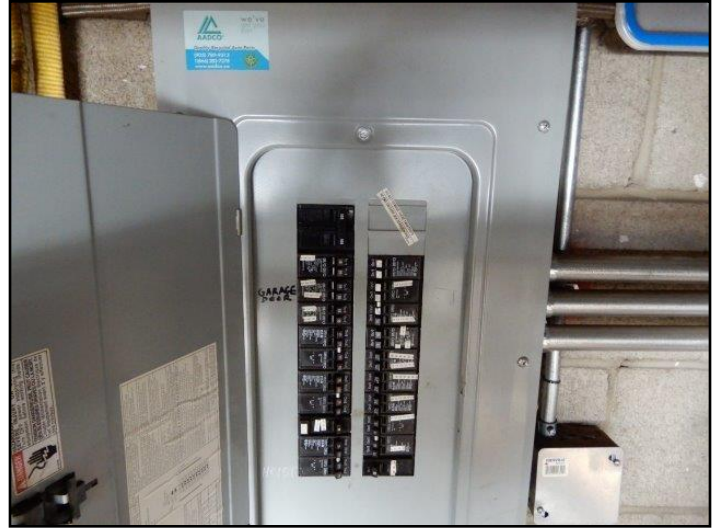
23. subpanel inspection

11. Condition: • recommend subpanel inspection from a licenced master electrician, no ESA or licensee stickers found on both subpanel and main panel, recommend searching for permits when work was conducted, further evaluation is required

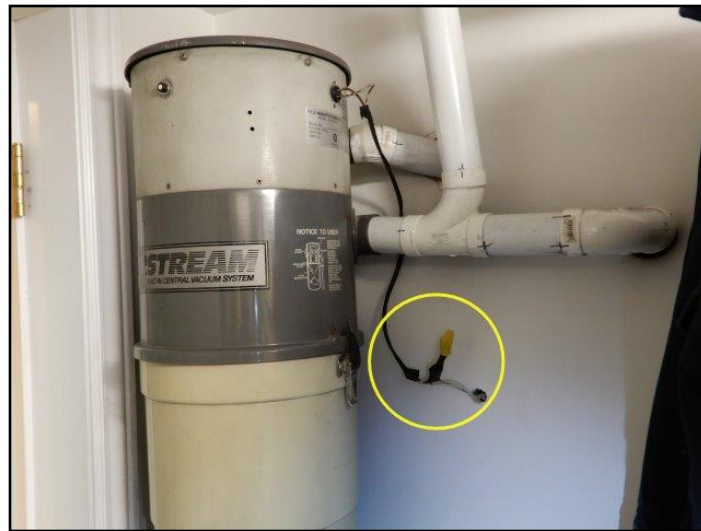
25. Missing

12. Condition: • [Missing](#)

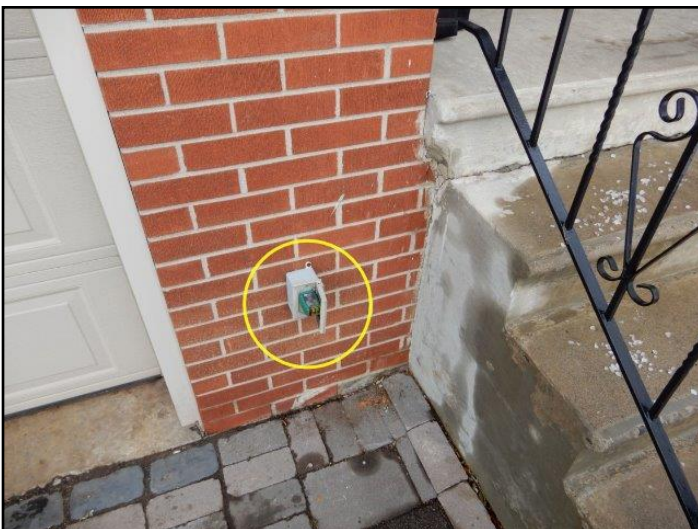
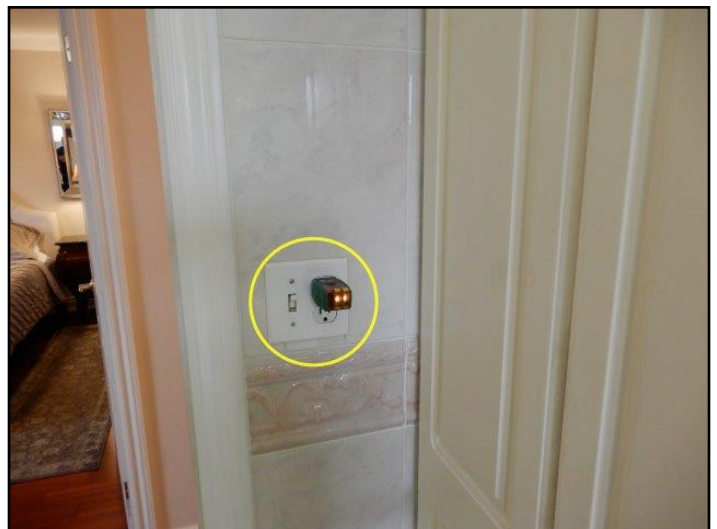
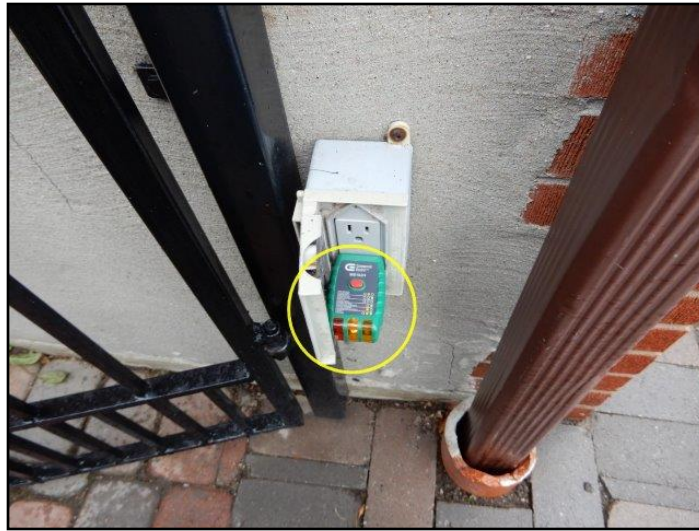
DISTRIBUTION SYSTEM \ Outlets (receptacles)**13. Condition:** • [Ungrounded](#)

please revert to comments made in the missing GFI section of the report, the two exterior receptacles are ungrounded and not protected with a GFI

14. Condition: • [GFCI/GFI needed \(Ground Fault Circuit Interrupter\)](#)

Recommend replacing the outlets to GFI receptacles, the two exterior receptacles are also ungrounded, main floor hallway bathroom require a GFI outlet

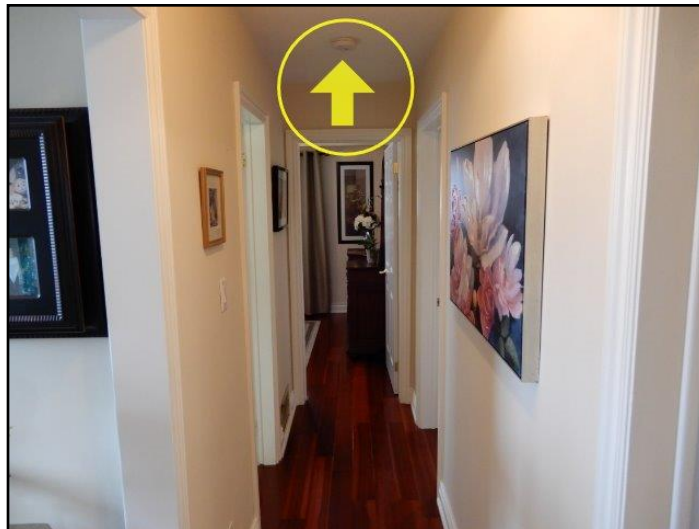
29. Smoke/Carbon alarms

15. Condition: • Its highly recommended to replace all smoke & carbon monoxide alarms, no smoke detector found in the basement area

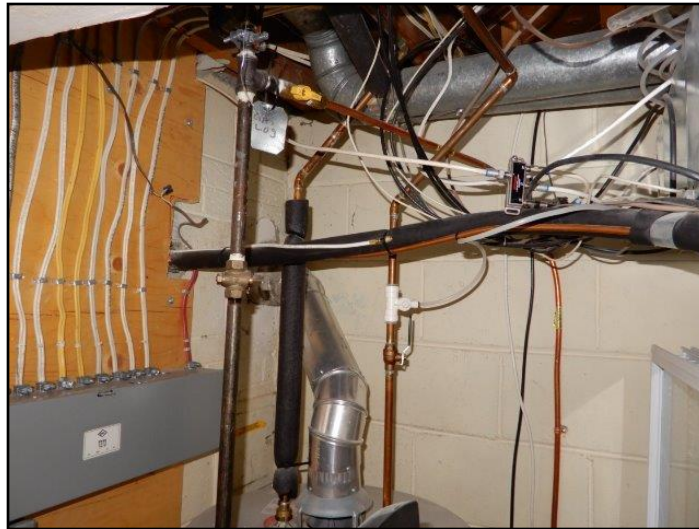
30. no gas tags

16. Condition: • Other

no gas tags noted for furnace, water heater and fireplace, consult with a licenced gas fitter to determine a safe seal to all gas appliances

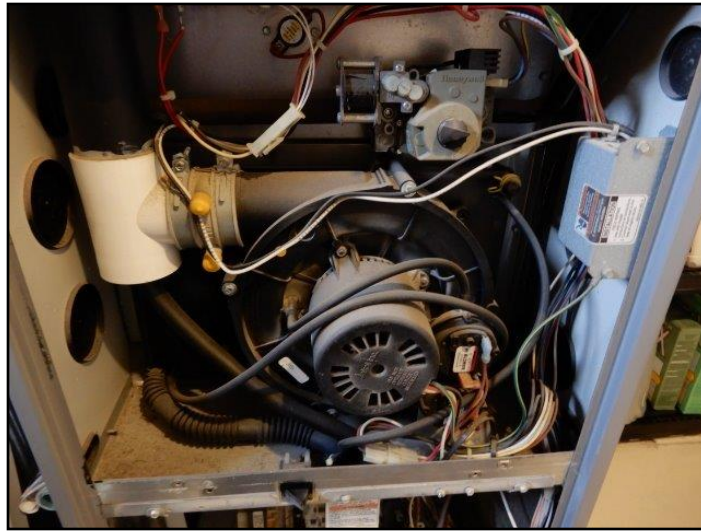
31. Old

17. Condition: • [Old](#)

recommend servicing the unit in order to maintain its life expectancy

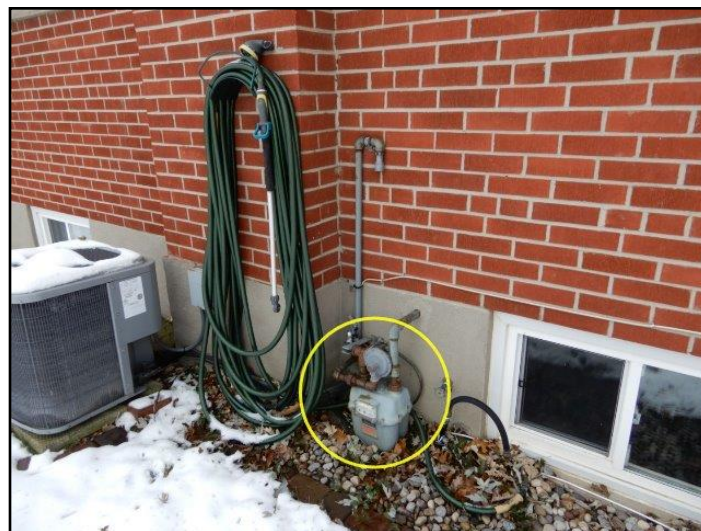
32. Poor location

18. Condition: • [Poor location](#)

remove river rocks surrounding main gas meter, paint and protect gas lines is recommended

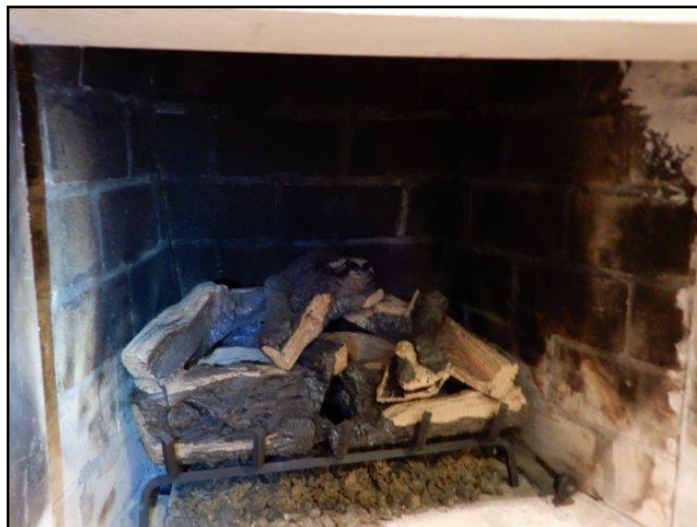
33. Damper in existing fireplace not fixed open

19. Condition: • [Damper in existing fireplace not fixed open](#)

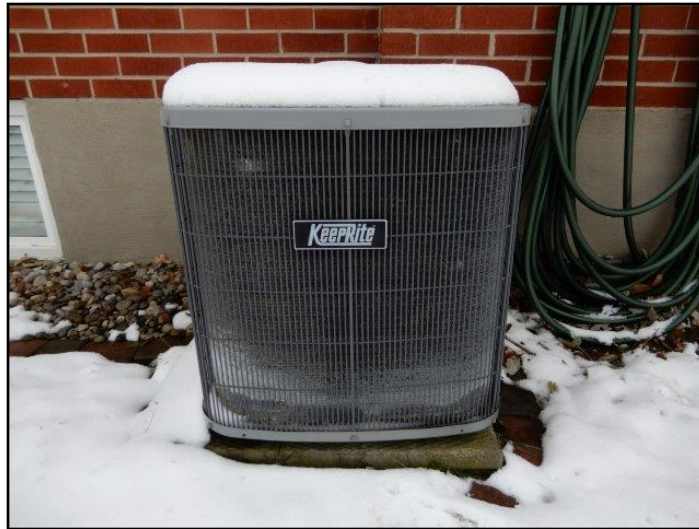
34. *Near end of life expectancy*

20. Condition: • [Near end of life expectancy](#)

near end of life expectancy, we are unable to test the A/C during the colder temperature, recommend monitoring unit until replacement is required

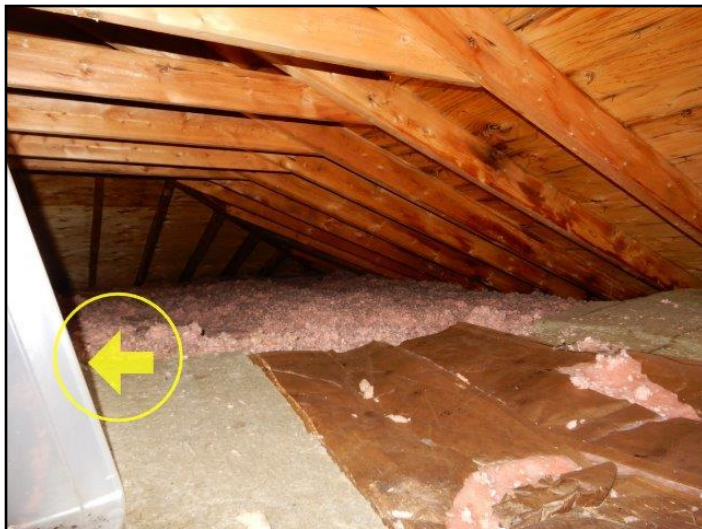
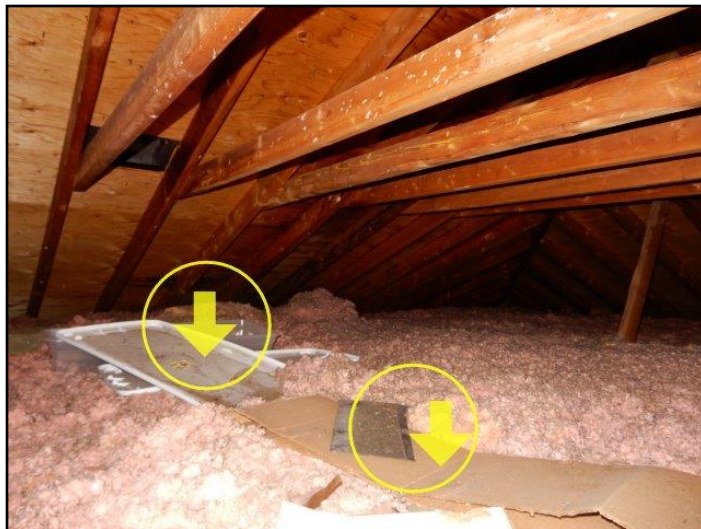
21. Condition: • Debris in attic

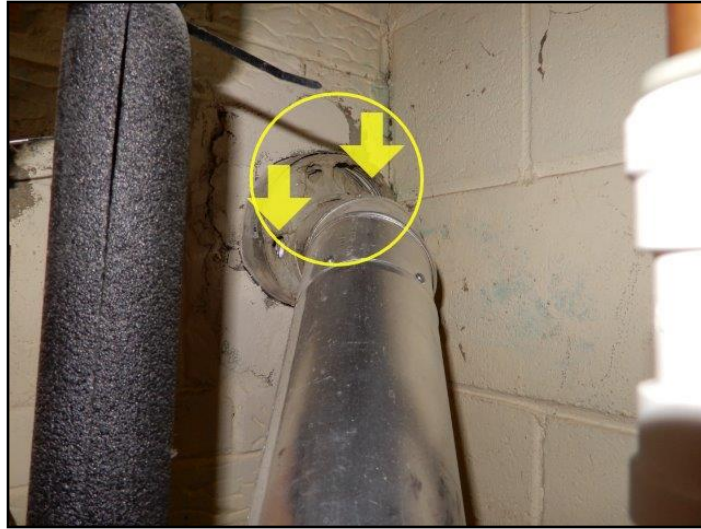
37. Poor connections

22. Condition: • [Poor connections](#)

repair vent seal immediately, possible back drafting can result in carbon monoxide reentering the home, there are direct or sealed venting options on newer units which maybe an option as well to replace entirely

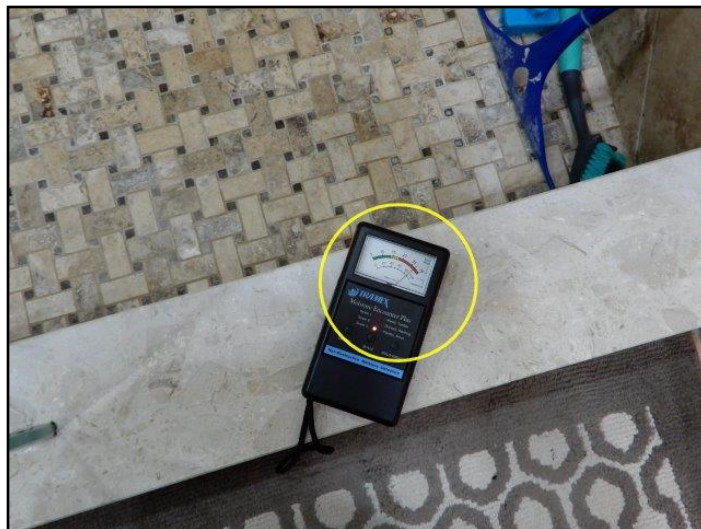
38. Moisture detected

23. Condition: • Moisture detected

Moisture was detected at the threshold of the shower, Using a grout sealer is recommended, hidden defects maybe present.

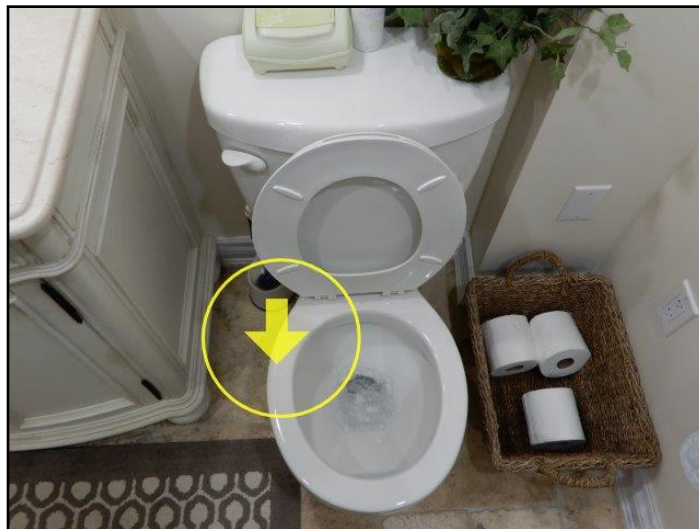
39. Loose

24. Condition: • [Loose](#)

loose toilet, repairs required

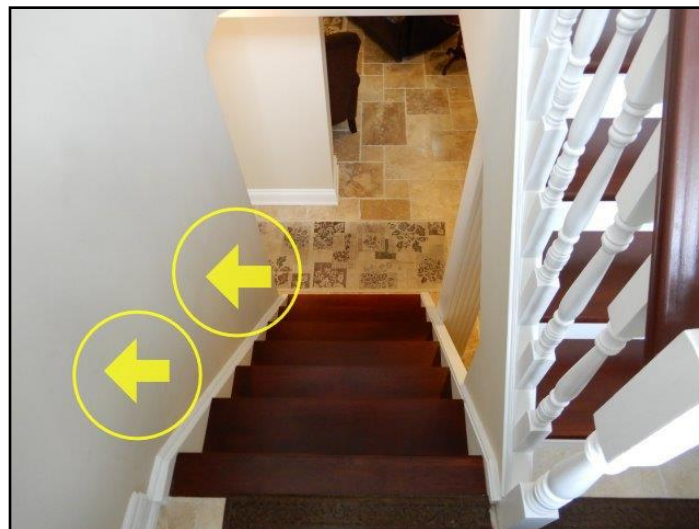
40. Missing

25. Condition: • [Missing](#)

handrail missing, recommend replacing immediately

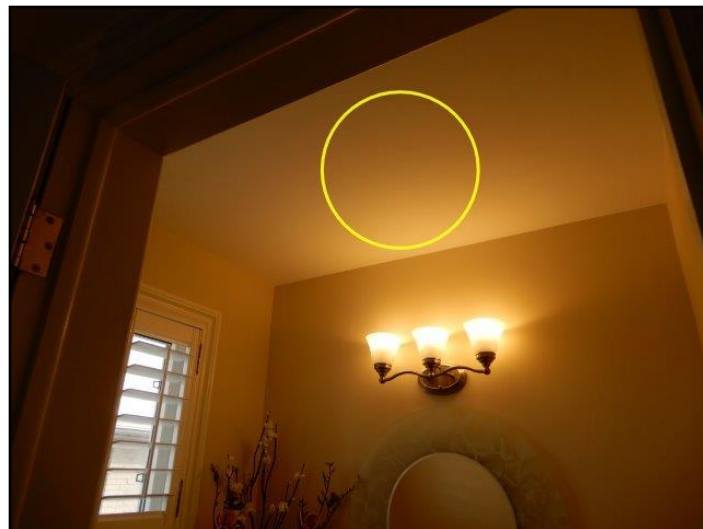
41. Missing

26. Condition: • [Missing](#)

recommend installing bathroom exhaust fan as a improvement to the ensuite bathroom

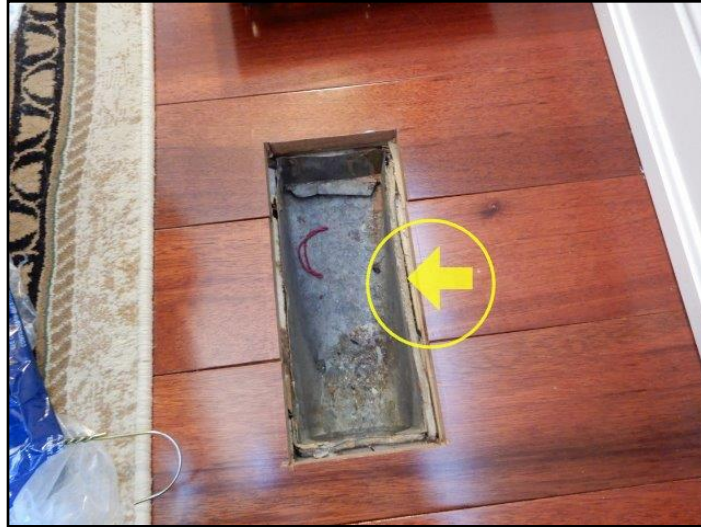
42. Possible asbestos containing materials

27. Condition: • Possible asbestos containing materials
possible asbestos wrapped supply pipes
