# Your Inspection Report

245 Kenilworth Avenue  
Toronto, ON M4L 3S7

**INSPECTION DATE:**  
Monday, May 5, 2025

Report No. 4500

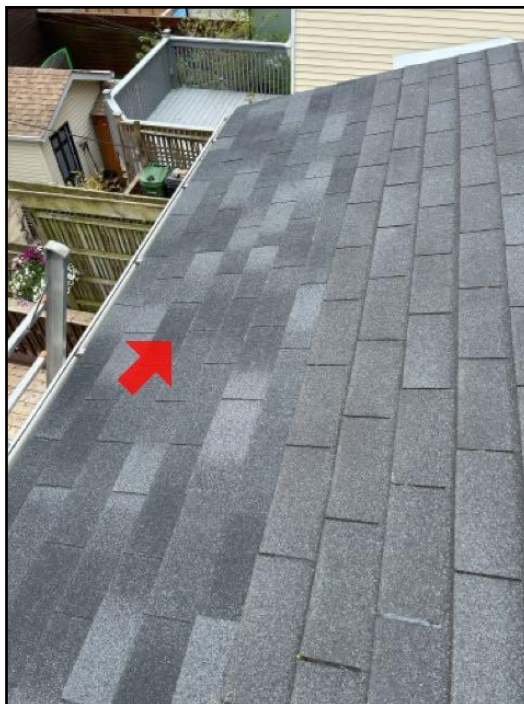
**Condition:** • The front facing shingles appear to be in good condition. The east slope has had recent repairs to prevent ice damming. The remaining shingles on the east slope are older and should be replaced in 3-5 years. The modified bitumen flat roof is older; re-inspect it in 2-3 years.

*Recent repairs*

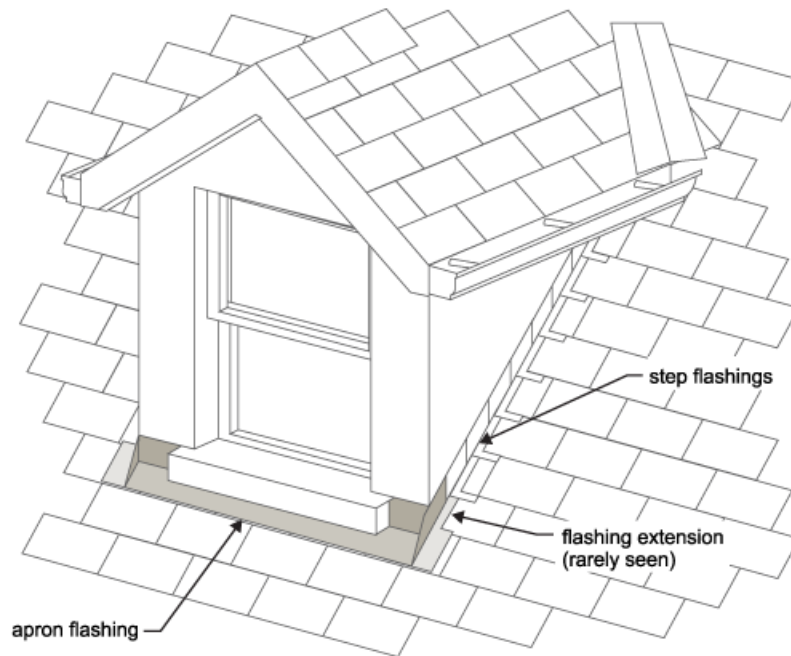
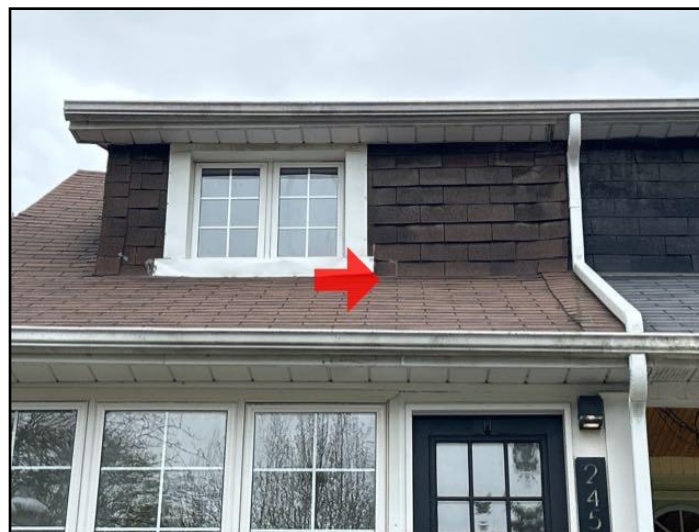
**Condition:** • [Missing](#)

**Location:** West

*Missing roof-wall flashing*

**Task:** Provide

**Time:** Next roof replacement

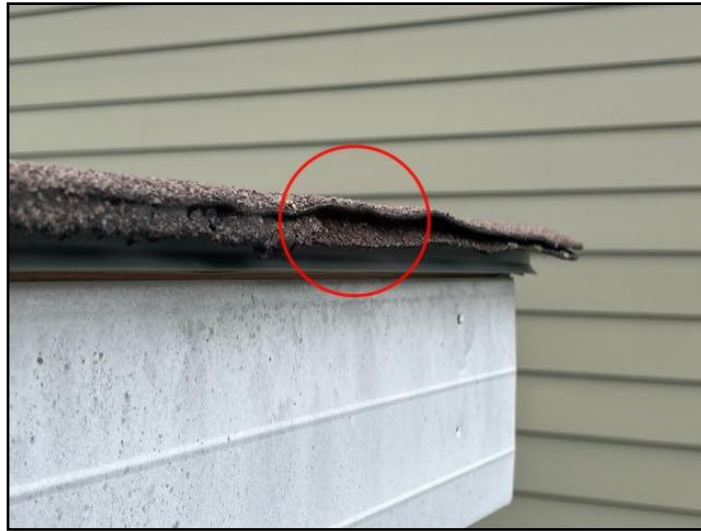
**Condition:** • [Multiple layers](#)

**Implication(s):** Shortened life expectancy of material

*Multiple layers*

**Task:** Strip at next roof replacement

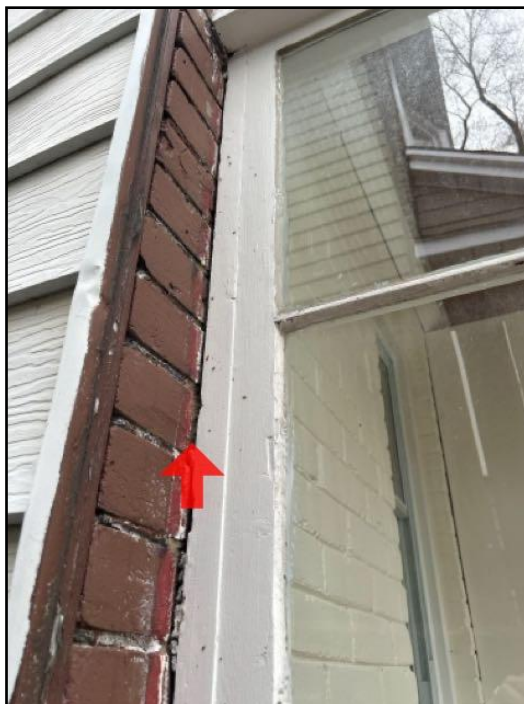
Condition: • [Caulking missing or ineffective](#)

Implication(s): Chance of water damage to structure, finishes and contents

Location: Northwest

*Caulking missing or ineffective*

Task: Provide

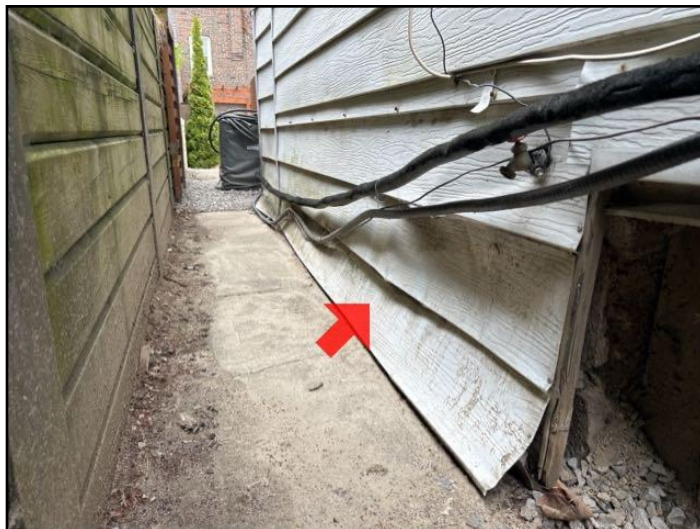
Condition: • [Loose or missing pieces](#)

**Implication(s):** Chance of water damage to structure, finishes and contents

**Location:** Northeast

*Loose or missing pieces*

**Task:** Repair

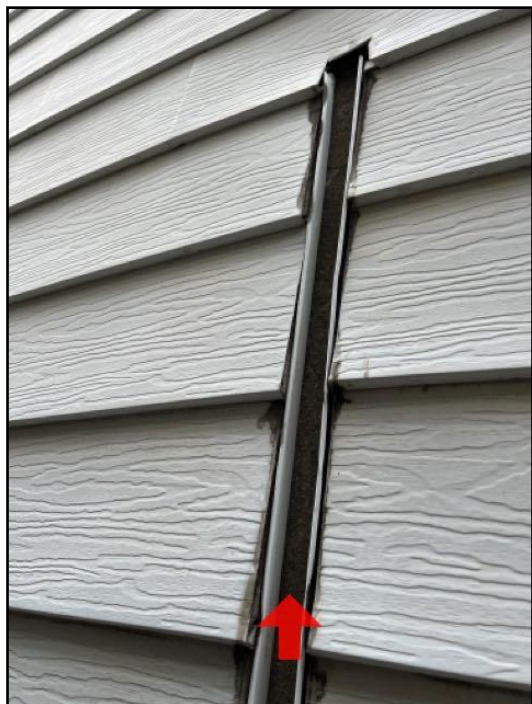
**Condition:** • Abandoned raceway

**Location:** Northwest

*Abandoned raceway*

**Task:** Repair

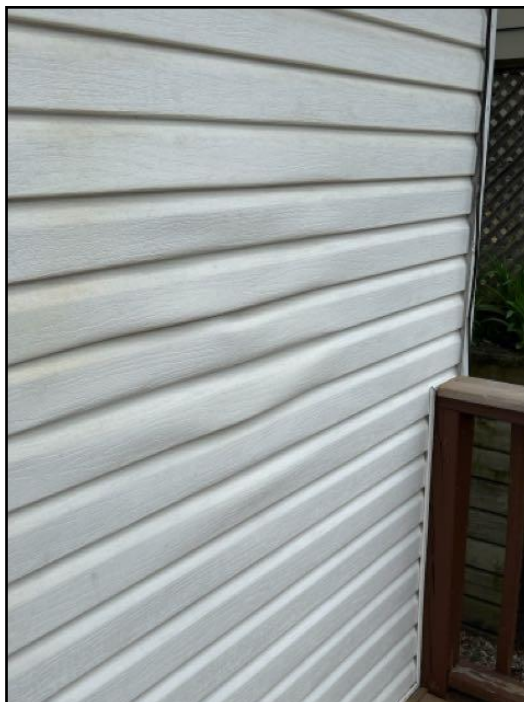
**Condition:** • [Buckled or wavy](#)

Damage was caused by a barbecue used too close to the wall. This is primarily a cosmetic issue.

**Implication(s):** Chance of water damage to structure, finishes and contents

**Location:** East

*Buckled or wavy*

**Task:** Repair

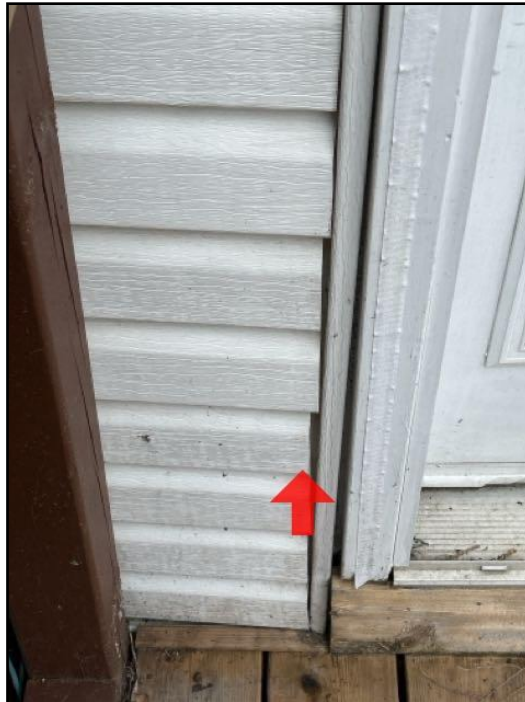
**Condition:** • [Loose or missing pieces](#)

**Implication(s):** Chance of water damage to structure, finishes and contents

**Location:** Southeast

*Loose or missing pieces*

**Task:** Repair

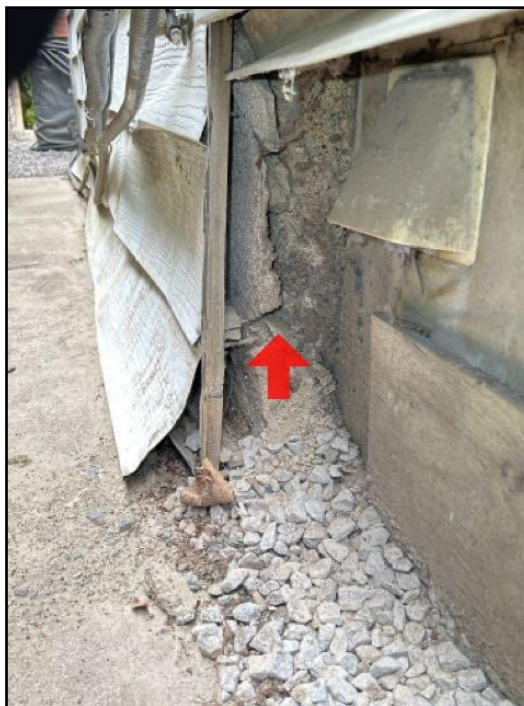
**Condition:** • [Spalling](#)

**Implication(s):** Weakened structure | Chance of structural movement

**Location:** North

Spalling

**Task:** Further evaluation/Repair

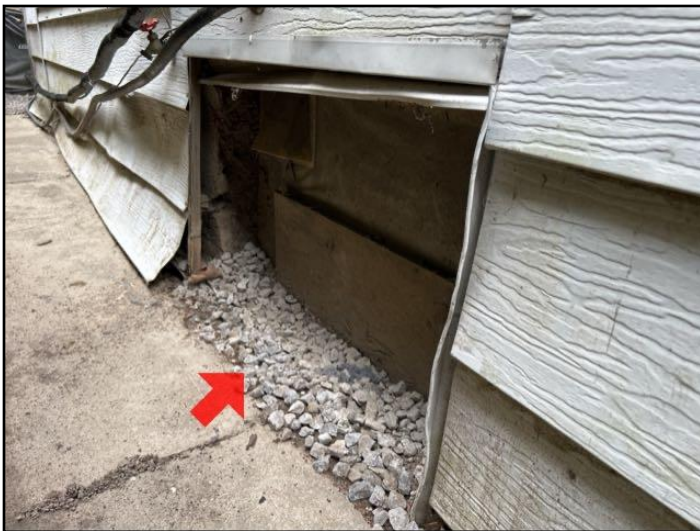
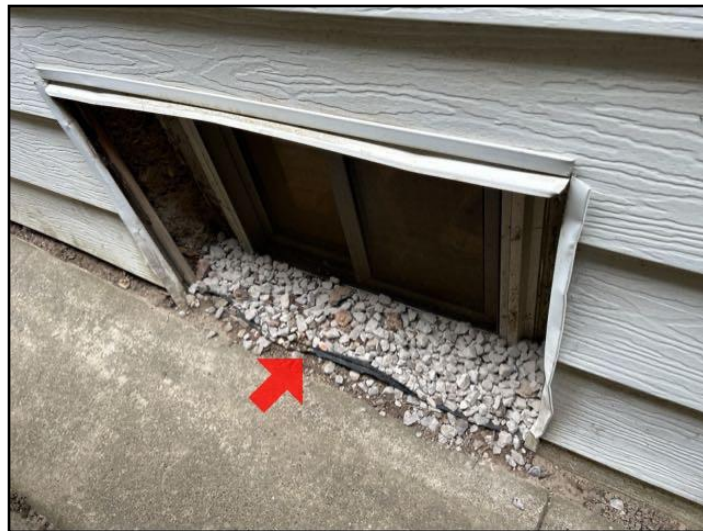
**Condition:** • Windows at grade

**Location:** North

Windows at grade

**Task:** Keep window area cleared of snow in winter

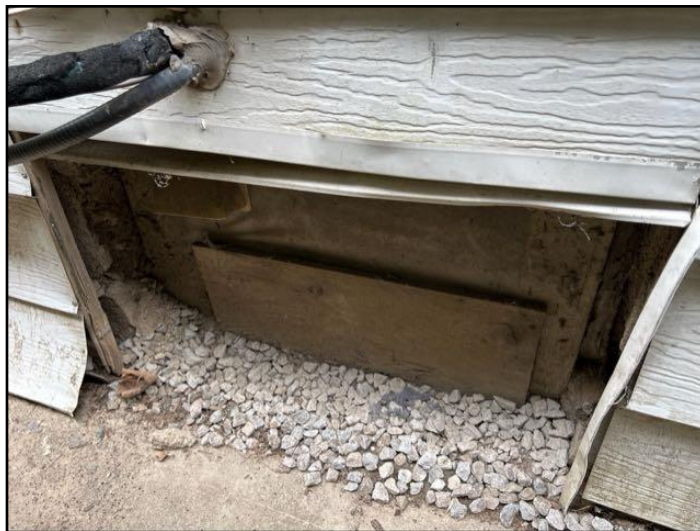
**Condition:** • Abandoned - the eastern basement window has been abandoned from the interior. If it is to remain abandoned, remove the window and frame and patch the opening.

**Location:** Northeast

*Abandoned window*

**Task:** Improve

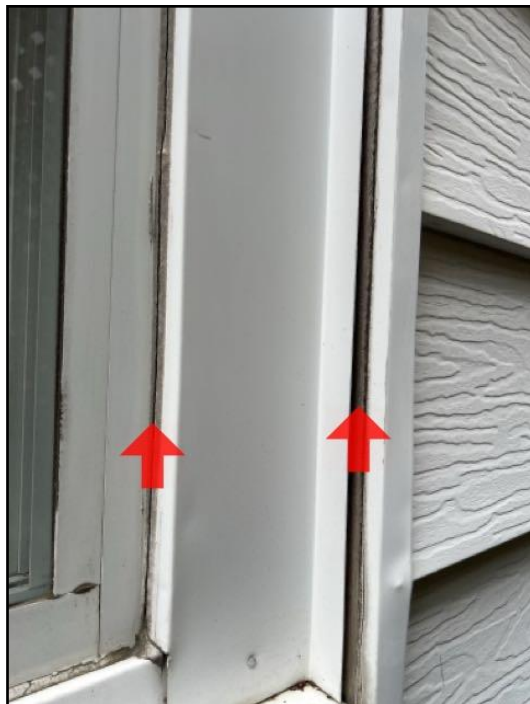
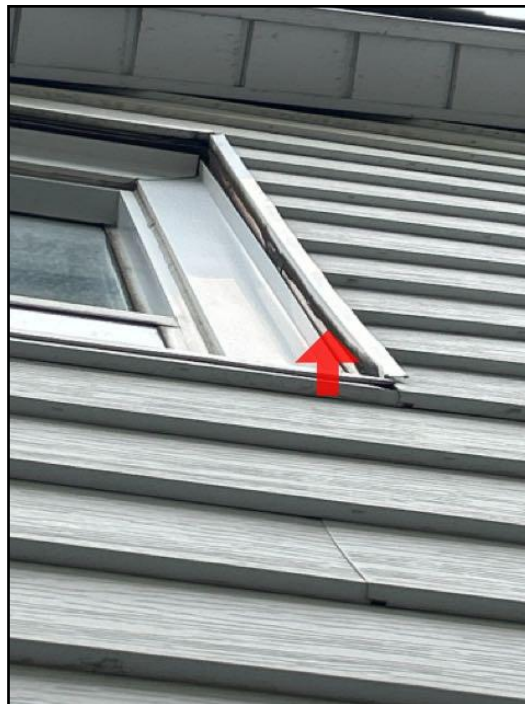
**Condition:** • [Caulking missing, loose or deteriorated](#)

**Implication(s):** Chance of water damage to structure, finishes and contents

**Location:** North

*Caulking missing, loose or deteriorated*

**Task:** Provide

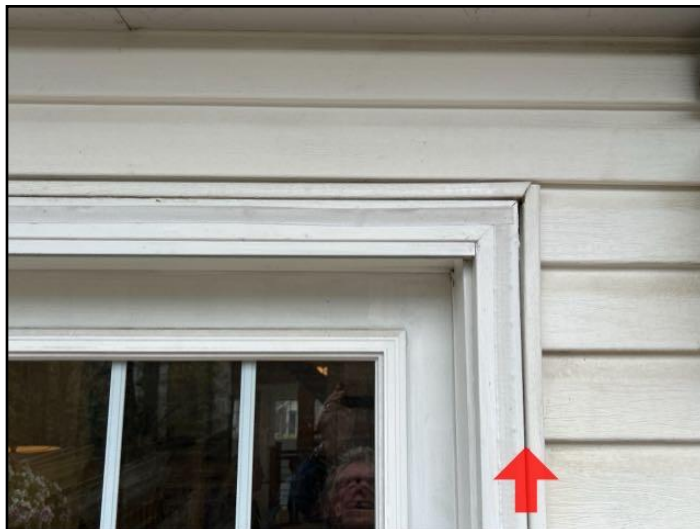
**Condition:** • [Caulking - deteriorated, loose or missing](#)

**Implication(s):** Chance of damage to finishes and structure

*Caulking - deteriorated, loose or missing*

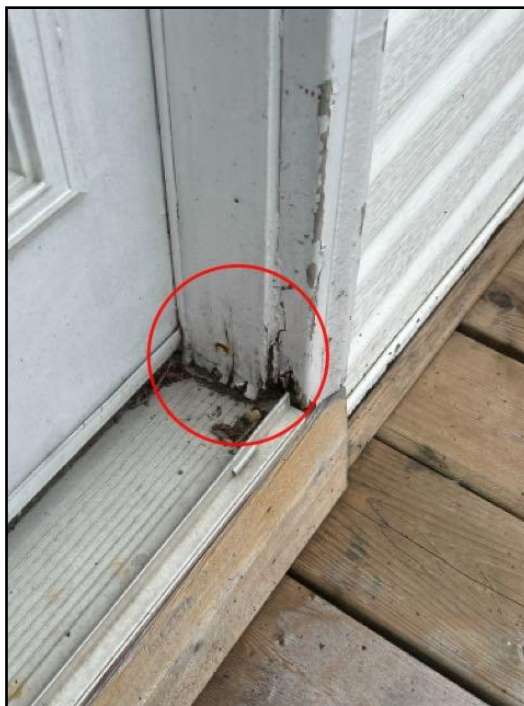
**Condition:** • [Rot](#)

**Implication(s):** Chance of damage to finishes and structure

**Location:** East

*Rot*

**Task:** Repair

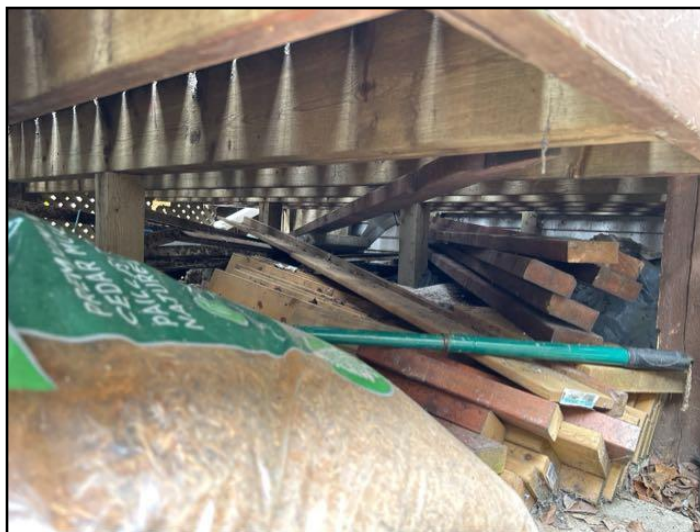
**Condition:** • Debris under deck

**Implication(s):** risk of insects, pests

**Location:** East

*Debris*

**Task:** Clean

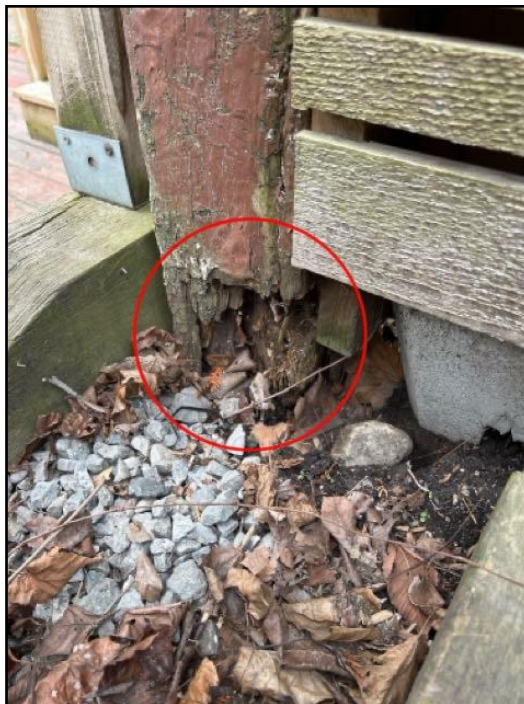
**Condition:** • [Rot](#)

**Implication(s):** Weakened structure | Chance of movement

**Location:** Southeast

*Rot*

**Task:** Repair

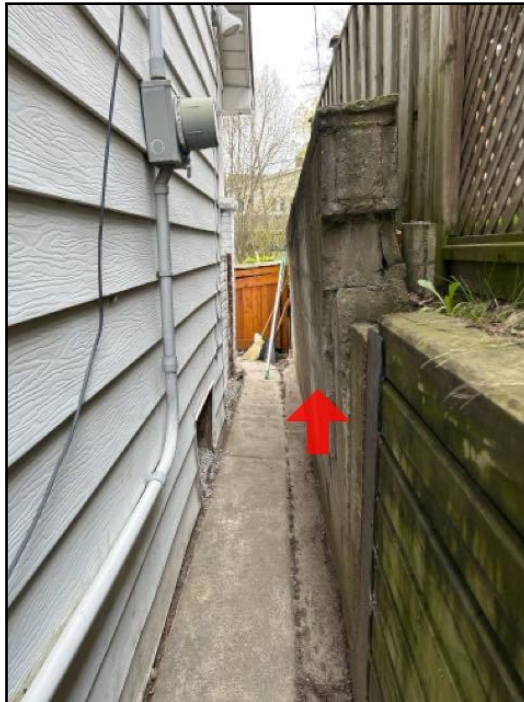
**Condition:** • [Leaning](#)

The retaining wall is part of the property to the north and is their responsibility.

**Implication(s):** Weakened structure | Chance of movement

*Leaning*

**Task:** Monitor

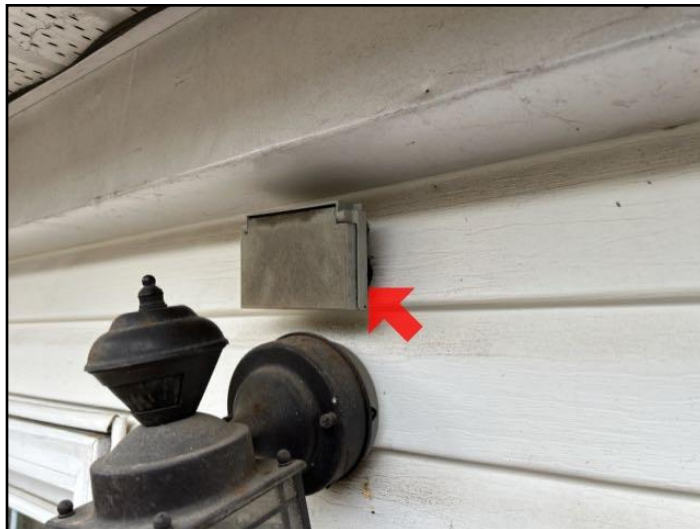
**Condition:** • [Loose](#)

**Implication(s):** Electric shock | Fire hazard

**Location:** East Exterior

*Loose*

**Task:** Repair

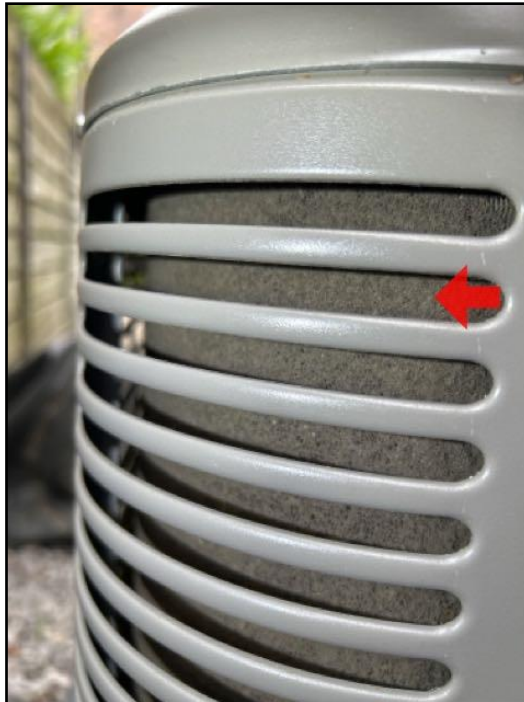
**Condition:** • [Dirty](#)

**Implication(s):** Reduced system life expectancy | Increased cooling costs | Reduced comfort

*Dirty*

**Task:** Clean/service

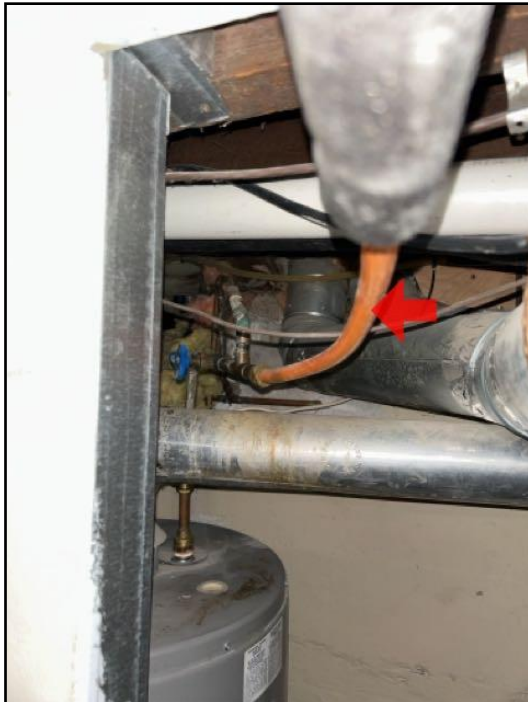
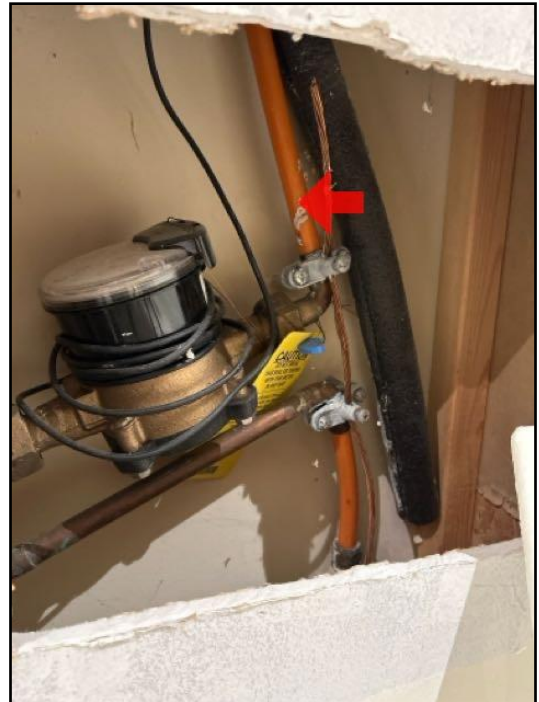
**SUPPLY PLUMBING \ Water supply piping in building**  
**Condition:** • PEX (cross-linked polyethylene)  
Pipe not suitable for potable water running from the water service entrance at the front of the basement to the water heater. Orange PEX is designed for hydronic heating. The seller is aware of this issue and has contracted to replace the suspect plumbing.

*Not for potable water*

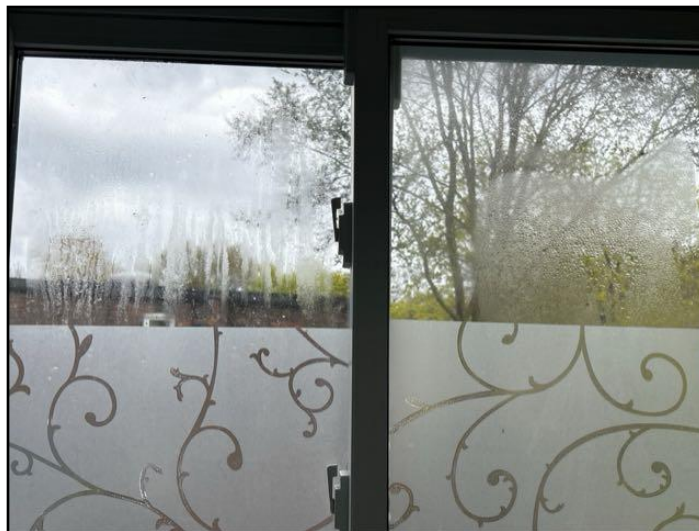
**Condition:** • Lost seal on double or triple glazing

**Implication(s):** Cosmetic issue, reduced energy efficiency

**Location:** Second Floor Bathroom

*Lost seal on double or triple glazing*

**Task:** Repair or replace

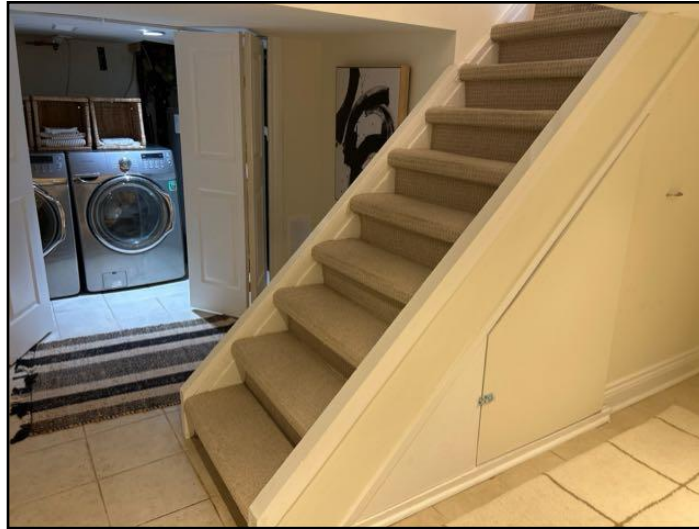
**Condition:** • [Missing](#)

**Implication(s):** Fall hazard

**Location:** Basement Staircase

*Missing handrail/guard*

**Task:** Provide

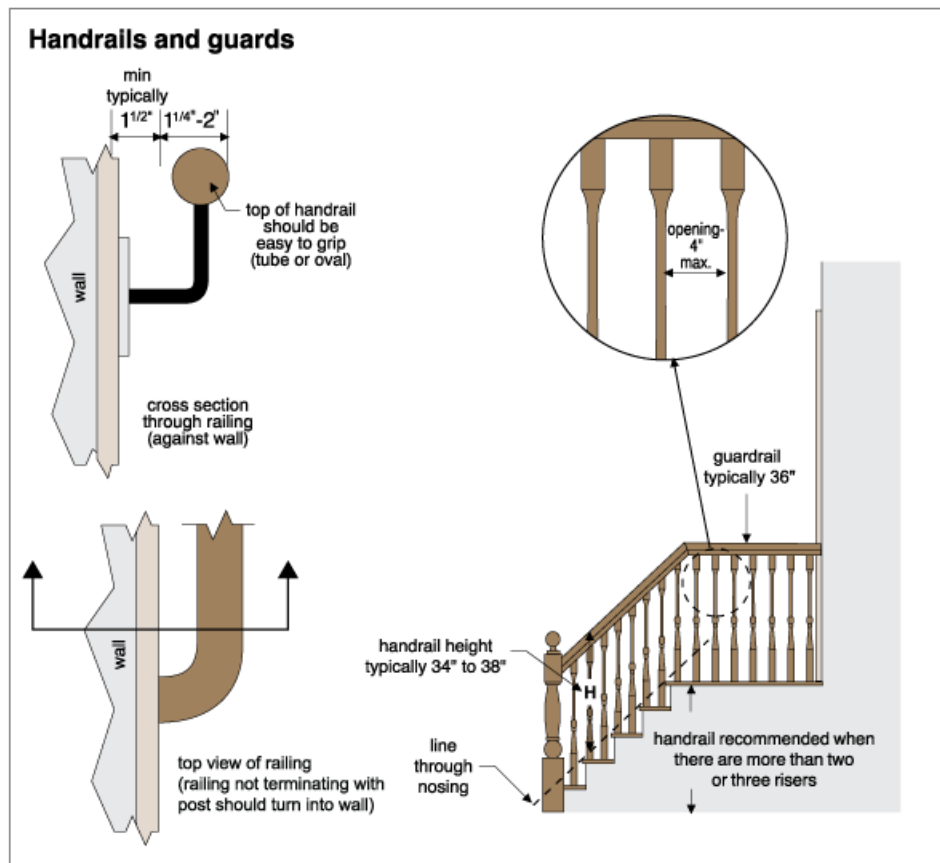
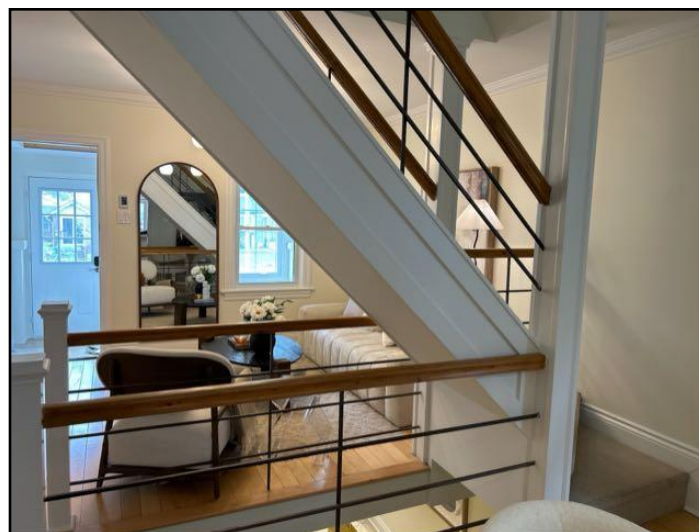
**Condition:** • [Missing](#)

**Implication(s):** Fall hazard

**Location:** First Floor

*Missing proper spindles*

**Task:** Provide

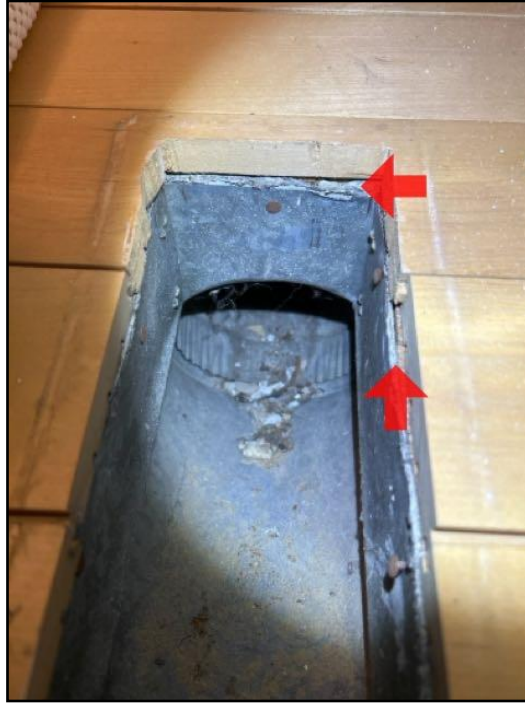
**Condition:** • Possible asbestos containing materials

Asbestos banding around heating ducts at their termination points is common on houses of this vintage. Left undisturbed it poses little risk. This banding was found at 3 registers.

**Implication(s):** Health hazard

**Location:** Living Room, Dining Room, West Bedroom

*Possible asbestos containing materials*

**Task:** Remove
