Your Inspection Report

5555 Sample Purpose Lane
Long Beach, CA 90813

INSPECTION DATE:
Tuesday, October 10, 2023

RE: Report No. 3817, v.3
5555 Sample Purpose Lane
Long Beach, CA
90813

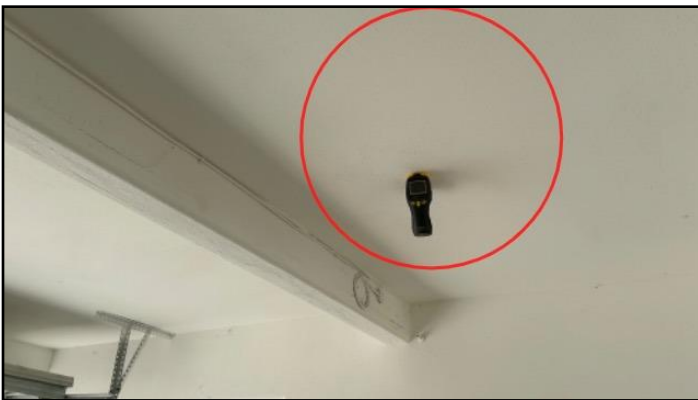
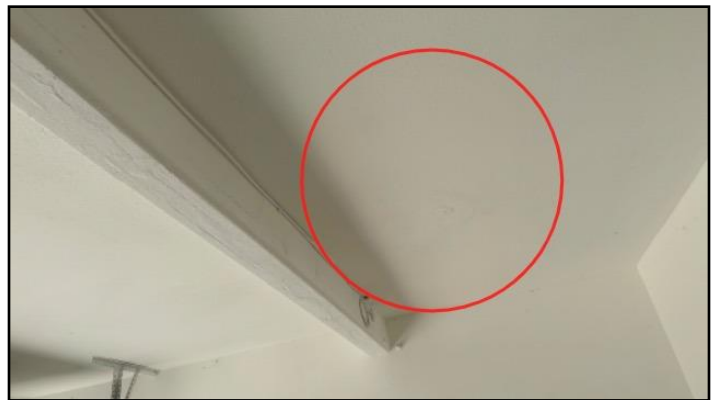
Damaged, patched area on ceiling that may be evidence of previous/current water damage

Moisture was detected at time of inspection

3. Damaged/Patched

4. Damaged/Patched

Recommend further evaluation and to request disclosure to verify any details

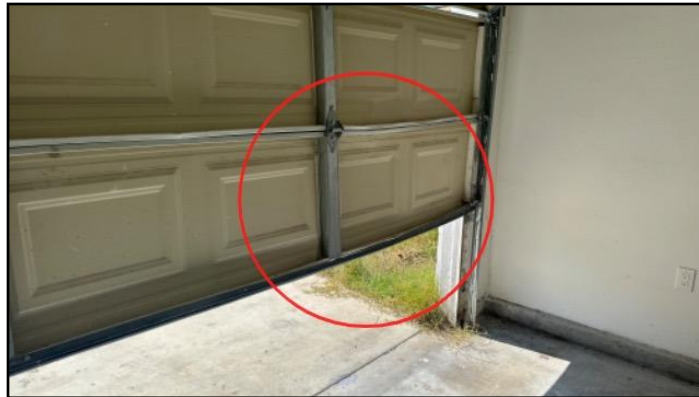
Damaged, dented door panel(s)

Implication(s): Damage to equipment

5. Damaged/Dented

Task: Repair or replace Service

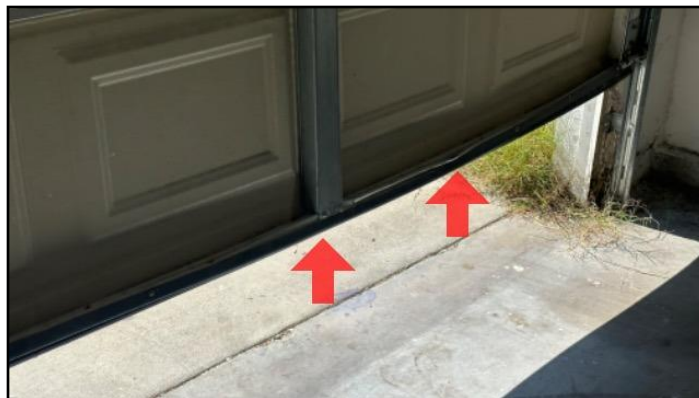
Weatherstripping is missing and/or damaged

Location: Garage

6. Damaged/Missing weatherstripping

Task: Repair or replace Improve Service

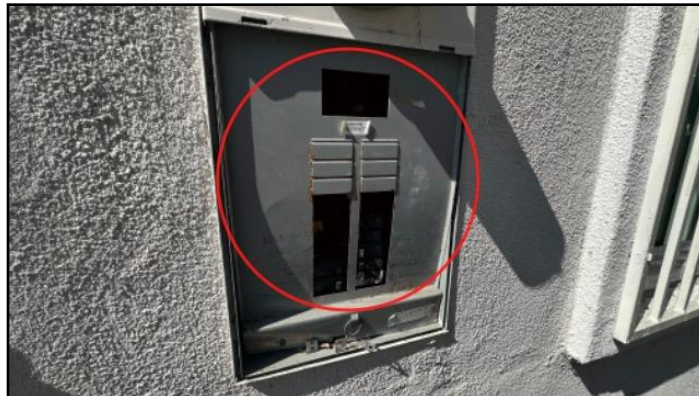
4. Condition: • Missing filler plates in main electrical panel

17. Missing filler plates

Task: Repair Provide Improve Service

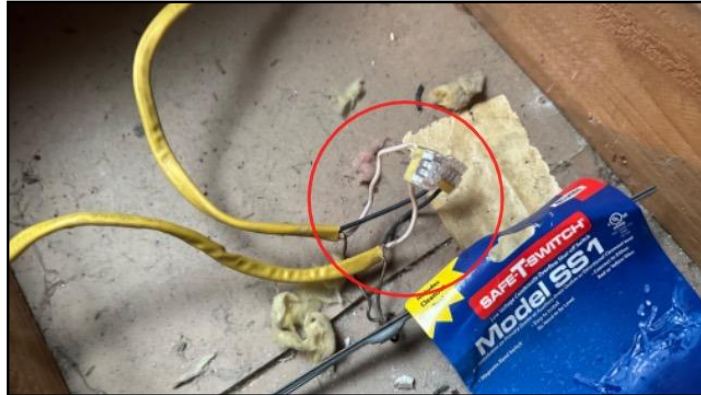
5. Condition: • [Open splices](#)

Implication(s): Electric shock | Fire hazard

18. Open splices

Task: Repair or replace Improve Service Correct

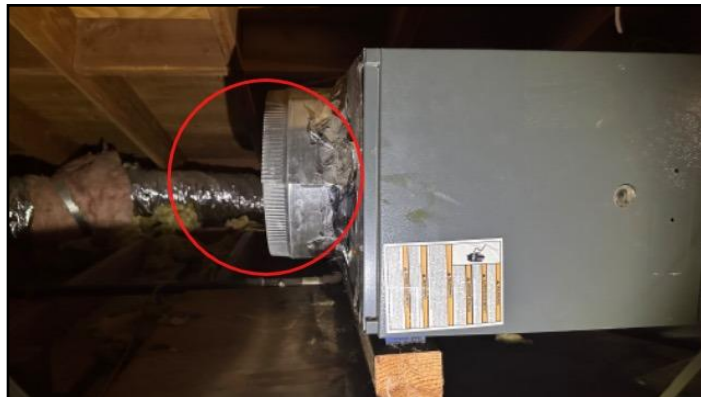
7. Condition: • Missing return duct

Return duct missing and disconnected

21. Missing return duct

Recommend to be serviced immediately

Task: Repair or replace Further evaluation Service Request disclosure

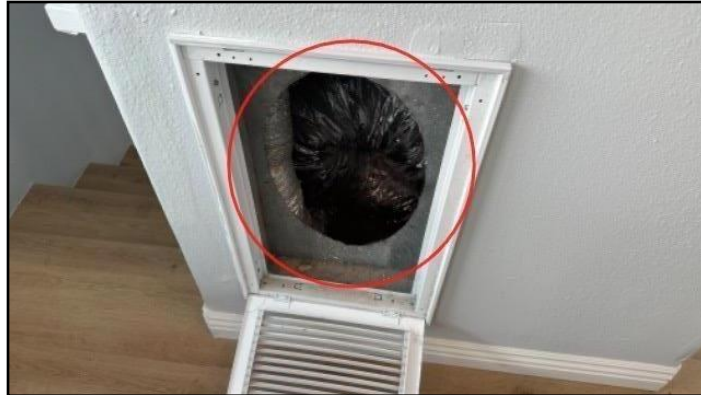
8. Condition: • Observation/Opinion

22. *Poor arrangement- return duct*

Recommend further evaluation

Task: Repair or replace Further evaluation Improve Service

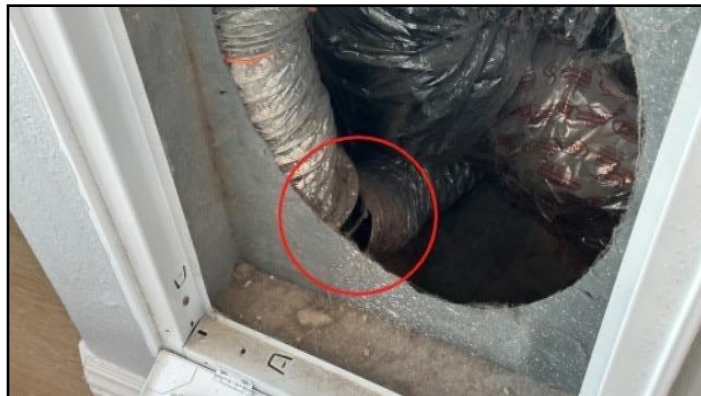
9. Condition: • Damaged, broken vent in return duct area

23. *Damaged/Broken vent*

Task: Repair or replace Further evaluation Improve Service

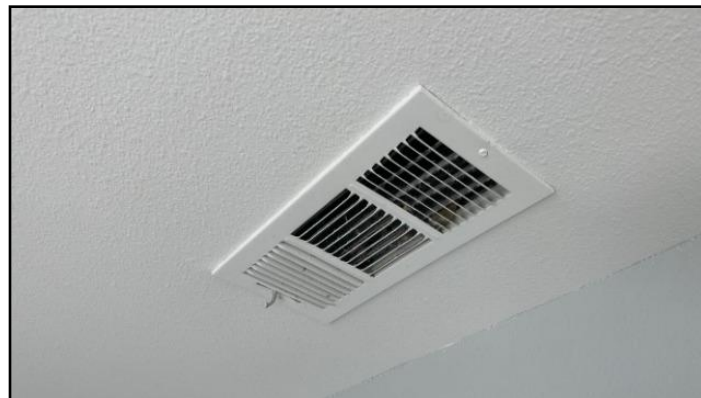
11. Condition: • [Inadequate cooling](#)

25. Inadequate cooling

Recommend further evaluation and to be serviced immediately

Task: Repair Improve Service

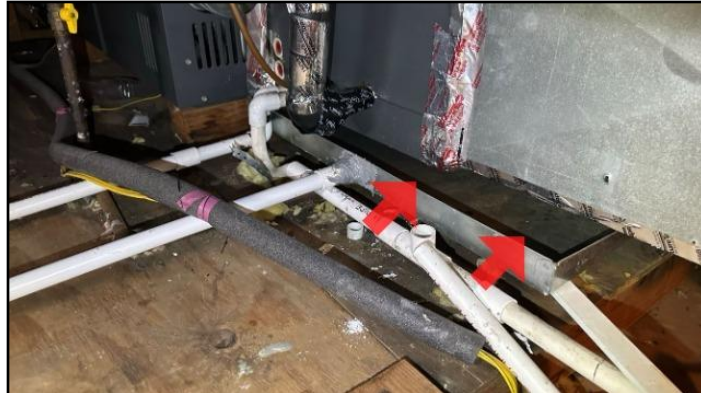
12. Condition: • Water in pan

26. Water in pan

Task: Repair Further evaluation Improve Service

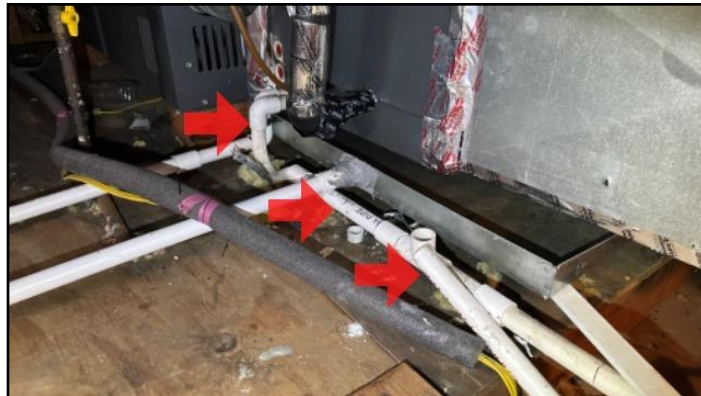
13. Condition: • Damaged, clogged condensate drain line(s)

27. Clogged

Recommend to be serviced immediately

Task: Repair or replace Improve Service

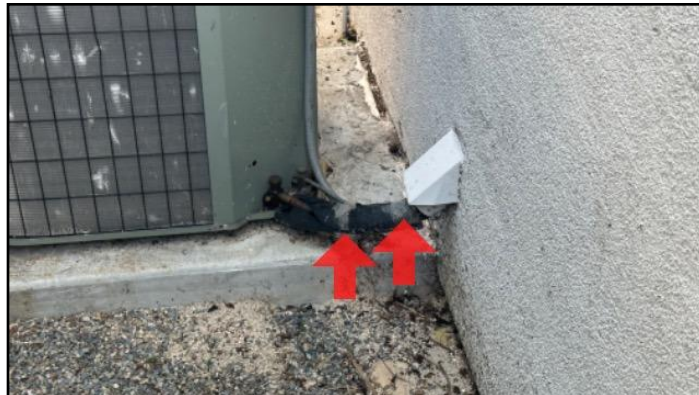
14. Condition: • [Insulation - missing](#)

Damaged, deteriorating and/or missing insulation

28. Damaged/Missing insulation

Task: Repair or replace Improve Service

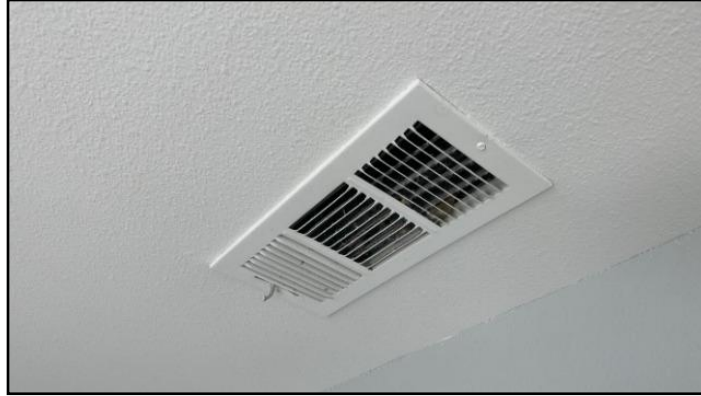
15. Condition: • [Dirty](#)

29. Dirty

Recommend to be serviced immediately

Task: Repair Service Clean

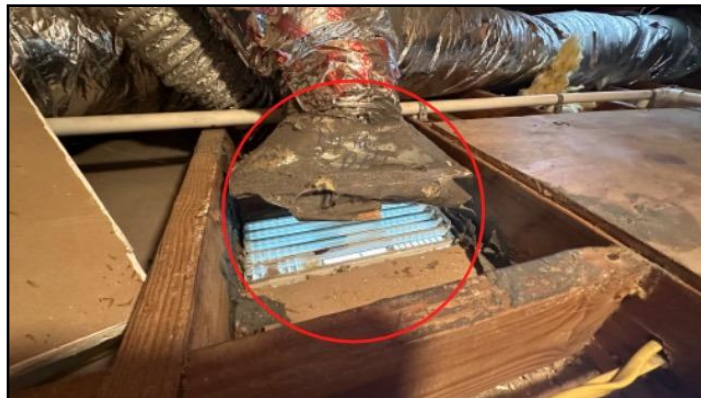
16. Condition: • [Disconnected or leaking](#)

Damaged, torn, disconnected ducts

30. Damaged/Disconnected duct(s)

Task: Repair or replace Further evaluation Improve Service Correct

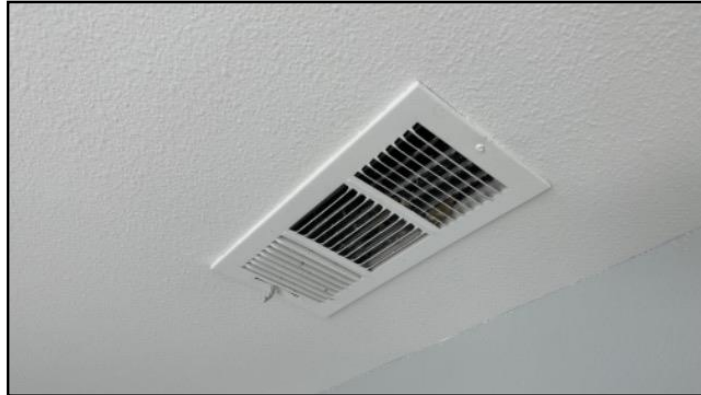
17. Condition: • [Weak airflow](#)

31. *Weak airflow*

Recommend to get serviced and cleaned immediately

Task: Repair Improve Service

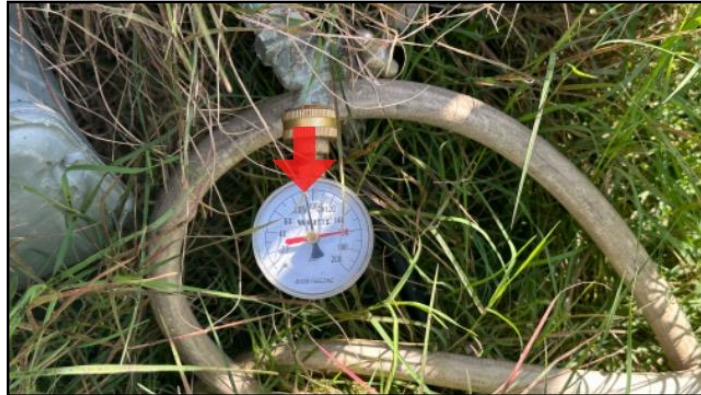
19. Condition: • Recommended due to high supply water presssure

Water pressure is high, tested at approximately 90 psi

Implication(s): Chance of water damage to structure, finishes and contents | Damage to equipment

36. High water pressure

Task: Repair Provide Improve Service

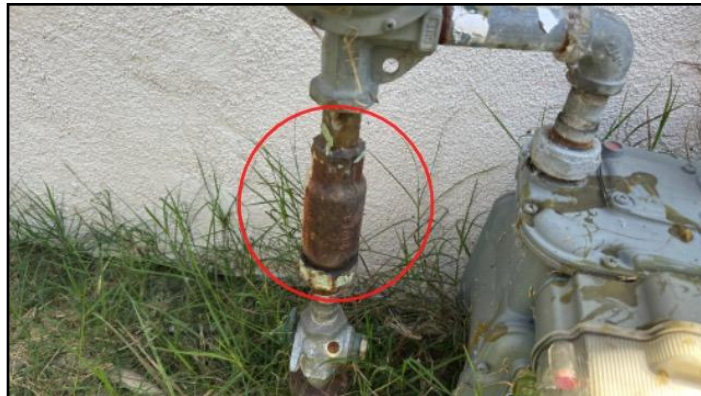
20. Condition: • [Rust](#)

Damaged and/or corroded pipe

Implication(s): Material deterioration | Fire hazard

Location: Rear exterior

37. Damaged/Rusted

Task: Repair Service

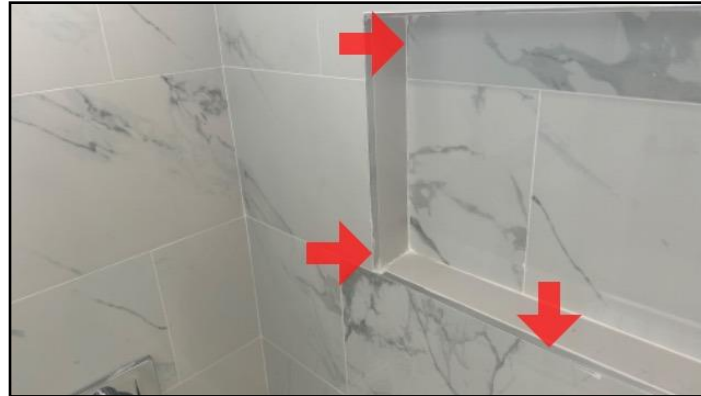
22. Condition: • [Grout loose, missing or deteriorated](#)

Damaged/missing seals, grout, caulking

Implication(s): Chance of water damage to structure, finishes and contents

Location: Bathroom(s)

38. *Damaged/Missing sealant*

Task: Repair Improve Service

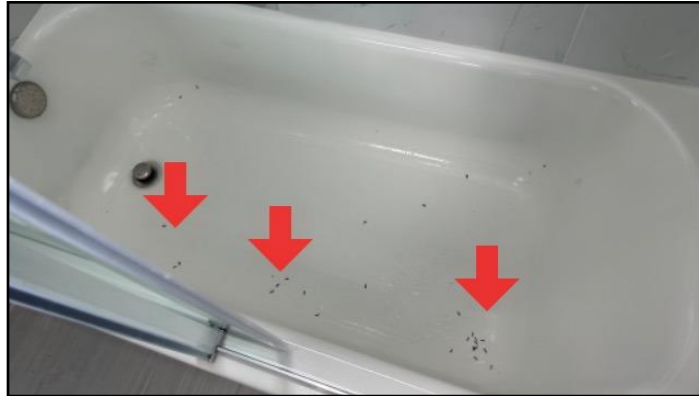
23. Condition: • During inspection, dead insects were identified throughout
Predominantly in bathroom(s)

45. Insects

Task: Further evaluation

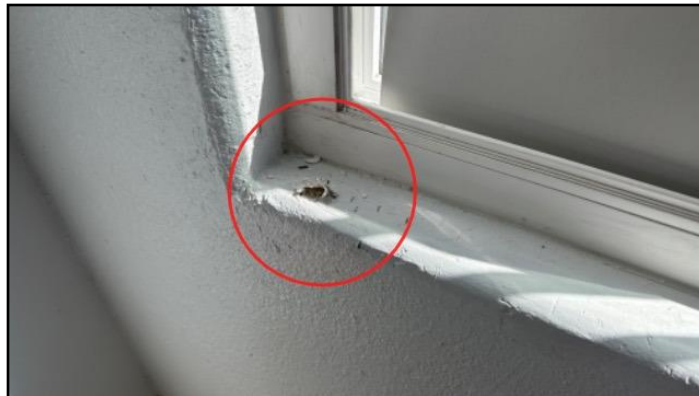
24. Condition: • Damaged and/or chipping interior window structural components and membranes

Location: Various throughout interior

46. Damaged/Chipping

Task: Repair Improve Service

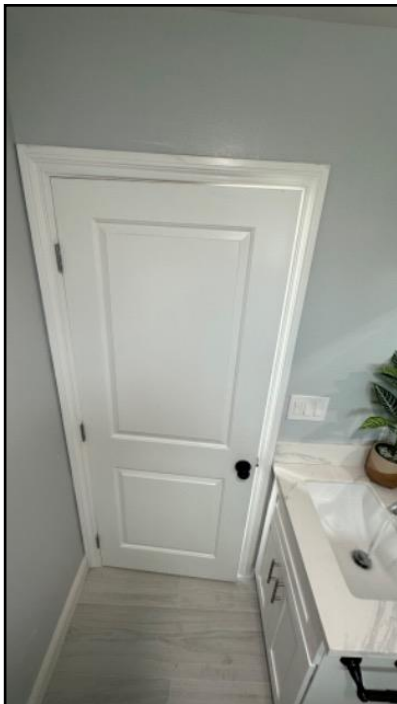
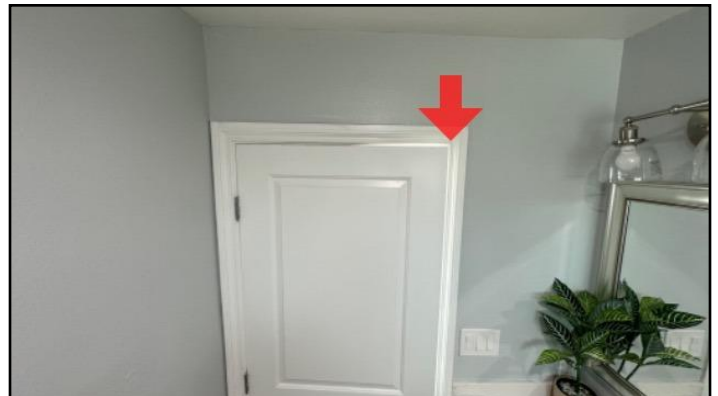
25. Condition: • [Racked/out-of-square](#)

Implication(s): Chance of damage to finishes and structure

47. Racked/Out-of-square

48. Racked/Out-of-square

Task: Repair Improve Service
