Your Inspection Report

53 Howie
Toronto, ON

Thursday, April 27, 2017

RE: Report No. 2164
53 Howie
Toronto, ON

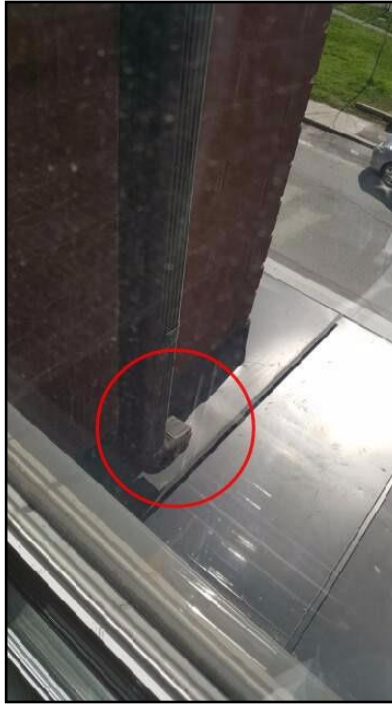
2. Condition: • [Downspouts discharging onto roofs](#)

Implication(s): Chance of water damage to contents, finishes and/or structure

Location: Northwest Exterior

1. Downspouts discharging onto roofs

If water volume from porch overhang is excessive, add eavestrough and downspout.

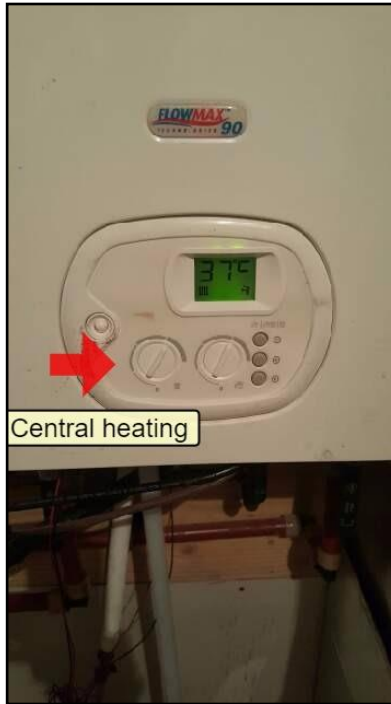
2. Heat controls

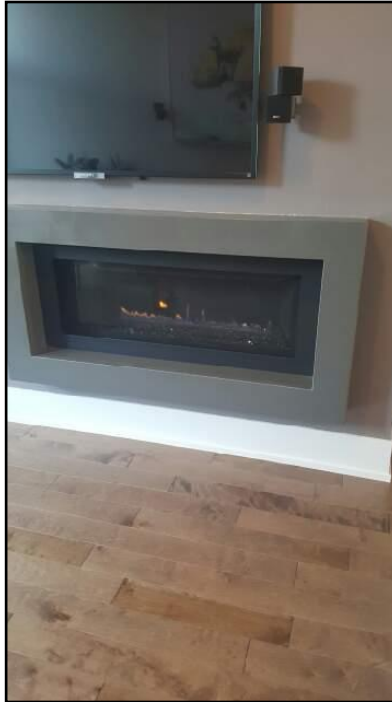
3. Gas fireplace

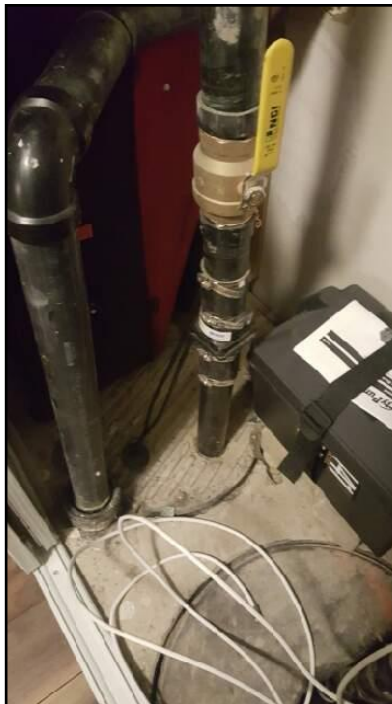
4. Solid waste pump (ejector pump)

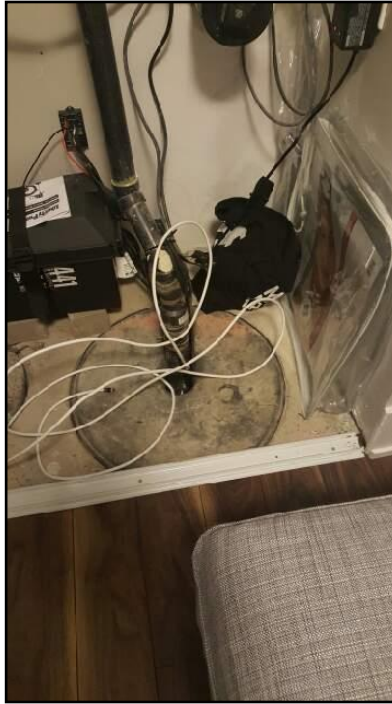
Sump pump discharge is metered, contact listing agent for details. Back up power present.

5. Sump pump
