# YOUR Inspection Report

3905 Catamaran Crt  
Quincy, IL 62305

Thursday, September 6, 2018

Report No. 1511, v.3

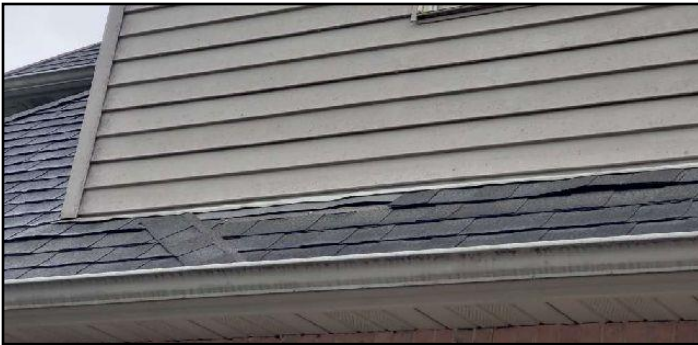
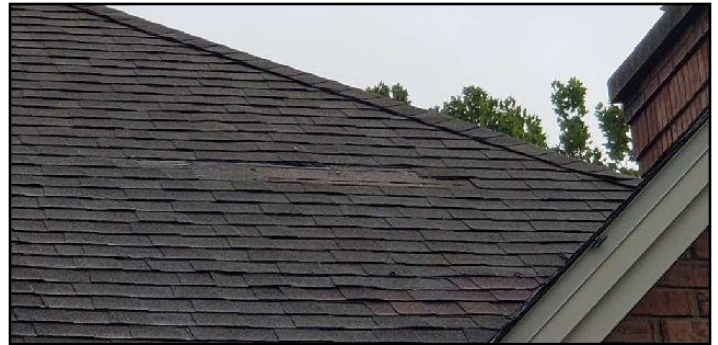
**Condition:** • [Missing, loose or torn](#)

**Location:** West and North Exterior Roof

1. Missing, loose or torn

2. Missing, loose or torn

Recommend repairing/replacing loose/missing shingles and further evaluating the entire roof for additional loose shingles and or possibly replacement of entire roof.

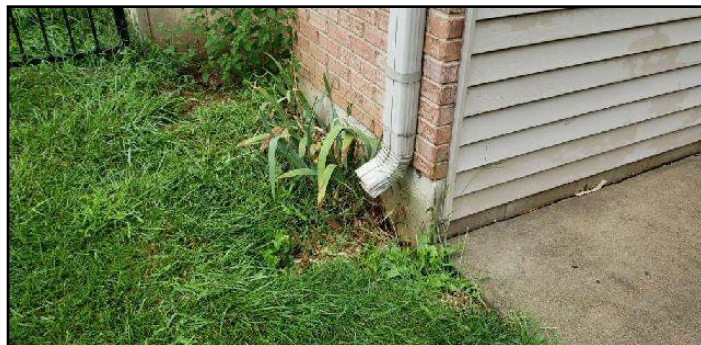
**Condition:** • [Should discharge 6 feet from building](#)

**Location:** Northeast Basement

3. Should discharge 6 feet from building

Recommend installing an extension for the downspout.

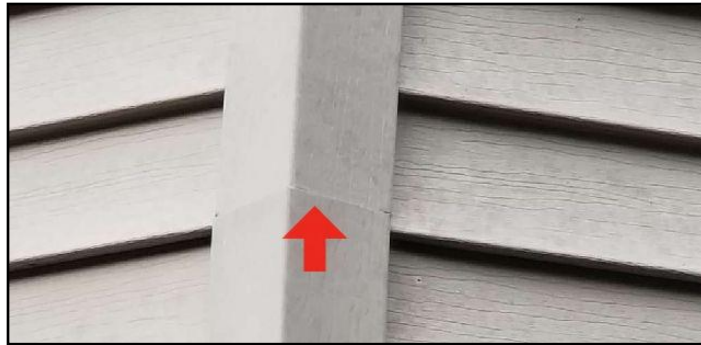
4.

**Condition:** • Recommend improving the corner trim which is installed incorrectly. It is overlapping in the wrong direction which can allow water to enter behind the trim. There is a total of 6 seams in the back that are like this.

**Location:** East Exterior Wall

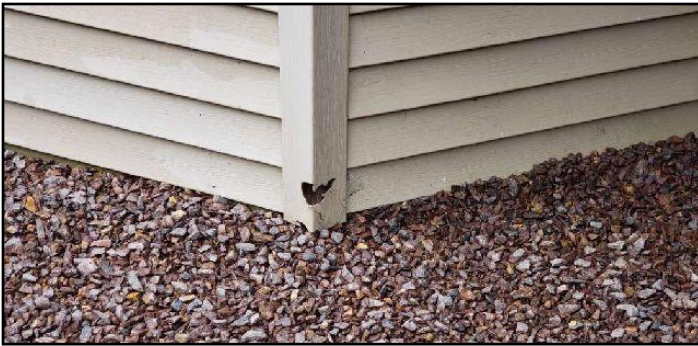
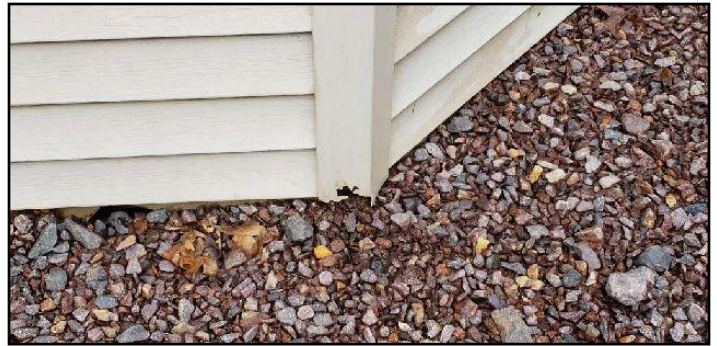
**Condition:** • [Mechanical damage](#)

**Location:** East Basement

5. Mechanical damage

6. Mechanical damage

Recommend repairing or replacing damaged siding trim.

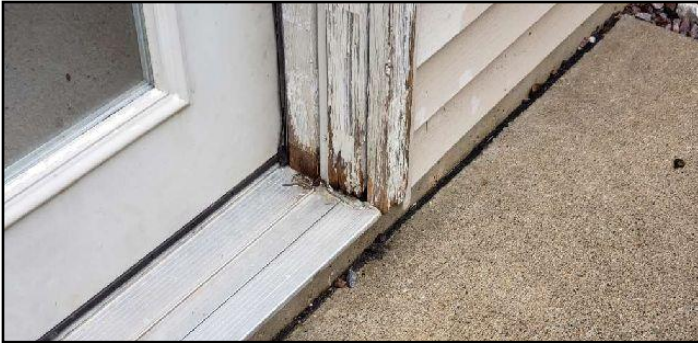
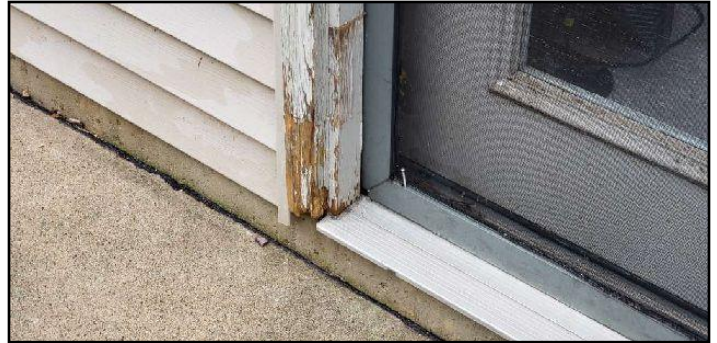
**Condition:** • [Rot](#)

**Location:** East Basement

7. Rot

8. Rot

Recommend repairing or replacing rotting door trim and painting as well.

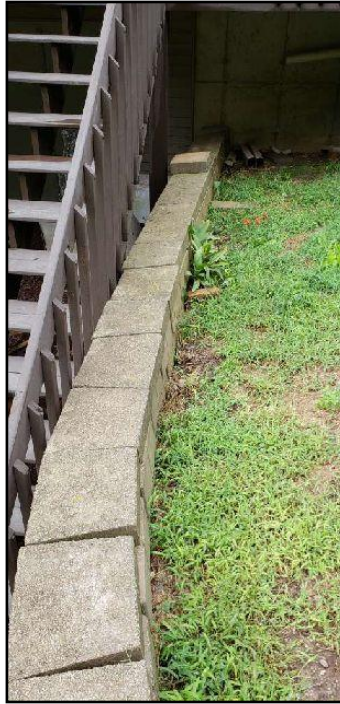
**Condition:** • [Leaning](#)

**Location:** Northeast Exterior

9. Leaning

Recommend correcting leaning retaining walls, both upper and lower.

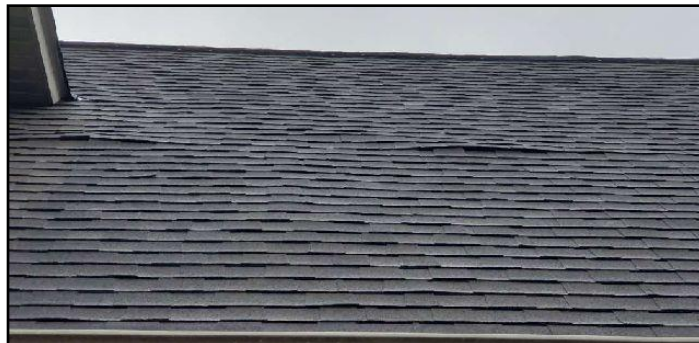
**Condition:** • [Buckled](#)

**Implication(s):** Weakened structure | Chance of structural movement

**Location:** North Exterior Roof

10. Buckled

Recommend further evaluation and repair if needed.

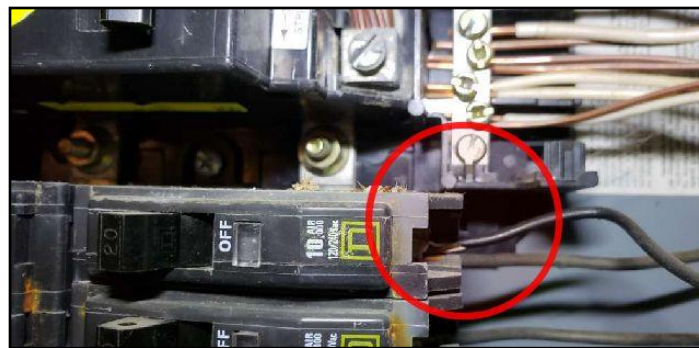
Condition: • [Double taps](#)

Recommend correcting double tap with wrong size wire. A 14 guage wire used for radon reduction system is double tapped to a 20 amp breaker.

Implication(s): Fire hazard

11. Double taps

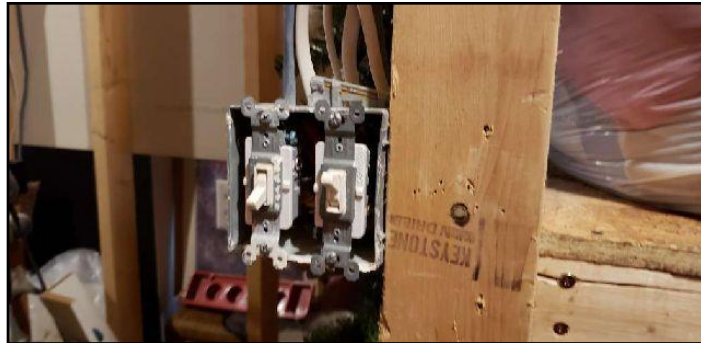
Condition: • For switch is missing

**Location:** West Basement

12. For switch is missing

Recommend installing a coverplate on switches.

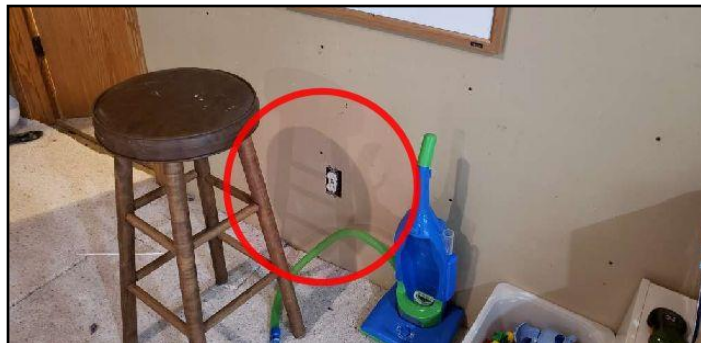
**Condition:** • For outlet (receptacle) is missing

**Location:** Middle Basement

13. For outlet (receptacle) is missing

Recommend installing a coverplate on receptacle.

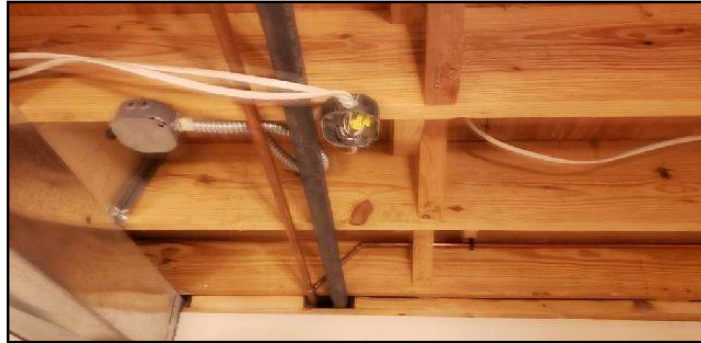
**Condition:** • For junction box is missing

**Location:** Northeast Basement Bedroom

14. For junction box is missing

Recommend installing a coverplate on junction box.

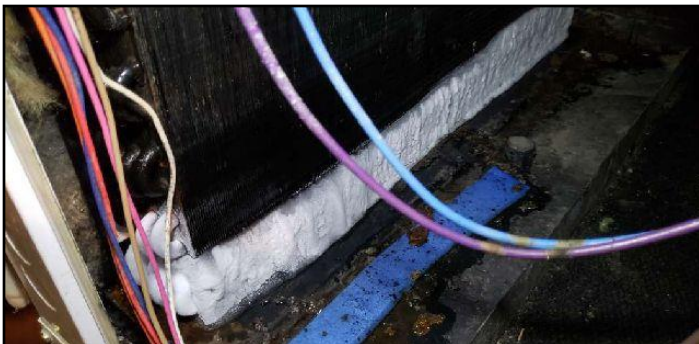
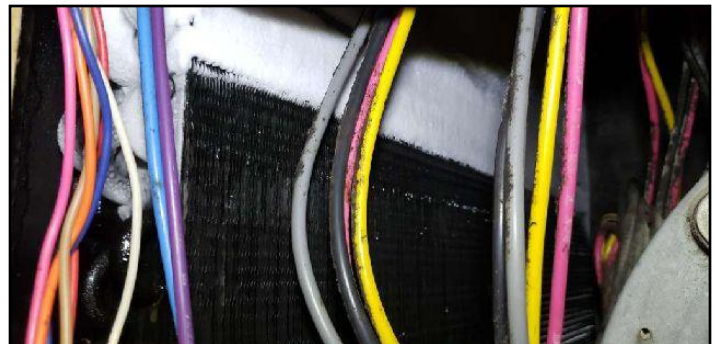
**Condition:** • [Frost](#)

**Location:** Middle Basement

15. Frost

16. Frost

Recommend further evaluation for coil frosted over and unit is not cooling the home.

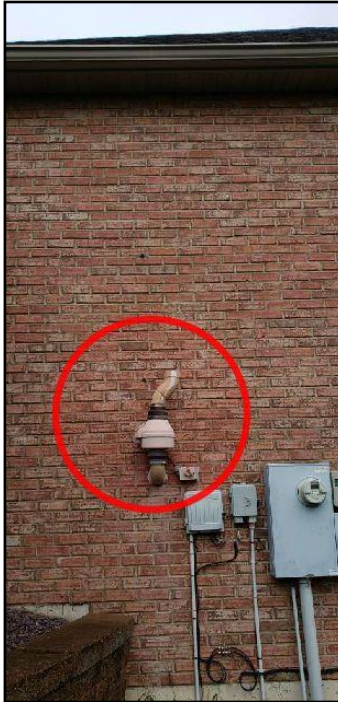
17.

**Condition:** • Recommend replacing missing radon mitigation exhaust pipe in accordance with Illinois mitigation guidelines.

**Location:** South Exterior Wall

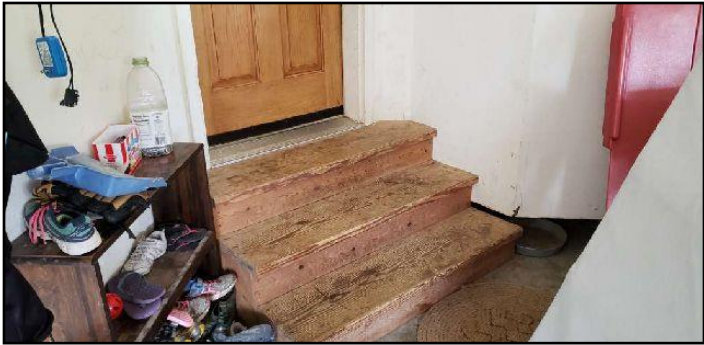
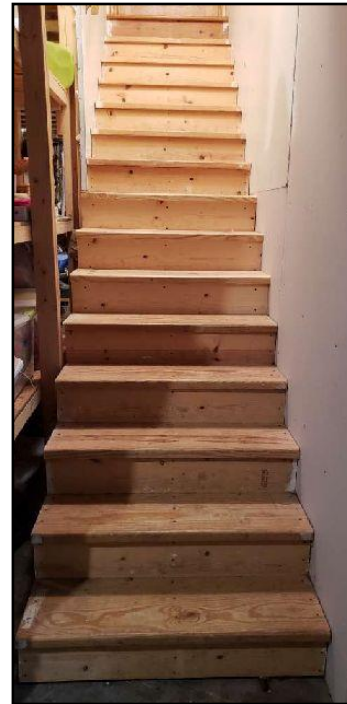
**Condition:** • [Missing](#)

**Implication(s):** Fall hazard

18. Missing

19. Missing

Recommend installing a handrail for the basement steps and the garage steps.

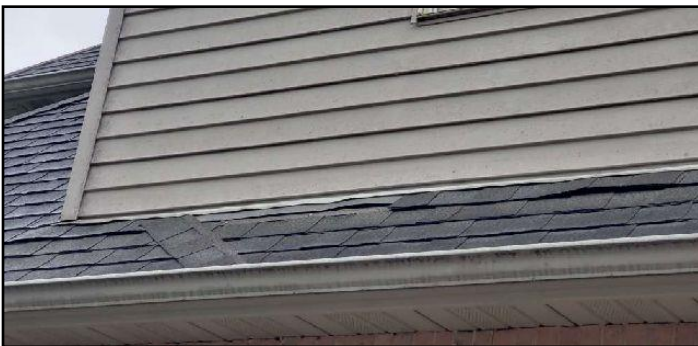
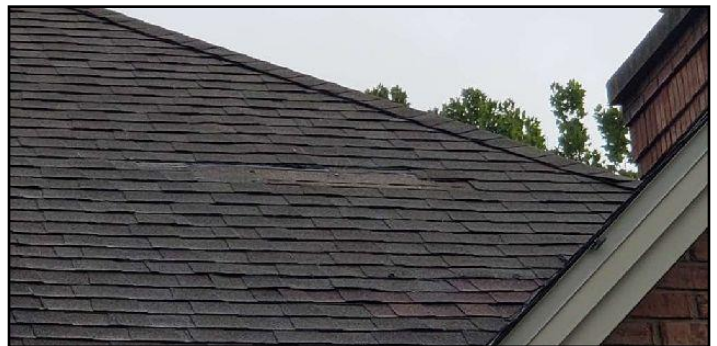
#### 1. Condition: • [Missing, loose or torn](#)

**Implication(s):** Chance of water damage to contents, finishes and/or structure

20. Missing, loose or torn

21. Missing, loose or torn

Recommend repairing/replacing loose/missing shingles and further evaluating the entire roof for additional loose shingles and or possibly replacement of entire roof.

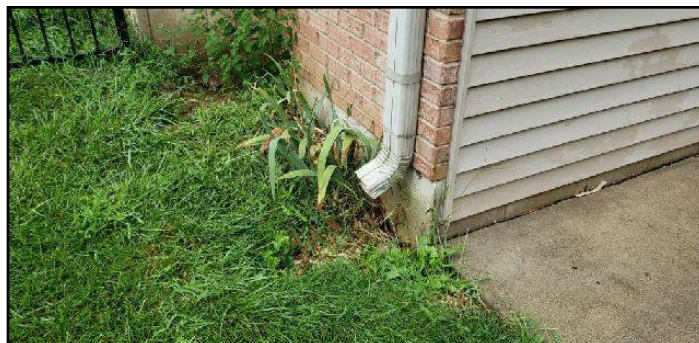
**2. Condition:** • [Should discharge 6 feet from building](#)

**Implication(s):** Chance of water damage to contents, finishes and/or structure

23. Should discharge 6 feet from building

Recommend installing an extension for the downspout.

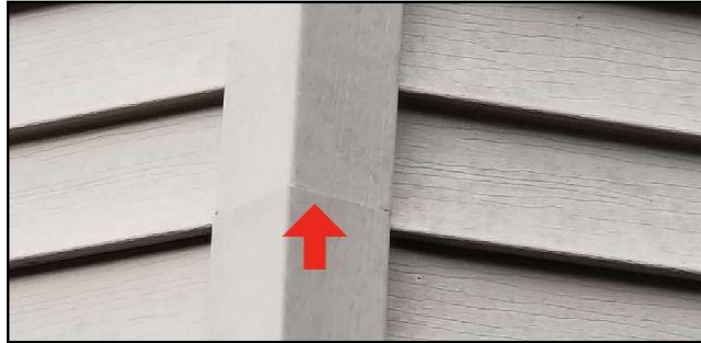
24.

**3. Condition:** • Recommend improving the corner trim which is installed incorrectly. It is overlapping in the wrong direction which can allow water to enter behind the trim. There is a total of 6 seams in the back that are like this.

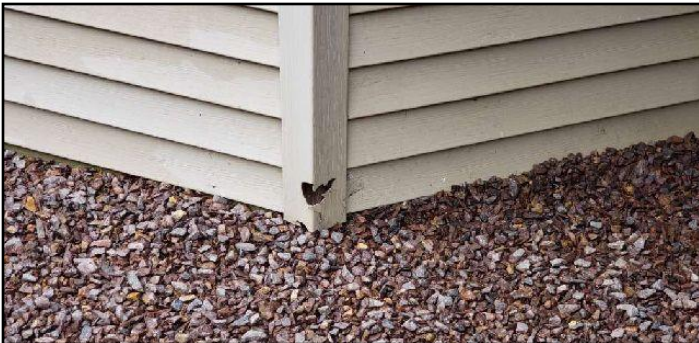
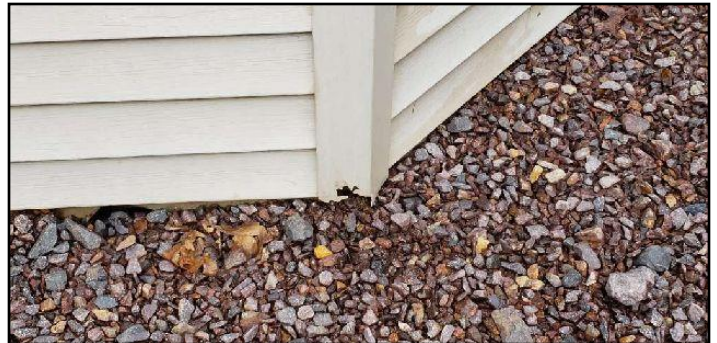
#### 4. Condition: • [Mechanical damage](#)

**Implication(s):** Chance of water damage to contents, finishes and/or structure

25. Mechanical damage

26. Mechanical damage

Recommend repairing or replacing damaged siding trim.

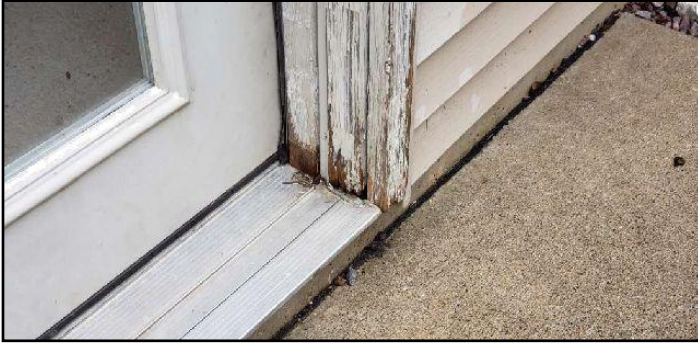
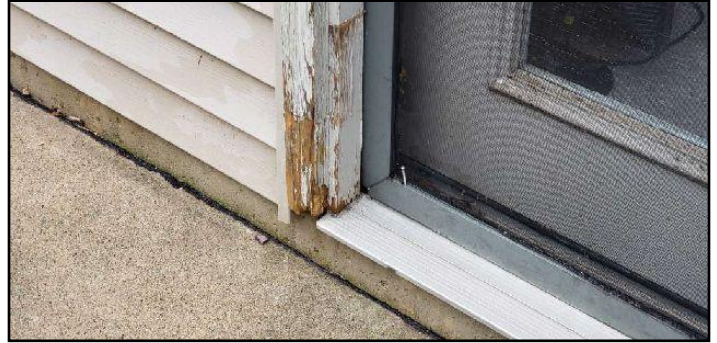
#### 6. Condition: • [Rot](#)

**Implication(s):** Chance of damage to finishes and structure

27. Rot

28. Rot

Recommend repairing or replacing rotting door trim and painting as well.

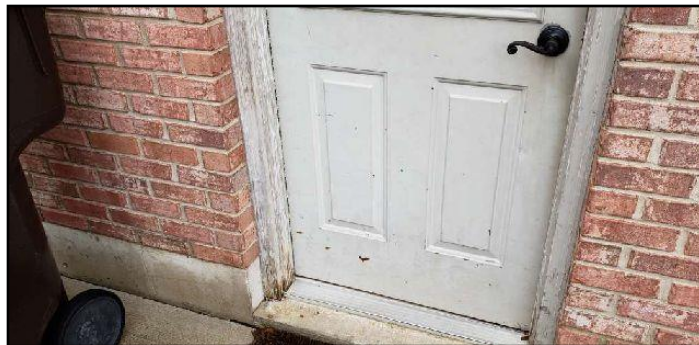
**7. Condition:** • [Paint or stain needed](#)

**Implication(s):** Chance of damage to finishes and structure | Material deterioration

29. Paint or stain needed

Recommend painting door trim.

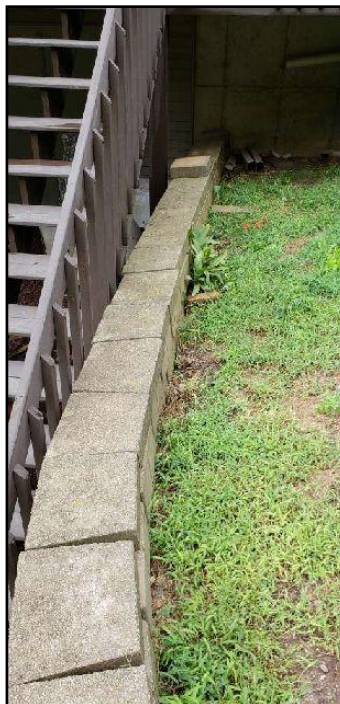
**8. Condition:** • [Leaning](#)

30. Leaning

Recommend correcting leaning retaining walls, both upper and lower.

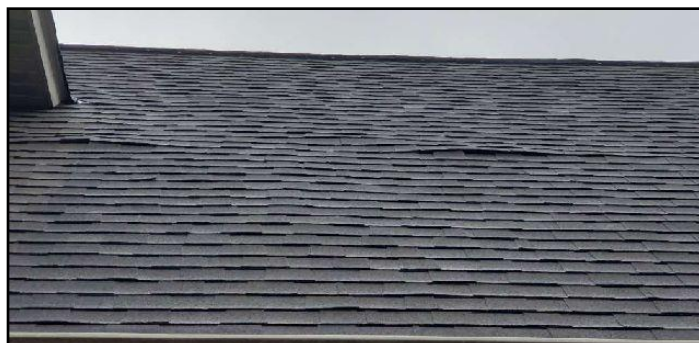
**11. Condition:** • [Buckled](#)

**31. Buckled**

Recommend further evaluation and repair if needed.

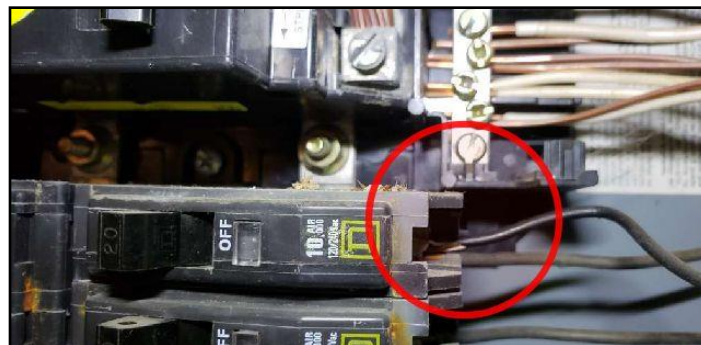
#### 12. Condition: • [Double taps](#)

Recommend correcting double tap with wrong size wire. A 14 gauge wire used for radon reduction system is double tapped to a 20 amp breaker.

**Implication(s):** Fire hazard

36. Double taps

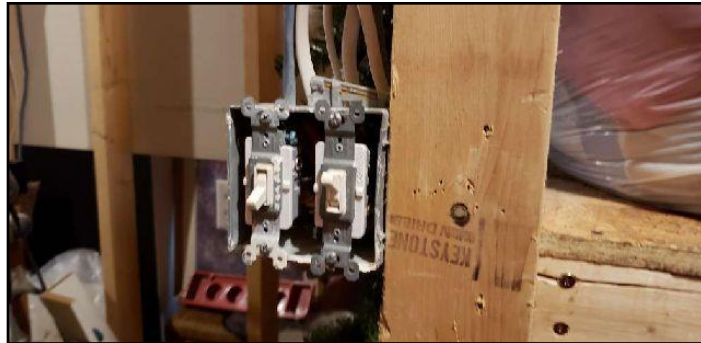
#### 13. Condition: • For switch is missing

37. For switch is missing

Recommend installing a coverplate on switches.

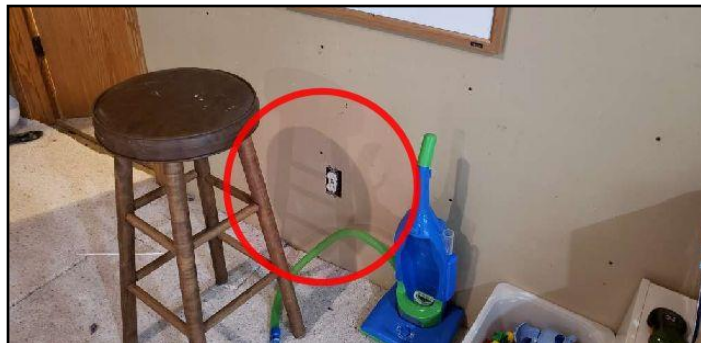
**14. Condition:** • For outlet (receptacle) is missing

38. For outlet (receptacle) is missing

Recommend installing a coverplate on receptacle.

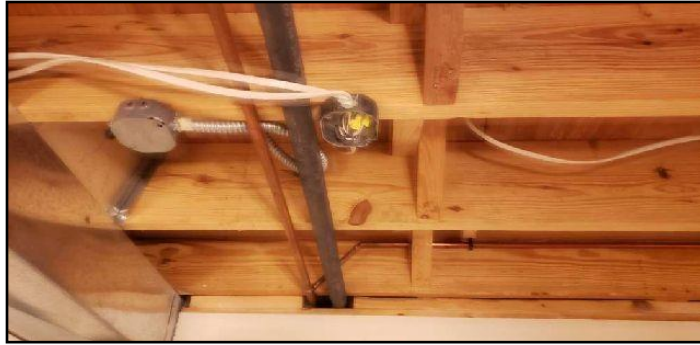
**15. Condition:** • For junction box is missing

**39.** *For junction box is missing*

Recommend installing a coverplate on junction box.

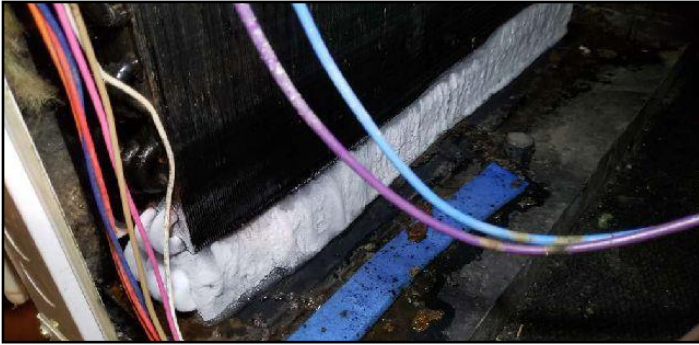
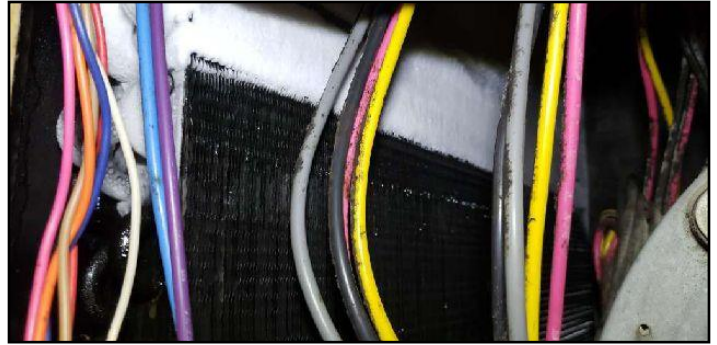
17. Condition: • [Frost](#)

42. Frost

43. Frost

Recommend further evaluation for coil frosted over and unit is not cooling the home.

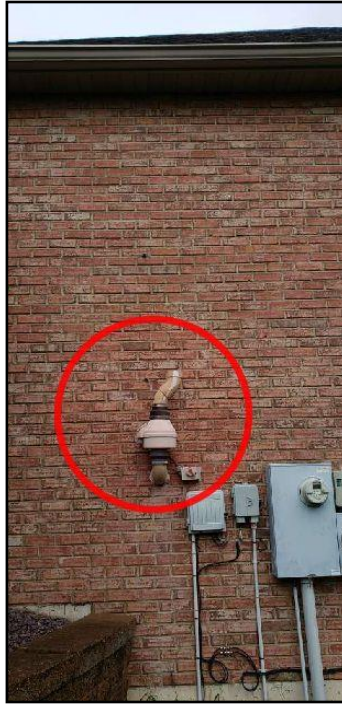
45.

**18. Condition:** • Recommend replacing missing radon mitigation exhaust pipe in accordance with Illinois mitigation guidelines.

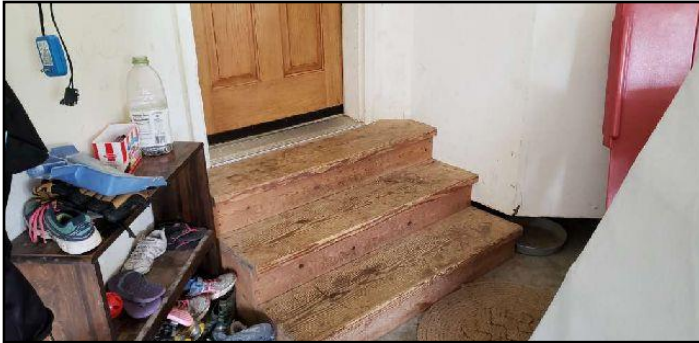
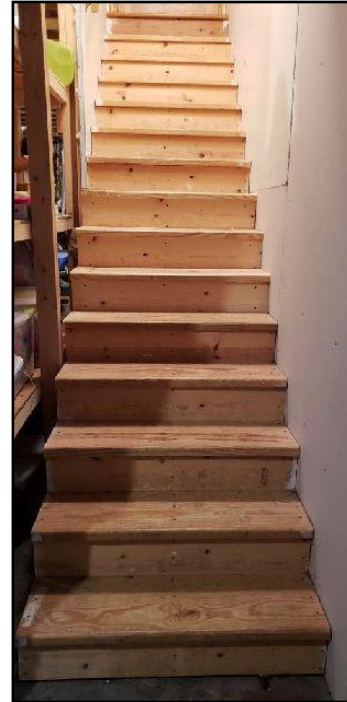
### 23. Condition: • [Missing](#)

**Implication(s):** Fall hazard

51. Missing

52. Missing

Recommend installing a handrail for the basement steps and the garage steps.
