YOUR INSPECTION REPORT

FOR THE PROPERTY AT:
2 Glamis Avenue
Toronto, ON M6N 4H4

INSPECTION DATE:
Thursday, October 5, 2023

RE: Report No. 7308, v.3
2 Glamis Avenue
Toronto, ON
M6N 4H4

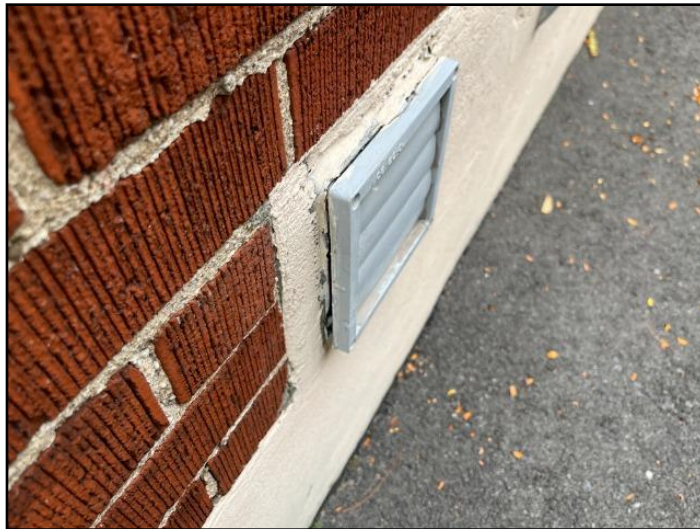
Condition: • Caulking around windows, doors and wall penetrations should be checked regularly for deficiencies and improved as needed.

4. example caulking needed at vent

Task: Provide caulking

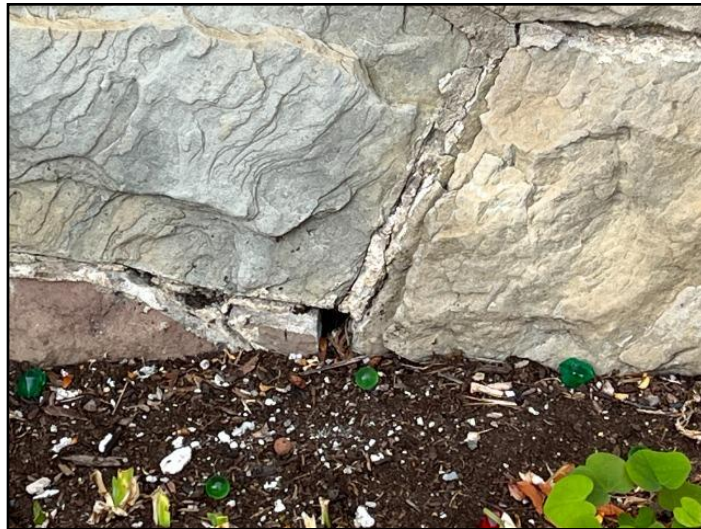
Condition: • [Mortar deterioration](#)

5. Mortar deterioration

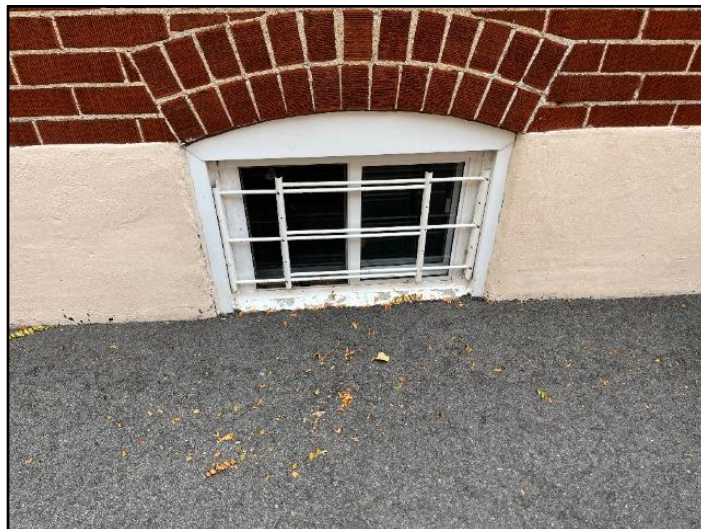
Condition: • Sill - Near or at Grade Level

6. Sill - Near or at Grade Level

Task: Monitor / Improve

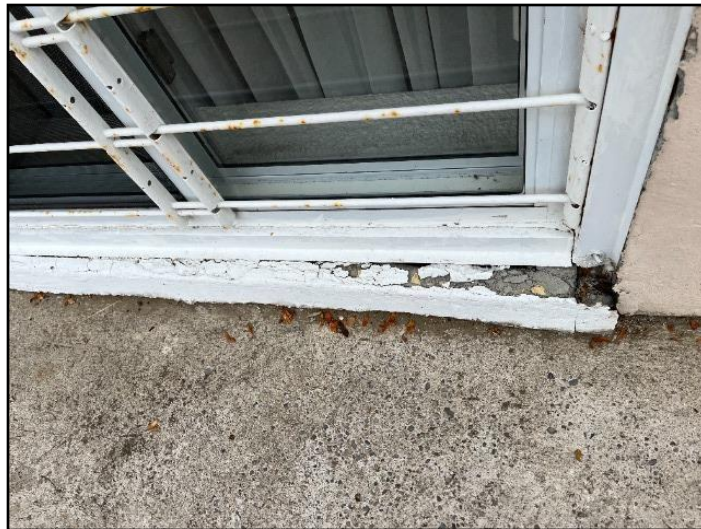
Condition: • [Sill deteriorated](#)

7. Sill deteriorated

Task: Repair

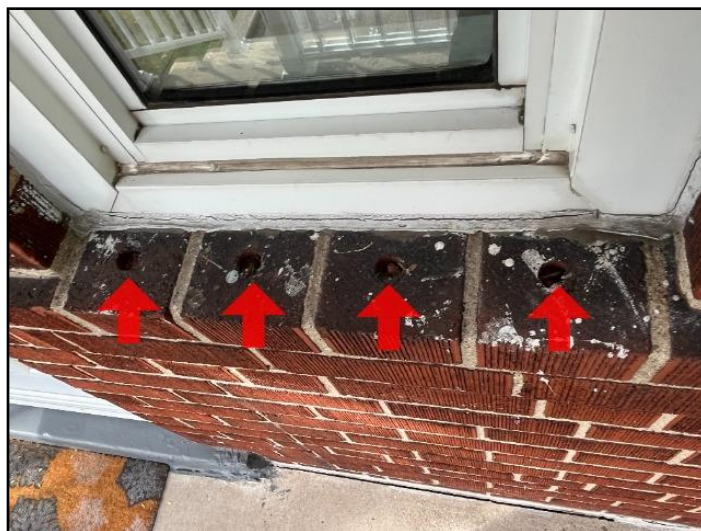
8.

Condition: • At front porch window sill, brick installed on side with hollows facing up.

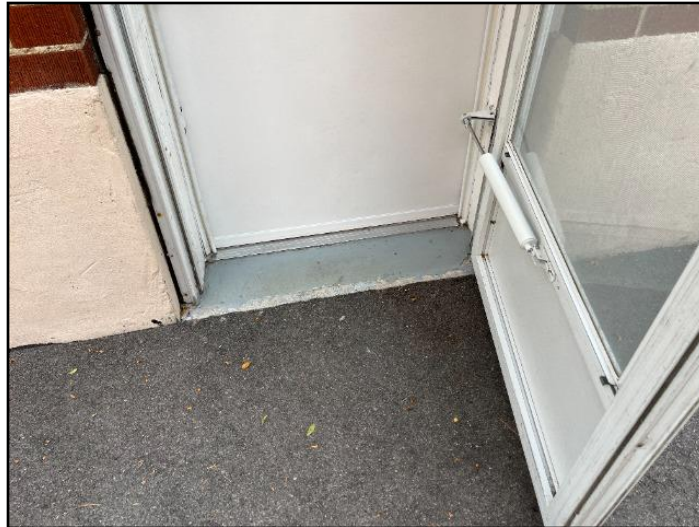
Condition: • [Sill too low](#)

9. Sill too low

Task: Improve

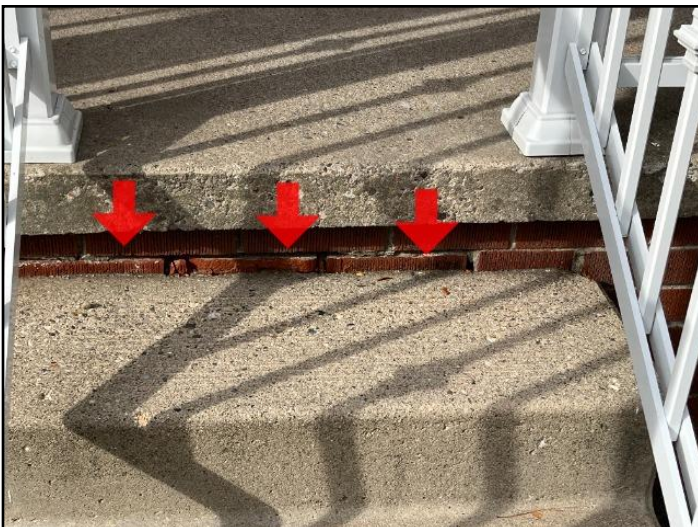
Repair localized spalling at brick riser.

10. Spalling at brick riser

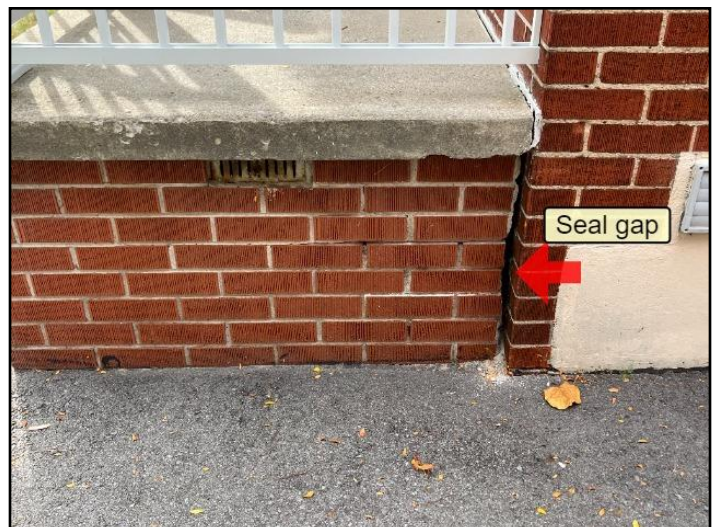
11. Gap where porch meets wall and mortar needed

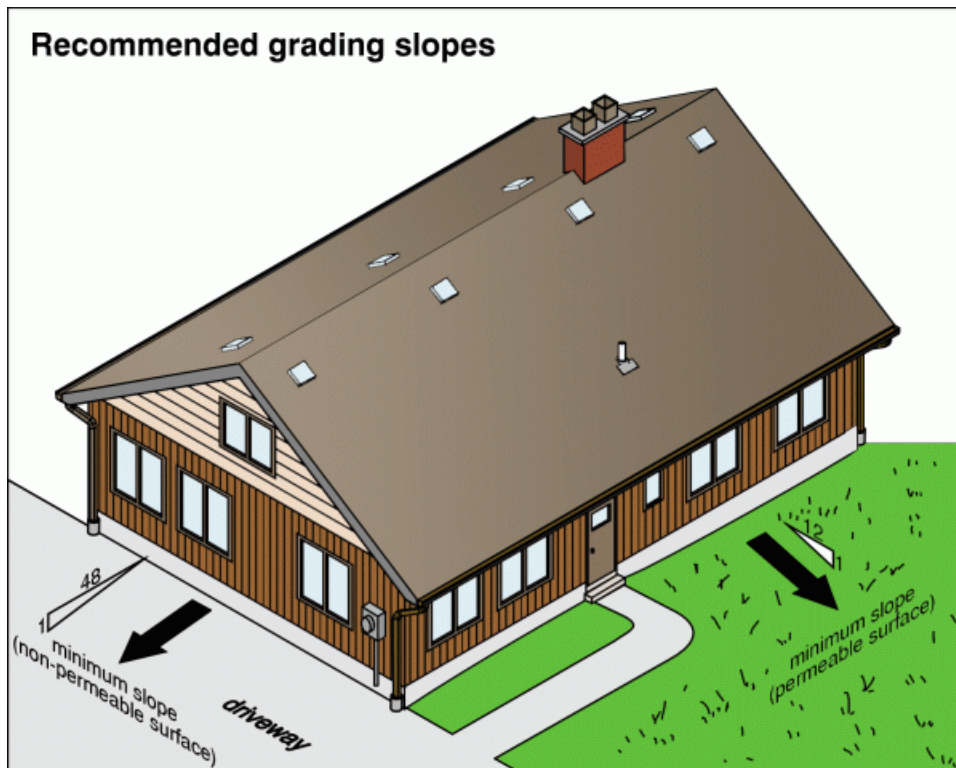
Condition: • Low Areas.

Low areas / settlement was noted at various areas including front planter and left side near front. Improve grade to slope away from home for at least 6 feet to help promote good drainage away from home. This is normal maintenance for ALL homes.

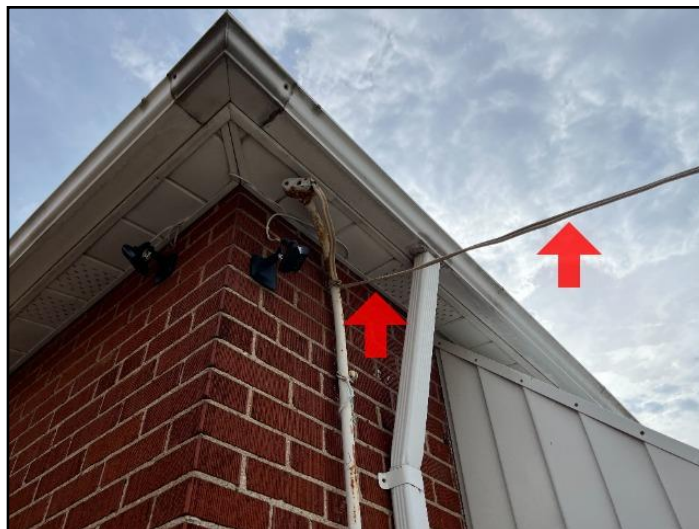
Condition: • [Height over walking area](#)

13. Height over walking area

Task: Correct

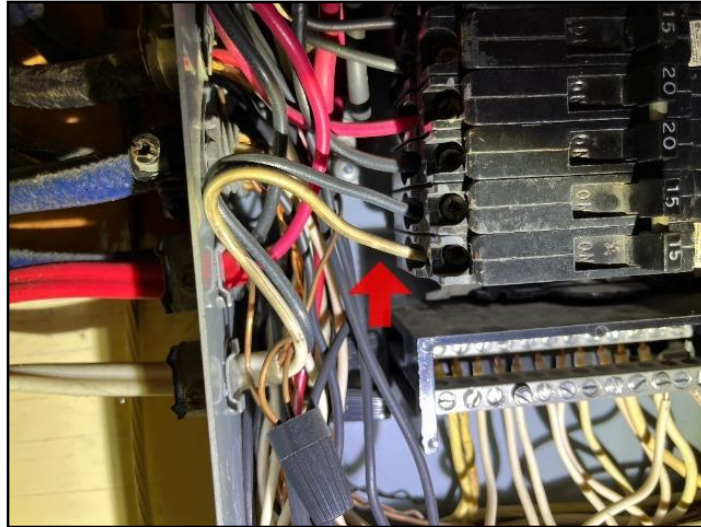
Condition: • White wires connected to breakers not identified as hot/live/ungrounded
White wire used as hot wire not marked

14. White wires connected to breakers not...

Task: Cover

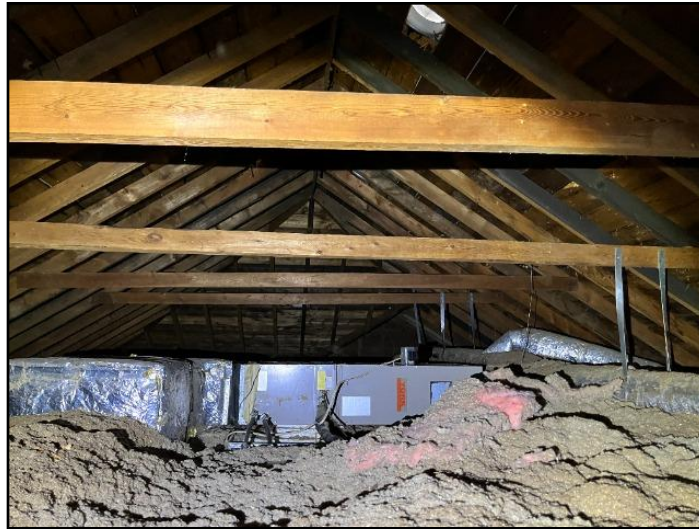
In the attic, an air handler is present, which is currently serving as a house fan and is connected to ducting leading to ceiling registers on the main level. While a cooling system was previously attached to the air handler and has since been removed, this presents an opportunity in the future to potentially attach a new air conditioner or replace the air handler with a furnace, offering versatile heating and cooling options in addition to the existing hot water boiler and radiator system and air conditioner system located at the family room.

15. view of air handler and ducting in attic
