INSPECTION REPORT

For the Property at:
123 YOUR NEW HOME
MY VILLAGE, BC

Inspection Date: Thursday, May 2, 2024

Valley to Peaks Home Inspections
1452 Willow St
Telkwa, BC V0J2X0
2506438449

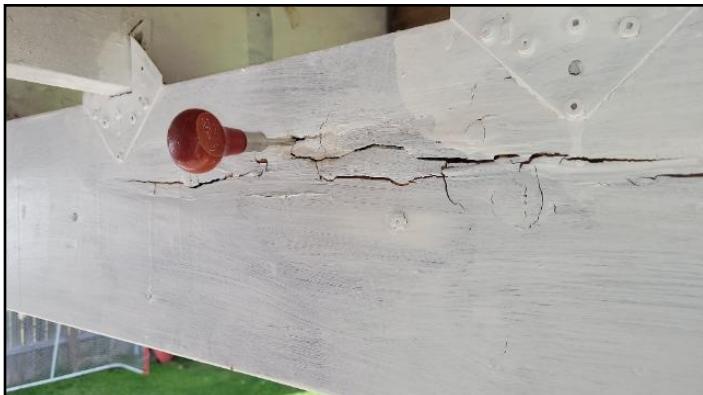
1. Condition: • Rot

Deck issues are one of the most common finds on a home inspection. But lets face it, they are a flat surface that is fully exposed to the weather, that gets walked on and has snow sitting on it for 4 months every year. So its not a surprise that they get worn out. The main thing we see is rot. Rot to the deck surface is pretty easy to repair, but when a issue that is left to long it can spread to the deck structure causing a safety issue. Most of the time decks can be repaired. Or repairs can be done to give the home owner more time to save to replace the deck in the future. Your inspector will be able to advise you on the best options for any issues for your deck.

3. Rot- Beam

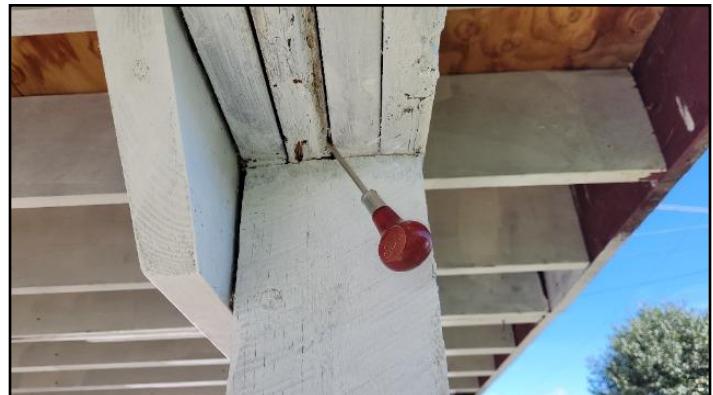
4. Rot- Beam

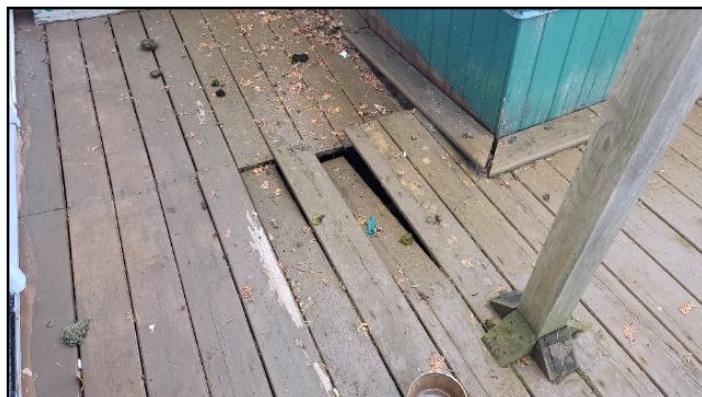
5. Rot- Joists

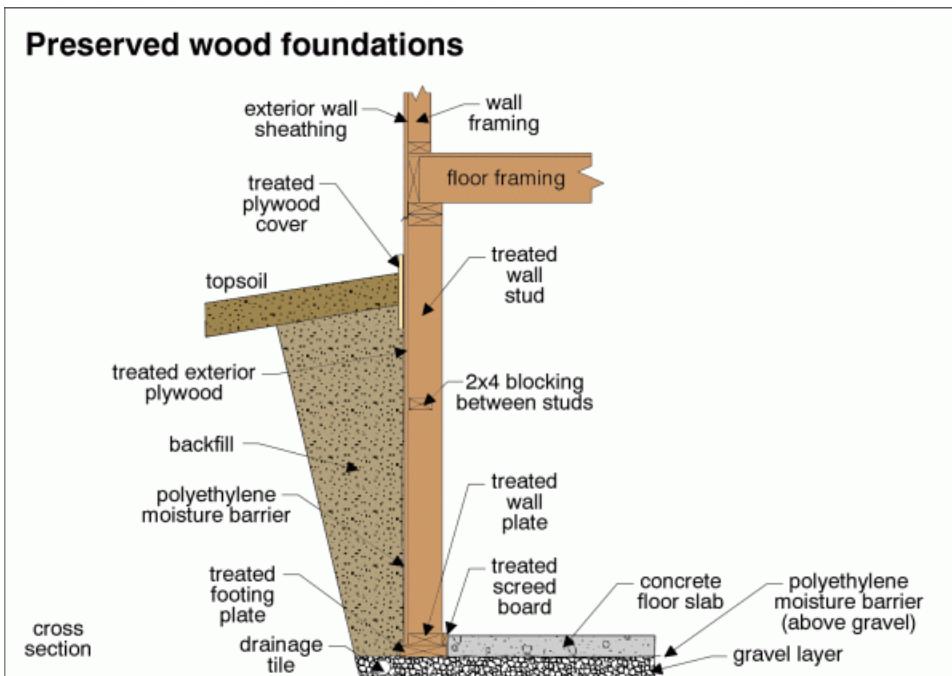
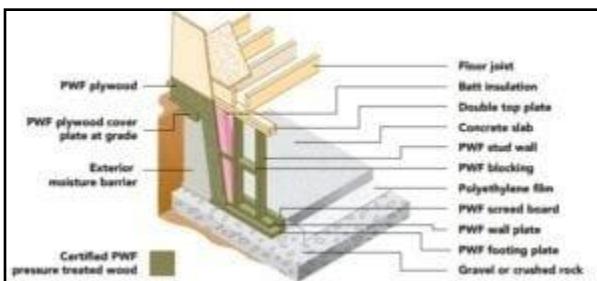
3. Condition: • [PWF - Permanent Wood Foundations](#)

A lot of people will tell you that PWF's are bad news. This is not totally true. A well built PWF with proper water mitigation and the right soils used for backfilling is no better or worse structurally than a traditional concrete foundation. A PWF is just as strong vertically, as a concrete foundation. It is not as strong laterally but is designed to be able to handle some deflection. There are pros and con's to both types. The wood used in a PWF is treated with Chromated Copper Arsenate. This is not the same treated lumber as what your deck is built from. Things to be on the lookout for when viewing these homes are. Is the ground sloped away from the foundation? Are there gutters with downspouts that empty away from the foundation? Is there a sump pump that is connected with the perimeter drain? Your inspector will check for bowing walls and evidence of moisture while inspecting this type of foundation. PWF's aren't for everybody, but they definitely are a better foundation system than some of the other types found in this area. For more information on PWF's click link in "blue" above.

10. PWF - Permanente Wood Foundations

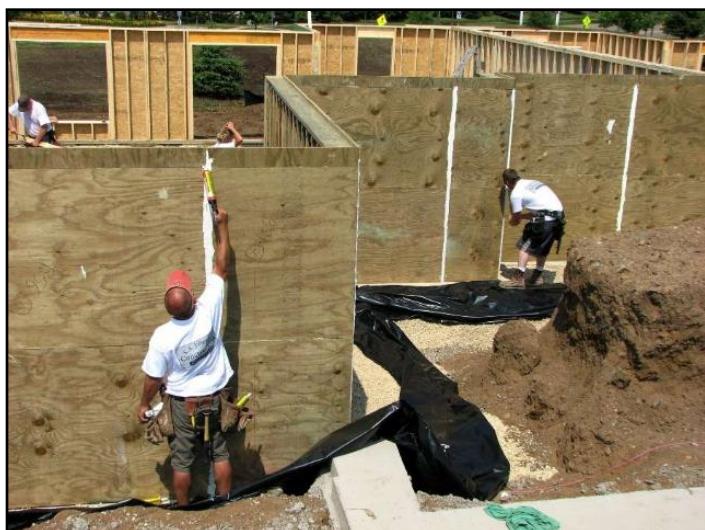
11. PWF - Permanente Wood Foundations

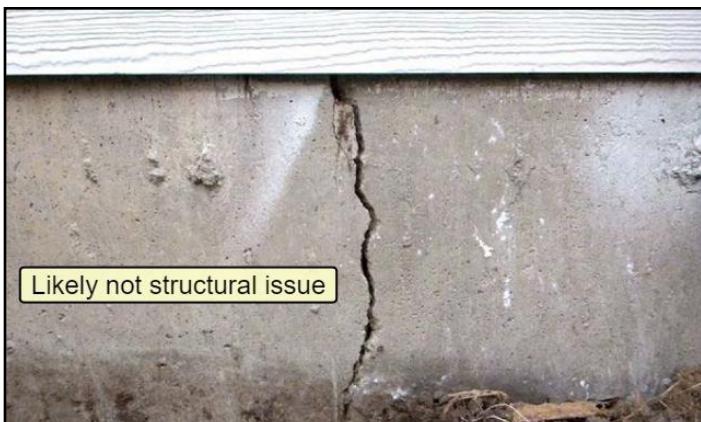
4. Condition: • Cracked

12. Common minor crack

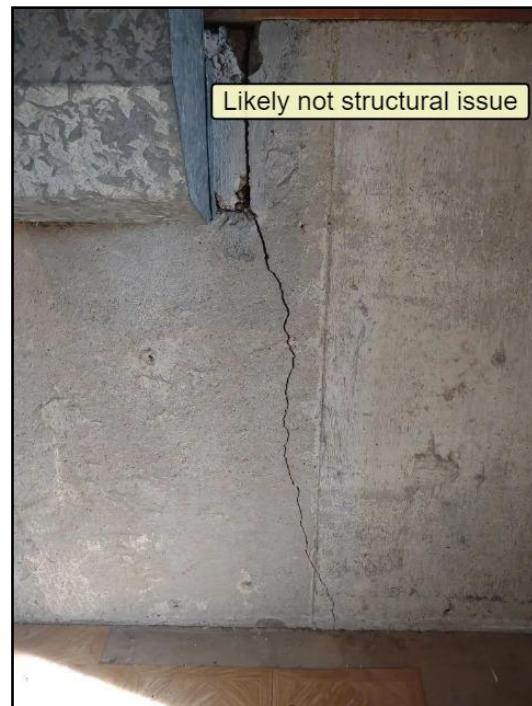
13. Common minor crack

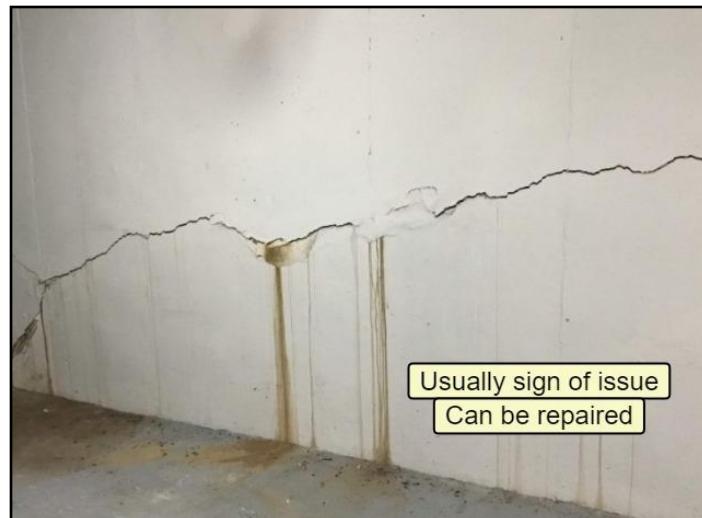
Not all cracks in foundations are cause for alarm. It's common for concrete to develop cracks during the curing process. Vertical cracks are very common and usually not a concern, but horizontal cracks are almost always a sign of an issue. However, when vertical cracks widen to more than a quarter of an inch, it's advisable to have them evaluated by a structural engineer or a concrete foundation repair specialist. Sometimes, even cracks smaller than a quarter inch can be worrisome, especially if there are accompanying signs of structural movement in the house, such as windows that stick, doors that don't close properly, or noticeable cracks in walls and floors. Assessing whether a crack poses a significant problem for a home is a complex task best left to professionals. Any crack in a home's foundation could potentially serve as an entry point for water, particularly during certain weather conditions. Therefore, if you notice any cracks on a home's exterior, it's wise to inspect the interior for signs of water damage. Fortunately, cracks in foundations can often be sealed to prevent water infiltration and mitigate potential damage if needed.

14. Horizontal crack

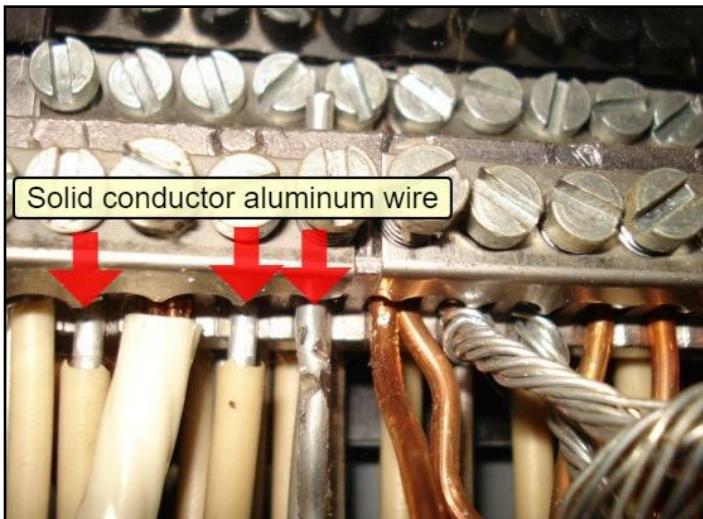
5. Condition: • Solid conductor aluminum wire

Solid conductor aluminum wiring (single strand) was used in BC homes between 1965 and 1973. It was used due to the high price of copper during that time. Unfortunately, they found that due to thermal expansion and contraction at the outlet and switch wire connections, the wires can become loose which can cause arcing which can be a fire hazard. So insurance companies do not like these wires. Luckily there is a real easy fix for this. An electrician can install copper pig tails at all the switches and outlets in the home that are designed to fix the issue. Not all insurance companies are ok with this, so important to find one that is first. Unfortunately, there is no way to tell if the home has aluminum wiring unless you remove the electrical panel (something you can not do during a home viewing). Your home inspector is trained to find this type of wire.

15. Solid conductor aluminum wire

When this type of wire is found in the panel, the pig tailing may have already be done. We can find more information by calling Technical safety BC to see if there have been any permits pulled for this procedure.

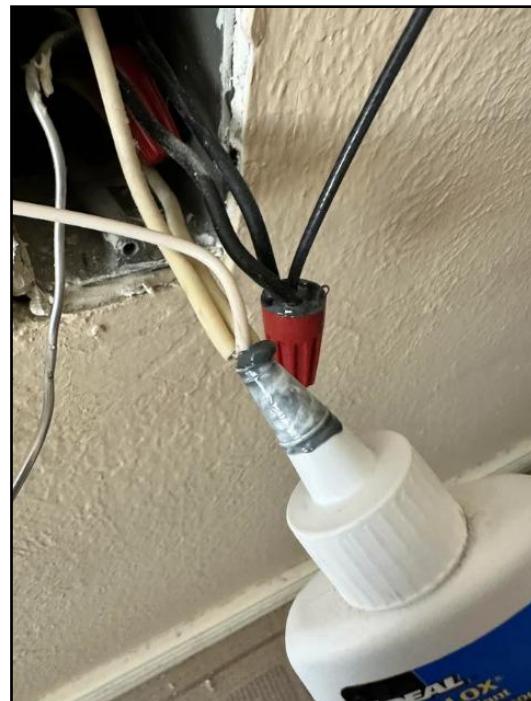
16. Pig tails

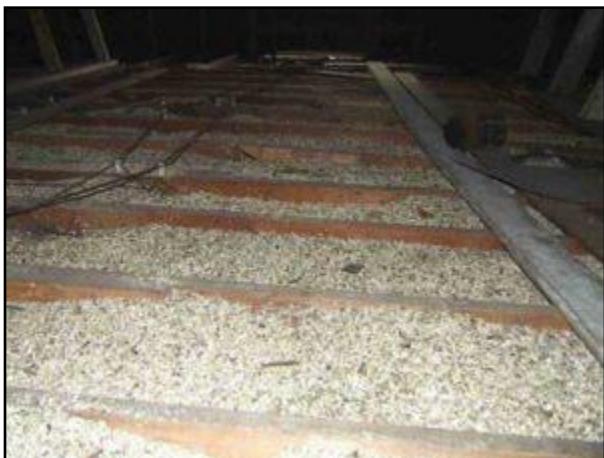
6. Condition: • Vermiculite

Vermiculite was used as an attic insulation product 1940 - mid 1980. Vermiculite is a natural mineral that is perfectly safe when pure. But unfortunately, one of the major mines in Libby, Montana, had asbestos deposits close to the vermiculite deposits. This mine were most (estimated 75%) of the residential insulation (Zionite) came from. Your Home inspector is trained to find vermiculite. However, the only way to know if this type of insulation has asbestos in it is to have it tested. Getting your vermiculite insulation tested is the safest route. Removal costs are expensive if asbestos is found.

17. Vermiculite

The best way to minimize asbestos exposure from vermiculite is to NOT remove or disturb the insulation. Moving the vermiculite will cause fibres to become airborne.

- Do not use the attic for storage.
- Nobody should go into the attic.
- If you plan to renovate, remodel, or demolish in a way that will disturb the insulation, hire a professional to take samples of the insulation and have it tested in a laboratory.
- If the results are positive, hire a qualified asbestos removal professional who is trained and certified to handle asbestos. Do NOT handle vermiculite that contains asbestos without the appropriate training.
- Never handle or remove the insulation yourself if you suspect asbestos.
- Seal all cracks and holes in the ceilings to prevent insulation from sifting through.
- Caulk around light fixtures and the access to the attic to prevent insulation from falling.

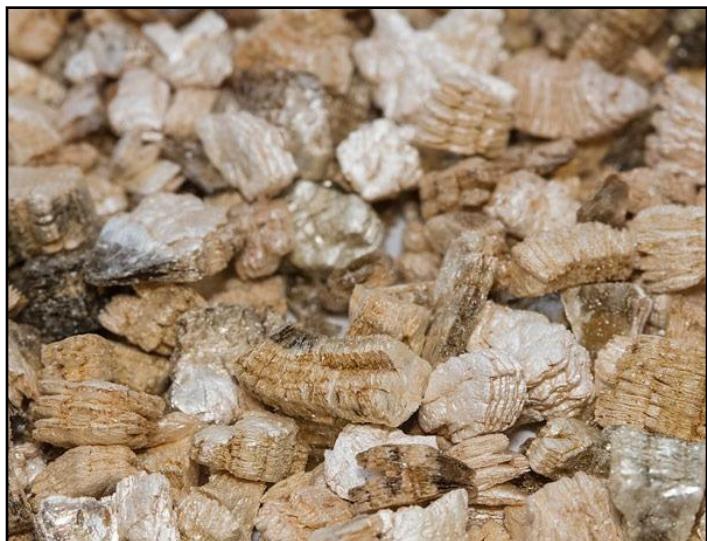
18. Vermiculite

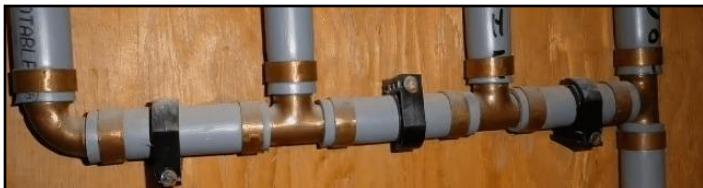
7. Condition: • [Poly B Piping](#)

Poly Butylene (Poly B), a plastic pipe widely used in this area from the early 80s to the late 90s, offered cost and installation advantages over copper. However, issues emerged, particularly with the initially used plastic fittings, which were prone to brittleness and breakage. Later, copper fittings were used, though concerns persisted about the pipe's chemical composition causing deterioration over time, accelerated by factors like water quality, installation methods, UV exposure, and high heat. Northern BC is not really seeing the same issues as other areas at this time. Plumbers are reporting leaks with this type of pipe to be no more than other pipes that are used. Despite better local conditions, the pipe was discontinued in 1998 due to widespread problems in other regions (of north America), leading to insurance challenges, especially with plastic fittings. However, some insurers in the area still provide coverage for Poly B. When inspecting homes from this period, watch for grey pipe, preferably with copper fittings, as some insurers may refuse coverage of pipe with plastic fittings otherwise. Insurance is still available for copper fittings. Your home inspector is equipped to locate these pipes and signs of any leaks if present.

19. Poly B Piping- copper fittings

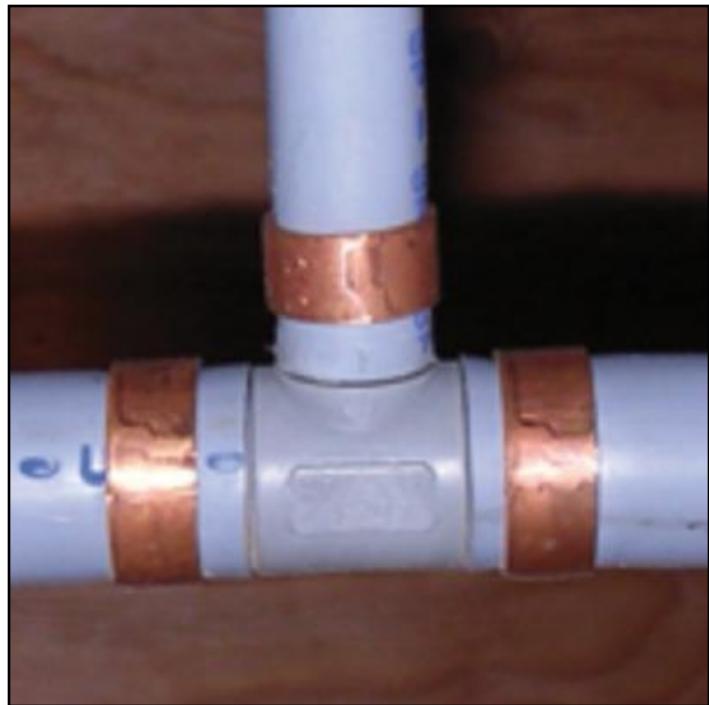
20. Poly B Piping- plastic fittings
