YOUR INSPECTION REPORT

FOR THE PROPERTY AT: 309 Beresford Toronto, ON

INSPECTION DATE: Thursday, June 8, 2017

RE: Report No. 2125, v.5 309 Beresford Toronto, ON

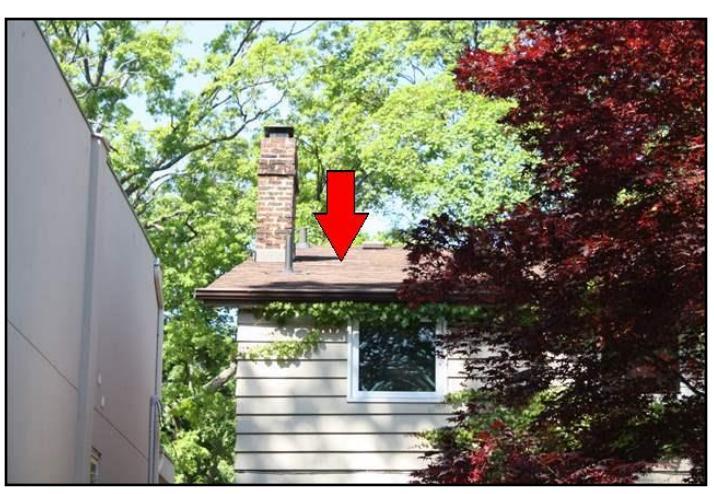
3. Patched

Condition: • Patched Implication(s): Chance of water damage to contents, finishes and/or structure Location: Rear Exterior Roof Task: Monitor Time: Ongoing

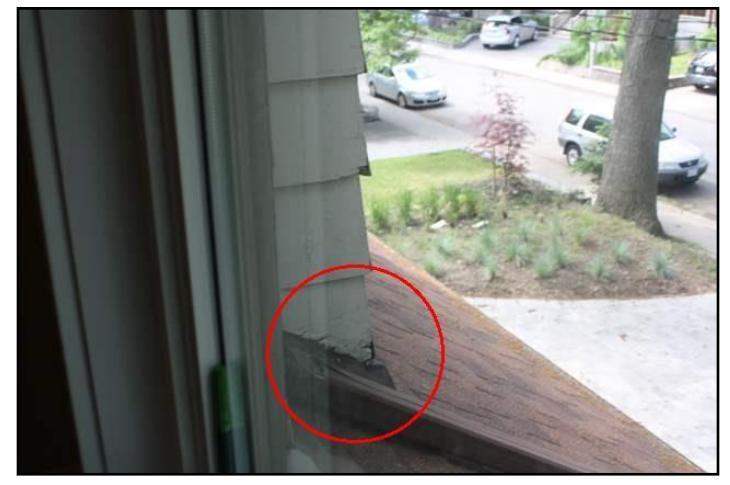
4. Example

Condition: • Cracked, split or broken

Implication(s): Chance of water damage to contents, finishes and/or structure

Location: Various Exterior Wall

Task: Repair or replace

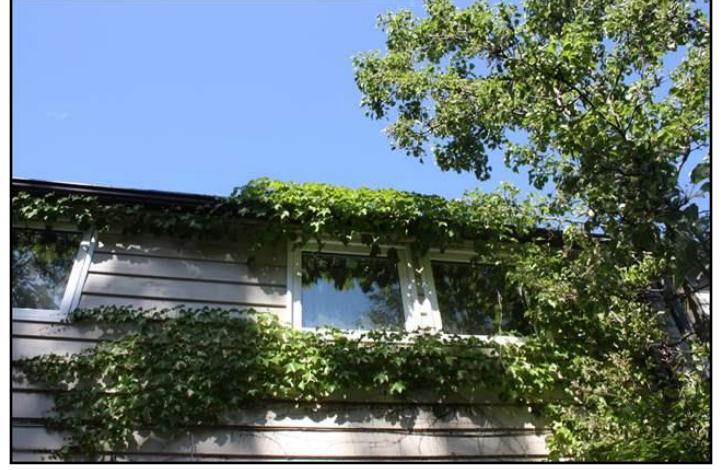
7. Vines on building

Condition: • Vines on building

Vines may damage the home over time. If vines are to remain, and we understand the aesthetic reasons for leaving them, we recommend controlling the growth so vines do not attach to wood surfaces or roofs, and do not clog gutters and downspouts.

Implication(s): Chance of pests entering building | Chance of damage to finishes

Location: Rear Exterior Wall

Task: Remove

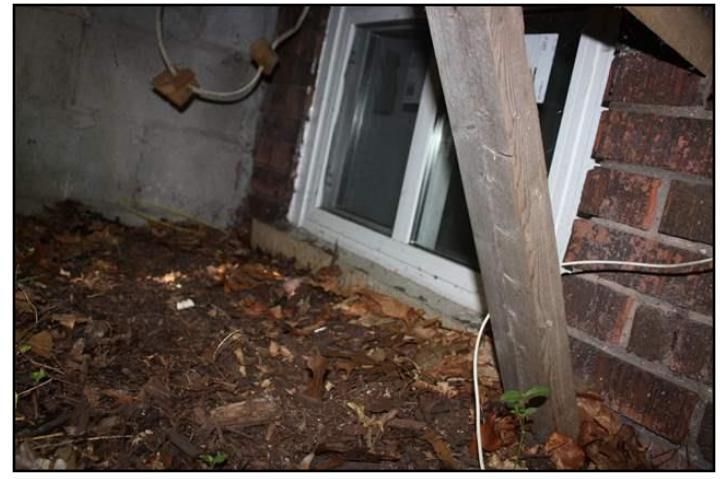
9. Improper slope or drainage

Condition: • Improper slope or drainage

Implication(s): Chance of water damage to contents, finishes and/or structure

Location: Rear Exterior

Task: Improve

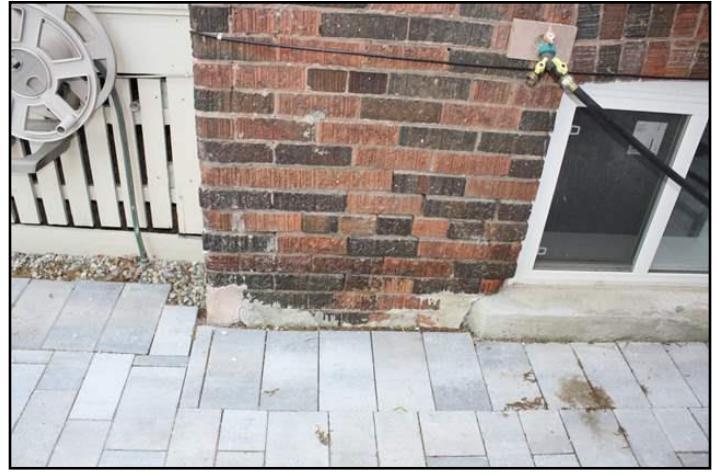
11. Mortar deteriorating

Condition: • Mortar deteriorating

Repointing / Tuck-Pointing needed at various areas. This is common for homes of this age.

Implication(s): Weakened structure | Chance of structural movement

Location: Various Exterior Wall and sills

Task: Repair

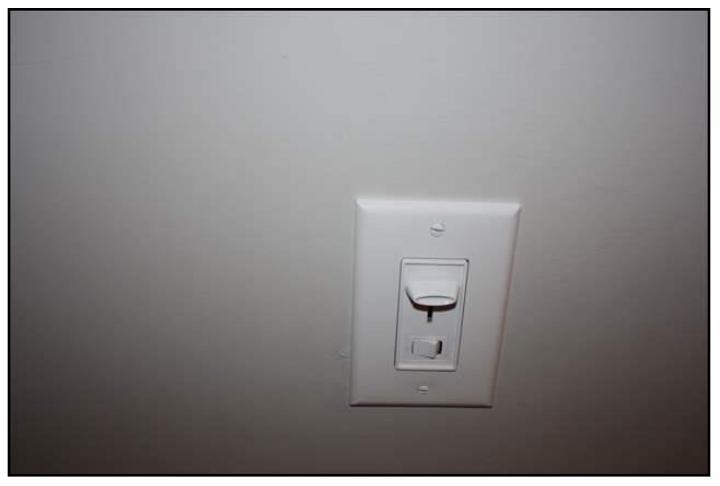
15. Faulty

Condition: • Faulty Implication(s): Fire hazard | Electric shock Location: Basement Task: Replace Time: Prior to first use Cost: Minor

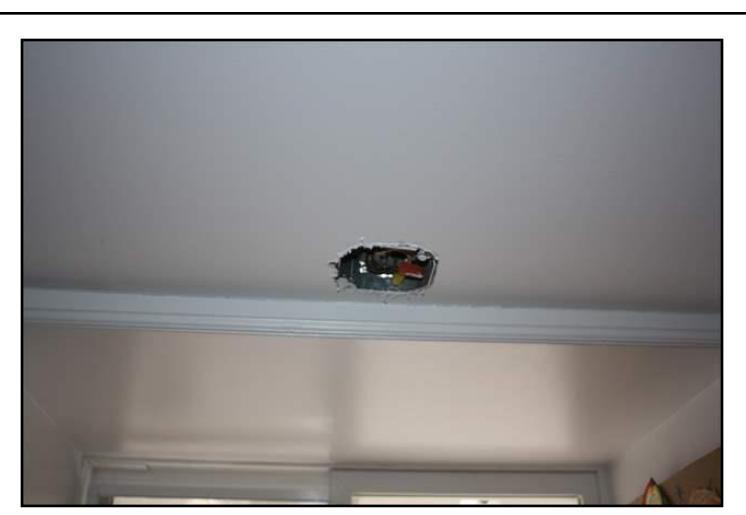
16. Cover loose or missing

Condition: • Cover loose or missing Implication(s): Fire hazard | Electric shock Location: Basement and Attic Task: Cover Time: Immediate Cost: Minor

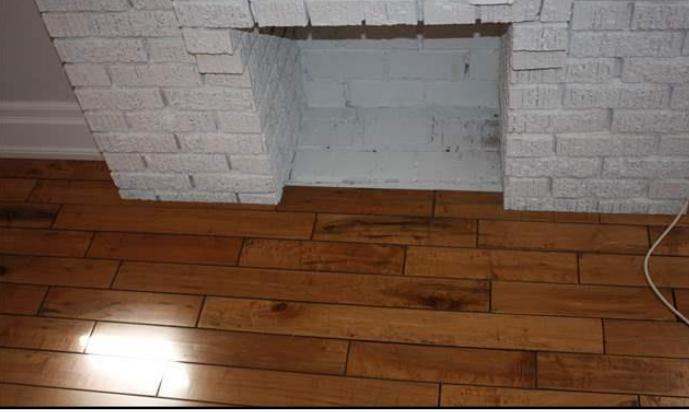
17. Combustible clearances

Condition: • <u>Combustible clearances</u> Do not use. Fireplace not in service Implication(s): Fire hazard Location: Second Floor

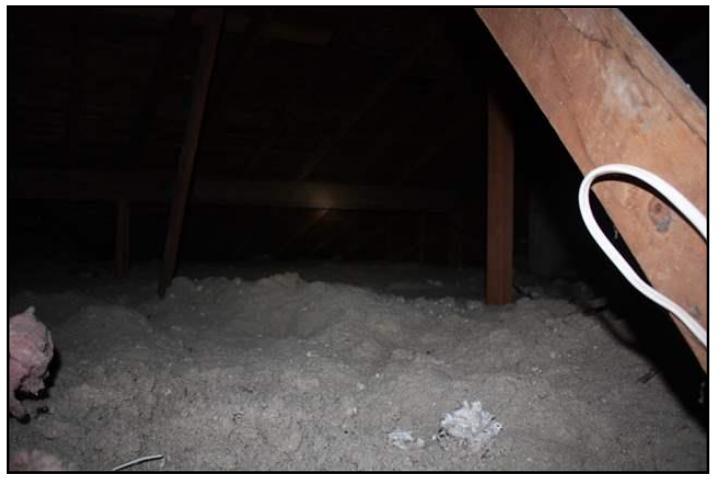
18. Amount less than current standards

Condition: • Amount less than current standards Below current standards of R-50 (as of 2012) Implication(s): Increased heating and cooling costs Location: Attic Task: Upgrade Time: Discretionary Cost: \$1,000 - and up

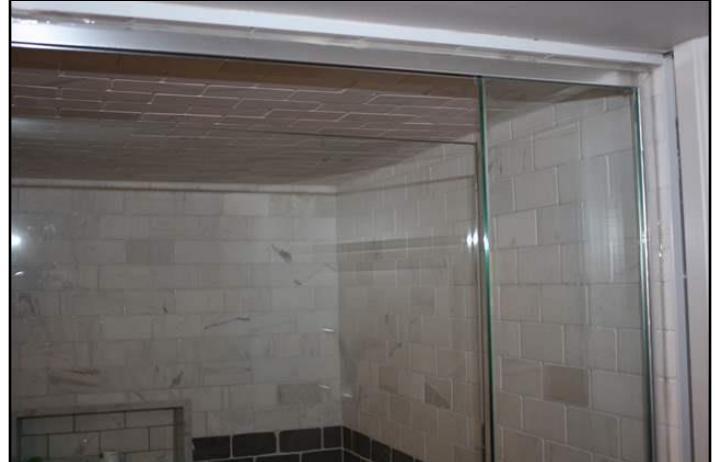
20. Entrance problems

Condition: • Entrance problems The shower doors needs adjustment and should be able to open away from the shower Implication(s): Difficult access Location: Basement Bathroom Task: Adjust Time: Prior to first use Cost: Regular maintenance item

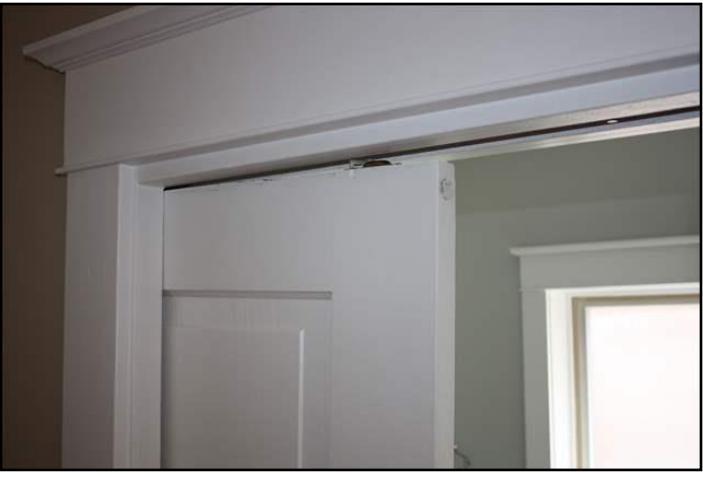
22. Ineffective

Condition: • Ineffective

Task: Repair or replace

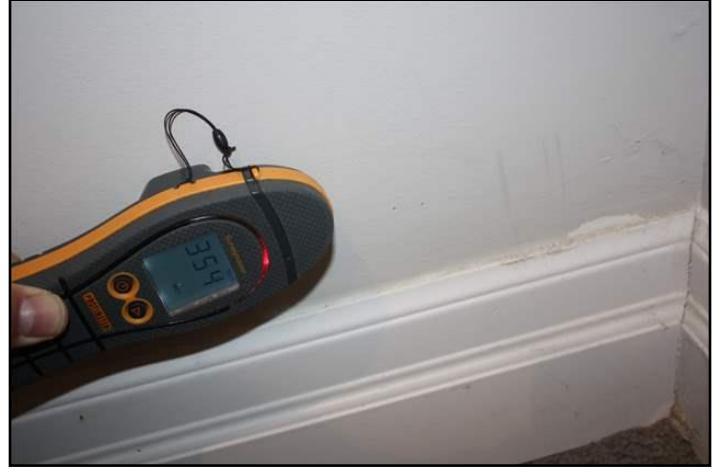
24. Dampness on floor or walls

Condition: • Dampness on floor or walls

Moisture was noted using a moisture meter. This area was adjacent to the wall areas where mortar deterioration has occurred. Water might be seeping in through the mortar. Determining whether the elevated readings are caused by a leak or condensation is outside the scope of inspection. Repair the brick mortar in these areas and monitor. To determine if basement wall is damp due to condensation or leakage will require removal of drywall to observe - if/when necessary. It is important to keep in mind that some level of dampness is common with older homes with brick or stone foundations. **Implication(s)**: Material deterioration | Chance of water damage to contents, finishes and/or structure **Location**: South Basement

Task: Repair

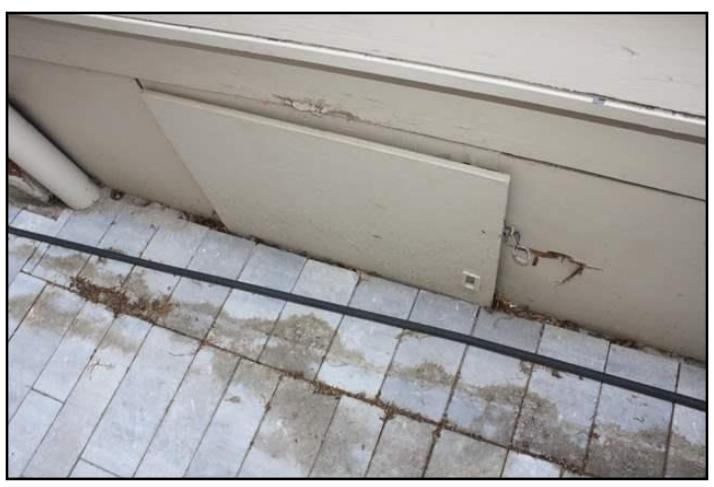
29. access to crawlspace

Condition: • We could not access the crawlspace due to the installation of the pavers.
Location: Right Side Exterior
Task: Provide access and inspect
Time: Immediate

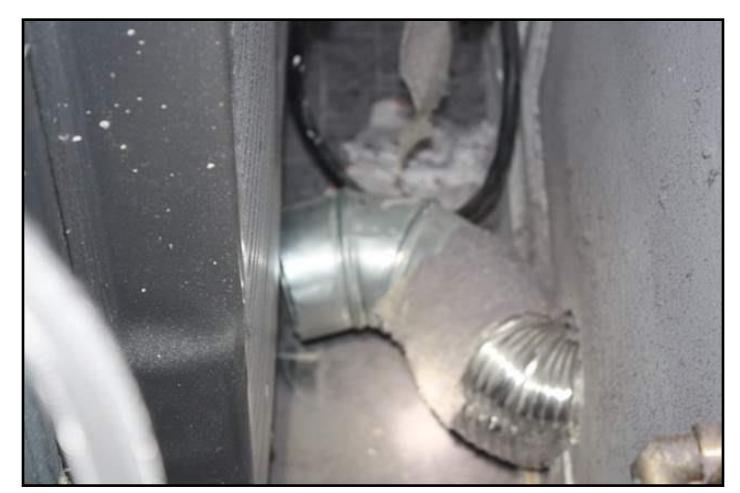
30. Dryer vent disconnected

Condition: • Dryer vent disconnected

Implication(s): Odors, molds, etc. | Fire hazard | Equipment not operating properly | Chance of damage to finishes and structure

Location: Laundry Area Task: Correct Time: Prior to first use
