# YOUR INSPECTION REPORT

123 Oak St  
My Village, ON M1E 4P3

Thursday, July 5, 2012

RE: Report No. 1404, v.6  
123 Oak St  
My Village, ON  
M1E 4P3

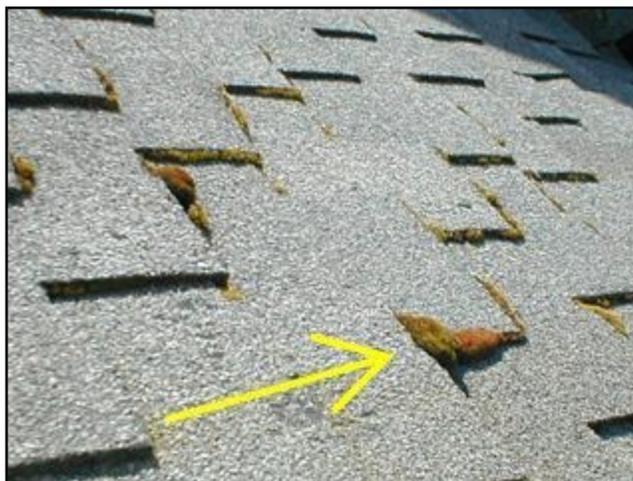
1. Moss/algae growth noted on roof surface. As...

**2. Condition:** • Moss/algae growth noted on roof surface. As a result, shingles can lift or be damaged. Leaks can result and/or the roof surface can fail prematurely. Recommend a qualified handyman to rectify to avoid any accelerated material damage.

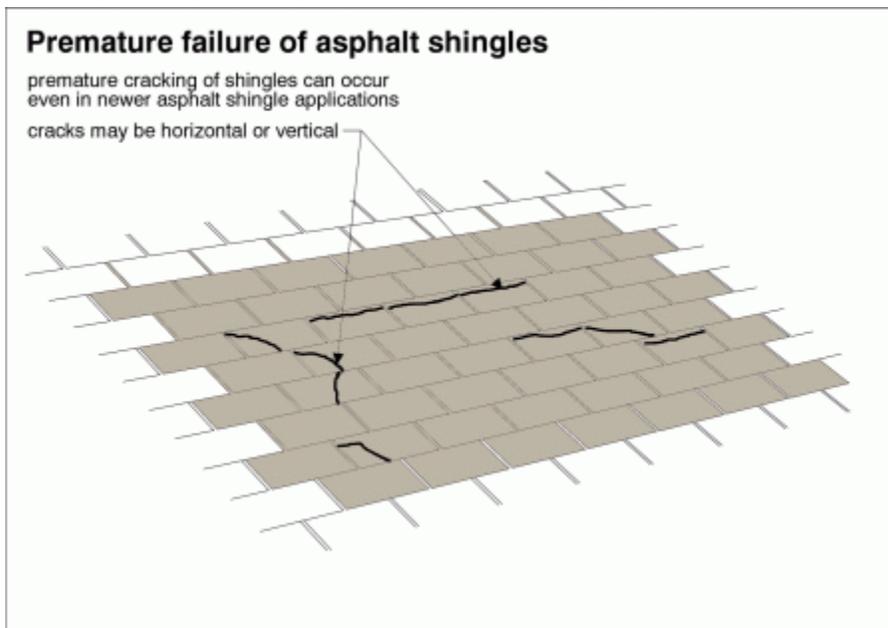
**3. Condition:** • [Cupping, curling, clawing](#)

**4. Condition:** • [Cracked](#)

Shingles on south side showing excessive wear.

**Task:** Monitor

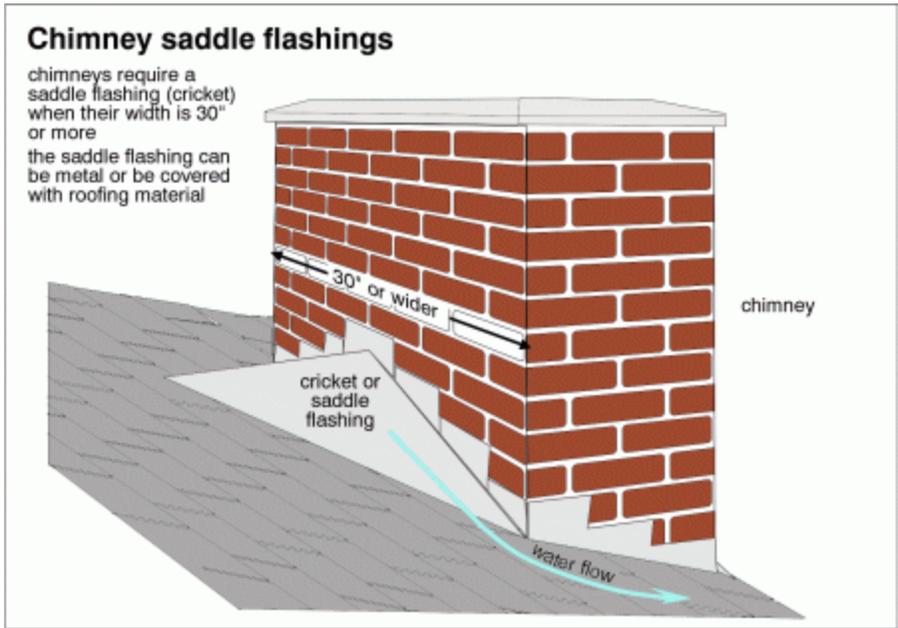
**5. Condition:** • [Cricket missing, loose, damaged](#)

Cricket flashing at chimney is missing. Recommend a qualified roofer install to prevent water infiltration around chimney area.

**Implication(s):** Chance of water damage to contents, finishes and/or structure

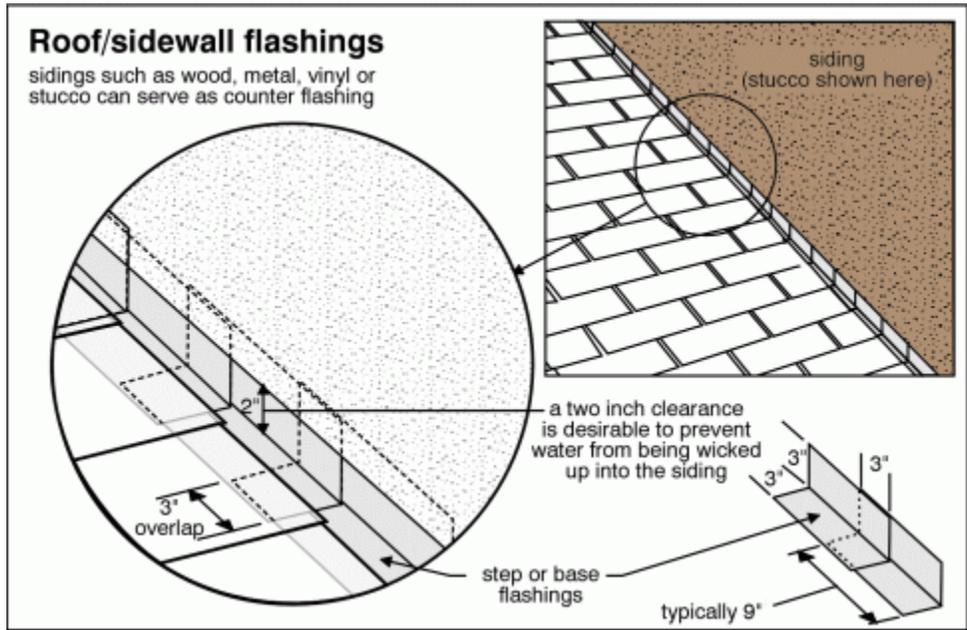
### 6. Condition: • Siding not cut back

Wood siding is touching roof flashing. Water can wick up the wood siding causing rot.

**Implication(s):** Chance of water damage to contents, finishes and/or structure

**Task:** Improve

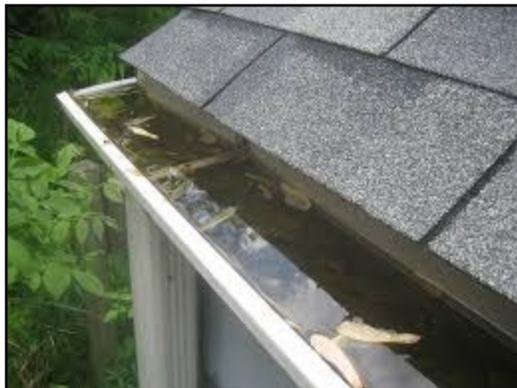
3. Clogged

12. **Condition:** • Maintenance - The guttering system needs to be maintained to allow proper drainage away from the home. Recommend a qualified handyman to clean regularly to prevent leaking and improve water flow. Monitor during a moderate to heavy rain and seal or repair as needed.
13. **Condition:** • [Clogged](#)
- Implication(s):** Chance of water damage to contents, finishes and/or structure

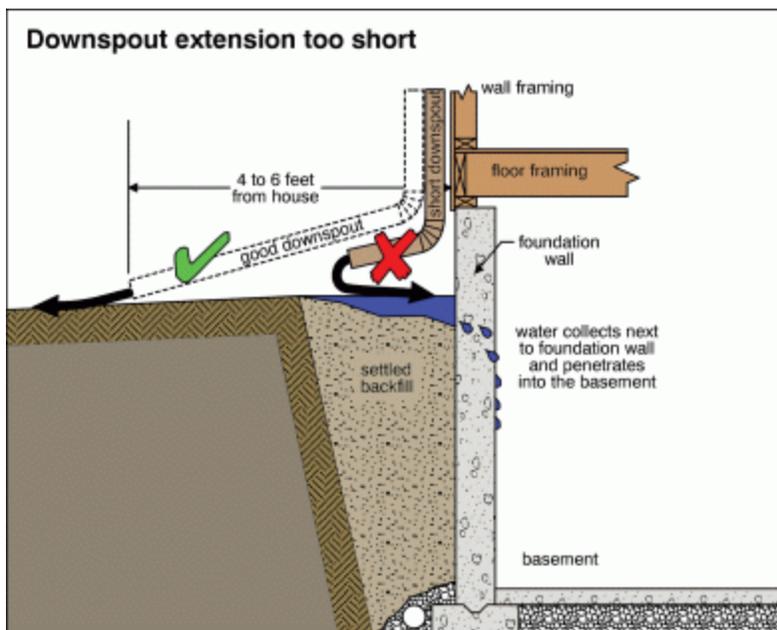
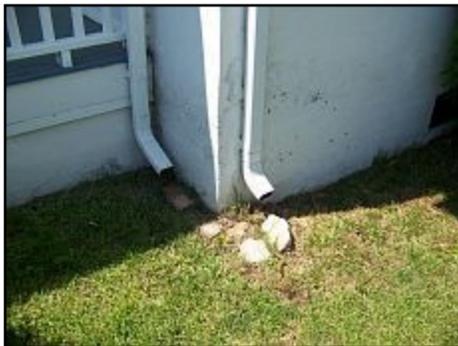
4. Downspouts end too close to building

**14. Condition:** • [Downspouts end too close to building](#)

**Implication(s):** Chance of water damage to contents, finishes and/or structure

Recommend extensions (4 to 6 ft) are installed to direct water discharge away from building foundation to avoid water infiltration.

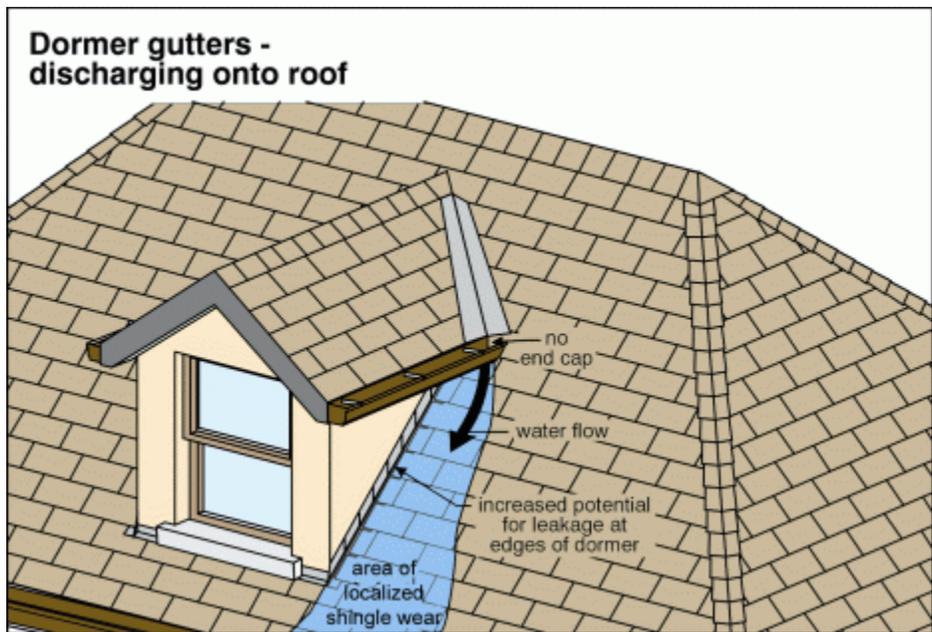
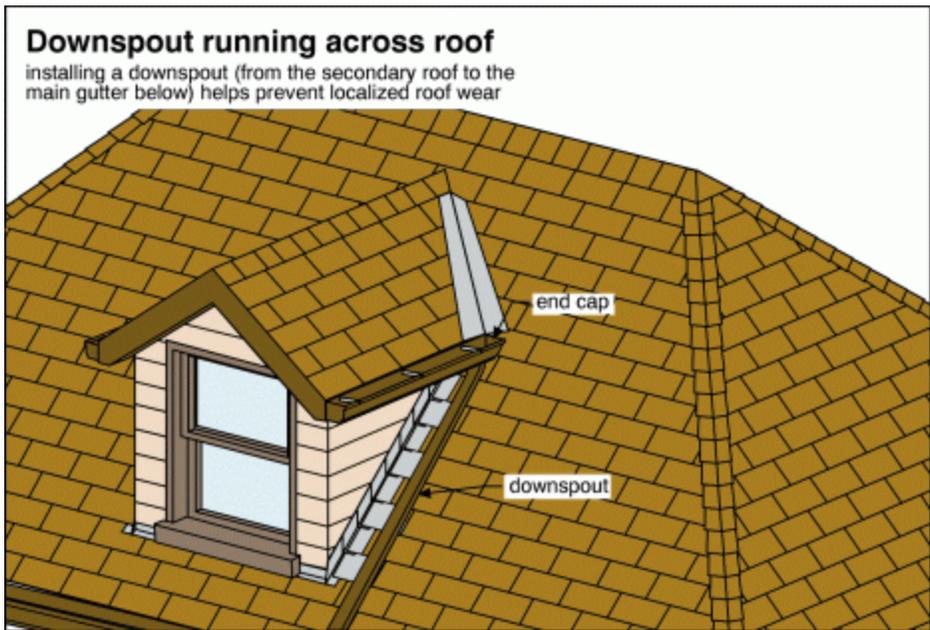
**15. Condition:** • [Downspouts discharging onto roofs](#)

Gutters from upper roofs should discharge directly in to the lower gutter system. Excessive wear on lower roof shingles may allow water infiltration in to roof area. Recommend a qualified handyman install downspout.

**Implication(s):** Chance of water damage to contents, finishes and/or structure

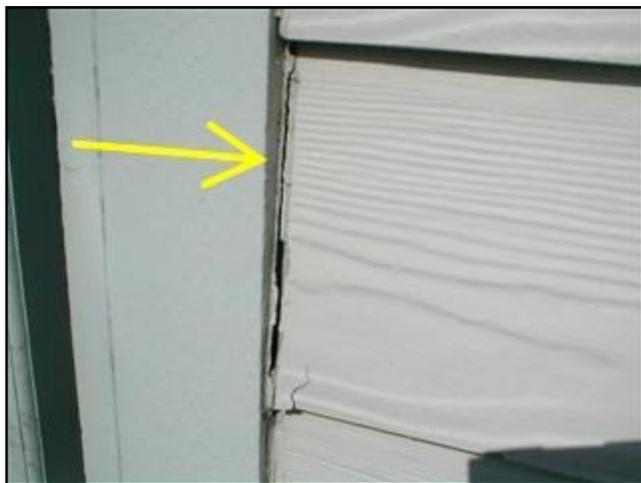
5. *Caulking missing or deteriorated*

17. **Condition:** • [Caulking missing or deteriorated](#)

**Task:** Recommend a qualified handyman to assess and rectify to avoid further deterioration

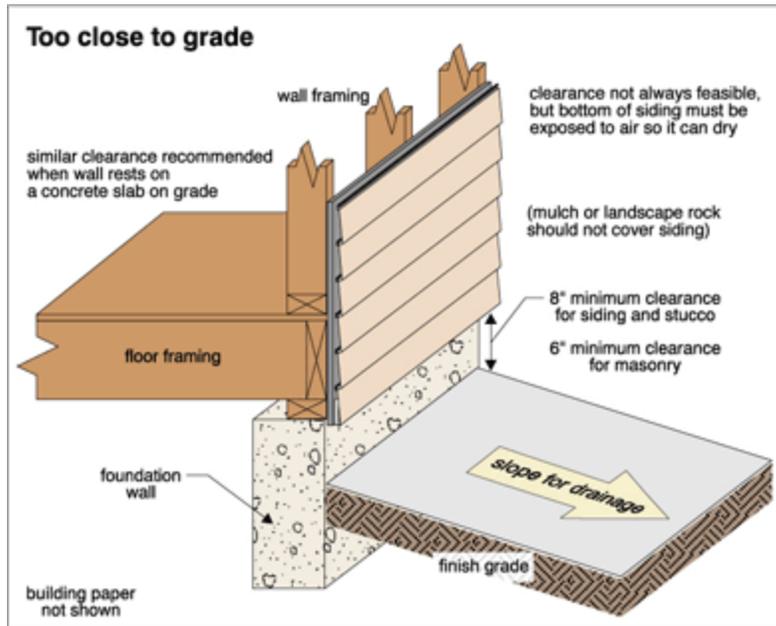
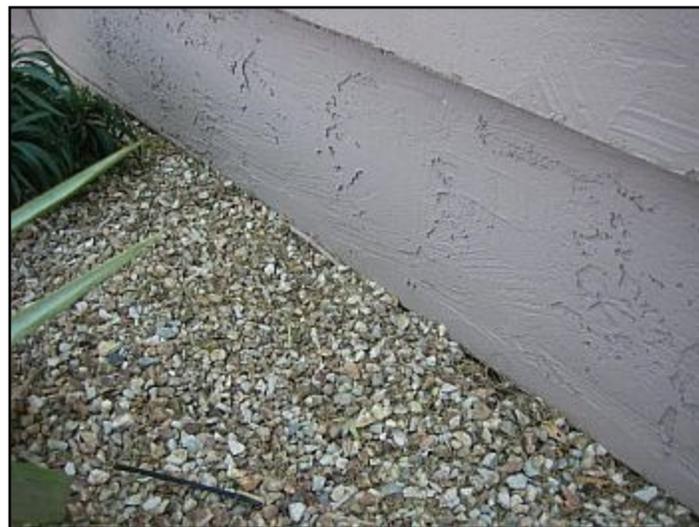
6. Siding too close to grade

**18. Condition:** • [Too close to grade](#)

**Implication(s):** Chance of water damage to contents, finishes and/or structure | Material deterioration | Rot | Insect damage

Recommend a landscaper lower ground around areas where soil contact the wood siding. Ensure lot grading slopes away from house.

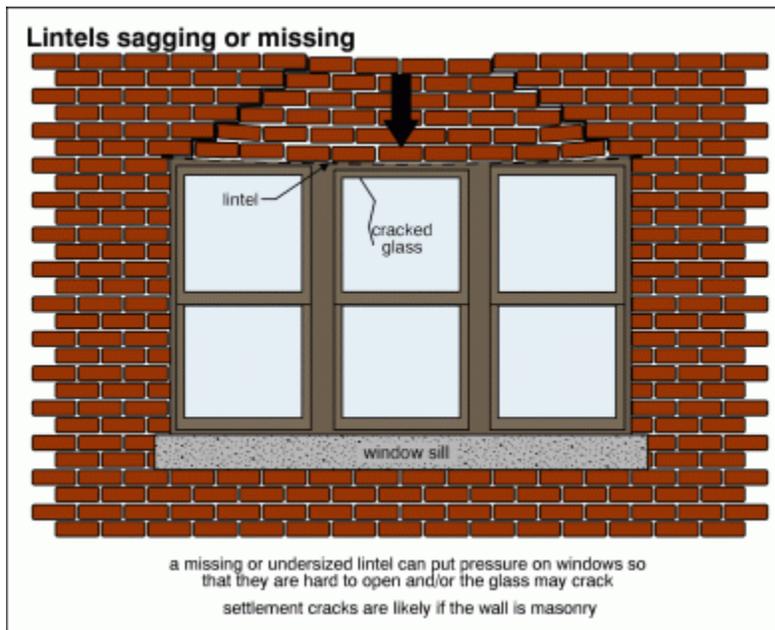
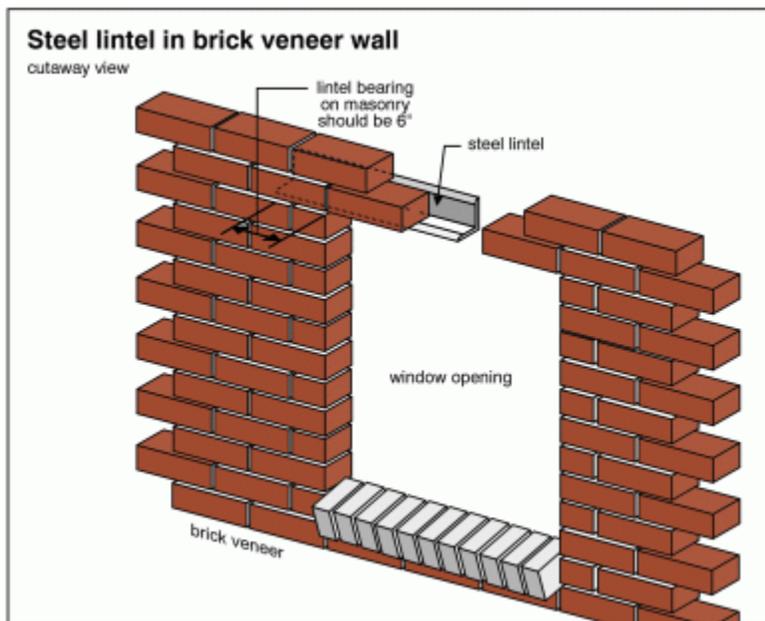
### 19. Condition: • [Lintel missing](#)

**Implication(s):** Weakened structure | Chance of structural movement

This should be assessed and rectified by a qualified contractor.

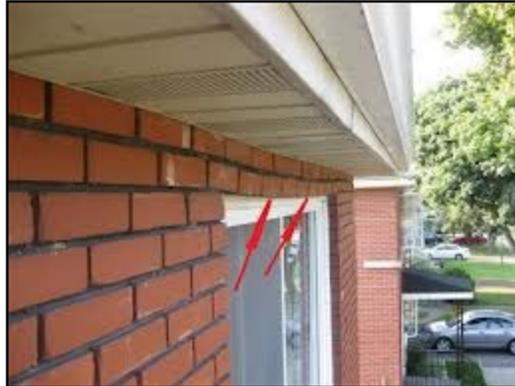
7. Missing

**20. Condition:** • [Missing or loose pieces](#)

**Implication(s):** Cosmetic defects | Chance of water damage to contents, finishes and/or structure

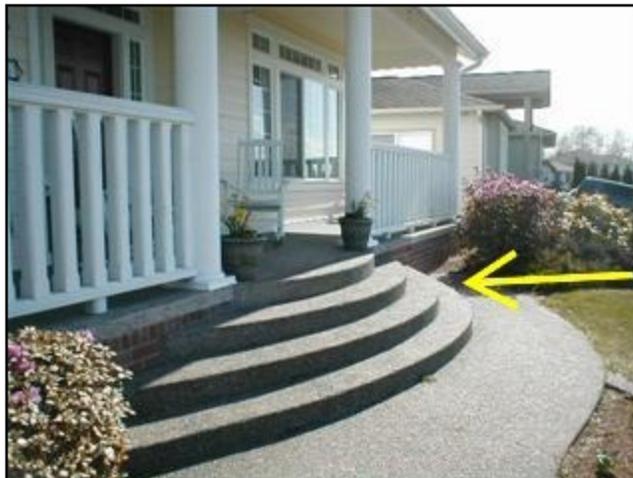
9. Missing

**22. Condition:** • [Missing](#)

**Implication(s):** Fall hazard

All exterior stairs with 3 or more steps require a handrail. Recommend a qualified carpenter install handrail for safety.

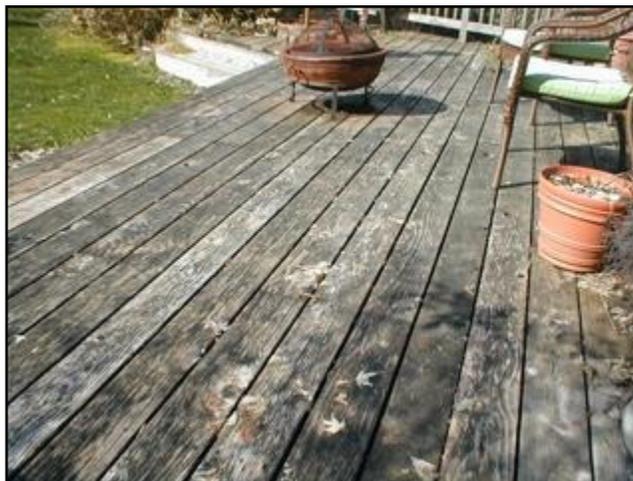
10. Maintenance - Whether treated or not, it is...

**23. Condition:** • Maintenance - Whether treated or not, it is important to keep a wood deck surface free of all forms of fungal growth and debris that retains moisture and will cause the deck to eventually rot. Recommend cleaning and re-sealing the deck annually by a qualified contractor.

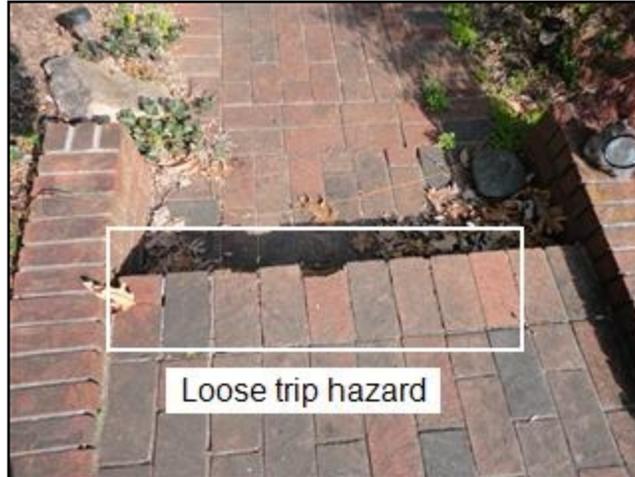
11. *Cracked or damaged surfaces*

**26. Condition:** • [Cracked or damaged surfaces](#)

**Implication(s):** Trip or fall hazard

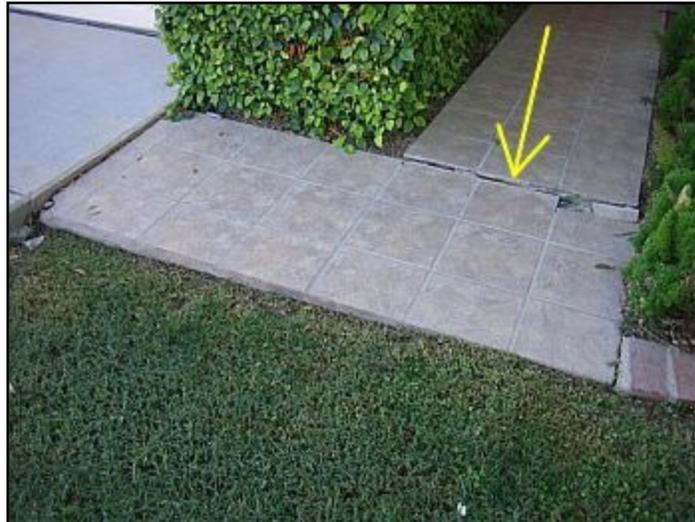
12. *Uneven (trip hazard)*

**27. Condition:** • [Uneven \(trip hazard\)](#)

**Implication(s):** Physical injury

Recommend a qualified contractor grind the uneven surface to prevent tripping.

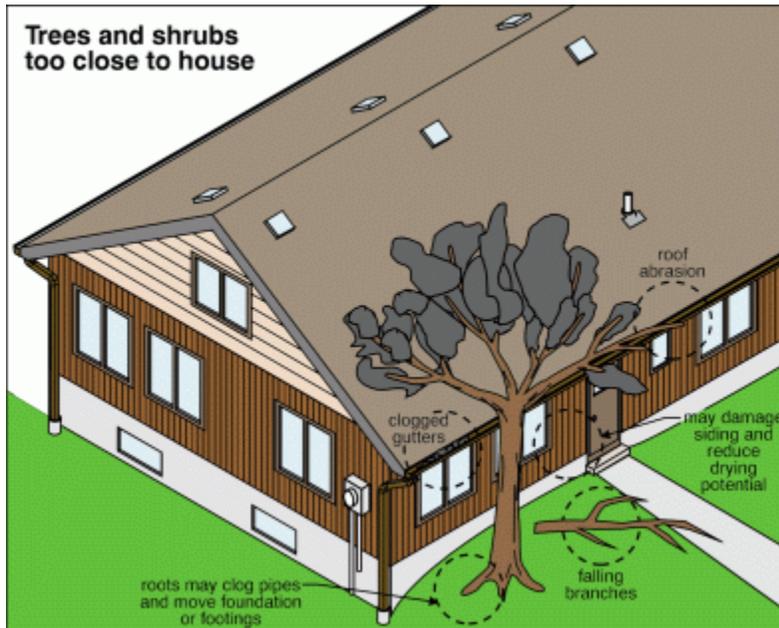
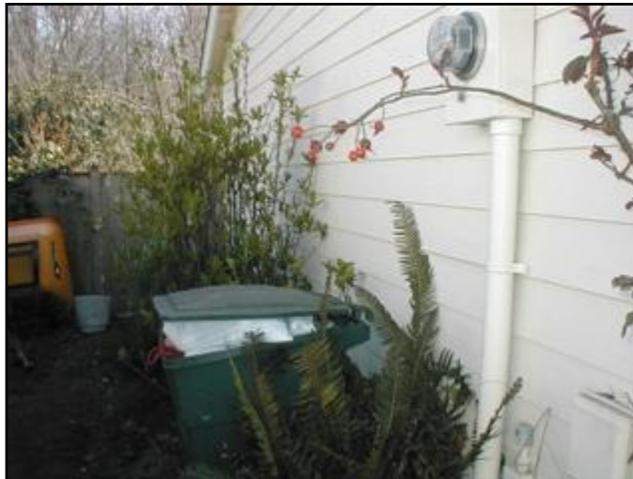
13. *Trees or shrubs too close to building*

## 29. Condition: • [Trees or shrubs too close to building](#)

Vegetation should be trimmed back from structure to prevent hidden damage and encourage surface drying.

**Implication(s):** Chance of water damage to contents, finishes and/or structure | Chance of pests entering house | Material deterioration

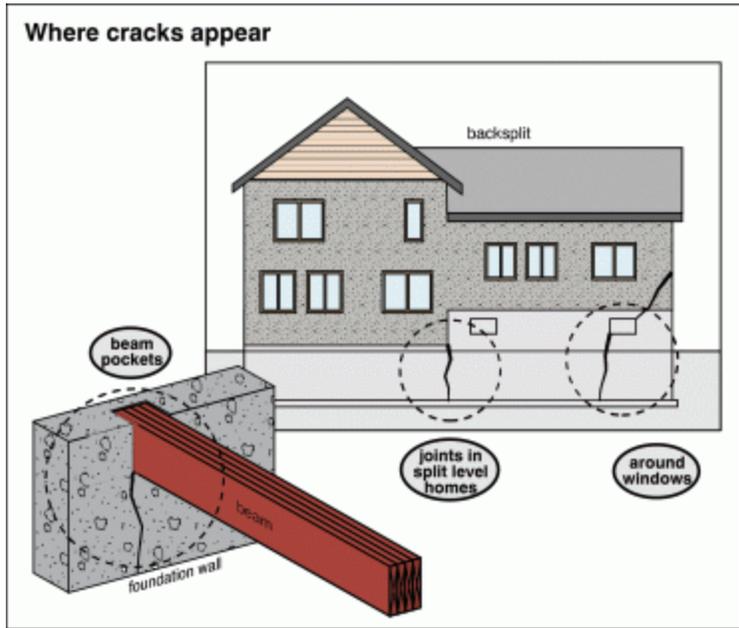
**31. Condition:** • Typical hairline foundation cracks were noted. All cracks are risks for water ingress or structural movement although it may be normal concrete curing cracks. Any cracks, gaps or openings should be sealed to prevent potential water infiltration. Recommend monitoring all cracks and seek advice from a qualified foundation contractor.

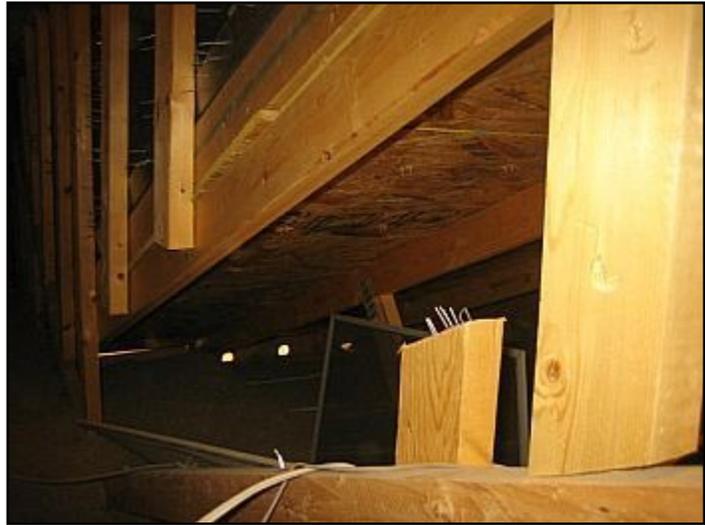
14. Missing webs

**Implication(s):** Weakened structure | Chance of structural movement

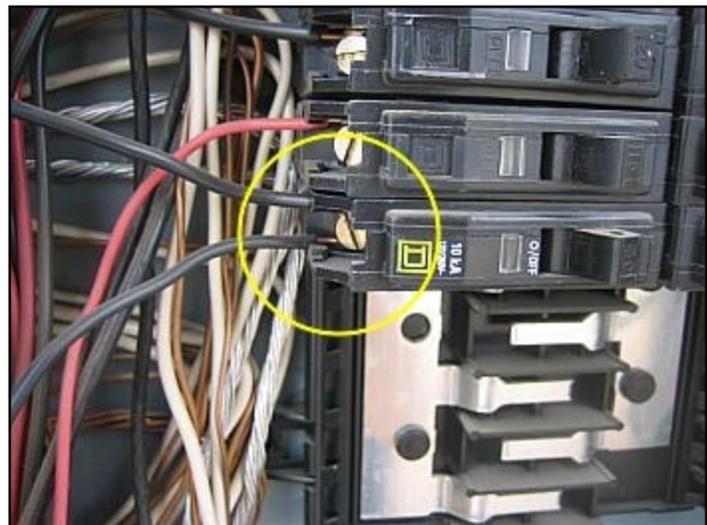
15. Double taps

**Implication(s):** Fire hazard

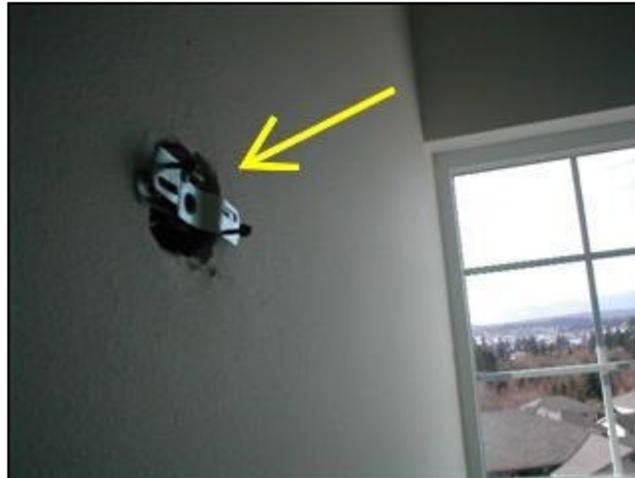
16. Missing

Light fixture missing in upstairs hallway. Recommend a qualified contractor install asap for safety.

**Implication(s):** Inadequate lighting

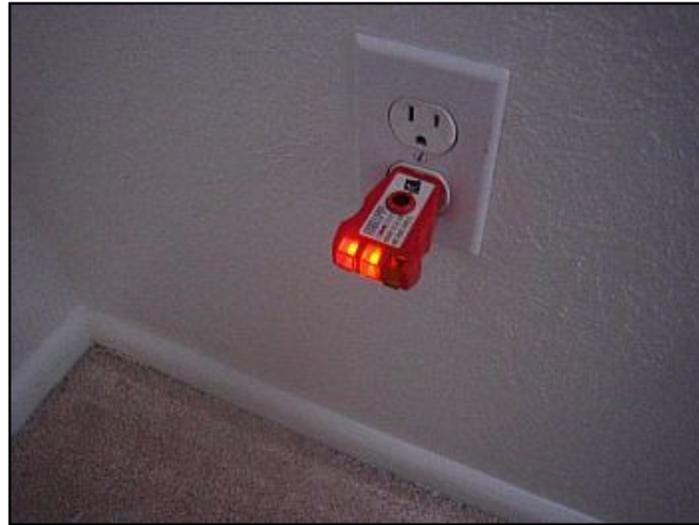
17. Reversed polarity

when the polarity is reversed, the wide receptacle slot is (incorrectly) hot and the narrow slot is neutral - this is not uncommon when people forget that the black wire should be attached to the receptacle's brass screws

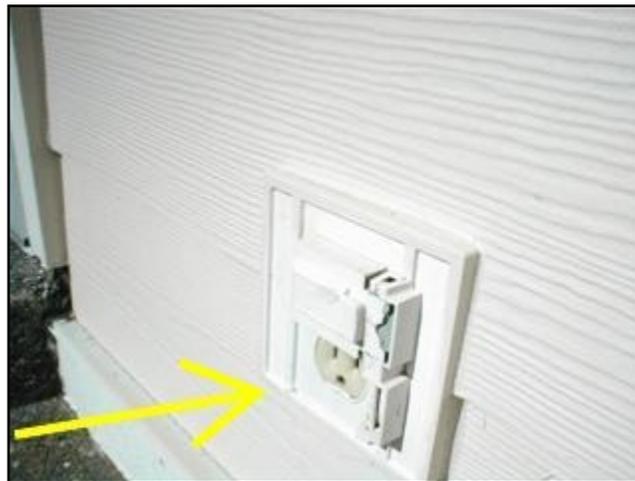
18. No GFI (Ground Fault Interrupter)

**41. Condition:** • [No GFI \(Ground Fault Interrupter\)](#)

This outdoor receptacle is not GFCI protected (cover is also broken).

**Implication(s):** Electric shock

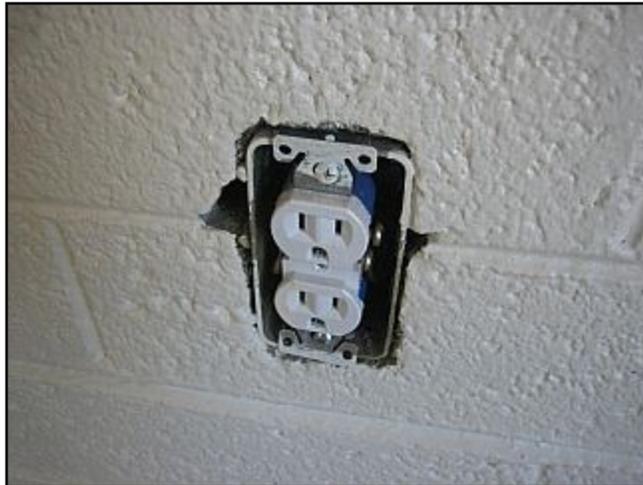
19. Missing

Various cover plates are missing through house.

**Implication(s):** Electric shock

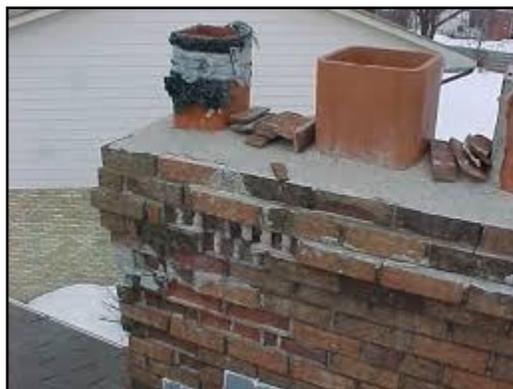
**22. Loose, missing or deteriorated masonry**

**Implication(s):** Material deterioration

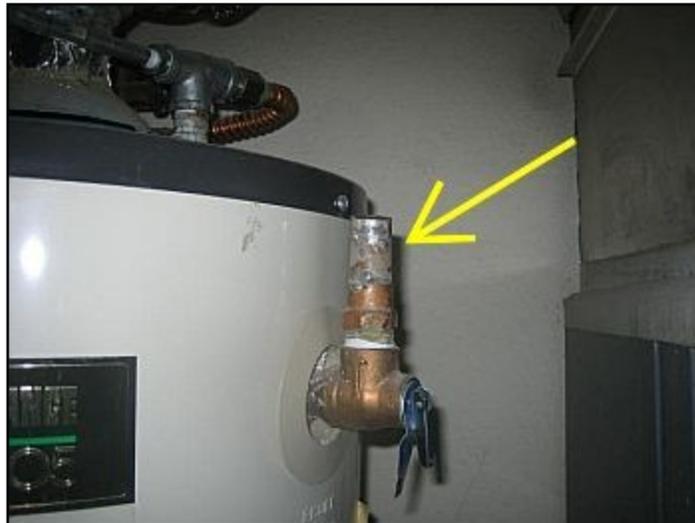
25. TPR valve facing up

**64. Condition:** • The water heater's temperature-pressure relief valve drain line is routed upward. This valve is an emergency device, but periodically small amounts of water could be discharged. If the drain is routed up, water can collect near the valve and that can lead to corrosion and impair the operation of the valve during an emergency. Therefore, drain line must be routed either down or horizontally. Recommend having a qualified plumbing contractor repair. Suggest that plumber, while on site, evaluate system and make additional recommendations for improvements.

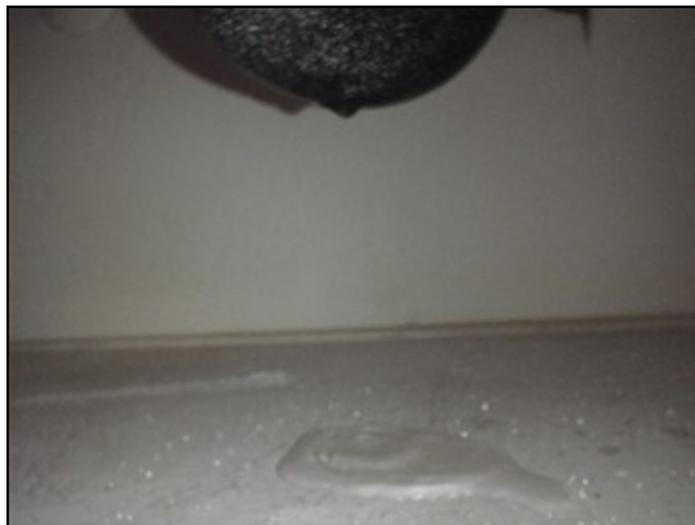
26. Leak

Time: Immediate

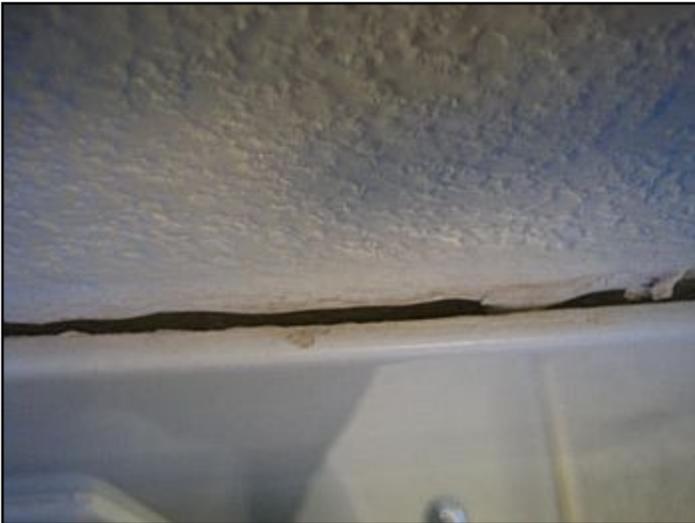
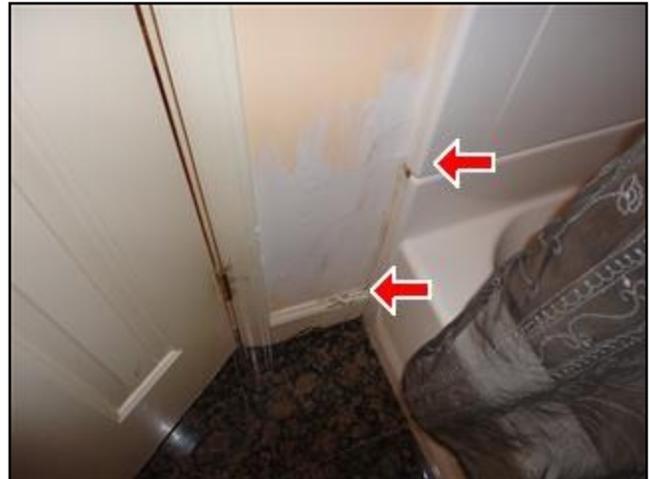
**27.** *Caulking loose, missing or deteriorated*

**Implication(s):** Chance of water damage to contents, finishes and/or structure

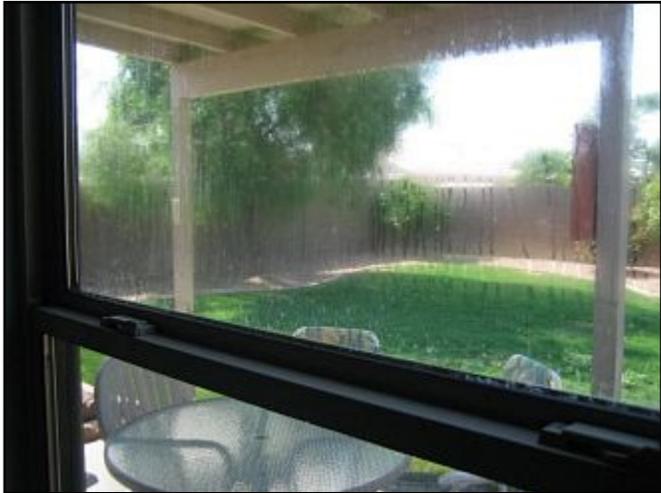
30. Lost seal on double or triple glazing

**Implication(s):** Cosmetic defects

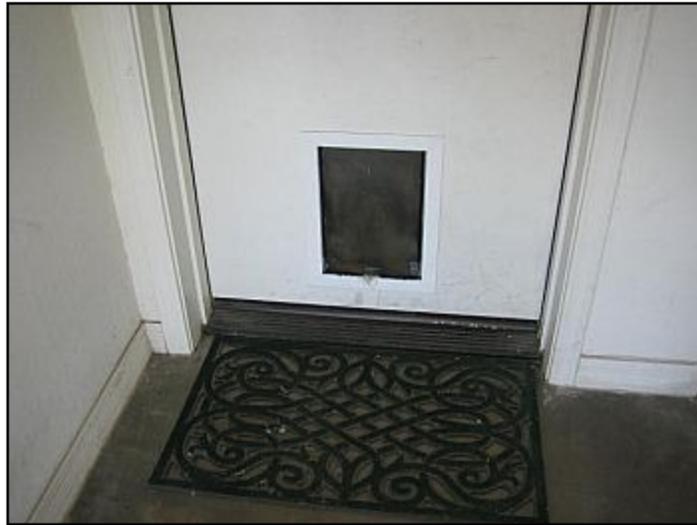
31. *pet access door*

**82. Condition:** • The door has a pet access installed. This can allow harmful gases to enter the dwelling which may potentially hazardous. Recommend a carpenter to either close the opening or replace the door for safety.
