INSPECTION REPORT

For the Property at:
1234 ROLLING CREEK RIVER
ANY CITY, IL

Prepared for: HAPPY BUYER
Inspection Date: Thursday, April 14, 2016
Prepared by: Jeff Walters

RE: Report No. 1004, v.5
1234 Rolling Creek River
any city, IL

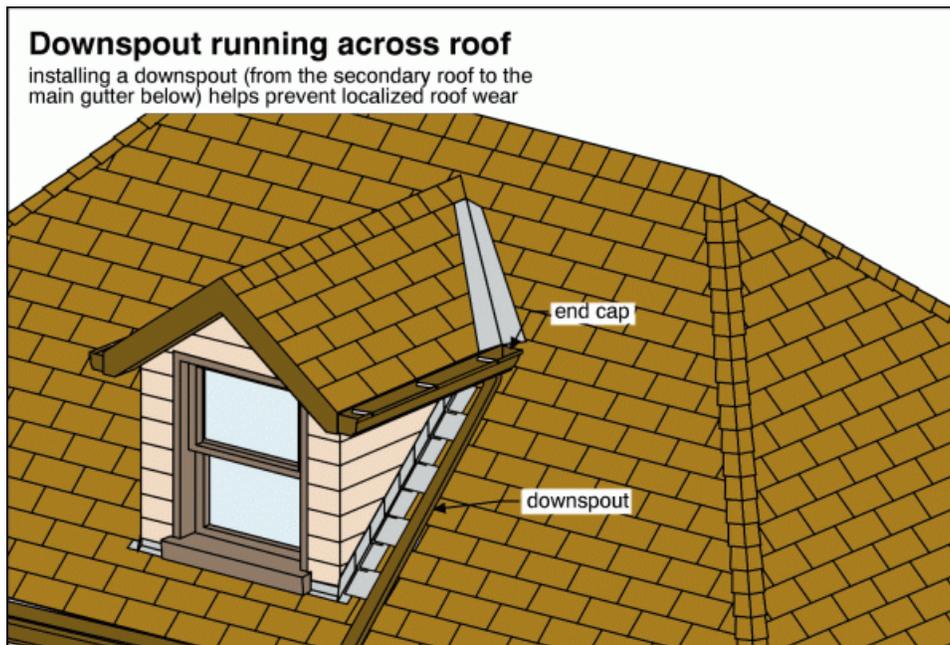
1. Condition: • Downspouts discharging onto roofs

Implication(s): Chance of water damage to contents, finishes and/or structure

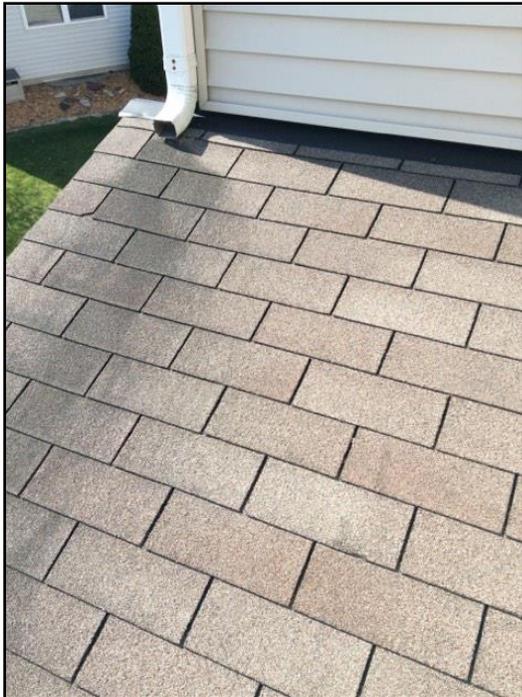
Location: Front Exterior

1. Downspouts discharging onto roofs

Task: Provide

Time: Immediate

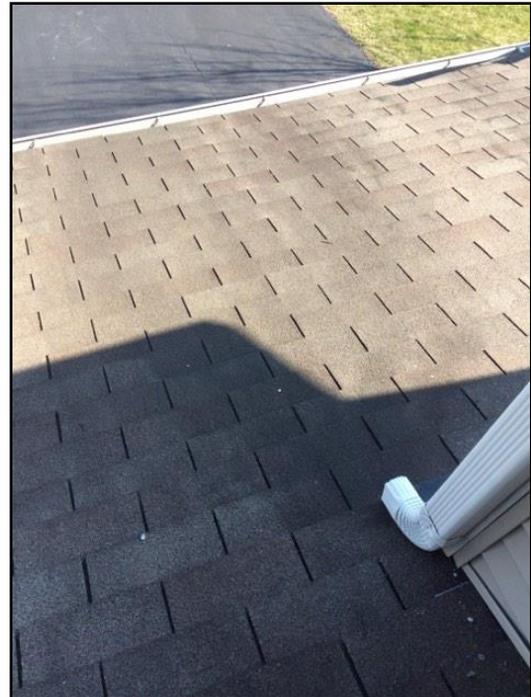
2. Downspouts discharging onto roofs

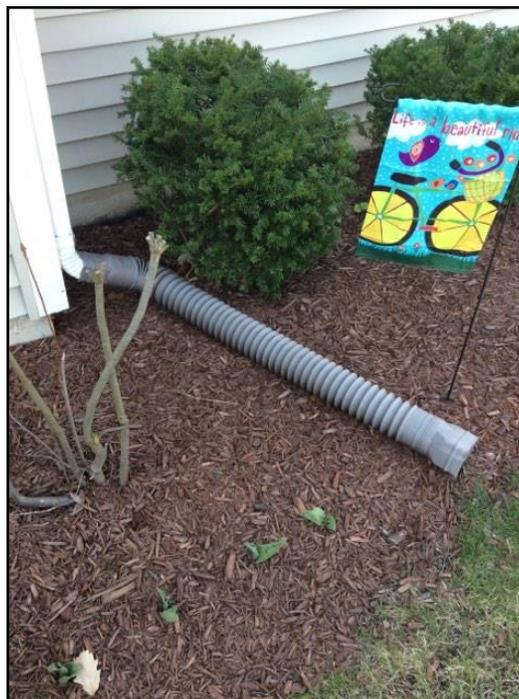
2. Condition: • Should discharge 6 feet from building

Implication(s): Chance of water damage to contents, finishes and/or structure

Location: Throughout Exterior

3. Should discharge 6 feet from building

Task: Improve

Time: Immediate

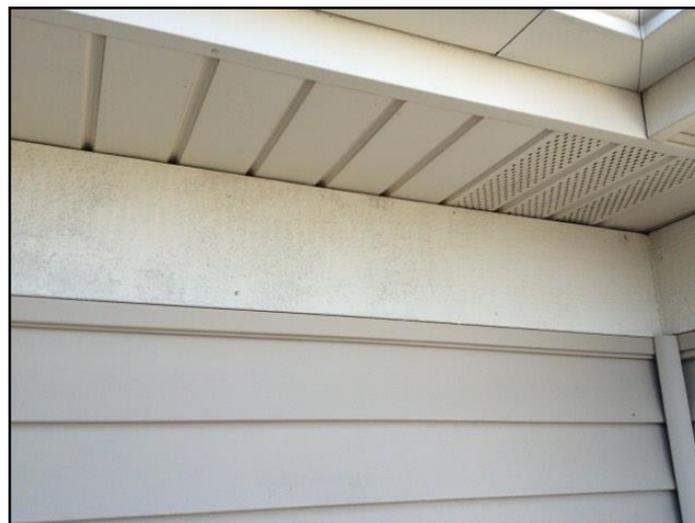
3. **Condition:** • Paint or stain needed

Implication(s): Cosmetic defects | Chance of water damage to contents, finishes and/or structure | Shortened life expectancy of material

Location: Throughout Exterior

4. *Paint or stain needed*

Task: Correct

Time: Less than 1 year

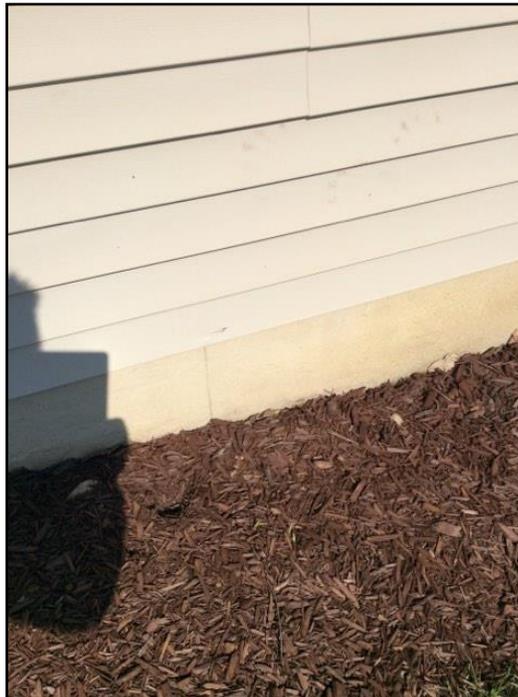
6. Condition: • Loose or missing pieces

Implication(s): Cosmetic defects | Chance of water damage to contents, finishes and/or structure

Location: Left Side Exterior Wall

5. Loose or missing pieces

Task: Repair Monitor

Time: Less than 1 year

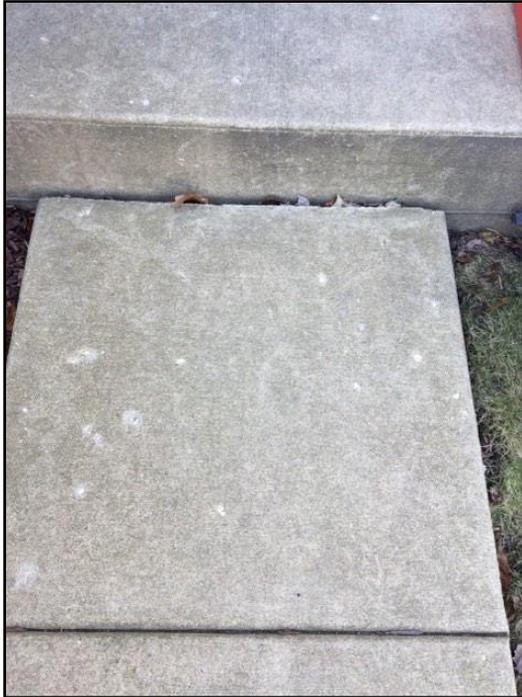
7. Condition: • Unsealed gap at building

Implication(s): Chance of water damage to contents, finishes and/or structure

Location: Front Exterior

6. Unsealed gap at building

Task: Repair or replace

Time: Less than 2 years

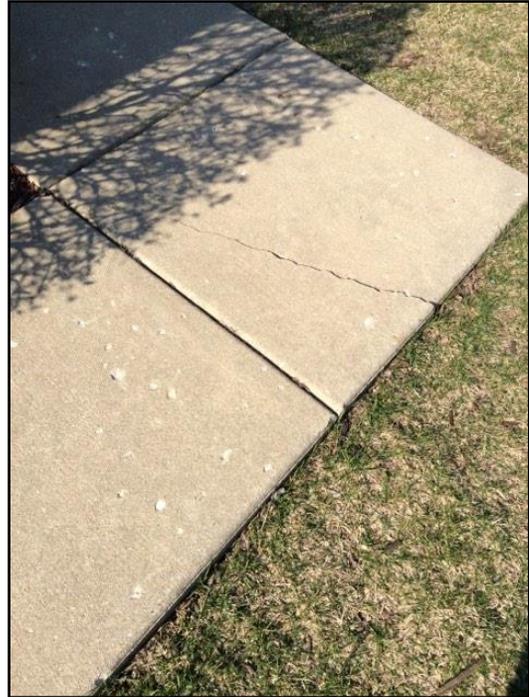
7. Unsealed gap at building

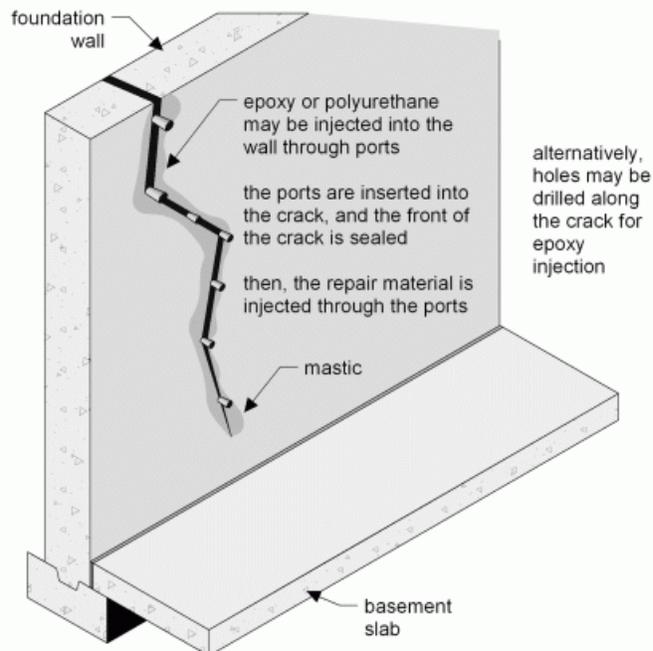
Crack repair - epoxy and polyurethane injection

polyurethane is flexible and is not a structural repair, however, it can prevent leakage

it starts out with low viscosity, then expands within the crack

do-it-yourself crack repair kits usually feature polyurethane foam

epoxy is as strong as concrete and forms a structural seal

however, it hardens slowly, and if there is space at the back of the crack, it may leak out

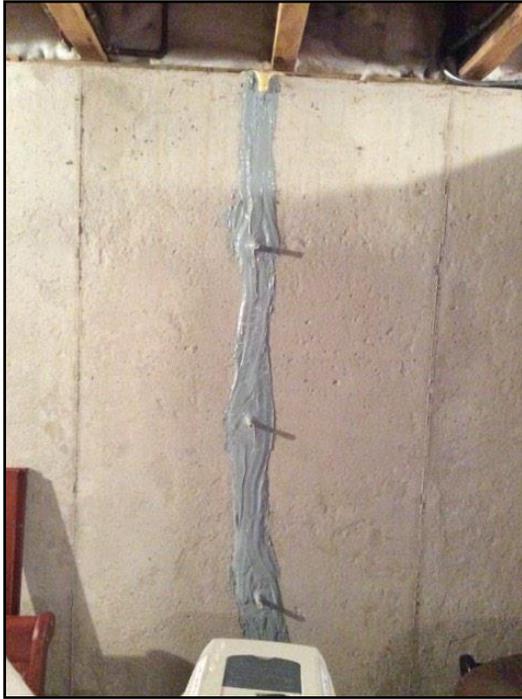
10. Condition: • Prior repairs

Implication(s): Weakened structure

Location: Basement

8. Prior repairs

Task: Monitor

Time: Ongoing

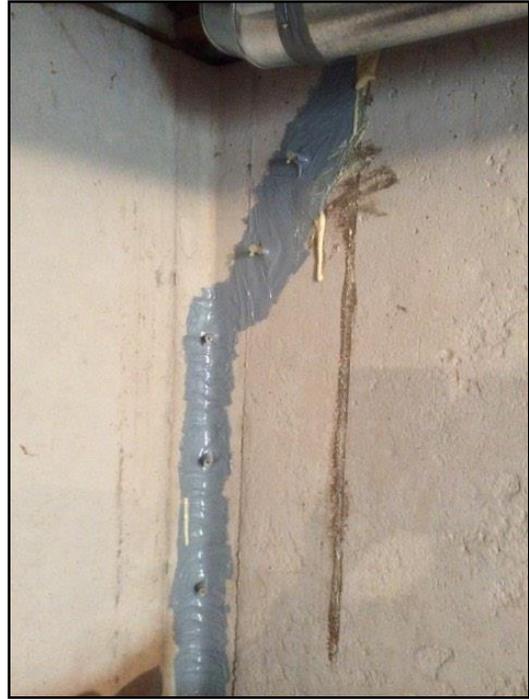
9. Prior repairs
