# YOUR Inspection Report

Sample Report  
Aurora, CO 80015

RE: Report No. 7612  
Sample Report  
Aurora, CO  
80015

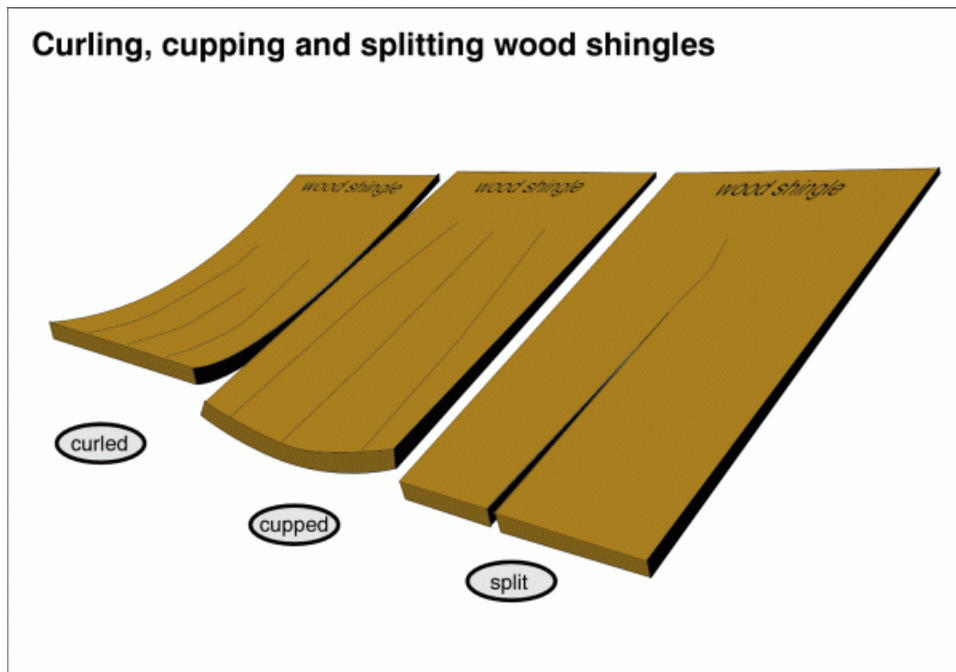
### Curling, cupping and splitting wood shingles

**2. Condition:** • Old, worn out

**Task:** Repair

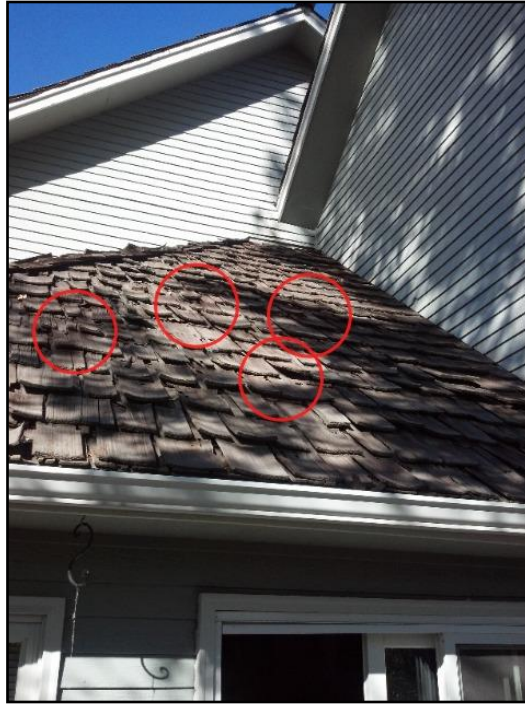
*Old, worn out*

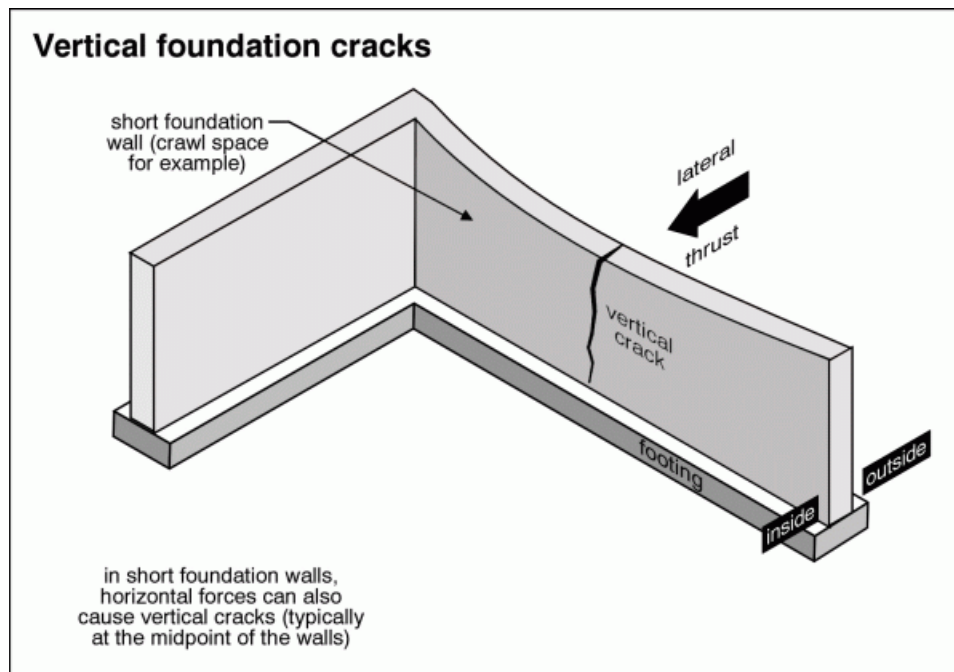
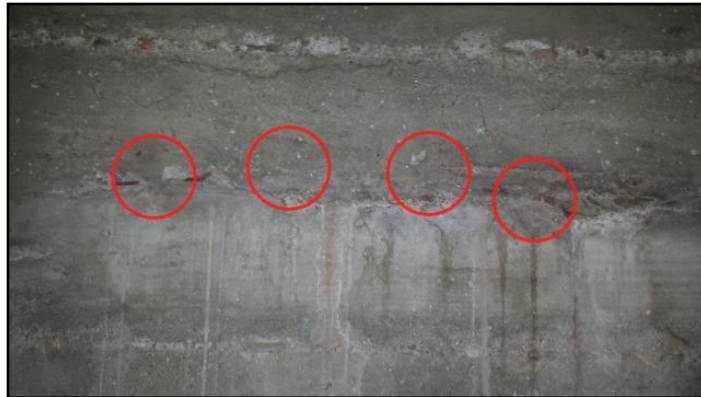
**4. Condition:** • Cracked

**Implication(s):** Chance of water damage to structure, finishes and contents | Weakened structure

**Location:** North Crawl Space

*Cracked*

**Task:** Further evaluation

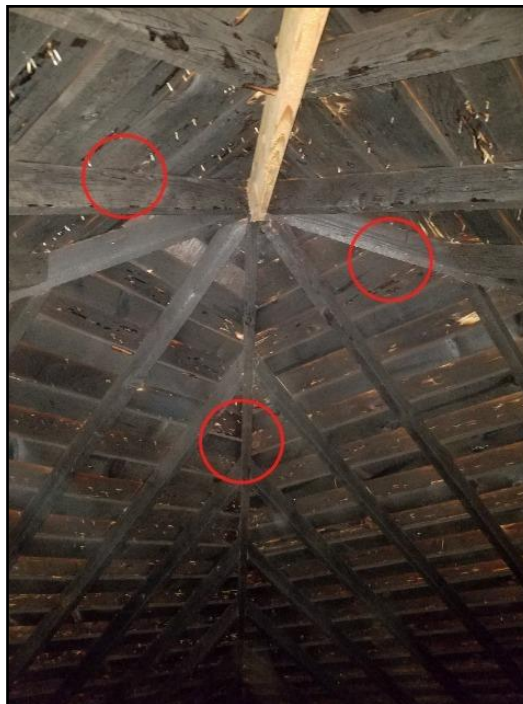
**5. Condition:** • Fire damage

Fire damage to attic, further evaluation by structural engineer.

*Fire damage*

**Task:** Further evaluation

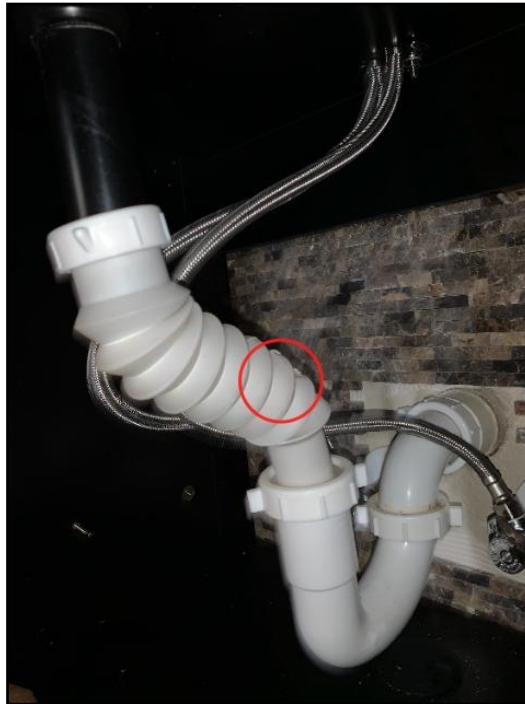
**11. Condition:** • Nonstandard materials and patches

**Implication(s):** Chance of water damage to structure, finishes and contents | Sewage entering the building

*Nonstandard materials and patches*

**Task:** Repair or replace

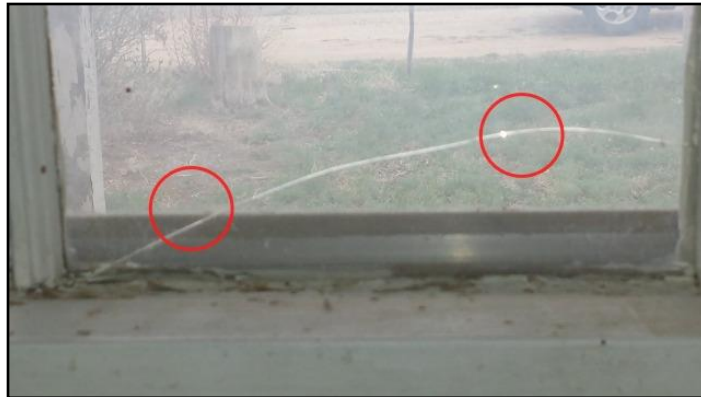
**13. Condition:** • Cracked

*Cracked*

**Task:** Repair
