YOUR Inspection Report

2343 Remington Rd
Elizabeth , CO 80107

RE: Report No. 1689, v.3
2343 Remington Rd
Elizabeth , CO
80107

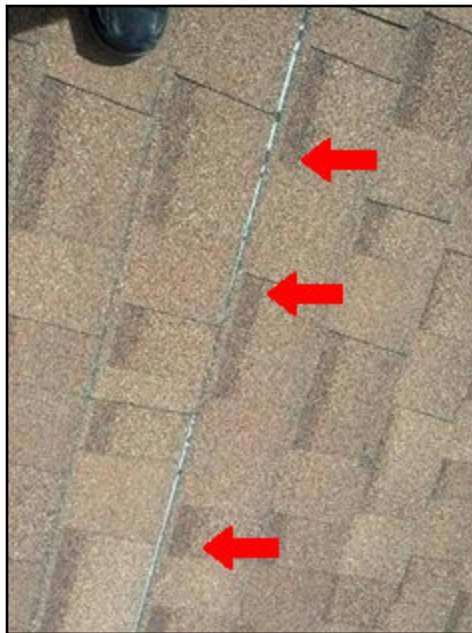
1. *Exposure too great*

1. Condition: • [Exposure too great](#)

Shingles have been installed incorrectly. To much exposure.

Implication(s): Chance of water damage to contents, finishes and/or structure

Location: West Exterior Roof

Task: Further evaluation Repair

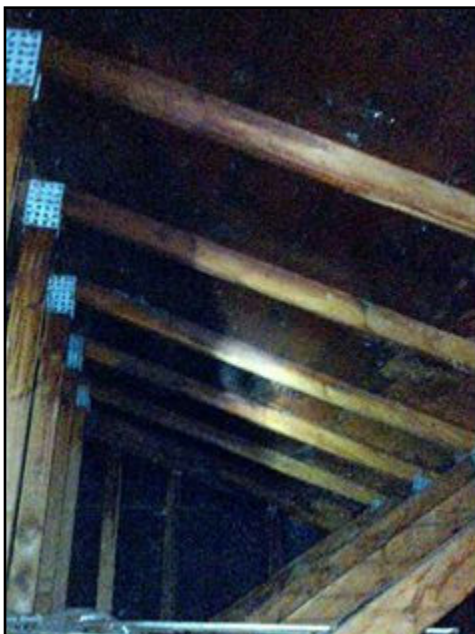
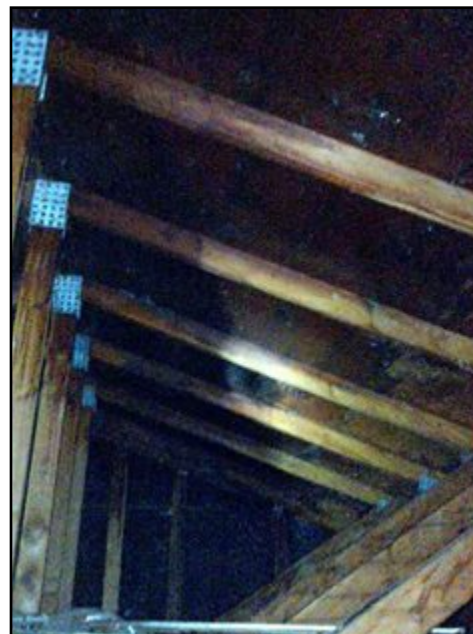
2. Water stains

2. Condition: • [Water stains](#)

Moisture/Water stains in attic from disconnected furnace flue. Possible mold.

Implication(s): Material deterioration

Location: Attic

Task: Further evaluation Repair

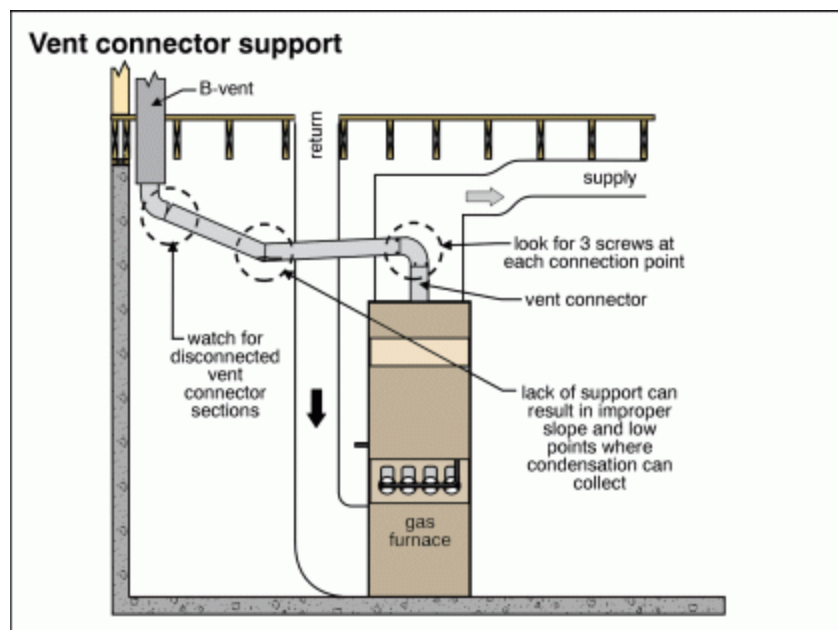
3. Condition: • [Poor connections](#)

Implication(s): Equipment not operating properly | Hazardous combustion products entering home

Location: Attic

Task: Repair

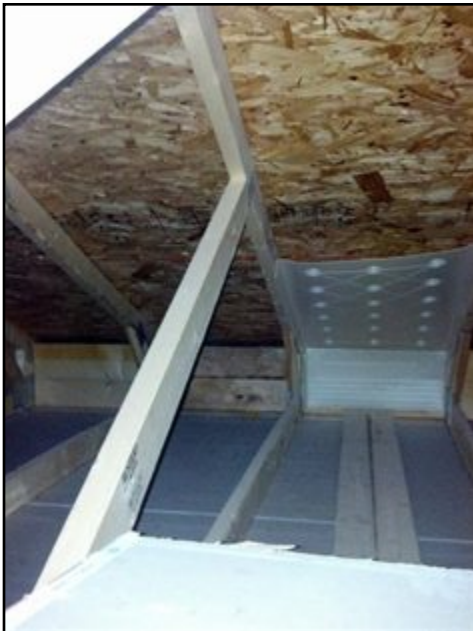
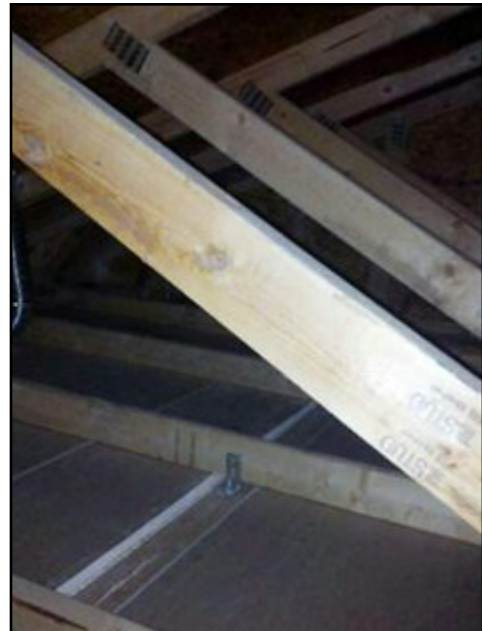
4. Gaps or voids

4. Condition: • [Gaps or voids](#)

Insulation is missing in the attic.

Location: Attic

Task: Replace

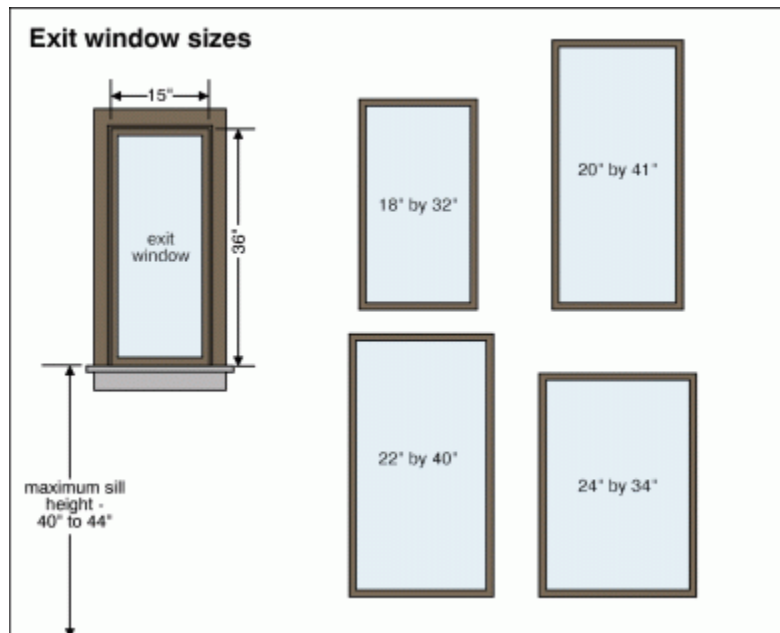
11. Condition: • [Too small](#)

Location: West Basement Bedroom

Task: Repair
