# Your Inspection Report

217 Glen Rd  
Toronto, ON M4W 2X2

**PREPARED BY:**  
Walter Collodel, P.Eng., RHI

RE: Report No. 87222, v.2  
217 Glen Rd  
Toronto, ON  
M4W 2X2

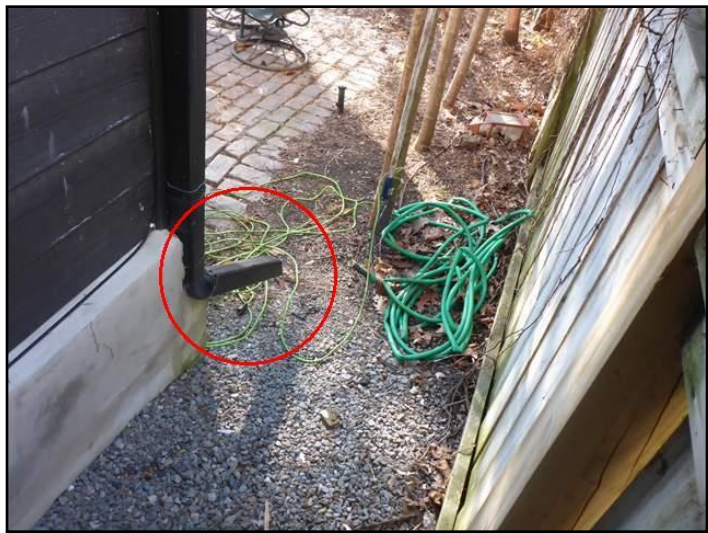
**Condition:** • [Discharge too close to building](#)

*Discharge too close to building*

**Time:** Less than 1 year

**Cost:** Less than \$500

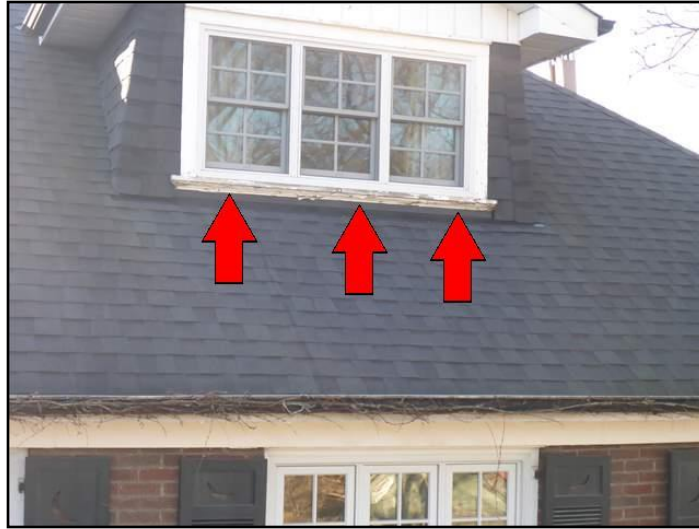
Wood appears to be in good condition but it needs paint. Some areas were not accessible at the inspection.

*Paint needed at front*

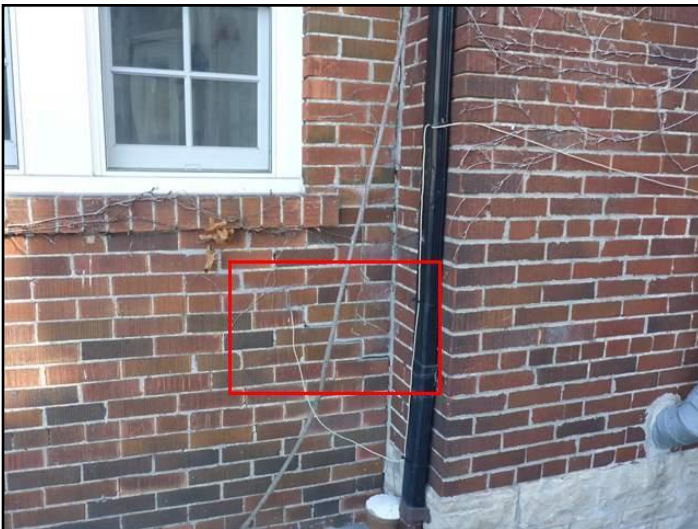
Cracks noted under the side window as well as where the porch meets the main house structure. Re-point all affected areas and monitor the repairs.

*Step crack at porch side wall*

**Task:** Repair / Monitor

**Time:** Less than 1 year

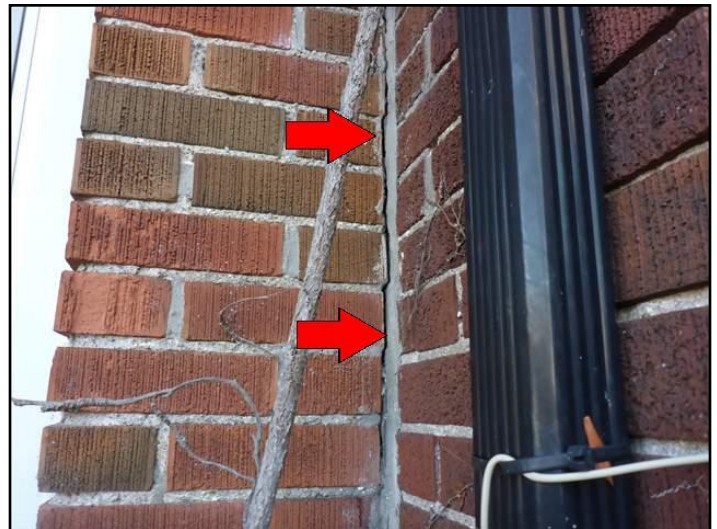
*Cracked where porch meets house*

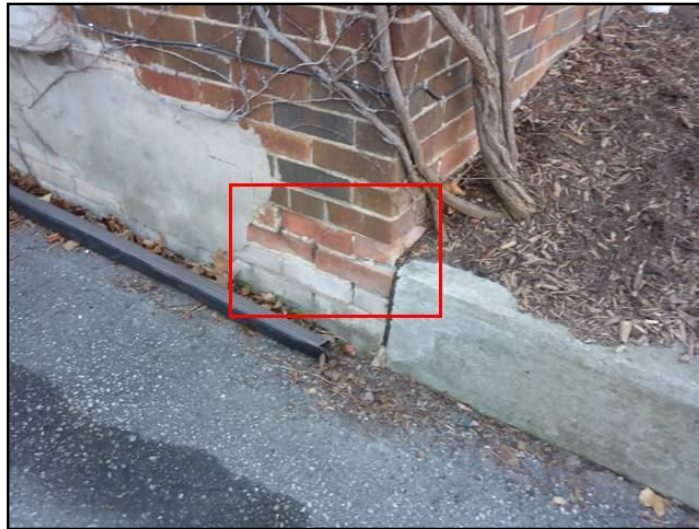
**Condition:** • Masonry deterioration

*Masonry deterioration at grade level*

**Task:** Repair

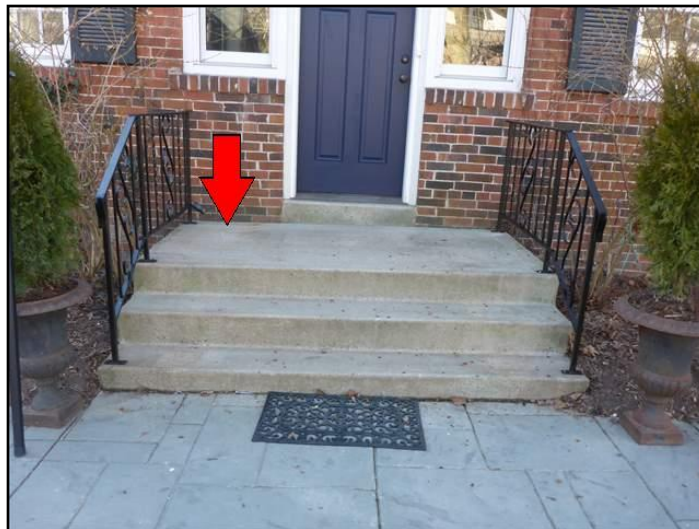
**Condition:** • [Steps or landings settling or heaving](#)

*Minor settlement noted at stair system*

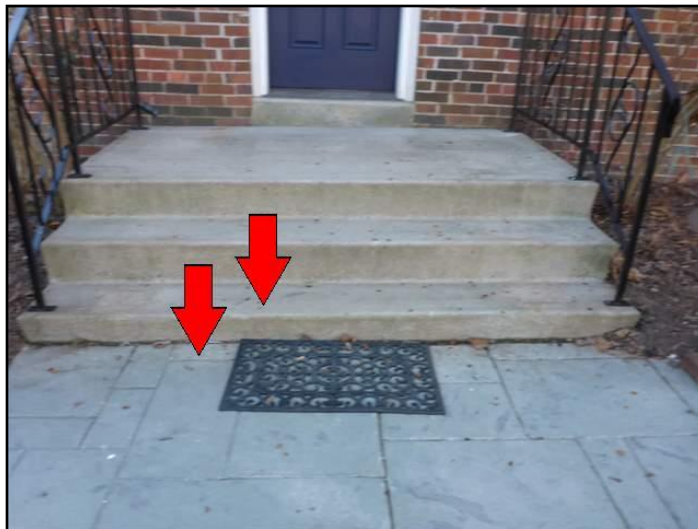
Short bottom step may create a trip hazard.

*Trip hazard at short bottom step?*

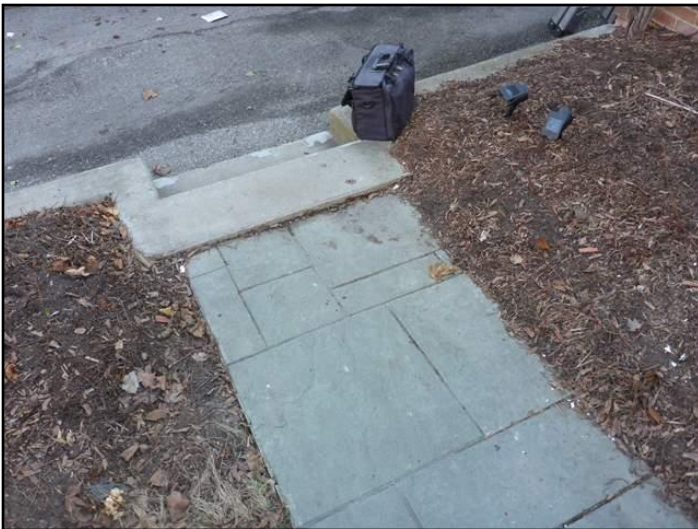
**Condition:** • [Uneven \(trip hazard\)](#)

*Trip hazard at edge of walkway*

**Task:** Improve

**Time:** If desired

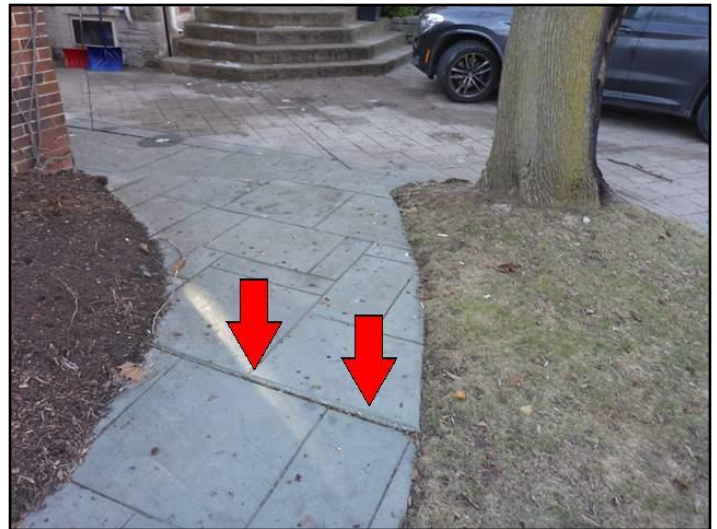
*Trip hazard beside tree*

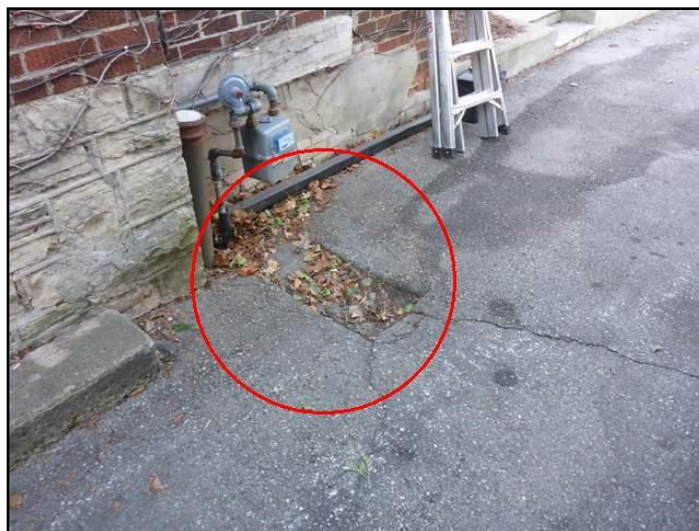
**Condition:** • [Cracked or damaged surfaces](#)

*Trip hazard at driveway*

**Task:** Correct

**Time:** As necessary

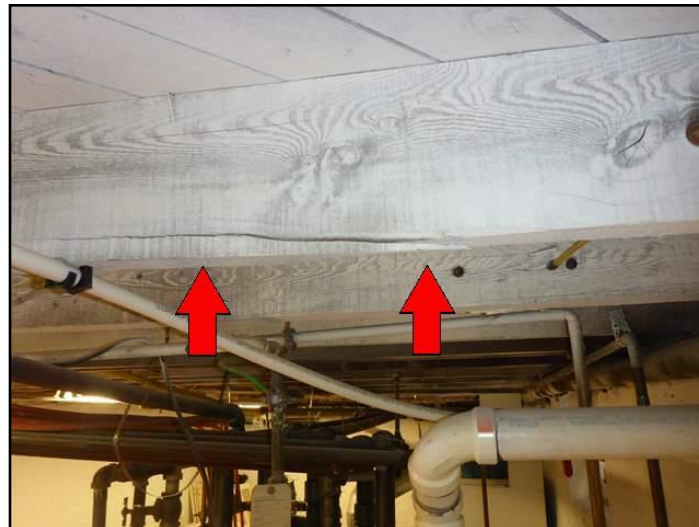
One joist is cracked (and appears to have been cracked for a long time).

*Cracked joist*

**Task:** Repair

**Time:** If / as necessary

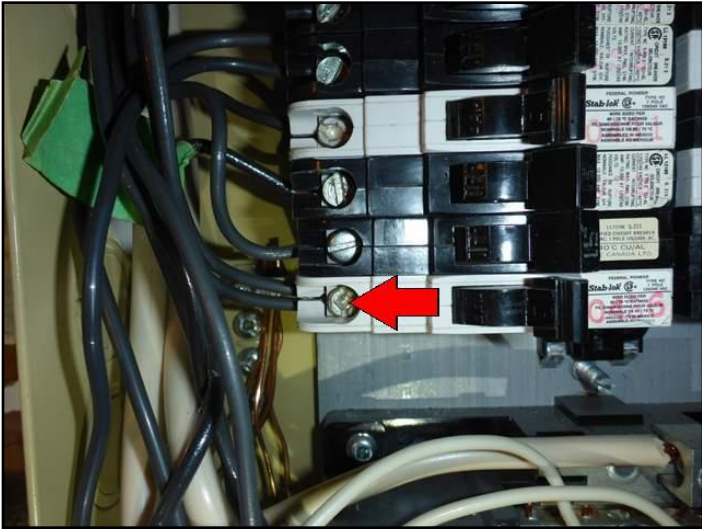
One double tap was noted (middle panel).

*Double tapped breaker*

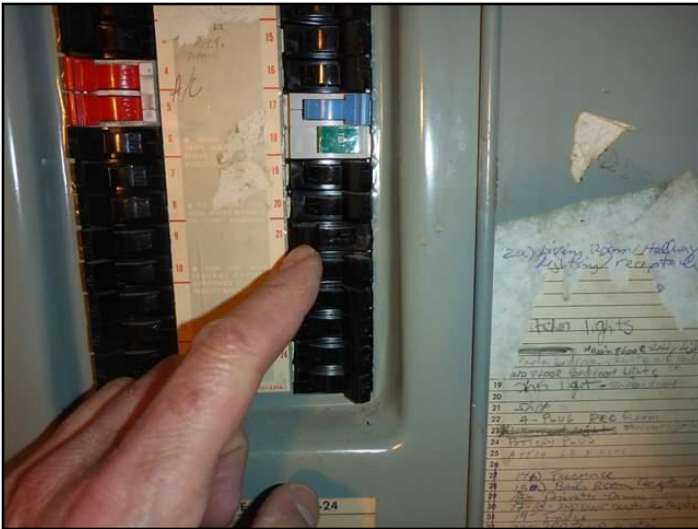
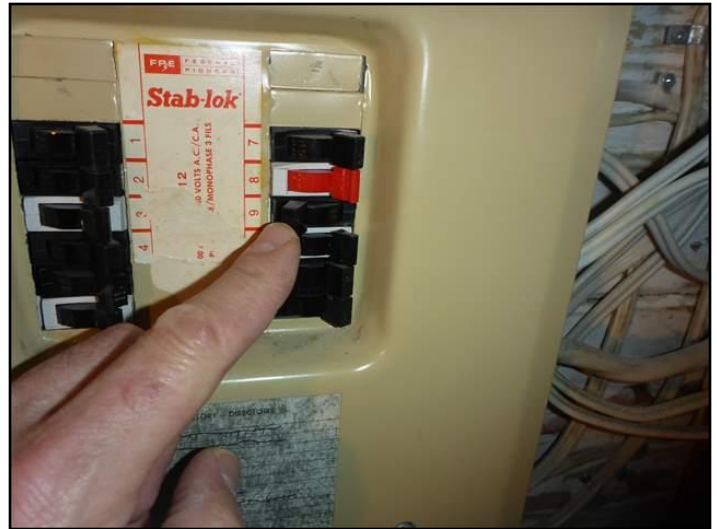
**Condition:** • Breaker in OFF position  
A few breakers were turned off at the panels. These were not turned on at the inspection.

Breaker in OFF position

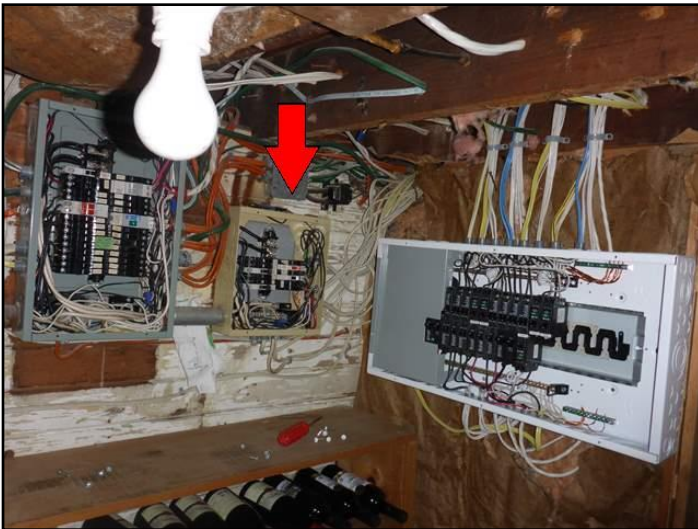
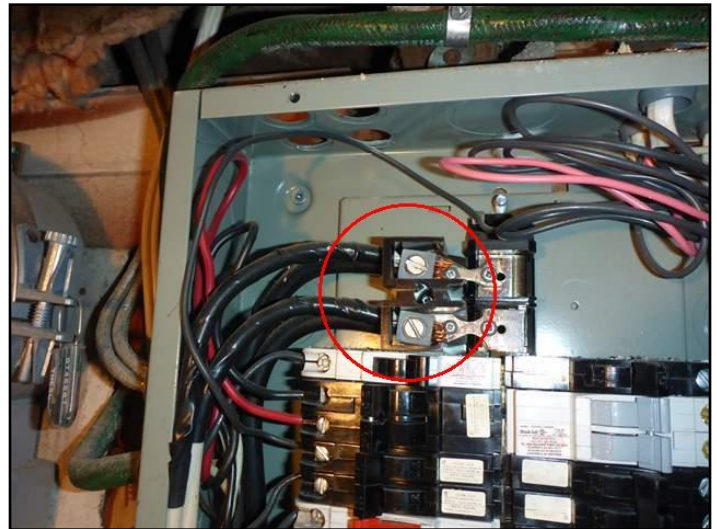
**Condition:** • Feed wire not protected by a fuse/breaker

Feed wire to this panel not protected

Feed wire not protected by a fuse/breaker

**Task:** Correct

**Cost:** Minor

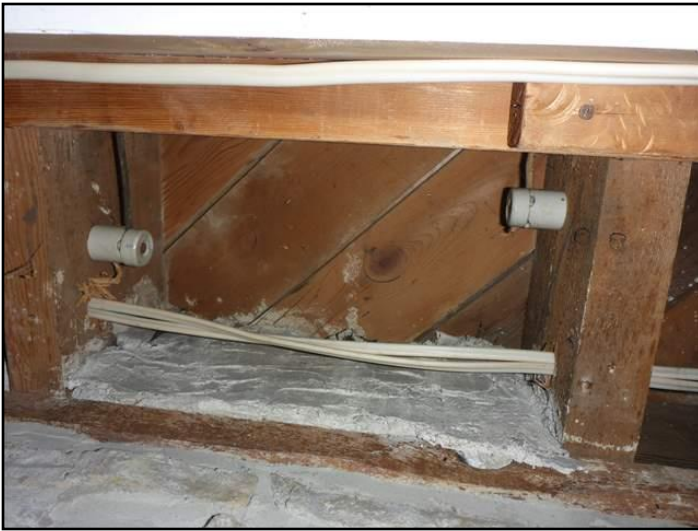
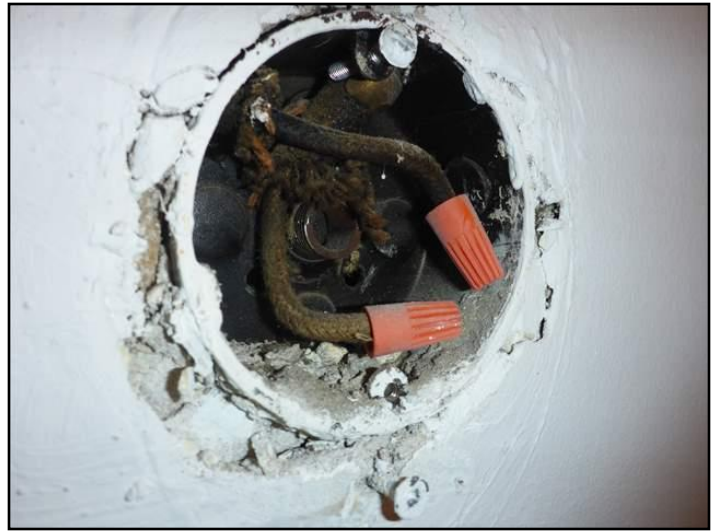
**Condition:** • Some remnants of knob-and-tube wiring found but appeared to be inactive. There is a possibility that there is active knob-and-tube in the home which maybe discovered in the future and/or during a renovation.

Typical of many renovated homes, some abandoned knob and tube components were noted in the basement. No energized or active knob and tube wiring was found at the inspection. It is presumed that the knob and tube was removed/disconnected when renovations were done.

Remnants of knob-and-tube wiring (basement)

Abandoned, not-energized (third floor)

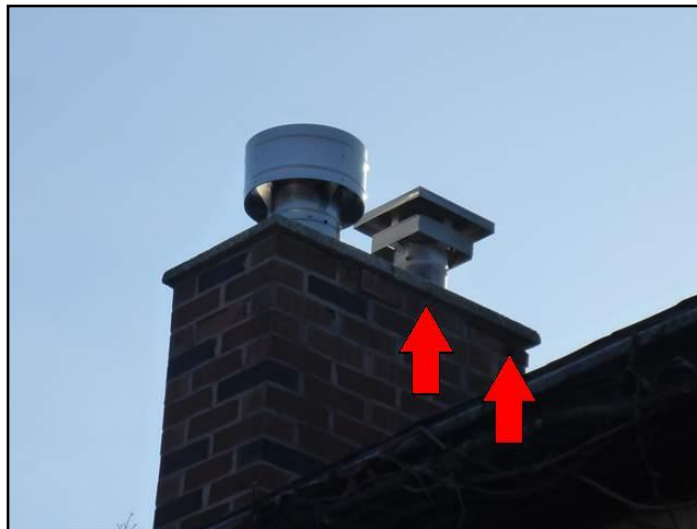
Damaged bricks were noted just under the cap. These will eventually need to be replaced.

*Loose, missing or deteriorated masonry*

**Task:** Improve

**Time:** When necessary

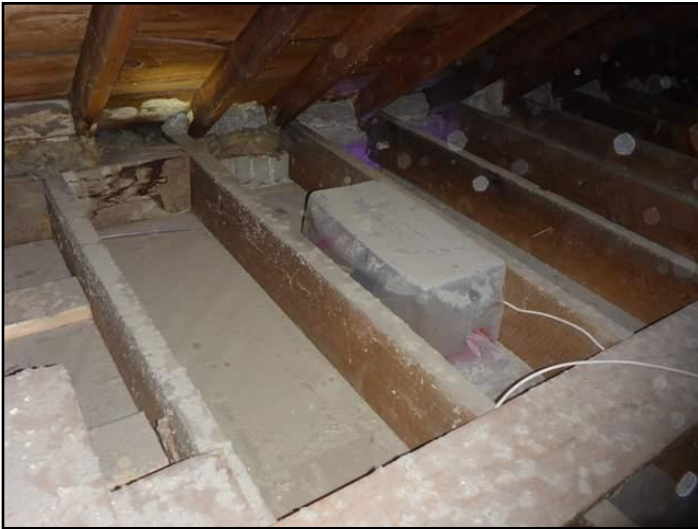
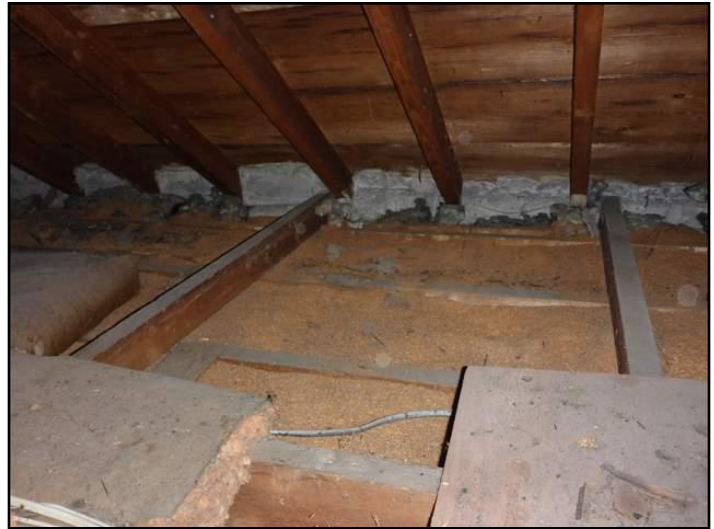
**Condition:** • [Amount less than current standards](#)

*No insulation at rear knee wall*

*Wood shavings at front knee wall*

**Time:** Discretionary

**Cost:** \$2,500 - and up

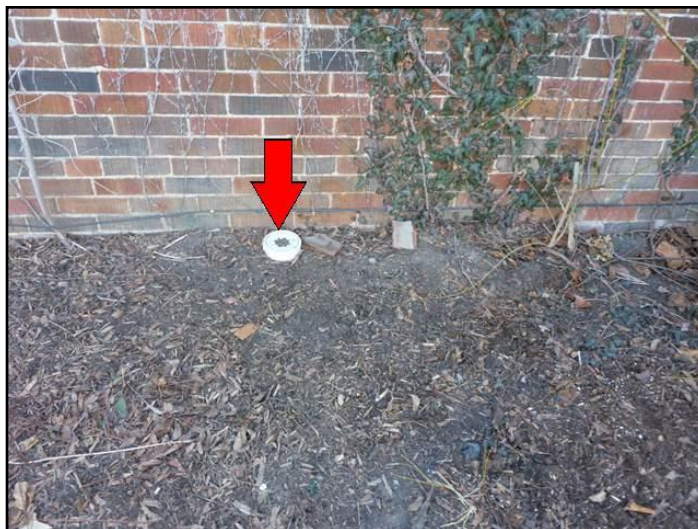
Plastic cleanout at front porch suggests that there has been excavation to perform drain repairs- ask seller for information regarding any repairs performed.

*Newer cleanout at front yard*

**Task:** Request Information

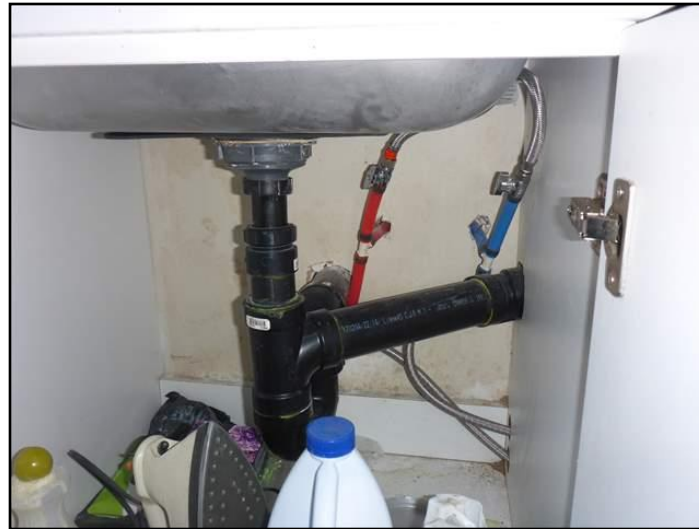
**Condition:** • [Leak](#)

*Leak at laundry tub drain*

**Task:** Repair

**Time:** Before using

**Cost:** Minor

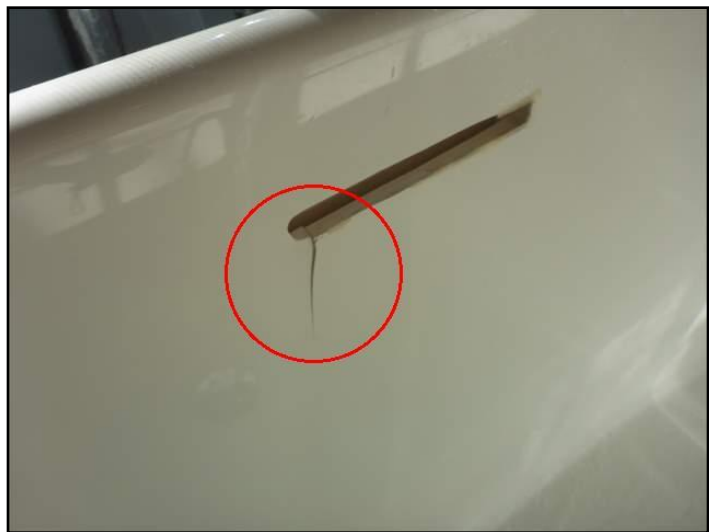
Tub is cracked near the overflow.

Surface defect (crack) at overflow

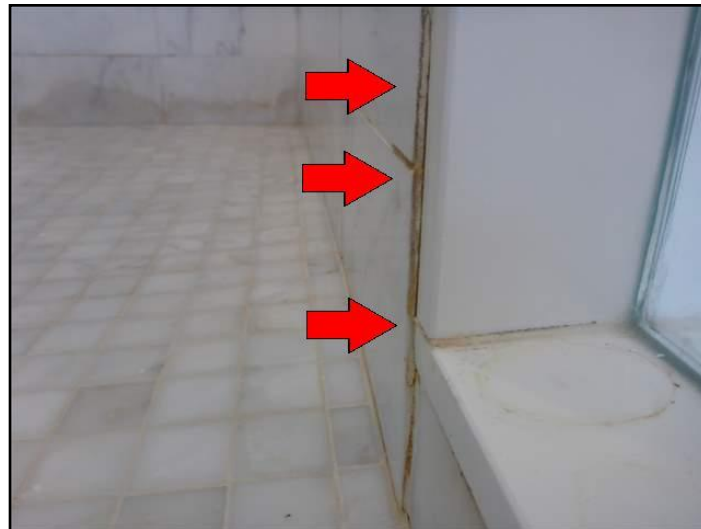
Condition: • [Tile loose, broken or missing tile](#)

*Tile pushing outwards slightly*

**Task:** Further evaluation / Repair

**Time:** Before using

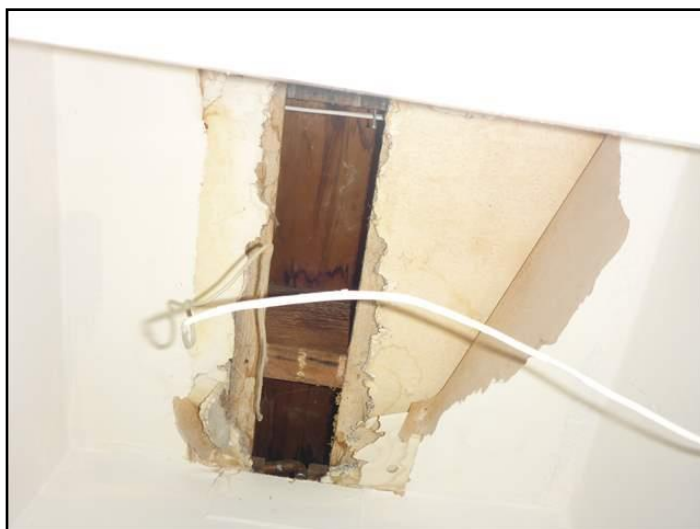
**Condition:** • Damage

*Damage- drywall removed at closet ceiling*

**Task:** Repair

**Time:** If desired

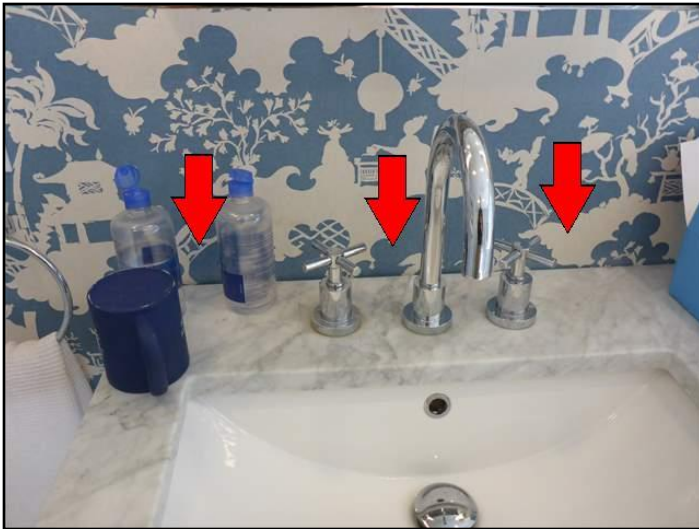
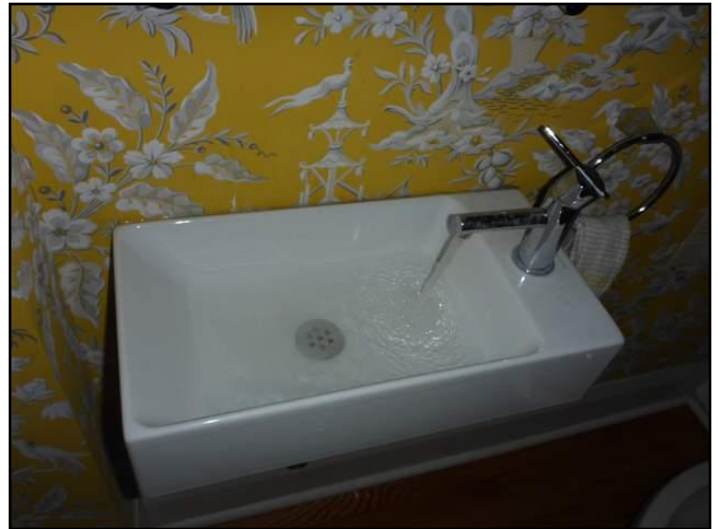
**Condition:** • Backsplash missing

Backsplash missing

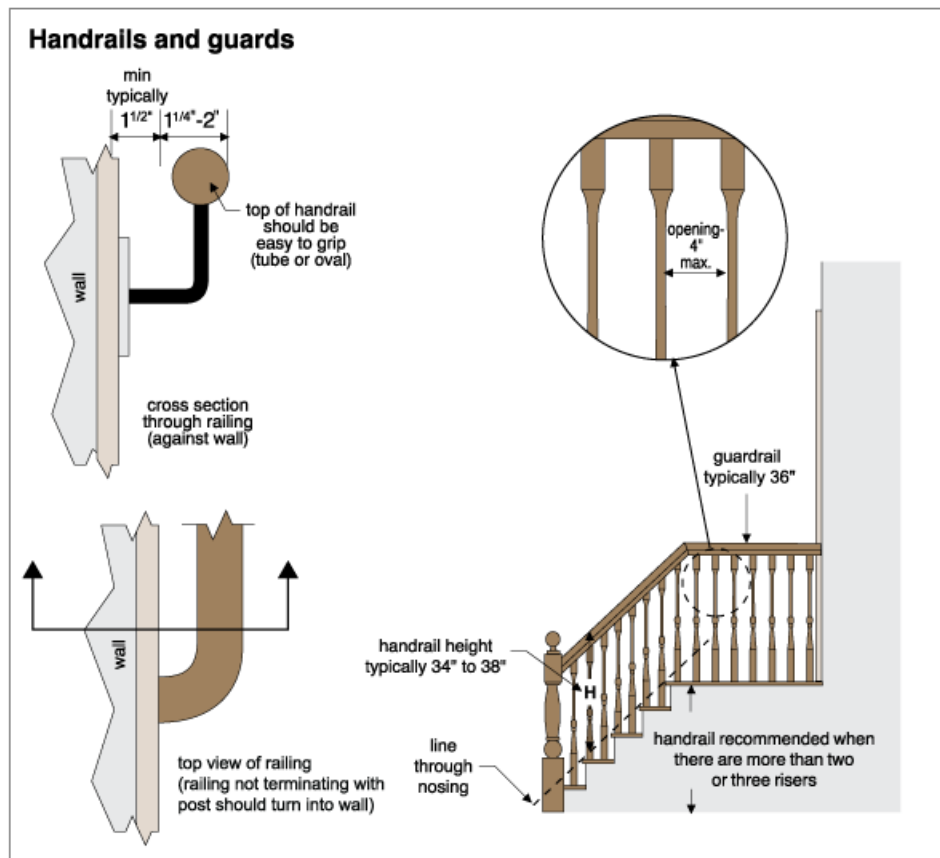
Railing here is typical for a house of this age but low by modern standards.

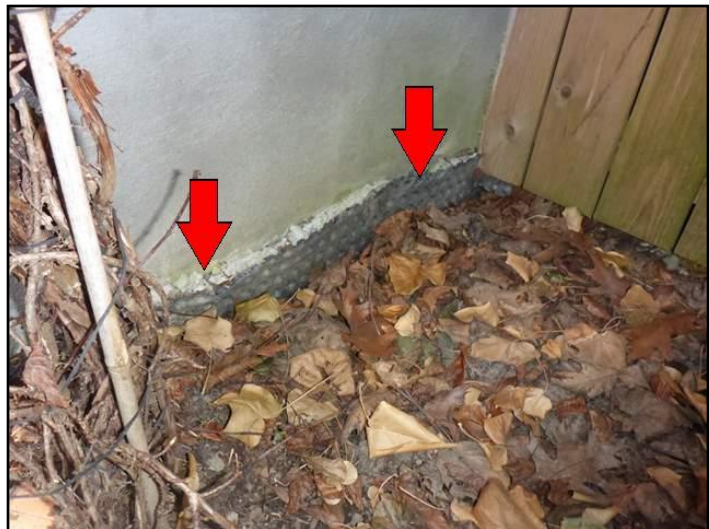
Exterior waterproofing membrane was noted along the rear exterior wall (this was likely done when the addition was built). Ask seller for details regarding any waterproofing work done on the home.

*New damp proofing material*

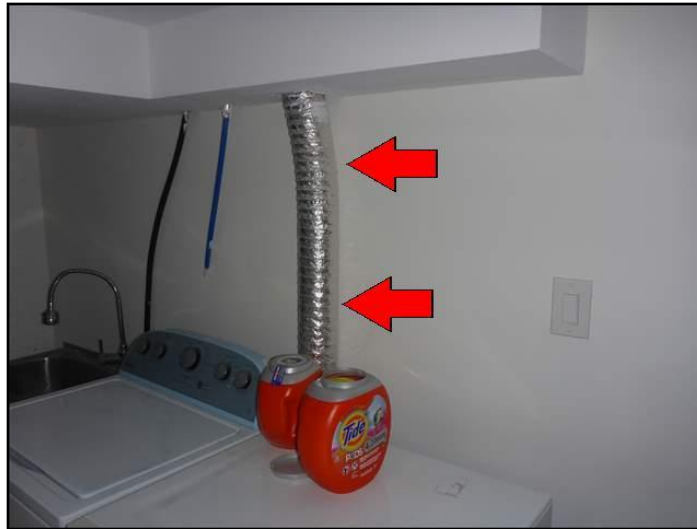
**Condition:** • Dryer vent material not smooth wall

*Dryer vent material not smooth wall*

**Time:** Less than 1 year

**Cost:** Minor
