Your Inspection Report

123 Any Street
Any Town, TN 12345

INSPECTION DATE:
Monday, February 19, 2018

RE: Report No. 4176, v.8
123 Any Street
Any Town, TN
12345

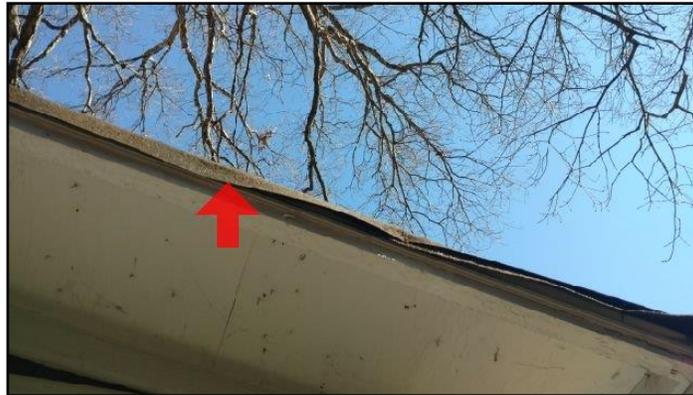
1. Overhangs too big or small Asphalt roofing...

1. Condition: • Overhangs too big or small -

Asphalt roofing is designed to overhang the edge of the roof from 1-1 without breaking when installed properly with starter strip and drip edge. This length allows the roofing to propel the water well over the edge of the structure preventing water damage. Overhangs that are left too short fail to do this. Just as bad however is leaving the overhang weighty and, when the tar based material heats and softens, allow it to bend under the weight and break where it folds and the roofline.

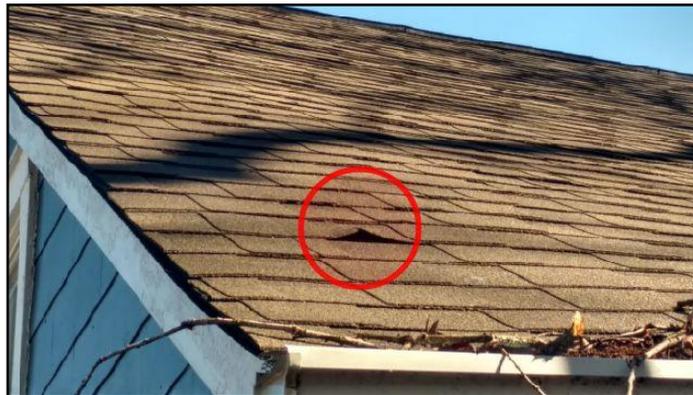
2. Raised fasteners under roofing - When you...

3. Condition: • Raised fasteners under roofing - When you see shingle humped up, usually that means a nail/fastener has backed out under it. This can cause a leak to form on top of the nail head due to weather deteriorating the high point faster than surrounding material. To correct this, you can use a flat wide piece of thin metal, like a flat bar. Gently lift the shingle only as high as necessary to see to place the metal on top of the head, then lay the shingle on the metal. Take a small bloc of wood and lay it on top of the shingle sandwiching the roofing between the metal and wood, then strike the wood with a hammer reseating the nail. This will spread the blow and lessen damage to the shingle we are trying to protect.

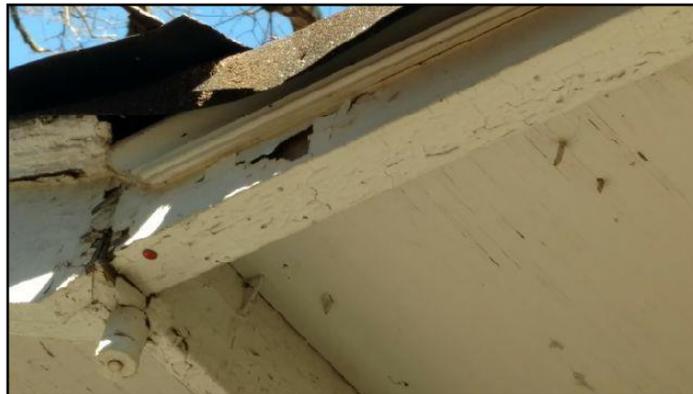
5. Water Damaged

6. Condition: • Water Damaged

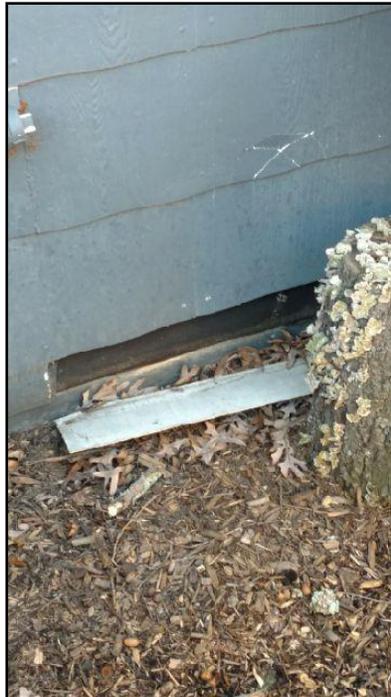
6. Mechanical damage

7. Condition: • [Mechanical damage](#)

Implication(s): Chance of water damage to structure, finishes and contents

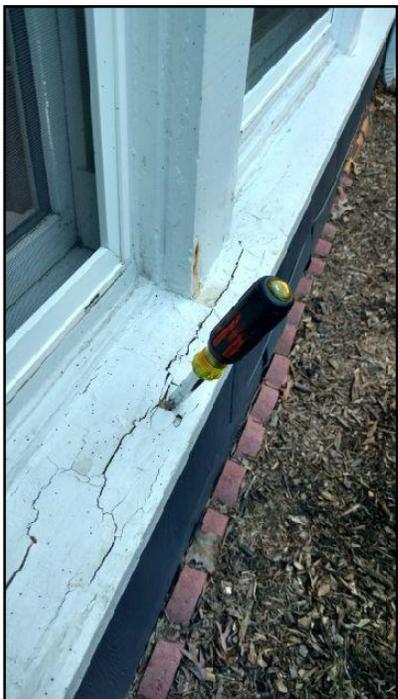
8. Rot

9. Condition: • [Rot](#)

Implication(s): Chance of water damage to structure, finishes and contents | Material deterioration

Location: Right Side Exterior

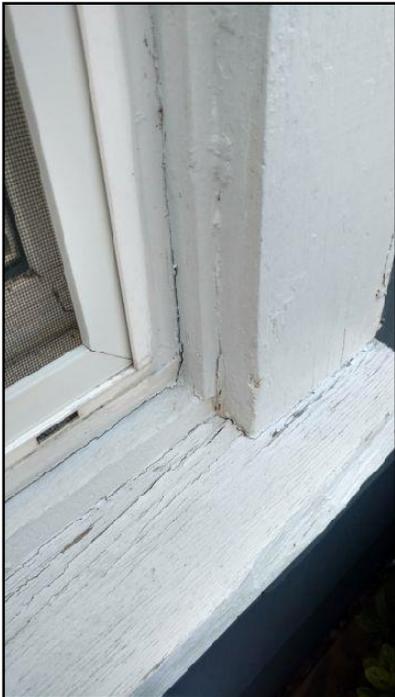
10. *Paint or stain needed*

10. Condition: • [Paint or stain needed](#)

There is what appears to be some lead-based paint that is not secure that needs to be scraped and/or painted over. Any loose paint should be scraped loose. Anything that is well attached can be painted over and sealed and become a non issue.

Implication(s): Chance of water damage to structure, finishes and contents | Material deterioration

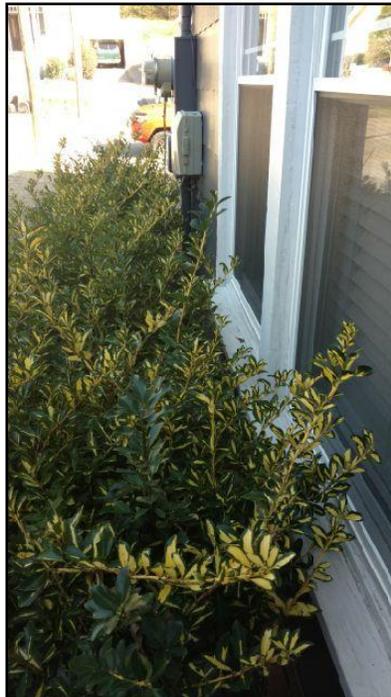
13. *Trees or shrubs too close to building*

12. Condition: • [Trees or shrubs too close to building](#)

Implication(s): Chance of water damage to structure, finishes and contents | Chance of pests entering building | Material deterioration

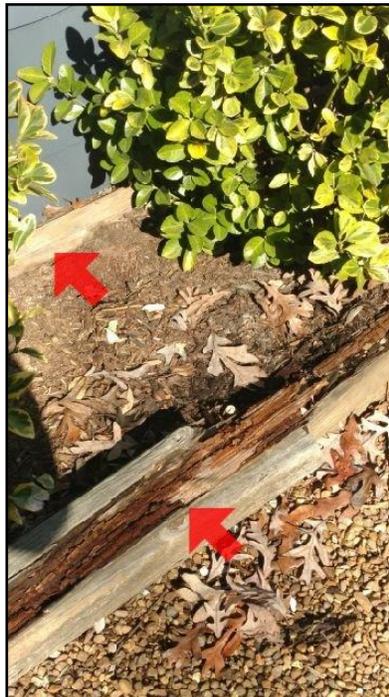
16. Wood touching foundation

14. Condition: • Wood touching foundation

There are some landscape Timber framed Planters beside the home that appear to have insect damage that are touching the foundation of the home where the siding is too close to grade. This is a perfect environment to allow wood-boring insects into the structure. I highly recommend this wood be removed and this area thoroughly inspected by termite inspector.

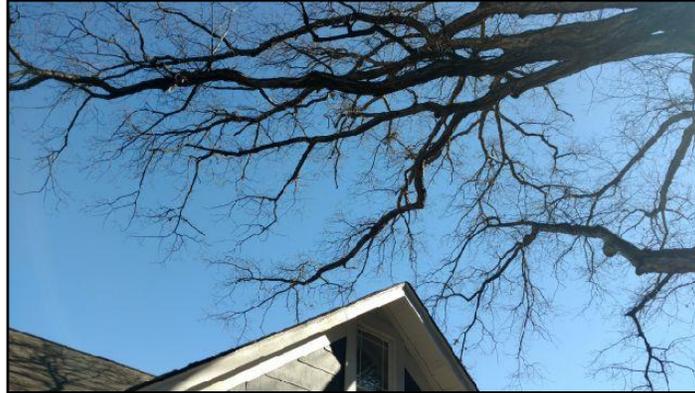
17. Trees overhanging roof can speed roofing...

15. **Condition:** • Trees overhanging roof can speed roofing deterioration and fill gutters.

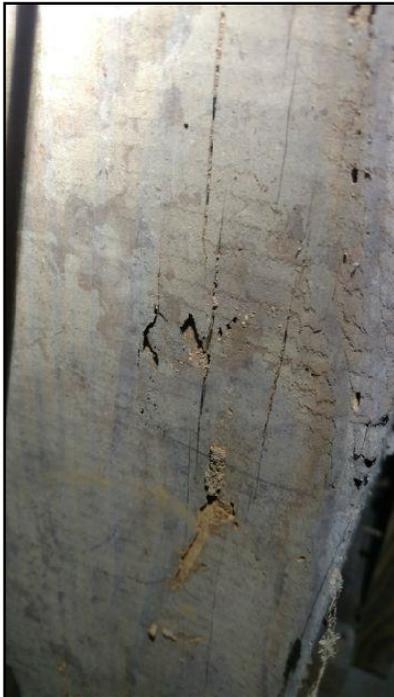
19. recommend termite inspector

17. Condition: • recommend termite inspector

Possible signs of wood-boring insect activity on Main beam. I highly recommend that there are termite inspection and any areas they find current or past activity and having a structural inspection.

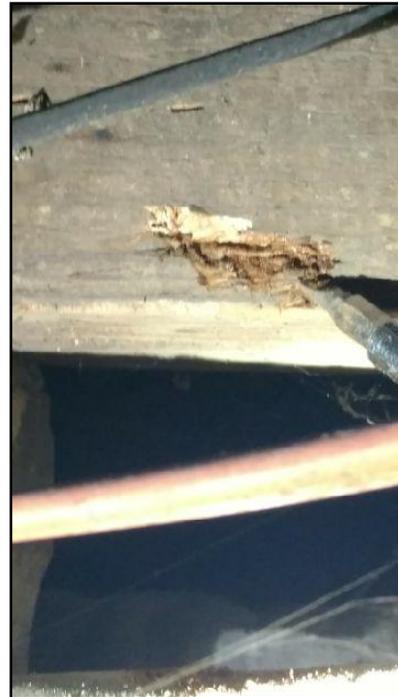
20. recommend termite inspector

18. Condition: • recommend termite inspector

Possible signs of wood-boring insect activity on Main beam. I highly recommend that there are termite inspection and any areas they find current or past activity and having a structural inspection.

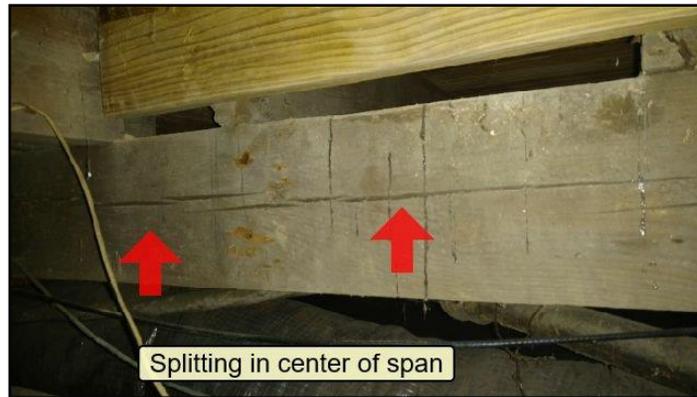
21. Rotated or twisted beams

19. Condition: • [Rotated or twisted beams](#)

The band that has possible wood-boring insect damage also seems to be splitting down the center where it is spanning between columns. I recommend this be checked for structural integrity

Implication(s): Weakened structure | Chance of structural movement

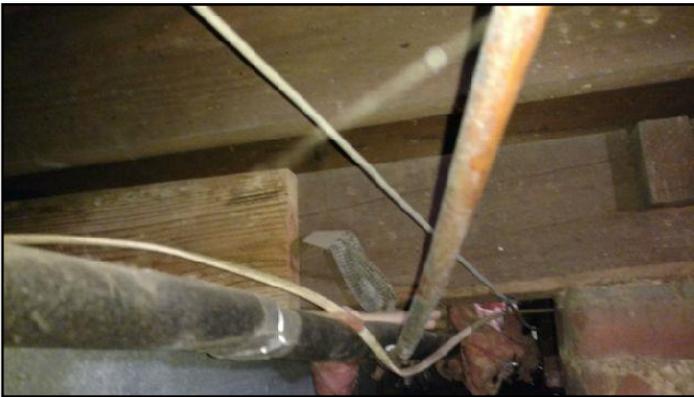
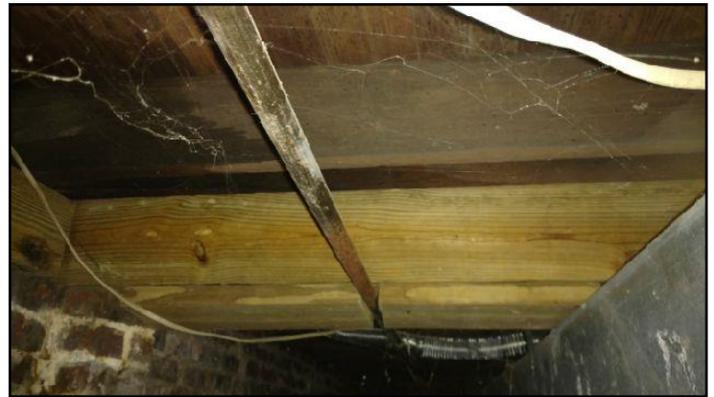
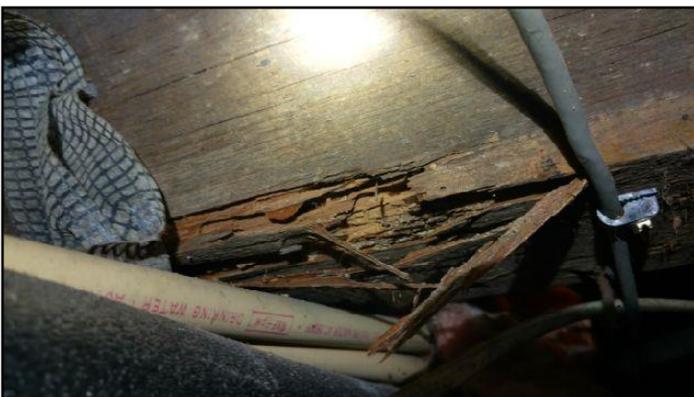
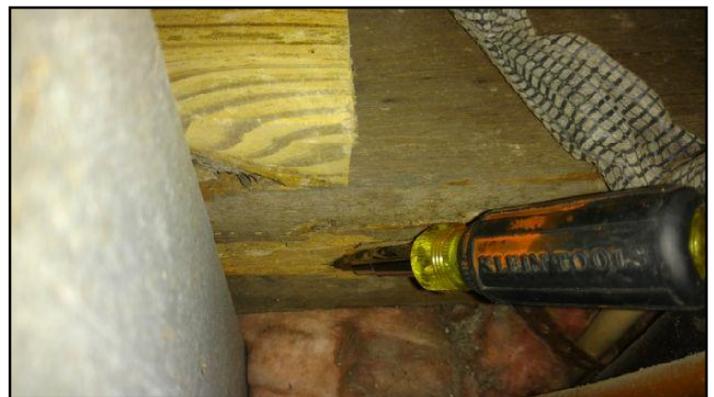
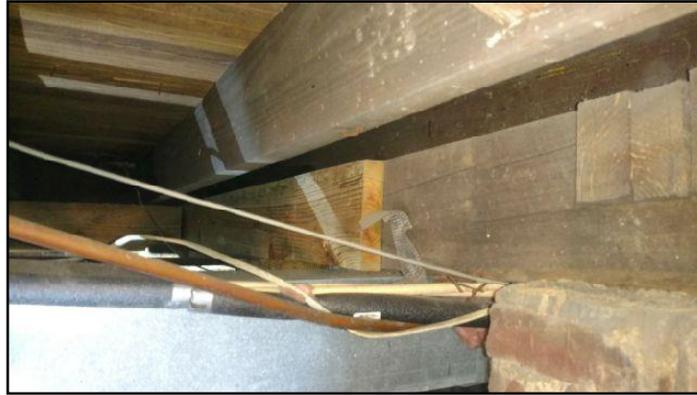
20. Condition: • [Prior repairs](#)

While a 2x8 has been scammed to a property of what appears to be a wood boring insect damaged beam, the board does not real a load bearing point not reach the full length plus some of the damaged beam.

Implication(s): Weakened structure

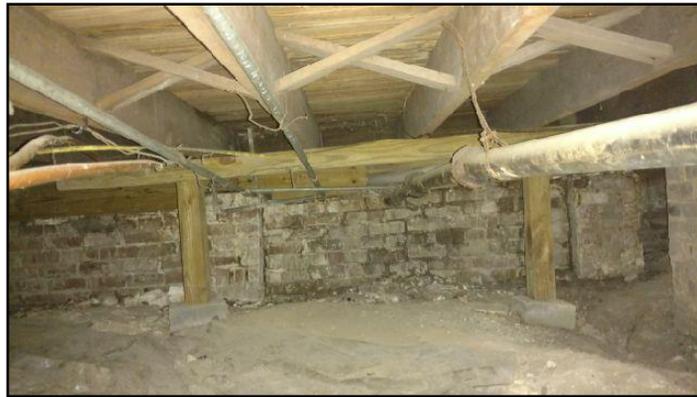
27. *Prior repairs*

21. Condition: • [Prior repairs](#)

Implication(s): Weakened structure

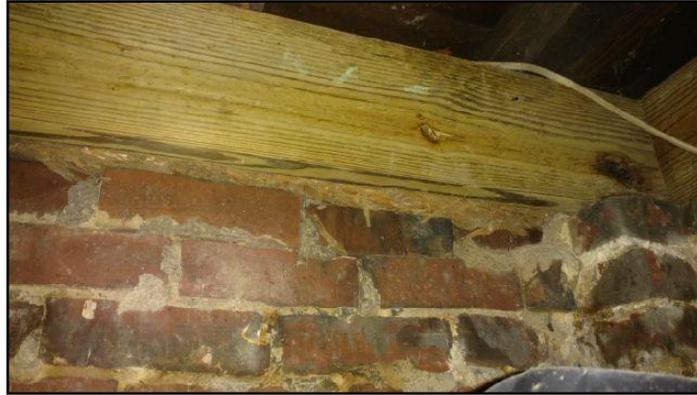
28. Rot or insect damage

22. Condition: • [Rot or insect damage](#)

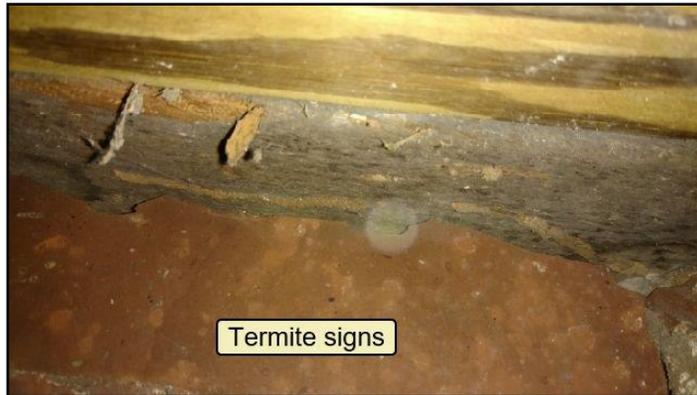
29. Insect damage

23. Condition: • [Insect damage](#)

Implication(s): Weakened structure

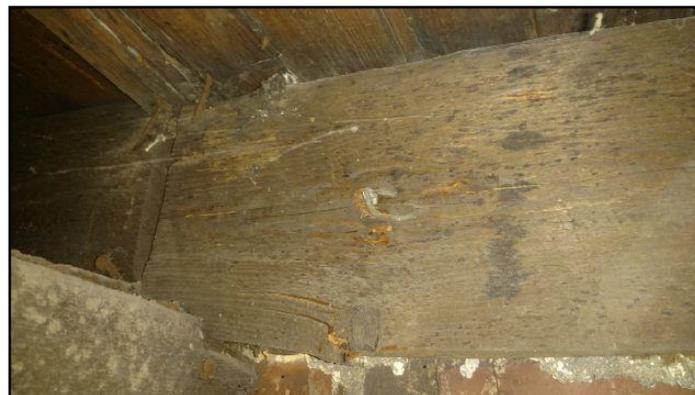
30. Rot, insect or fire damage

24. Condition: • [Rot, insect or fire damage](#)

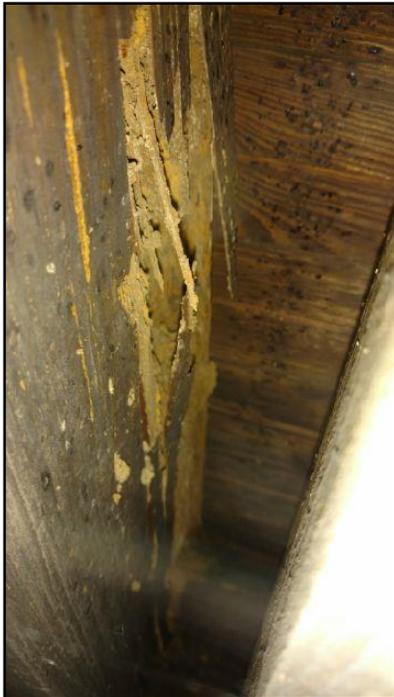
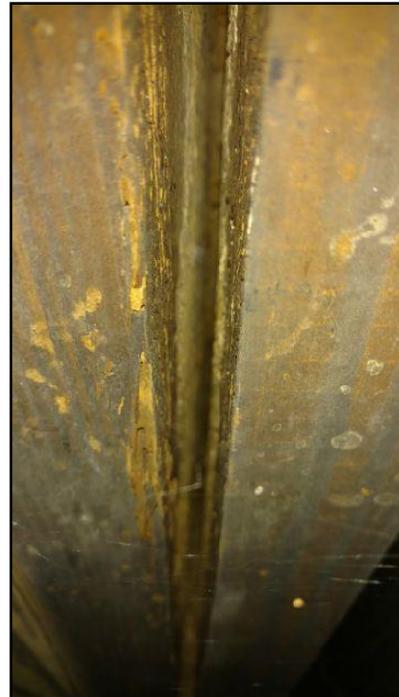
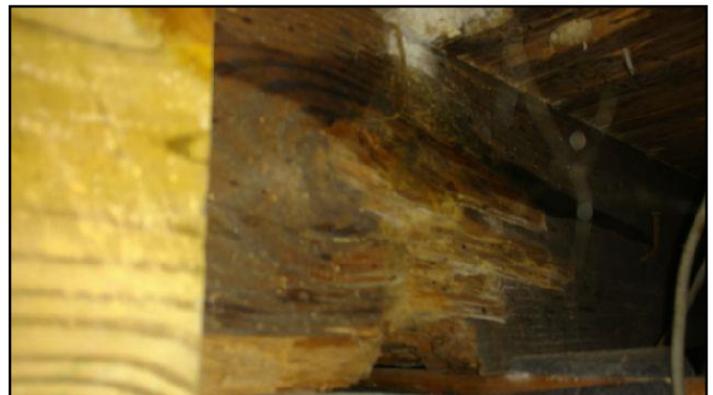
25. Condition: • [Rot, insect or fire damage](#)

A short area of insect damaged joist does have a repair board but here again it does not reach the length of the damage in to undamage material. This board serves no purpose as it is installed

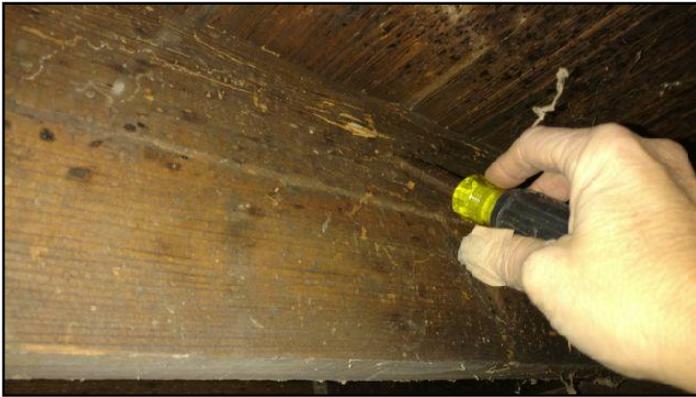
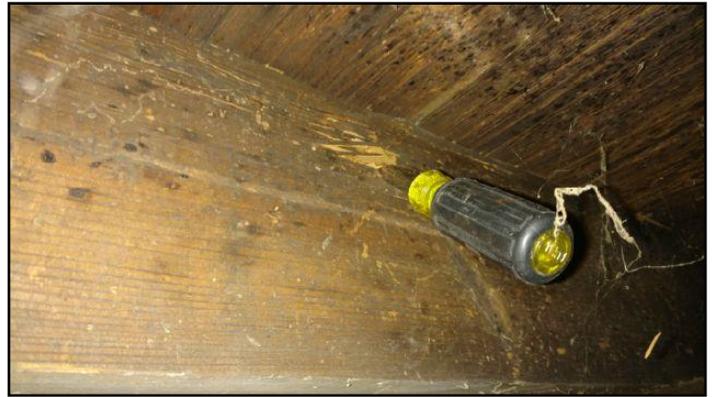
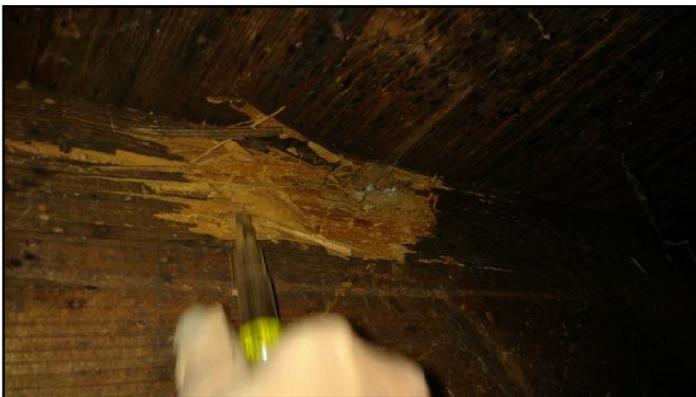
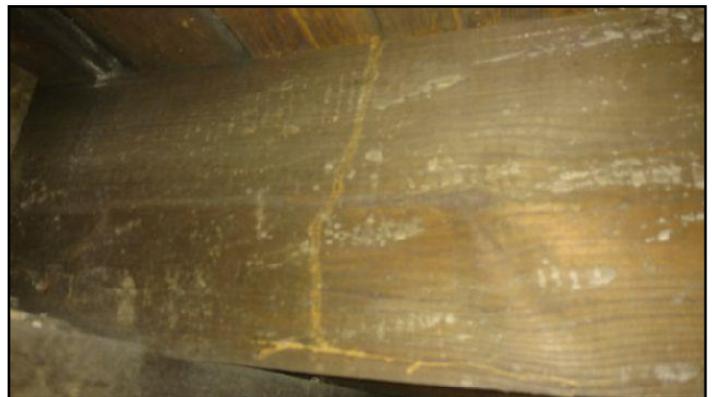
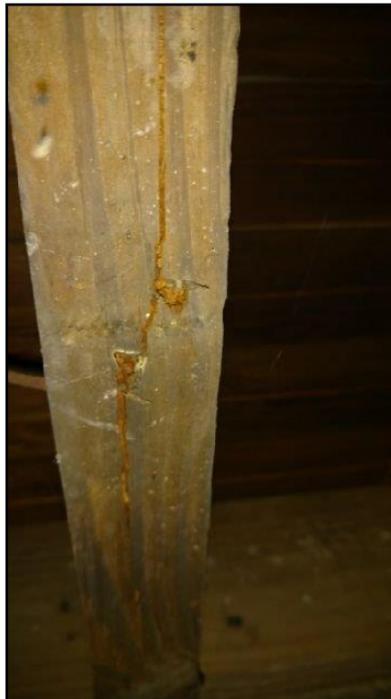
26. Condition: • [Rot, insect or fire damage](#)

Several Joists have no repairs made to them with signs of insect damage. I highly recommend a thorough termite an individual joist structural inspection

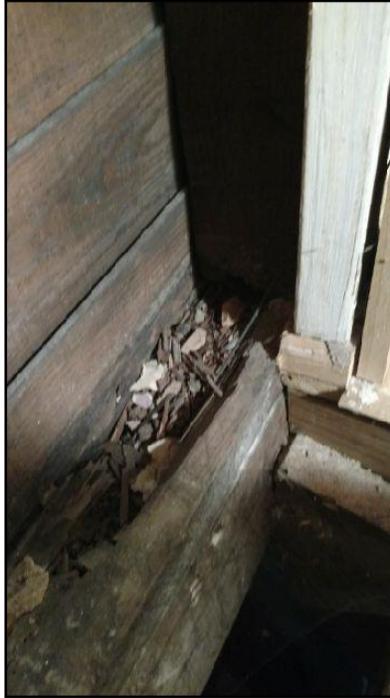
40. *Rot, insect or fire damage*

27. Condition: • [Rot, insect or fire damage](#)

Damaged area is by Stellar access and does not appear to be jeopardizing the structure.

Implication(s): Weakened structure

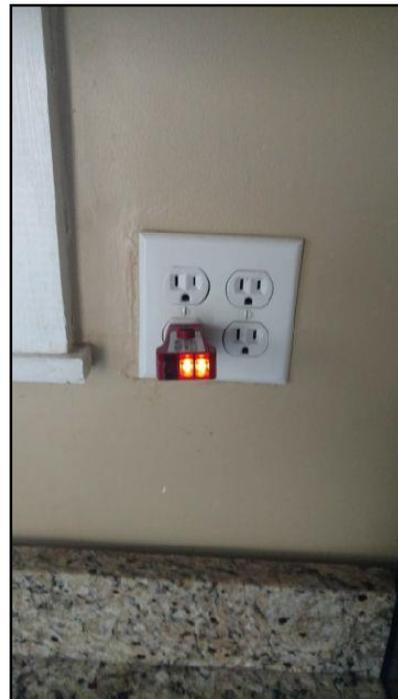
29. Condition: • Open Ground

Only the right Outlet in the double Outlet panel beside the kitchen sink is open ground.

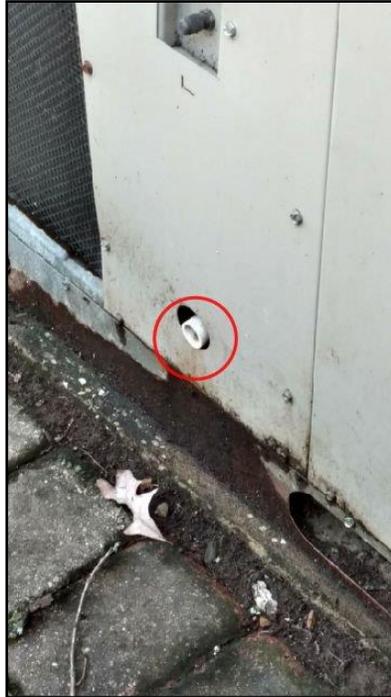
46. Missing

34. Condition: • [Missing](#)

Implication(s): Chance of water damage to structure, finishes and contents | Damage to equipment

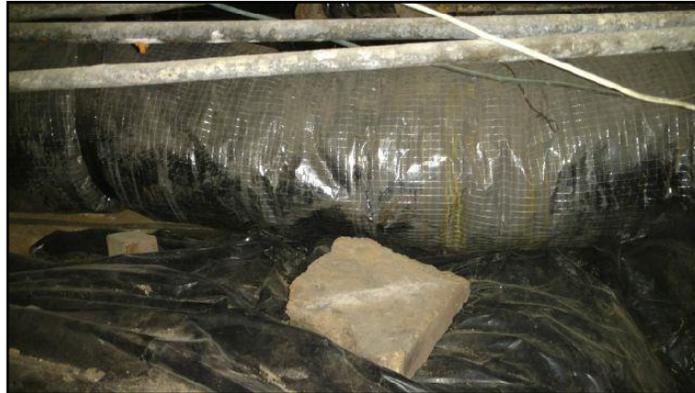
47. Ductwork is laying on the ground. This will...

35. **Condition:** • Ductwork is laying on the ground. This will deteriorate the protective coating causing leaks.

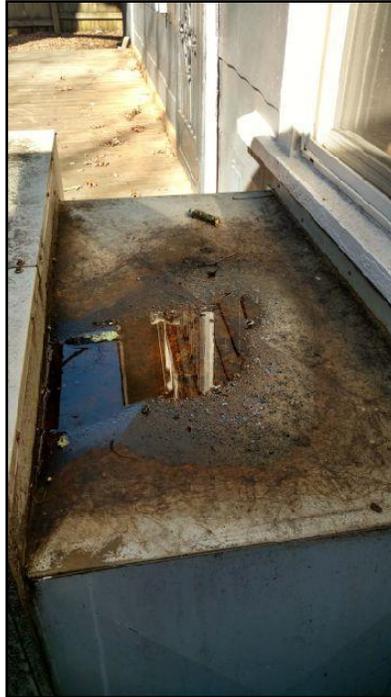
48. Cowling is sagging and retaining water and...

37. **Condition:** • Cowling is sagging and retaining water and debris.

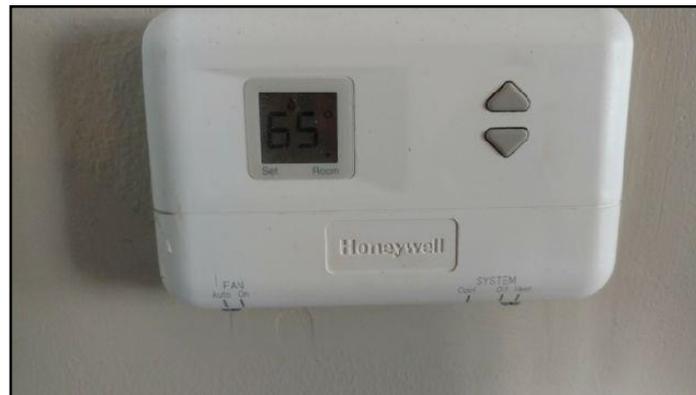
49.

38. Condition: • This inspector could not get the first floor thermostat to change temperature and was unable to test the downstairs unit. I highly recommend that a HVAC professional be consulted during the inspection period To evaluate this equipment. This inspector also placed the thermostat fan in the on position rather than the auto position and could not get the unit fan to come on.

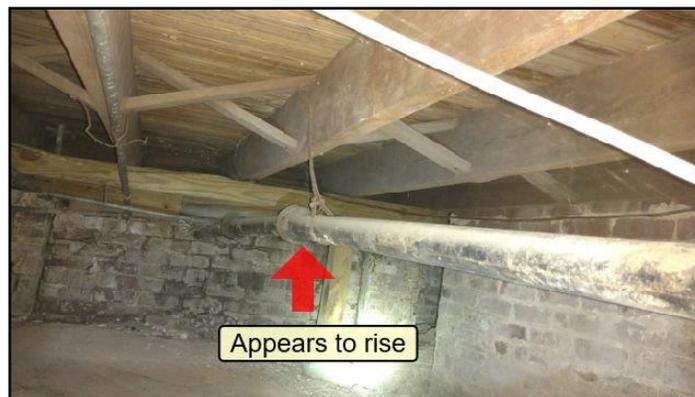
52. Fall on drain line is not sufficient

43. **Condition:** • Fall on drain line is not sufficient

Task: Improve

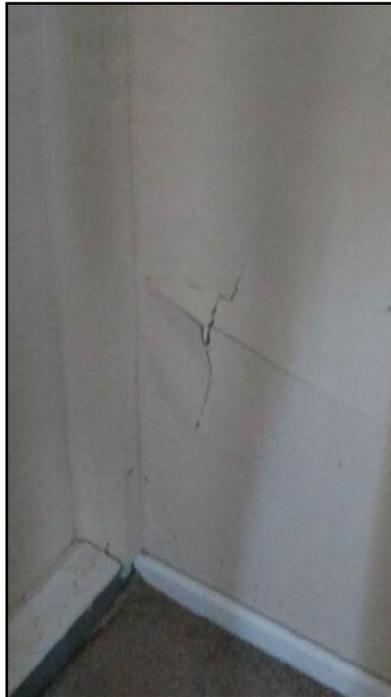
57. Damaged

49. Condition: • Damaged

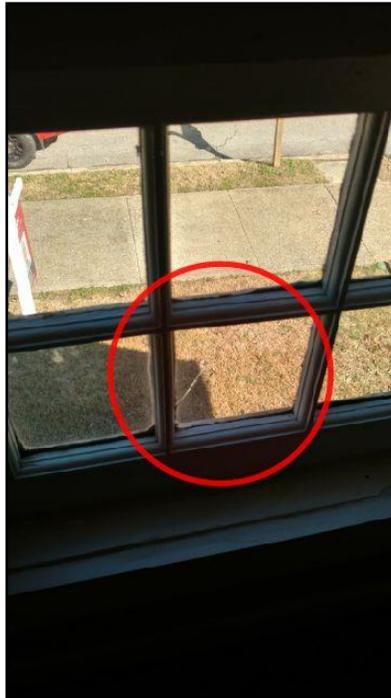
58. Cracked

50. Condition: • [Cracked](#)

Implication(s): Physical injury

Location: Front Second Floor

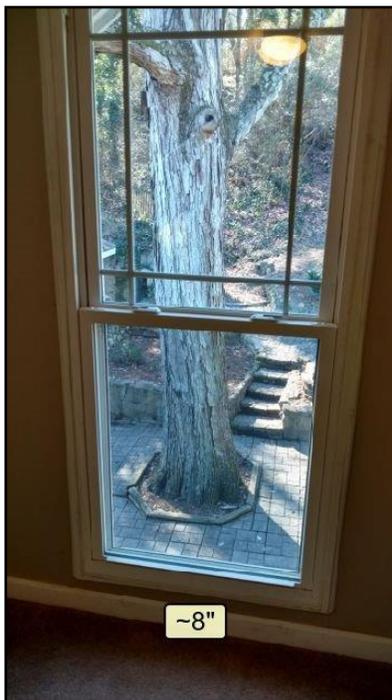
59. Safety glass not installed

51. Condition: • Safety glass not installed

When a window is less than 16 inches from the ground it is normally required that this glass be tempered. The window in the bonus area upstairs is approximately 8 inches from the floor. I recommend checking with the building inspector to see if this is okay according to the code as they enforce or having this bottom sash changed to a tempered glass for safety sake. It does appear with the amount of remodeling that has been done on this structure a building permit would have been required and the areas that were affected would be subject to current code AS of the date that permit was pulled

Implication(s): Physical injury

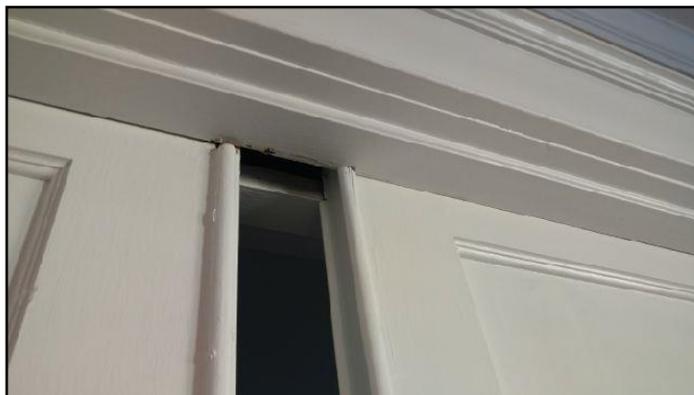
60.

52. Condition: • The right hand pocket door between the living room and dining room was hard to open and close. I recommend it be adjusted

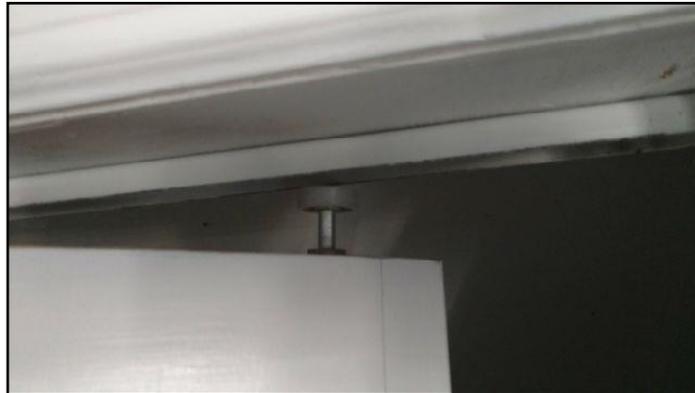
62. *Ineffective*

55. Condition: • [Ineffective](#)

Implication(s): Equipment ineffective

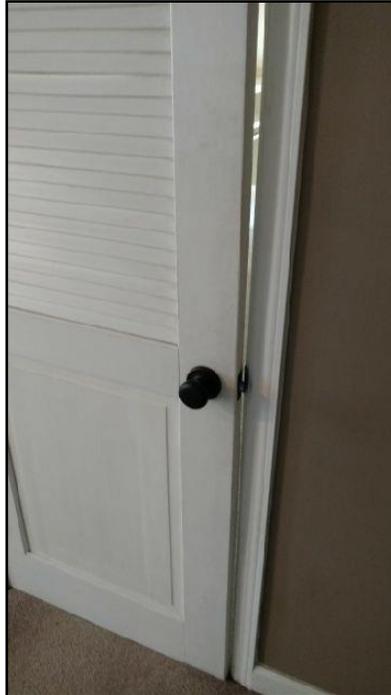
63. Ineffective

56. Condition: • [Ineffective](#)

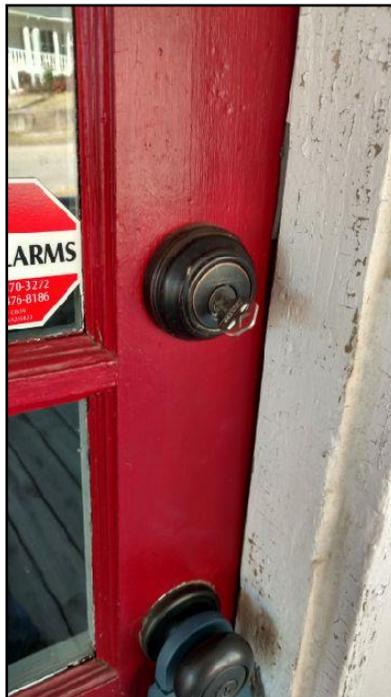
64. Stiff operation

57. Condition: • Stiff operation

While this inspector could get the deadbolt to latch from the inside using the thumb turn while applying pressure to the door she could not get the deadbolt to latch using the key from the outside. I recommend this be adjusted

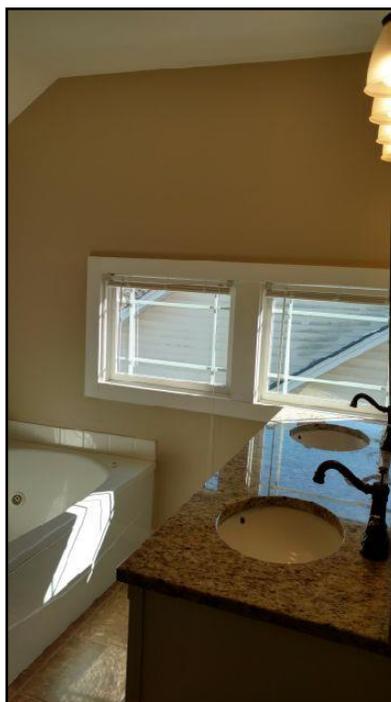
66. Missing

61. Condition: • [Missing](#)

Implication(s): Chance of condensation damage to finishes and/or structure

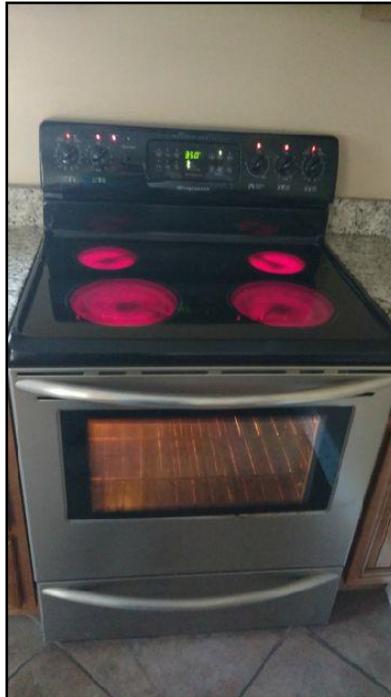
67. Missing Anti-tip bracket on range - The...

62. Condition: • Missing Anti-tip bracket on range - The anti-tip bracket is provided by the manufacturer to prevent the unit from being pulled over in certain conditions, such as a child using the oven door for a step. This is a severe injury/life-safety issue. This bracket is in the owner's manual packet when a range is purchased. If it is not available, you can contact the manufacturer, provide the model number of the appliance that can normally be found on a label in the

pan drawer, and they will normally provide one for you. They can also be purchased after-market on line or at some hardware stores.
