# Your Inspection Report

2061 Holly Oak Drive  
Shreveport, LA 71118

RE: Report No. 1497, v.4  
2061 Holly Oak Drive  
Shreveport, LA  
71118

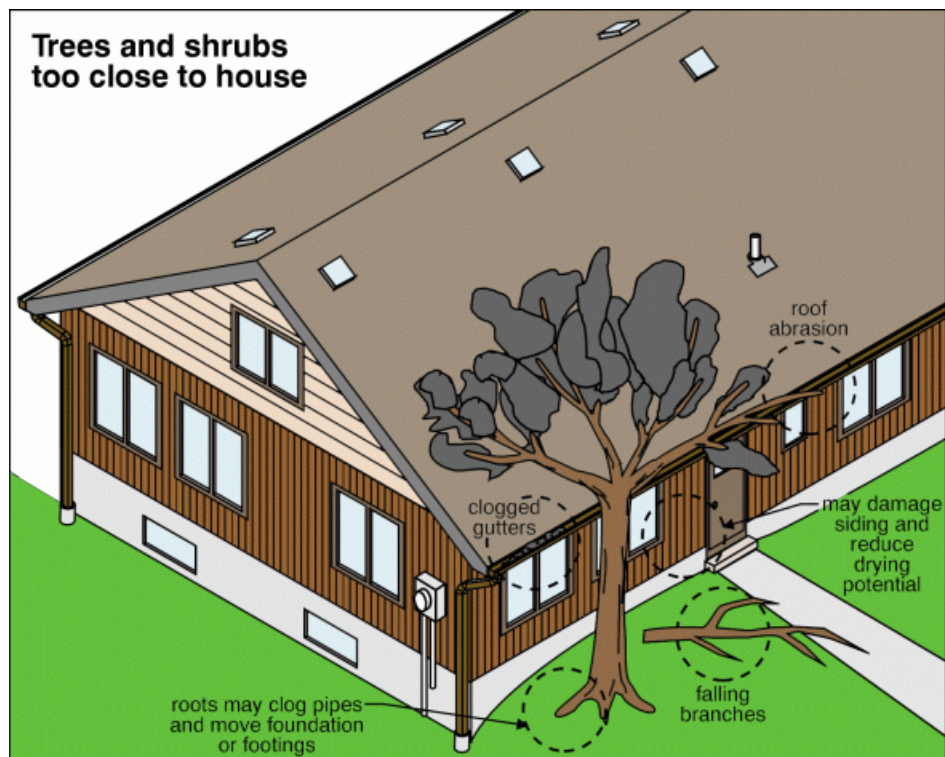
**Condition:** • Tree branches touching roof

Tree branches touching the roof materials may damage roof materials. Recommend all tree branches touching the roof be removed.

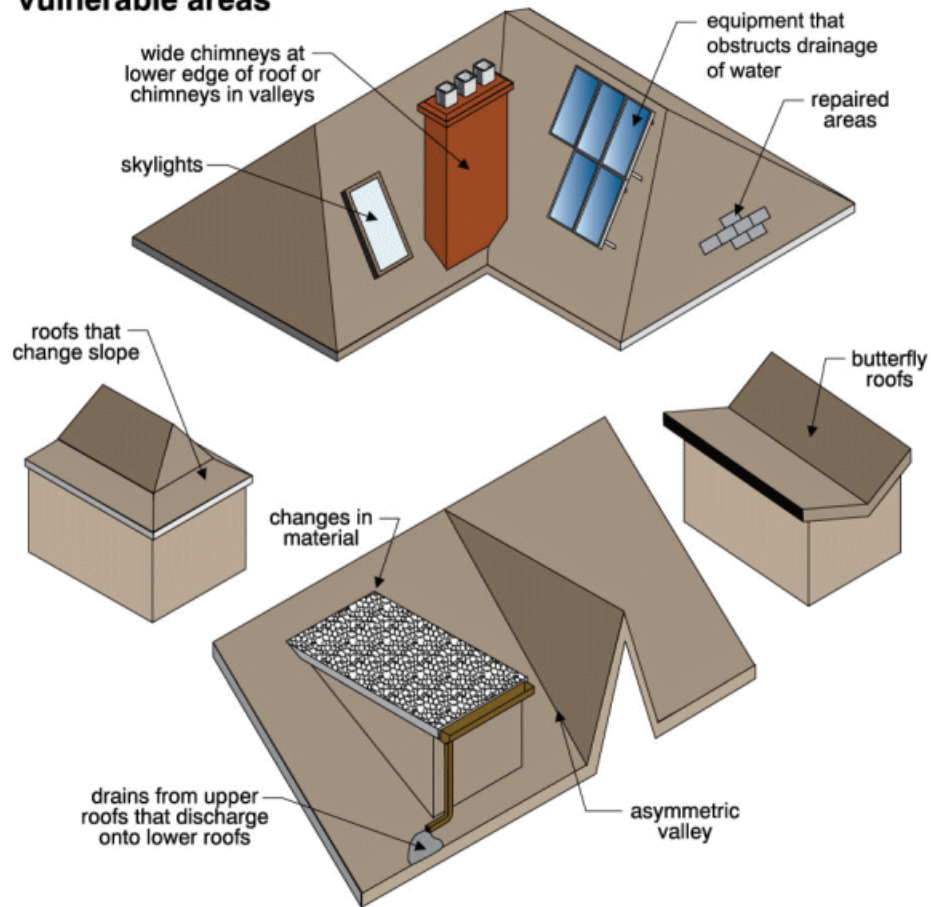
2. Vulnerable areas

**Condition:** • [Vulnerable areas](#)

**Implication(s):** Chance of water damage to contents, finishes and/or structure

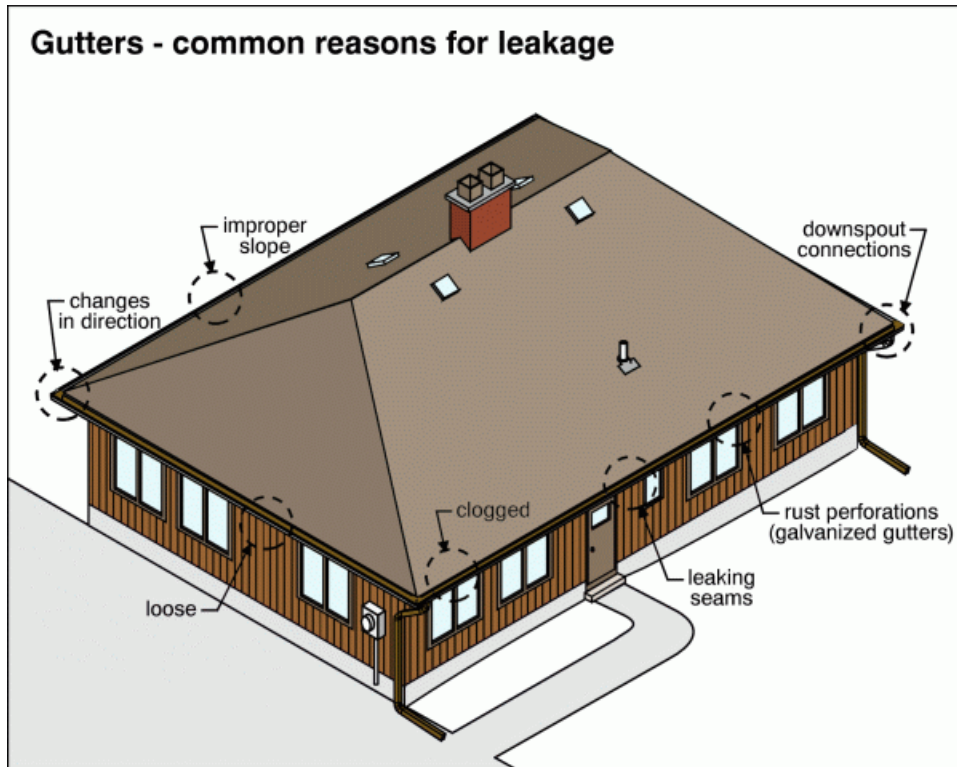
3. Clogged

**Condition:** • [Clogged](#)

**Implication(s):** Chance of water damage to contents, finishes and/or structure

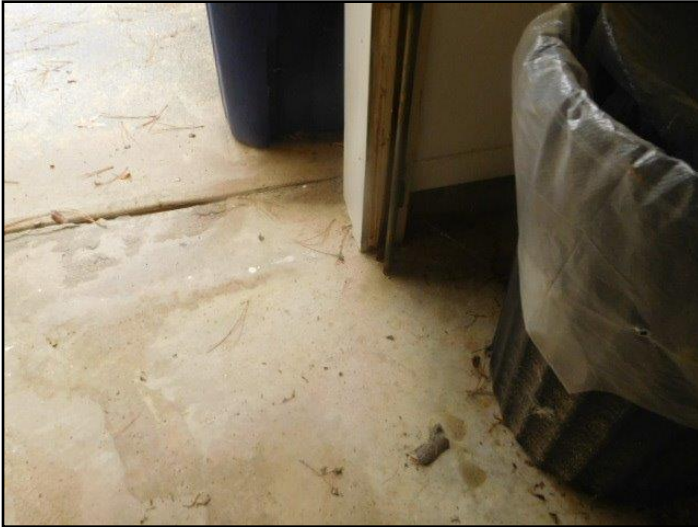
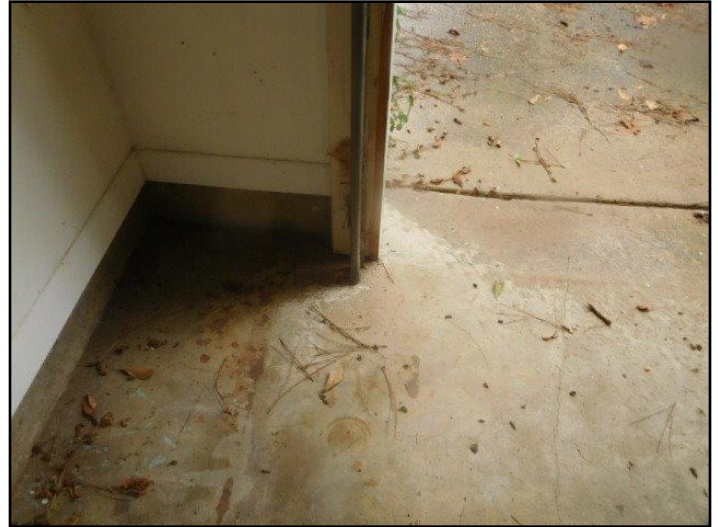
6. Missing auto reverse sensors

**Condition:** • The absence of auto reverse sensors will increase the chance of injury or damage to vehicle. Recommend the unit be updated for safety concerns.

**Implication(s):** Physical injury and or damage to vehicle

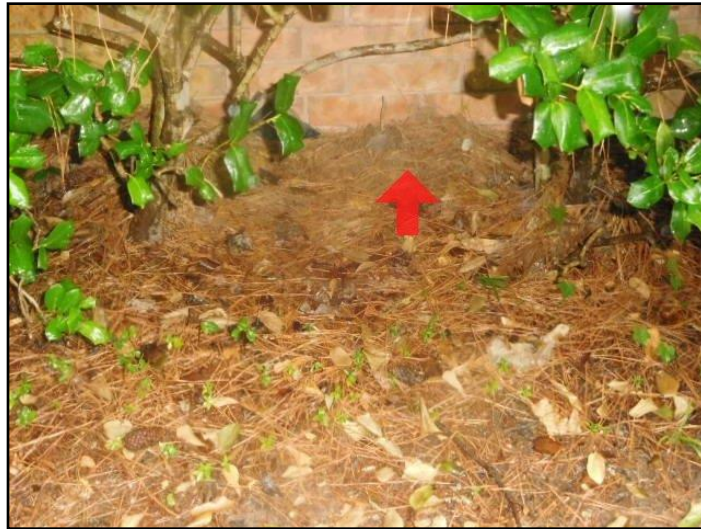
8. Foundation below grade

**Condition:** • Foundation below grade

Areas of the foundation on the left side of the home are considered below grade, which may provide a pathway for moisture and or insects. Improvement recommended.

**Implication(s):** Pathway for moisture and or insects

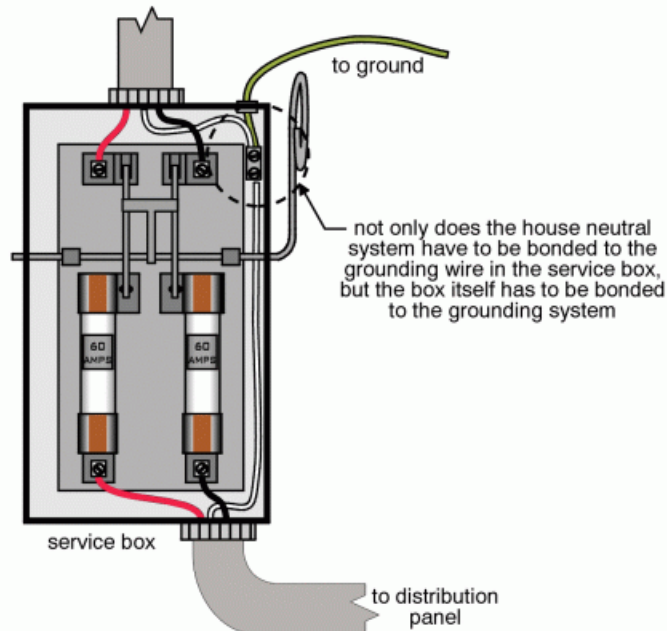
9. Box not bonded to ground

**Condition:** • [Box not bonded to ground](#)

No panel bonding visible. Recommend further evaluation by licensed electrician.

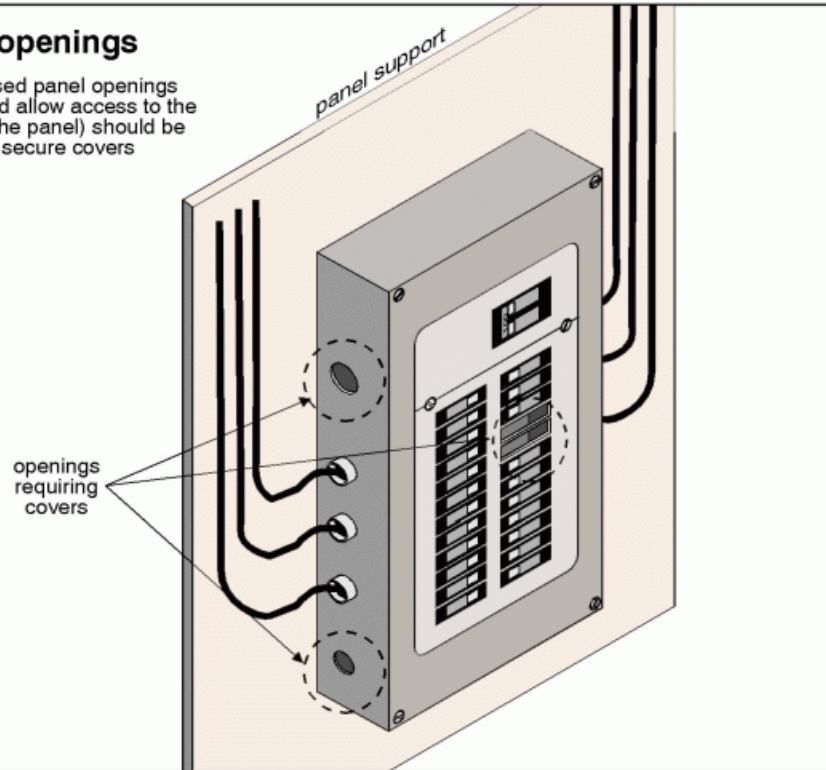
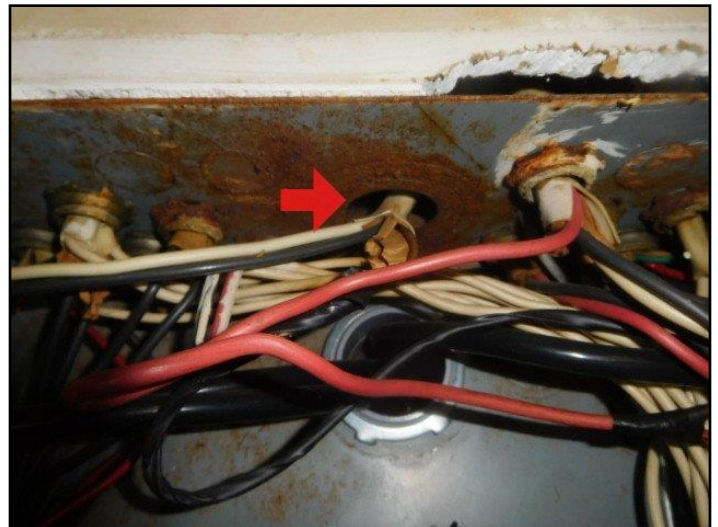
10. Openings in panel

**Condition:** • [Openings in panel](#)

**Implication(s):** Electric shock | Fire hazard

any exposed panel openings (that would allow access to the inside of the panel) should be fitted with secure covers

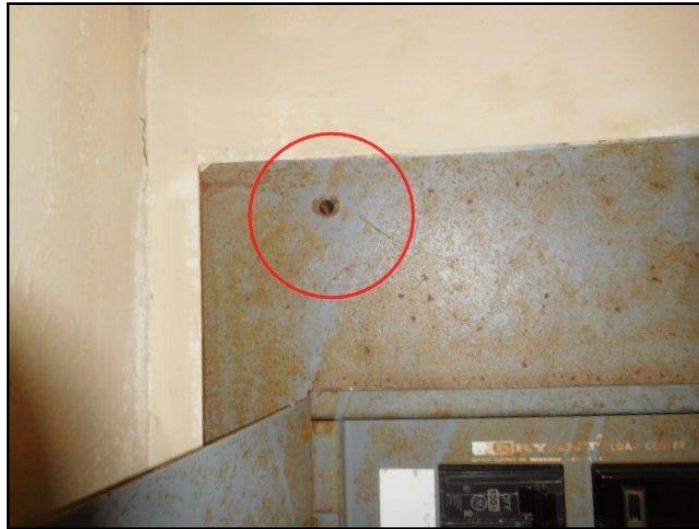
12. Openings in panel

**Condition:** • [Openings in panel](#)

**Implication(s):** Electric shock | Fire hazard

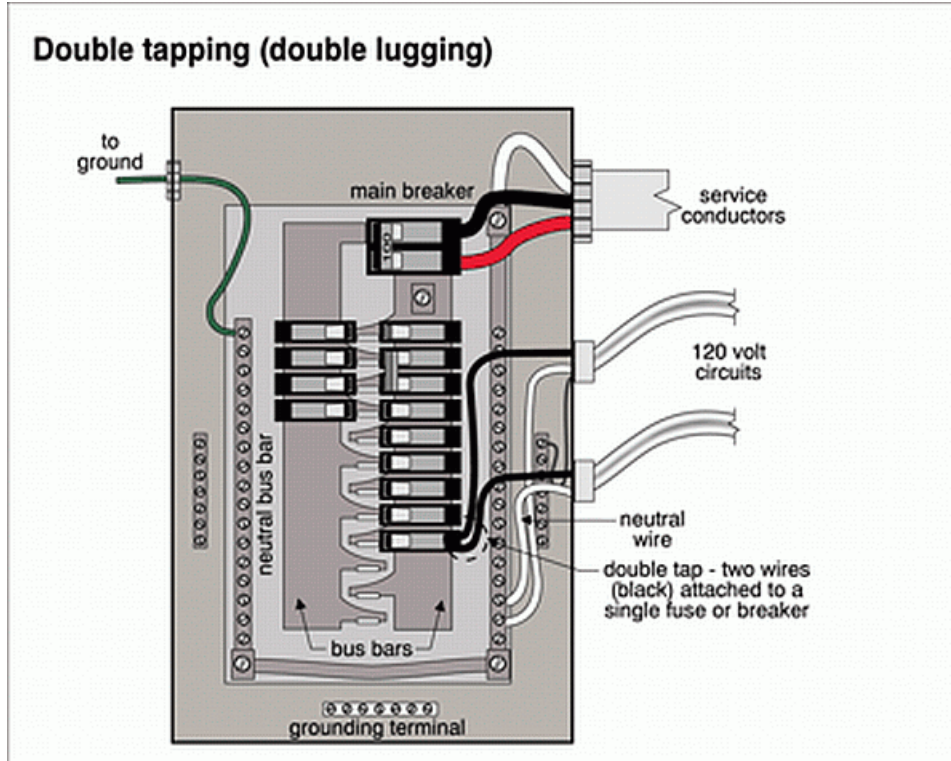
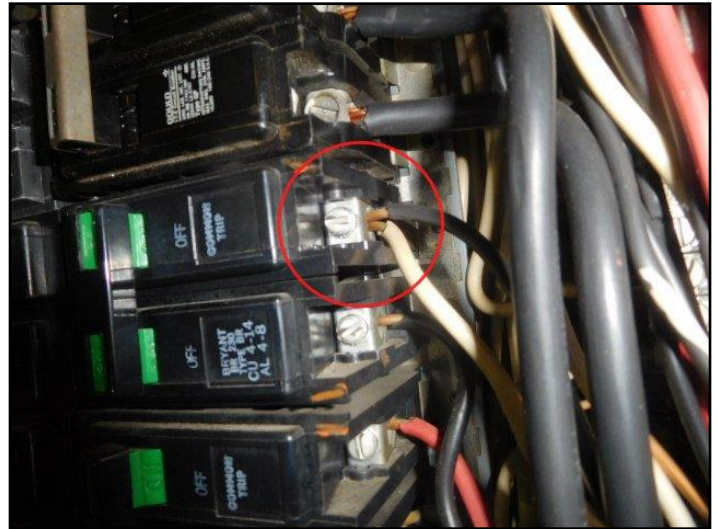
13. Double taps

**Condition:** • [Double taps](#)

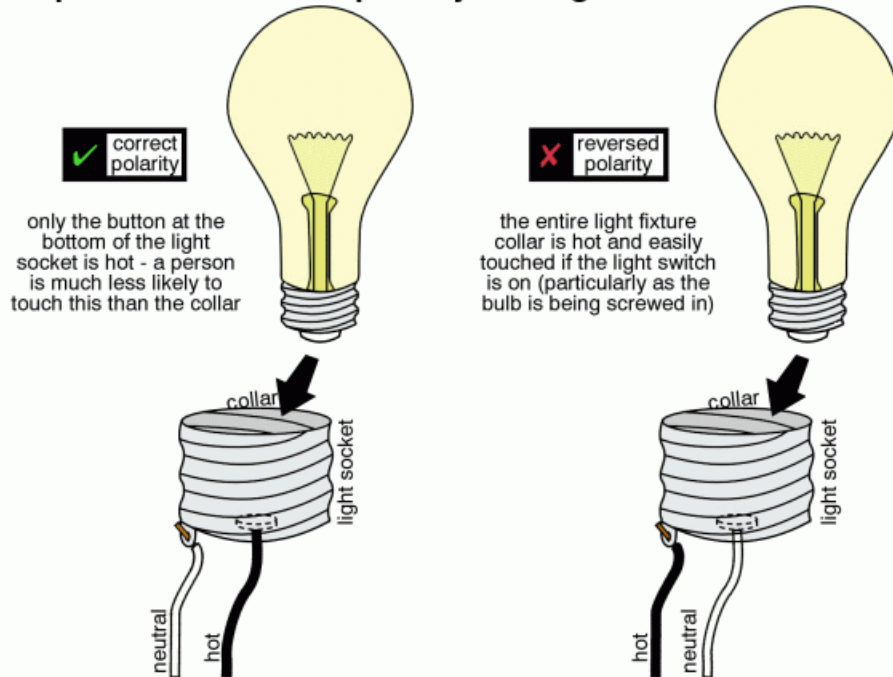
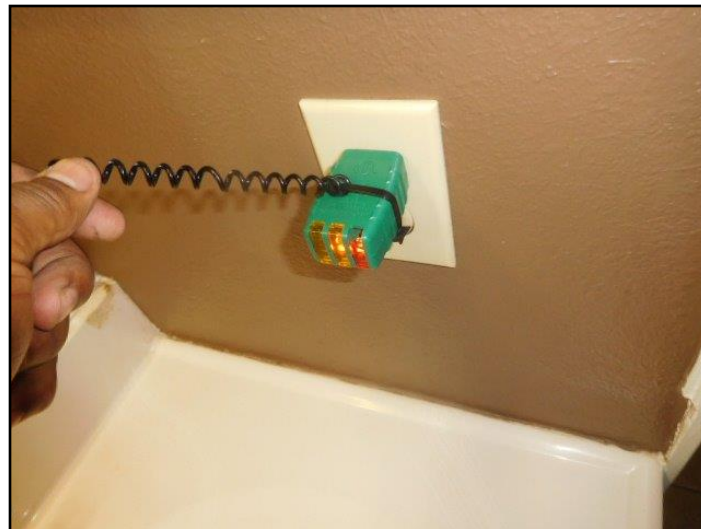
17. Reversed polarity

**Condition:** • [Reversed polarity](#)

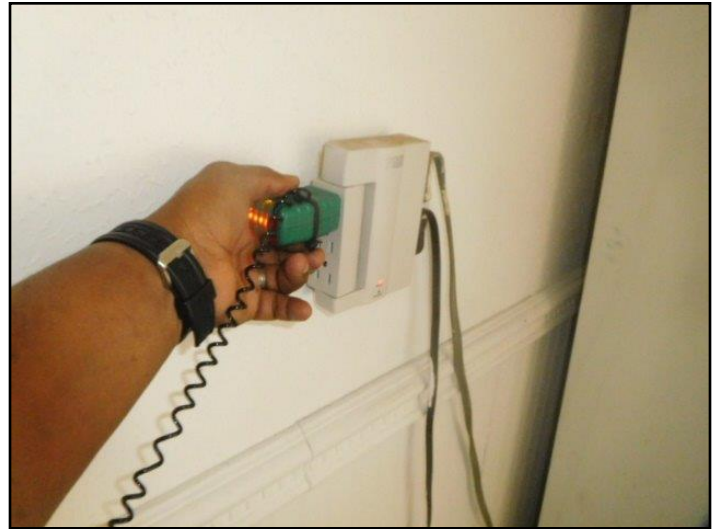
19. GFCI/GFI needed (Garage)

**Condition:** • [GFCI/GFI needed \(Ground Fault Circuit Interrupter\)](#)

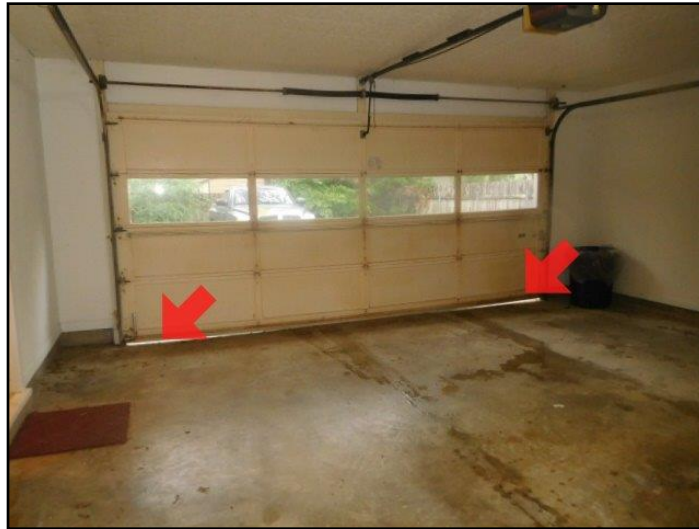
50. Ineffective weatherstrip

**Condition:** • Missing or ineffective weatherstrip should be replaced to prevent pathway for water and or rodent activity.

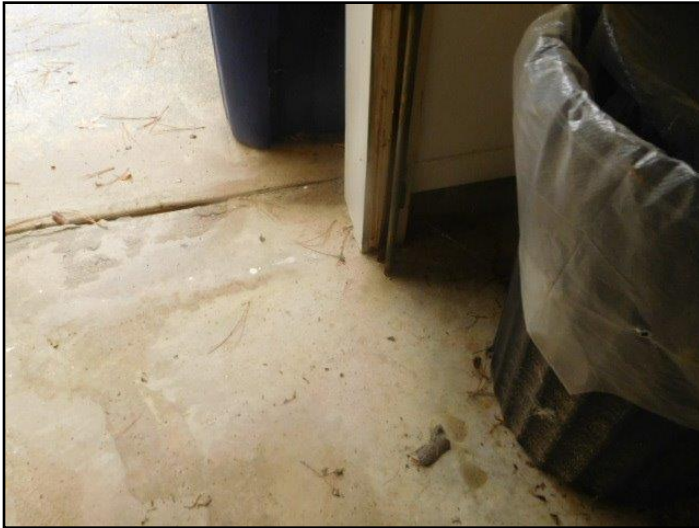
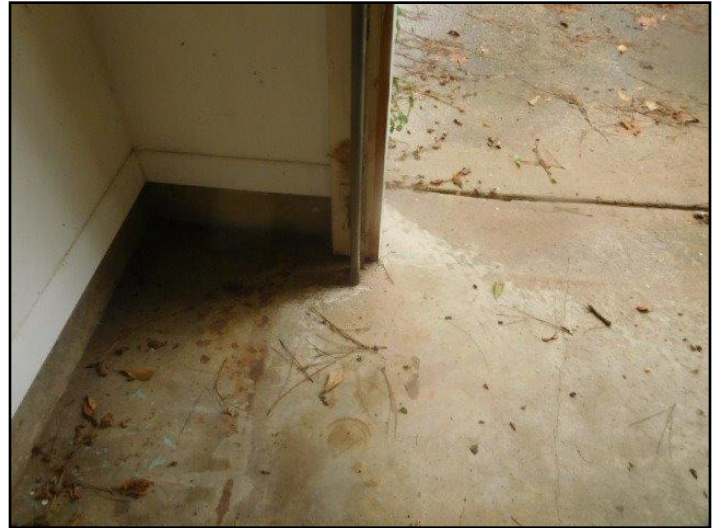
51. Missing auto reverse sensors

**9. Condition:** • The absence of auto reverse sensors will increase the chance of injury or damage to vehicle. Recommend the unit be updated for safety concerns.

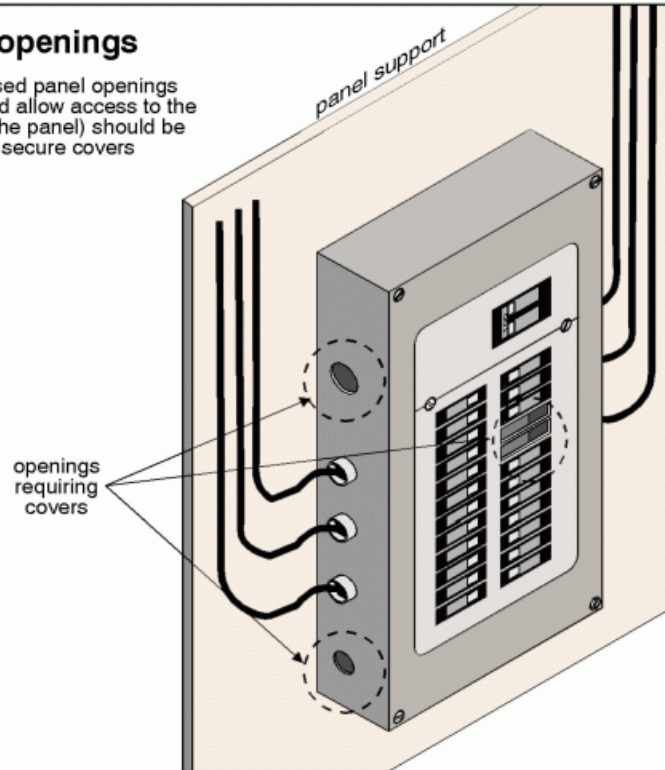
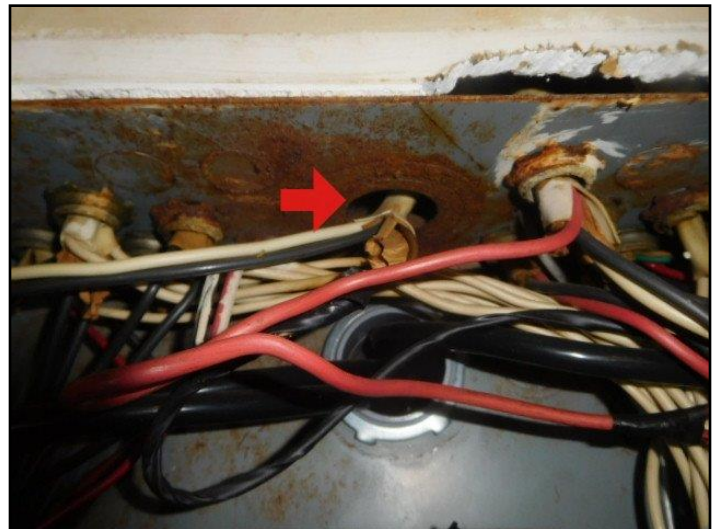
65. Openings in panel

**SERVICE BOX, GROUNDING AND PANEL \ Distribution panel****13. Condition:** • [Openings in panel](#)

any exposed panel openings (that would allow access to the inside of the panel) should be fitted with secure covers

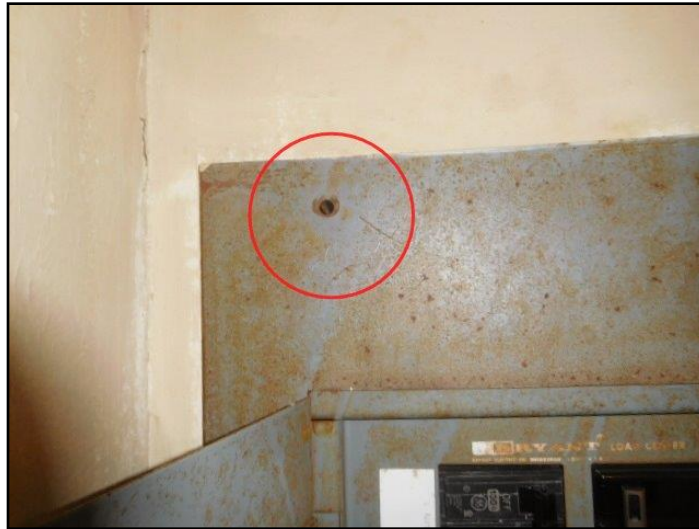
67. Openings in panel

### 14. Condition: • [Openings in panel](#)

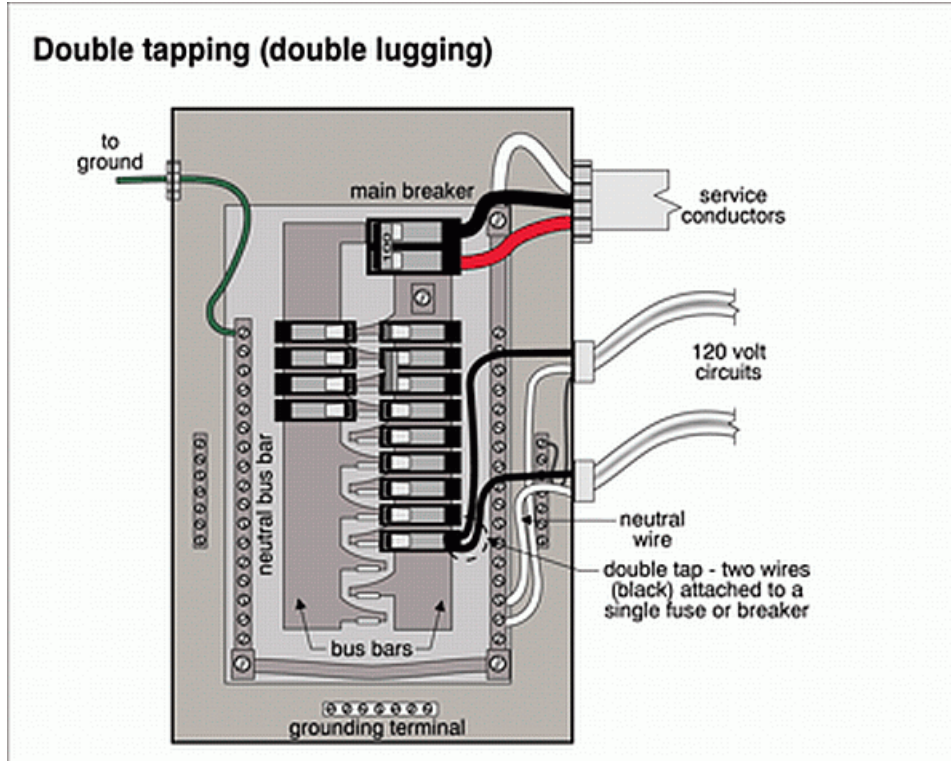
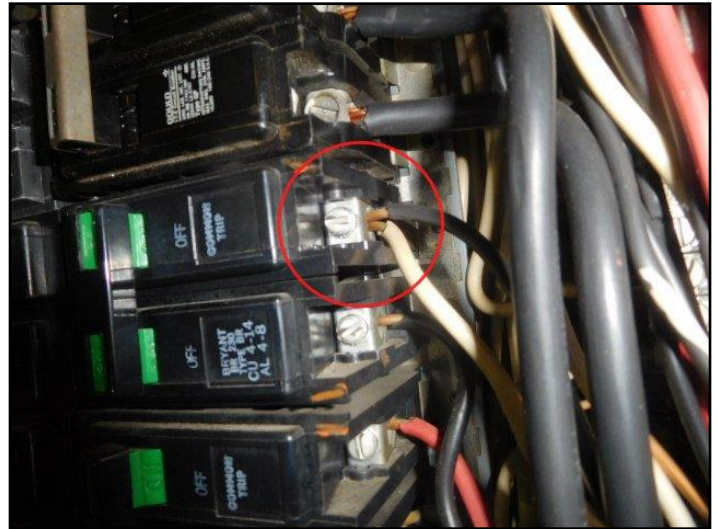
68. Double taps

**15. Condition:** • [Double taps](#)

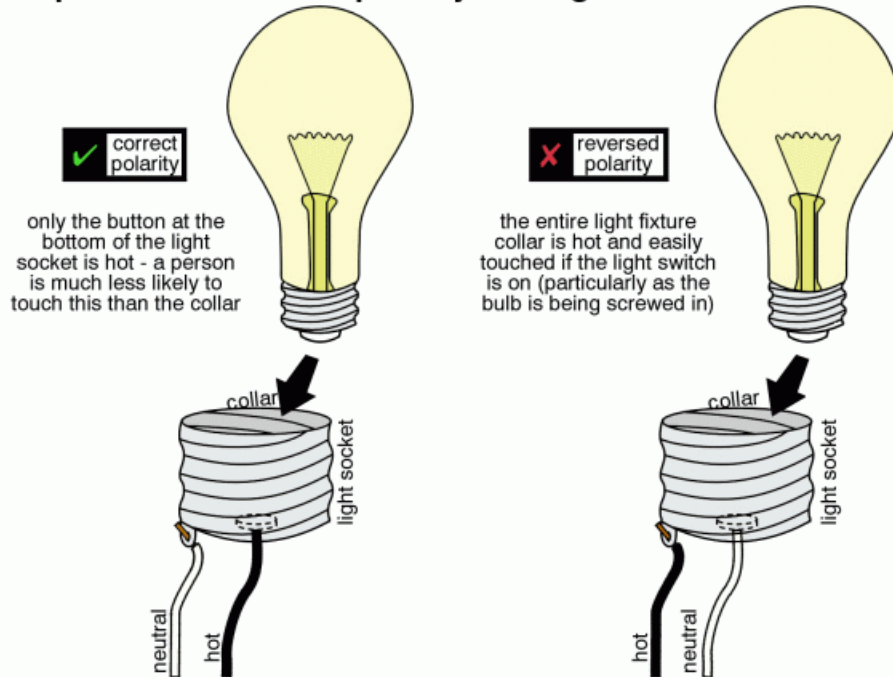
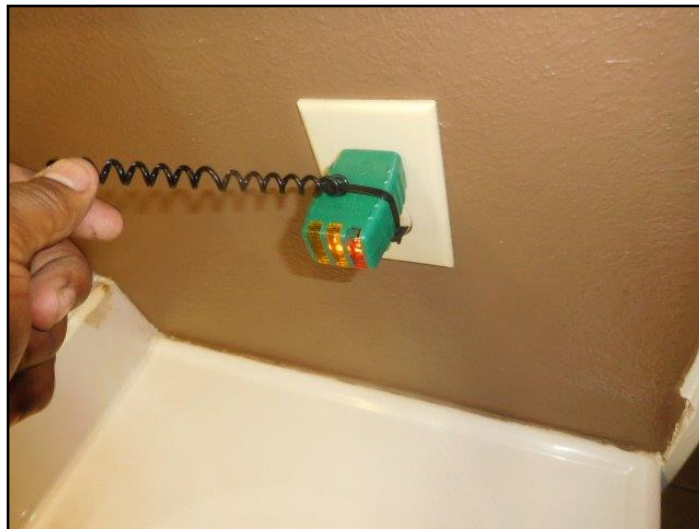
72. Reversed polarity

**18. Condition:** • [Reversed polarity](#)

when the polarity is reversed, the wide receptacle slot is (incorrectly) hot and the narrow slot is neutral - this is not uncommon when people forget that the black wire should be attached to the receptacle's brass screws

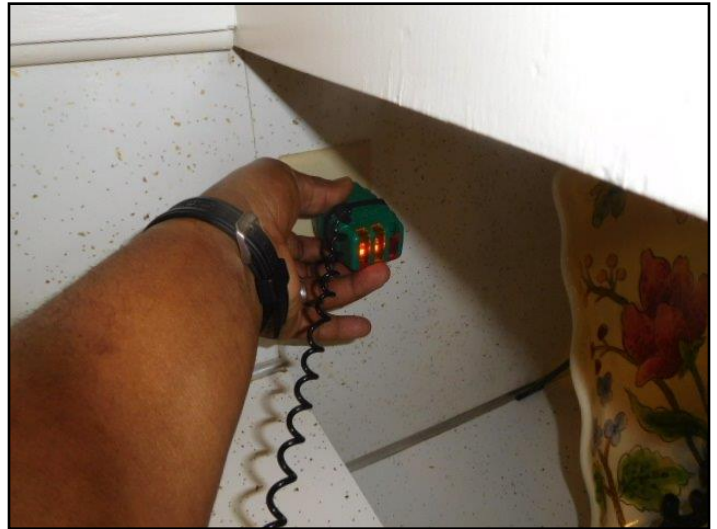
76. GFCI/GFI needed (Kitchen)ircuit...

#### 19. Condition: • [GFCI/GFI needed \(Ground Fault Circuit Interrupter\)](#)
