Your Inspection Report

123 Sell My House Court
Louisville, KY 40204

INSPECTION DATE:
Tuesday, June 5, 2018

RE: Report No. 1068, v.4
123 Sell My House Court
Louisville, KY
40204

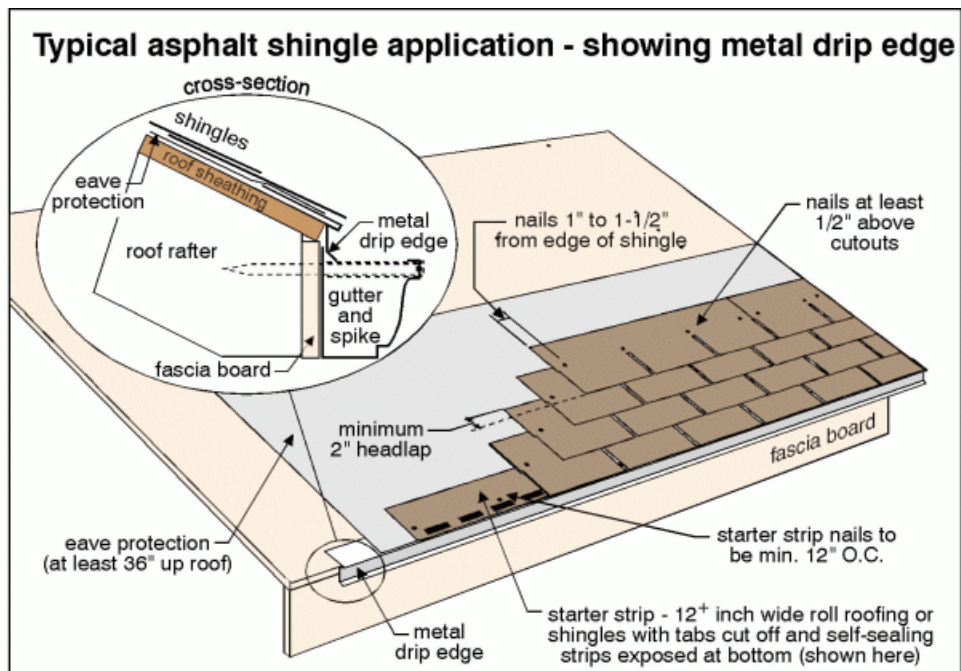
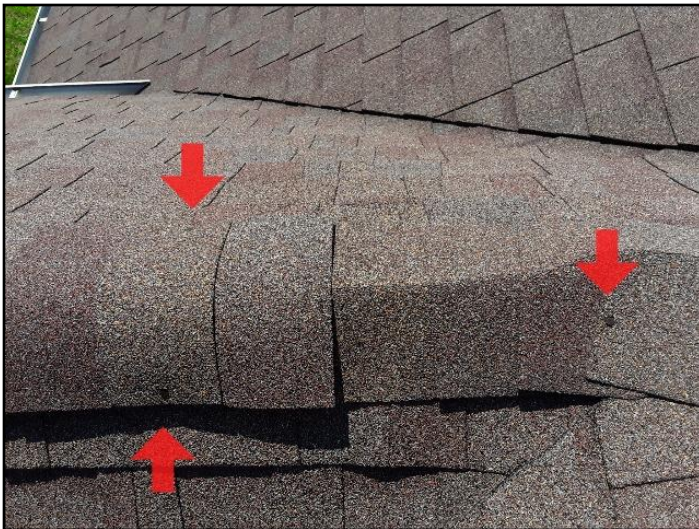
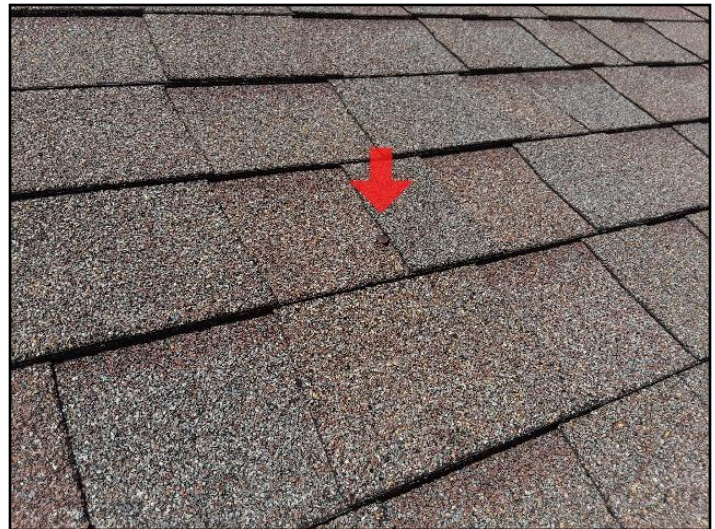
3. Exposed fasteners

1. **Condition:** • [Exposed fasteners](#)

Several roofing nails were exposed

Implication(s): Chance of water damage to contents, finishes and/or structure

Task: Cover nail heads with a dab of roofing tar or caulk

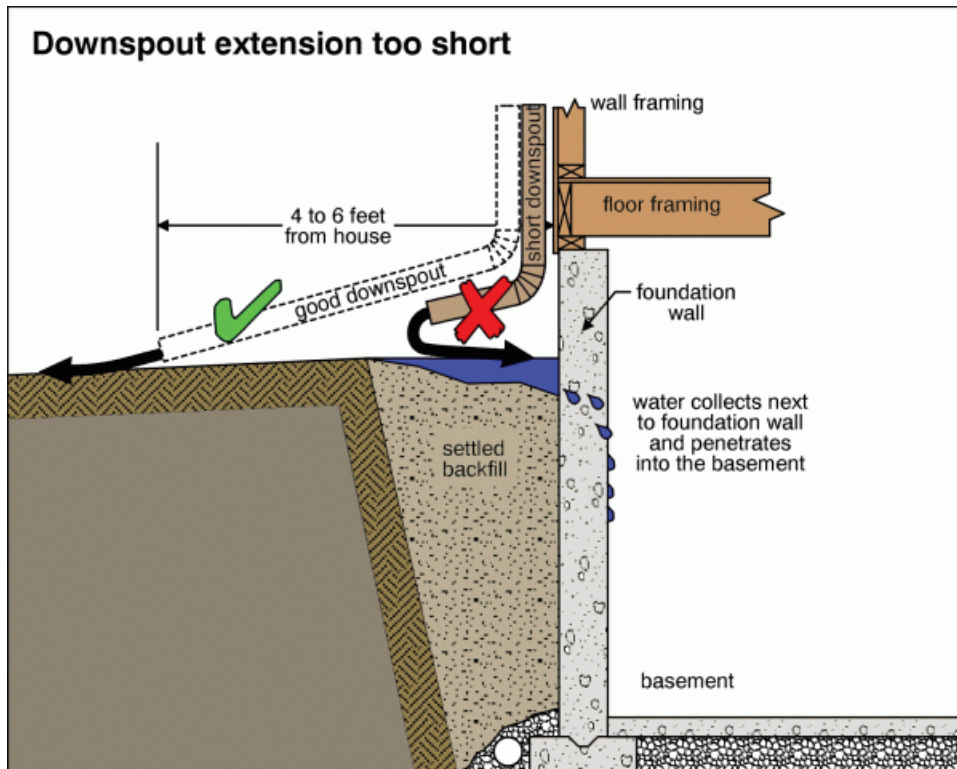
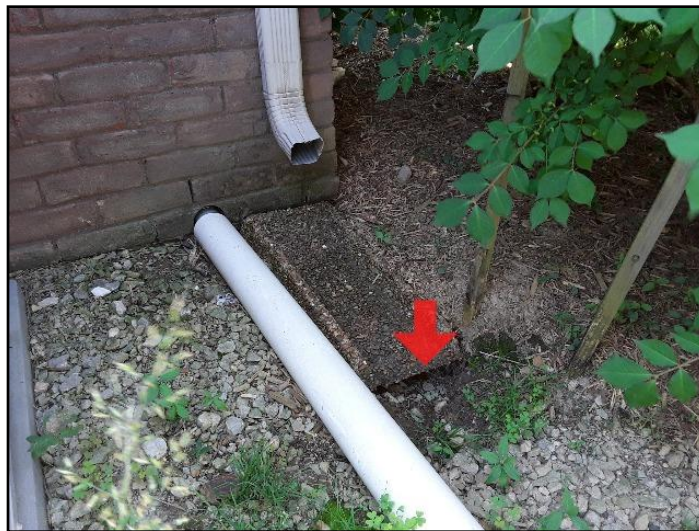
5. Wash-out beneath splash block

2. Condition: • [Discharge too close to building](#)

Soil/gravel wash-out beneath splash block noted

Implication(s): Chance of water damage to contents, finishes and/or structure

Location: Rear right side of house

Task: Adjust splash block and add fill dirt as needed to divert drainage further away from the house

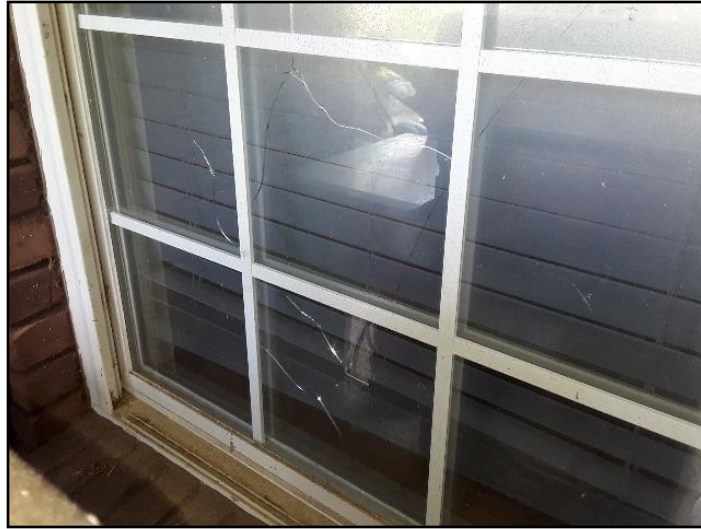
6. Cracked window

Condition: • [Cracked](#)

Rear porch window was cracked

3. Condition: • [Cracked](#)

Task: Replace cracked glass

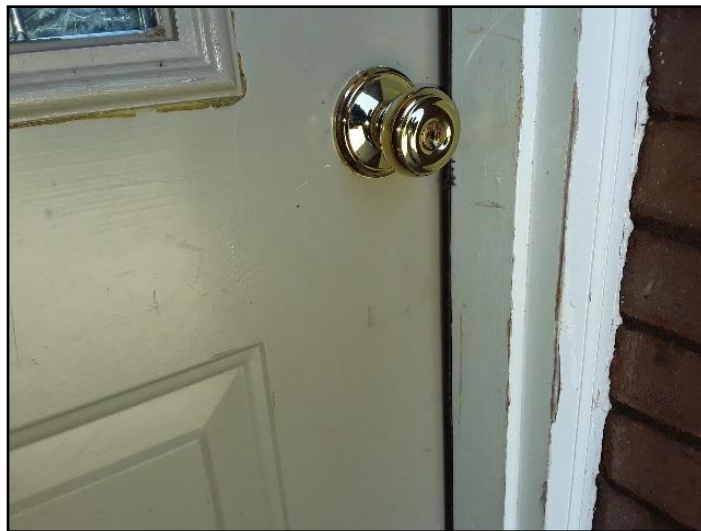
7. Paint or stain needed

4. Condition: • [Paint or stain needed](#)

Small paint chips were noted on the front door and trim. A fresh coat of paint on the front door will help make a good first impression.

Task: Paint door and trim as needed

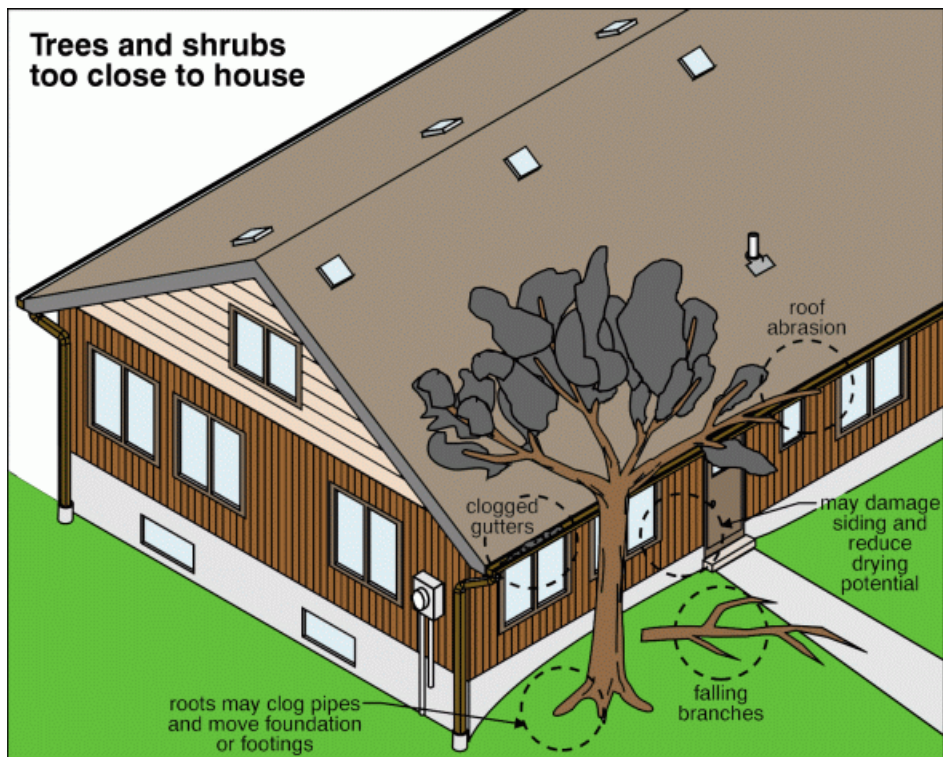
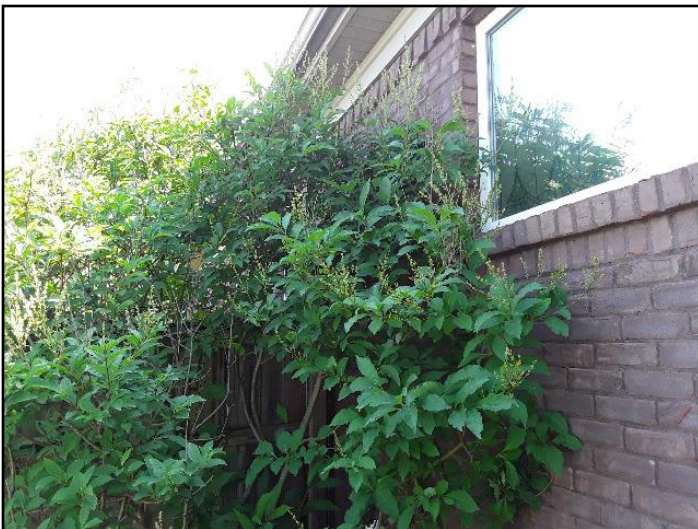
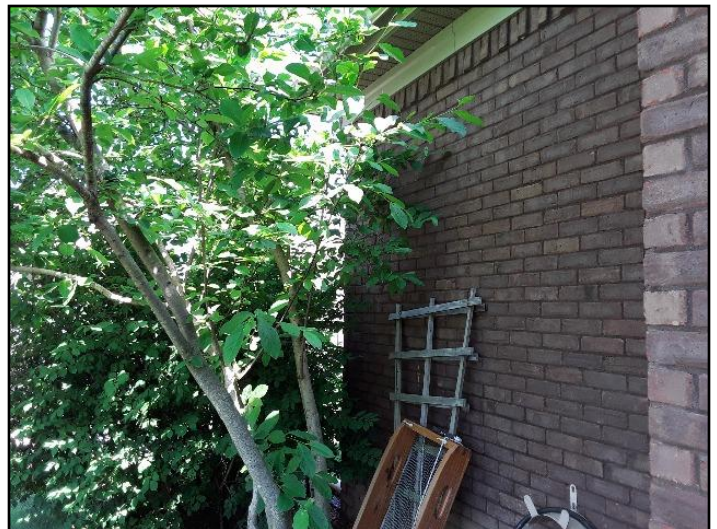
8. Trees or shrubs too close to building

5. Condition: • [Trees or shrubs too close to building](#)

Implication(s): Chance of water damage to contents, finishes and/or structure | Chance of pests entering building | Material deterioration

Location: Rear and right side of house

Task: Trim back shrubs from house

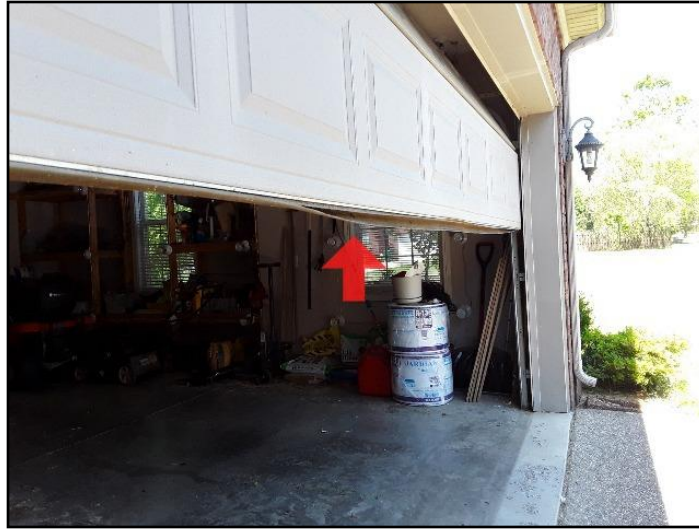
10. *Damaged weather strip*

6. Condition: • Damage

Torn door weather strip

Location: Garage vehicle door

Task: Replace weather strip

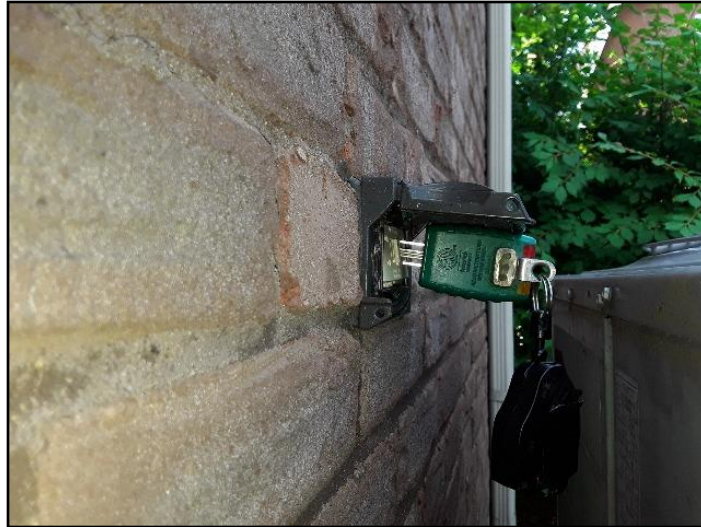
12. Damage

7. Condition: • [Damage](#)

Receptacle installed incorrectly in the outlet box making it unusable.

Location: Exterior GFCI by A/C unit

Task: Repair or replace receptacle

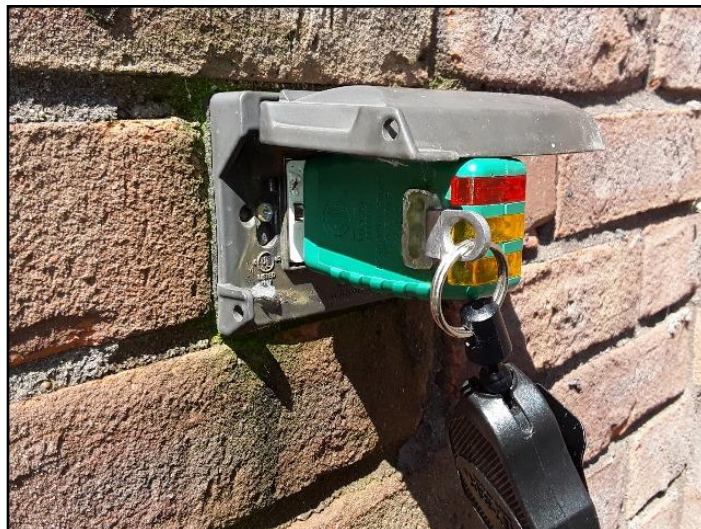
13. Inoperative

8. Condition: • [Inoperative](#)

Implication(s): Equipment inoperative

Location: Front side of garage exterior

Task: Repair or replace

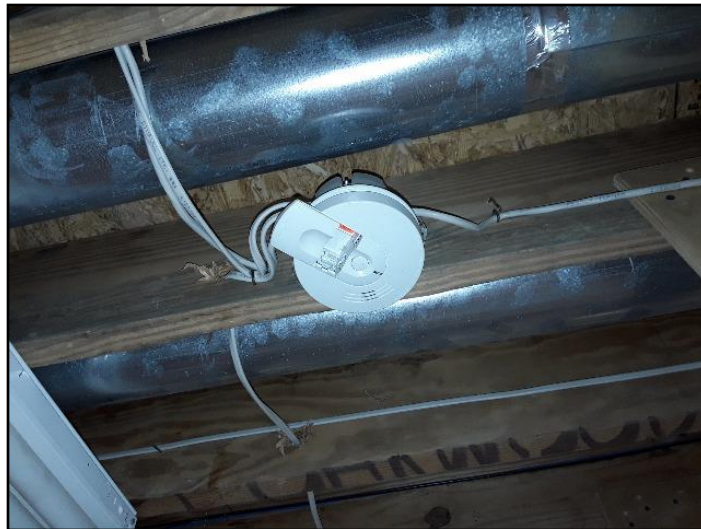
9. Condition: • [Inoperative](#)

Backup battery missing

Implication(s): Fire hazard

Location: Basement

14. *The backup battery has been removed*

Task: Install 10 year backup battery

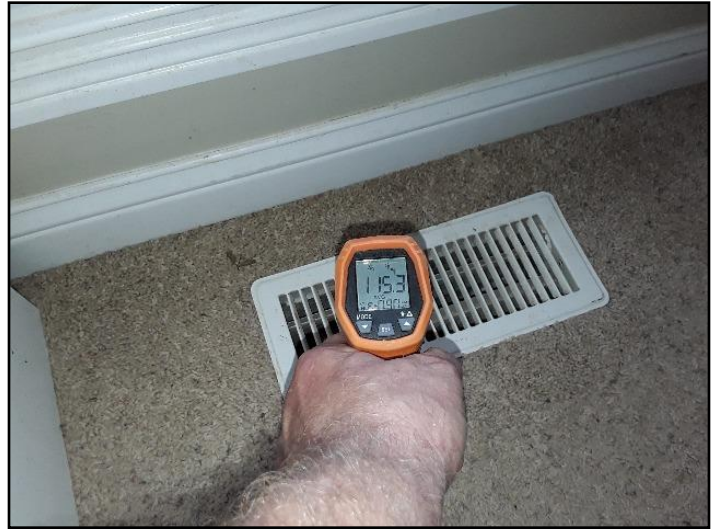
16. Heat supply temp 115 deg

Temperature difference: • 35°

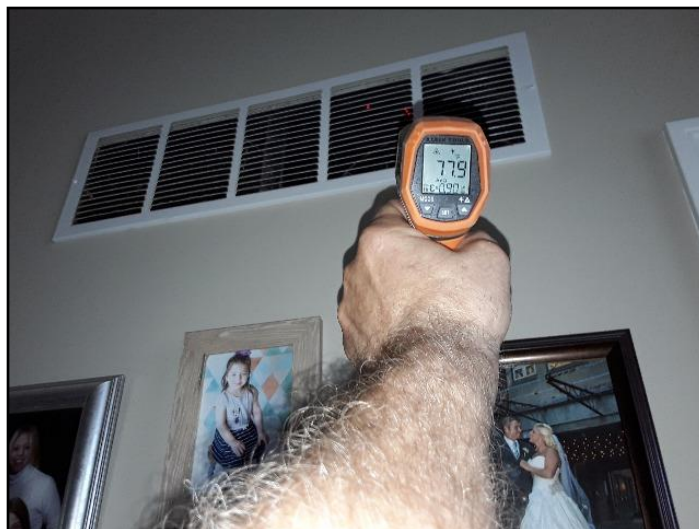
17. Heat return temp 78 deg

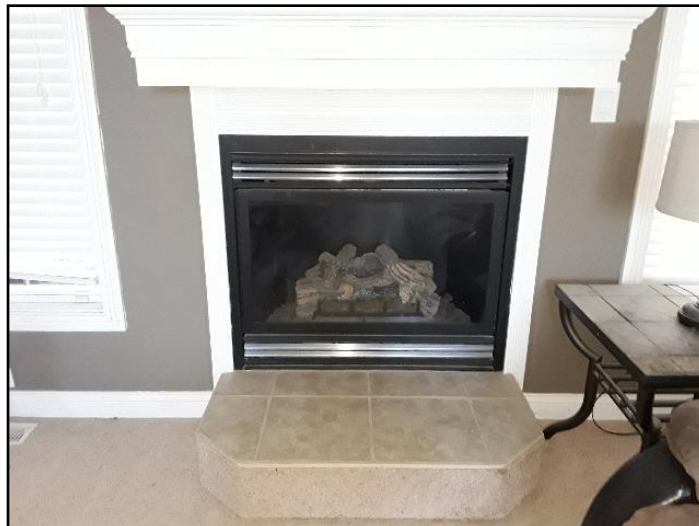
18. Fireplace turned off

The gas fireplace pilot light was not lite so the fireplace was not tested

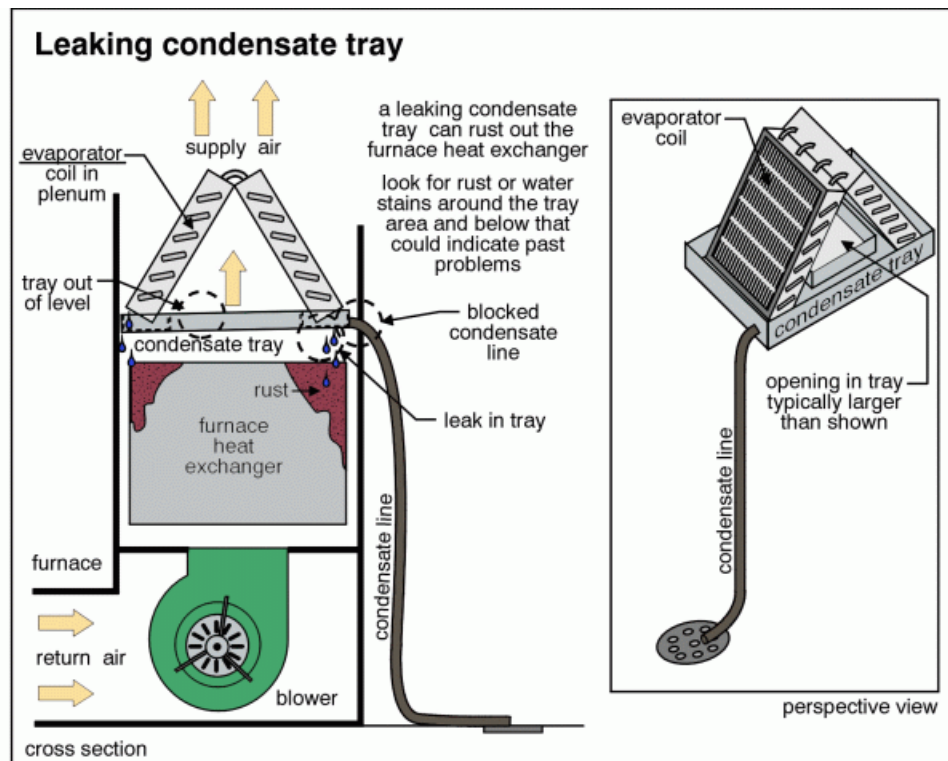
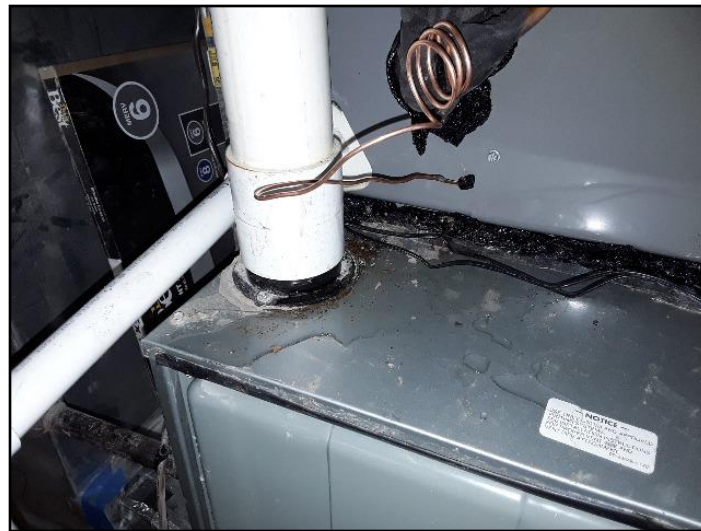
20. Pan leaking

Condition: • [Pan leaking](#)

Water was noted on the furnace beneath the A-coil and water was noted on the floor. This may indicate a leak or clogged condensate drain line.

11. Condition: • [Pan leaking](#)

Implication(s): Chance of water damage to contents, finishes and/or structure | Damage to equipment

Task: Have evaluate by a qualified HVAC serviceman

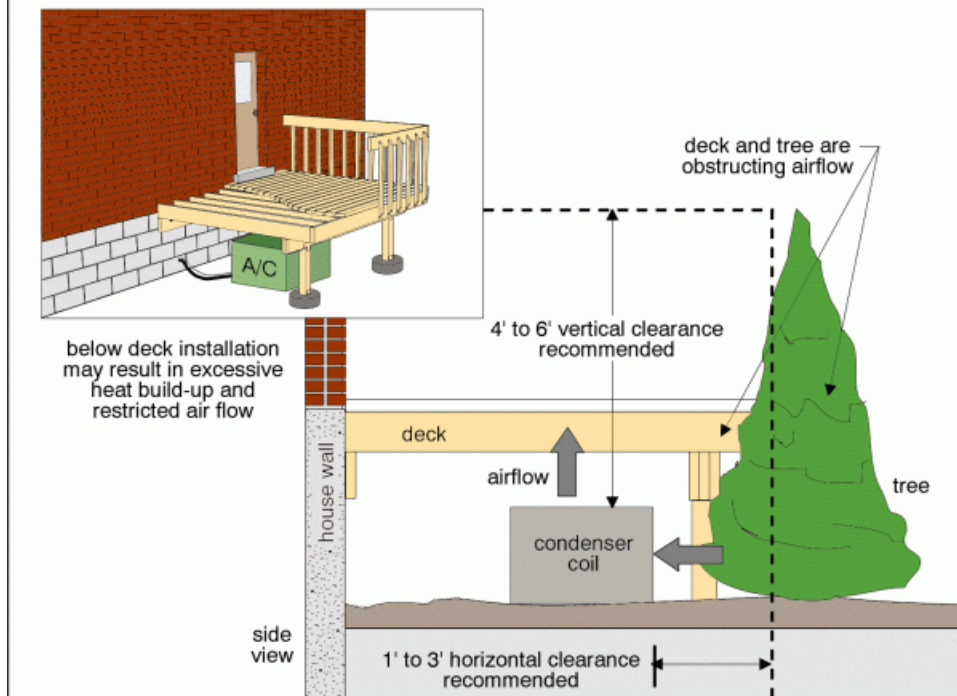
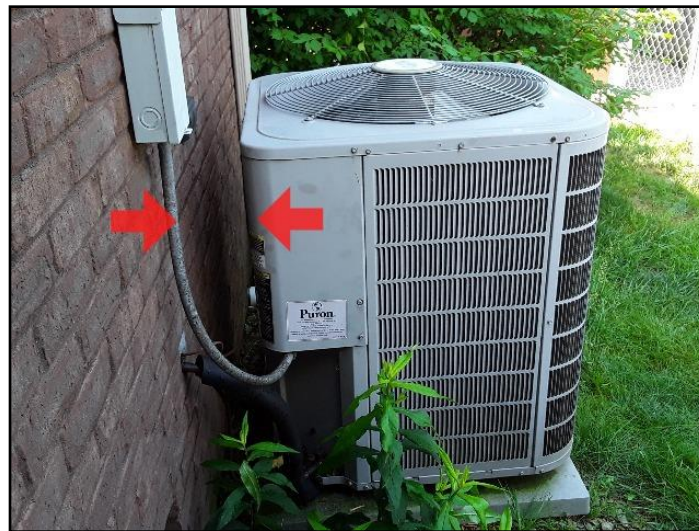
21. Too close to house

12. Condition: • [Poor location](#)

The A/C compressor unit was too close the the house. Recommended distance is 18" minimum.

Implication(s): Reduced system life expectancy | Increased cooling costs | Reduced comfort

Task: It would not be practical to move this unit, but when this unit is eventually replaced, install the new one further out.

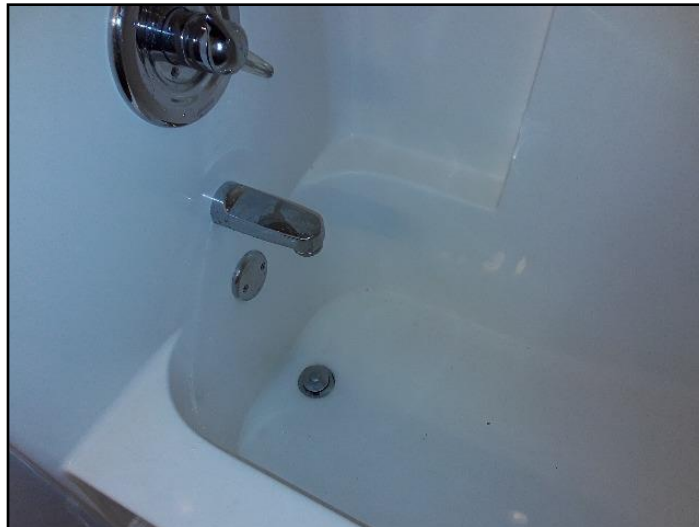
29. Slow drain

13. Condition: • [Slow drain](#)

Implication(s): Chance of water damage to contents, finishes and/or structure

Location: Hall bath

Task: Clear drain, if that doesn't fix it have evaluate by a plumber

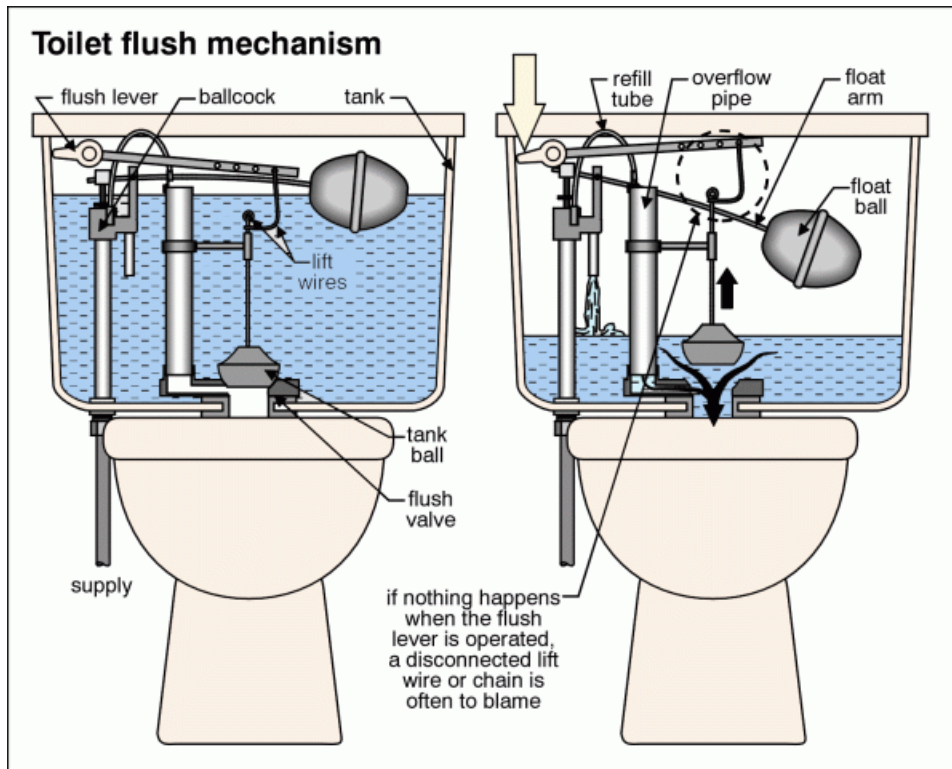
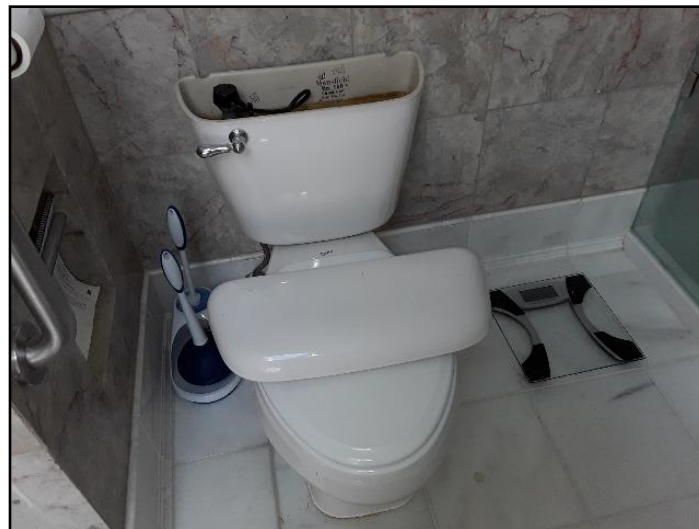
30. Running continuously

14. Condition: • [Running continuously](#)

Toilet in master bath runs

Implication(s): Chance of condensation damage to finishes and/or structure | Increased water consumption

Task: Replace the flush valve mechanisms

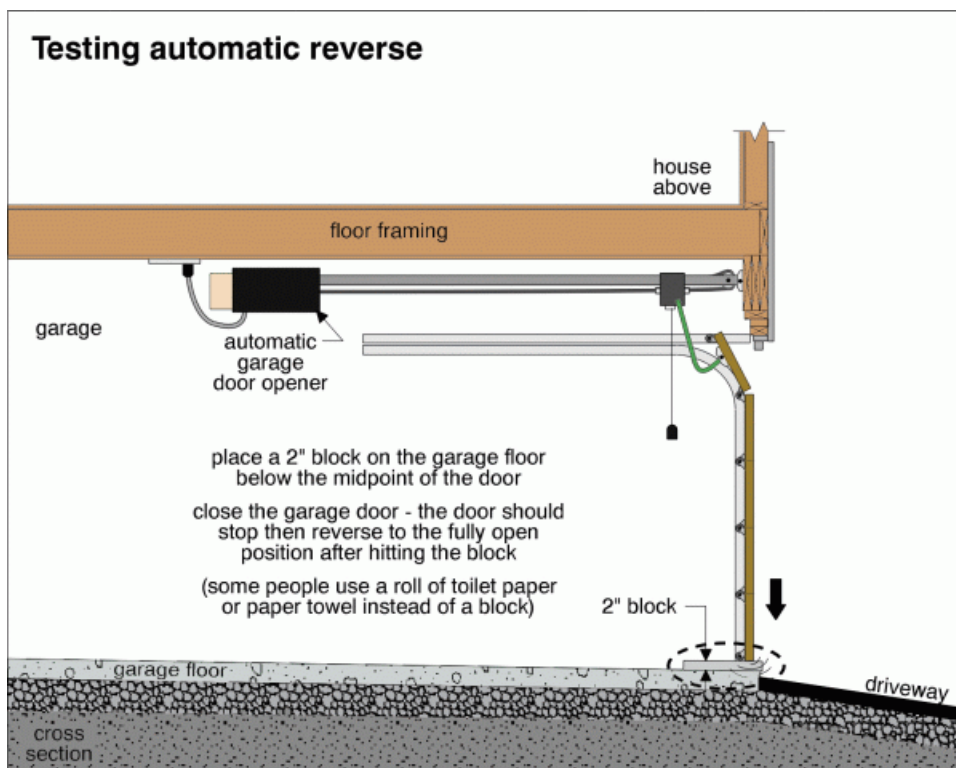
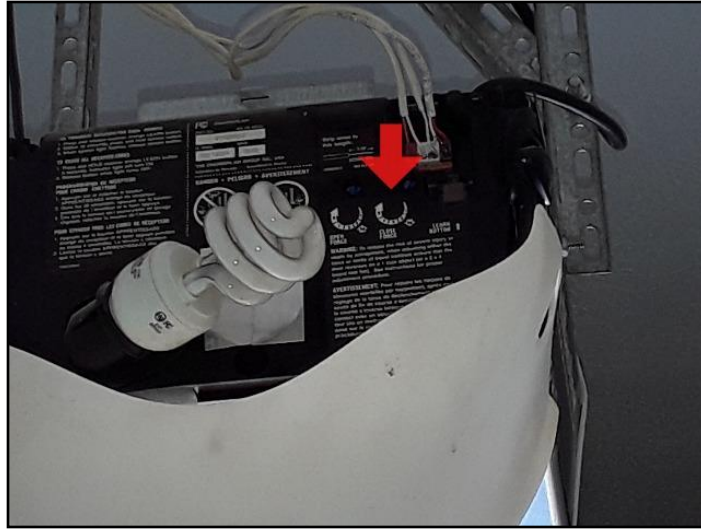
32. Adjustment needed to open or close pressure

15. Condition: • [Adjustment needed to open or close limits](#)

Pressure sensitive level was set too high for the auto-reverse to work properly. This will cause the door to close with too much pressure, possible injuring persons or property.

Location: Garage vehicle door

Task: Adjust pressure sensor adjustment of garage door operator. FYI, don't use a hard object to test door.
