296 Douglas Dr Toronto, ON M4W 2C2

INSPECTION DATE: Thursday, June 2, 2022

PREPARED BY: Walter Collodel, P.Eng.

RE: Report No. 81792, v.2 296 Douglas Dr Toronto, ON M4W 2C2

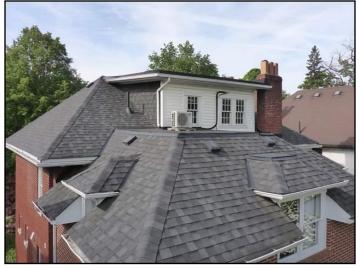
Condition: • Complex roof layout creates numerous vulnerable areas

Complex roof layout

Task: Monitor

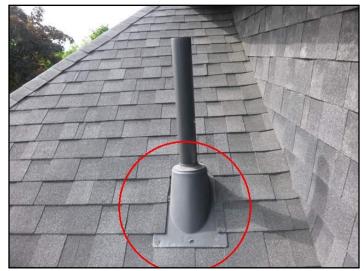
The plumbing stack flashing was manufactured in 2016. The roof is presumed to be six years old.

Plumbing stack flashing (circled)

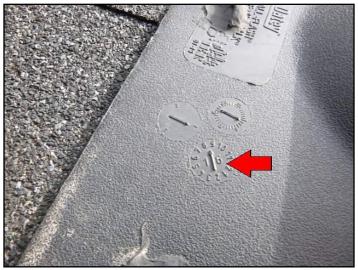
Flashing manufactured in 2016

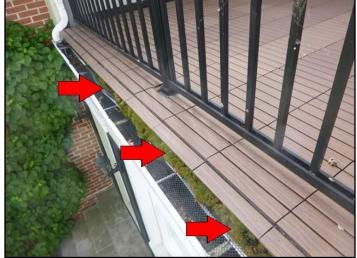
Mossy build-up at edge of flat roof

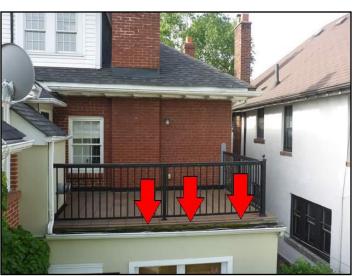
Moss at flat roof edge

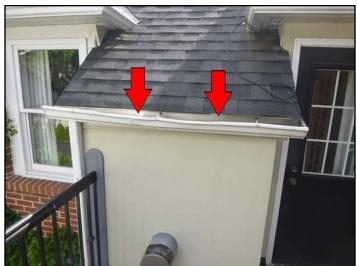
Condition: • Damage Location: Second Floor Deck Task: Repair / Replace Time: As necessary

Damaged (bent/sagging) gutter

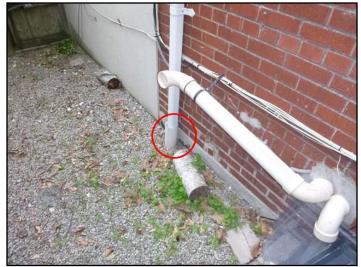
Condition: • Downspouts that discharge below grade may leak or be clogged, resulting in water in the basement or crawlspace.

Discharge below grade (rear)

Task: Re-direct downspouts to discharge above grade at least 6 feet from home.

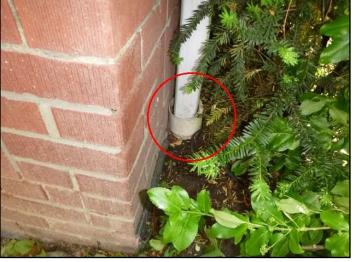
Discharge below grade (front)

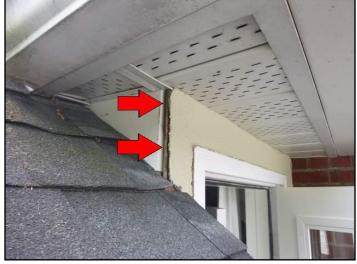
Condition: • Exposed wood

Unprotected wood was noted in some areas above the second floor balcony. General clean up is needed to ensure water/wind stays out.

Exposed wood, gaps at second floor walkout

Task: Improve

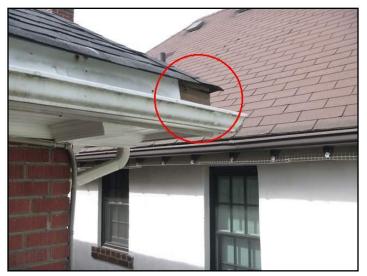
Exposed wood at fascia

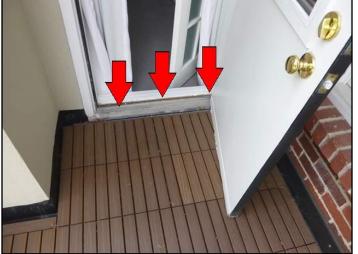
Condition: • Threshold - ineffective

Threshold - minimal

Task: Monitor / Improve

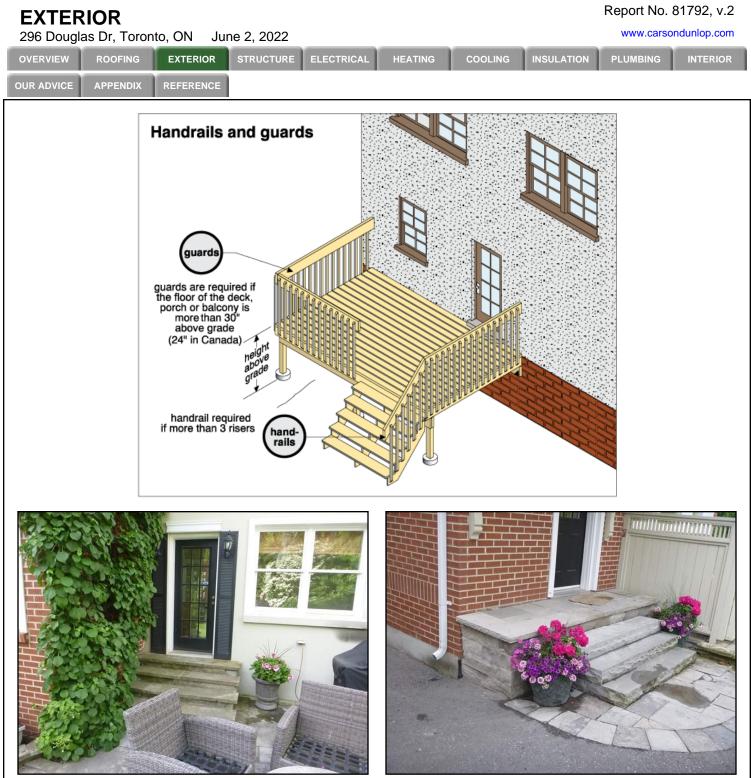
Condition: • Missing railings Location: Rear Steps Task: Improve Time: As necessary

Missing railings

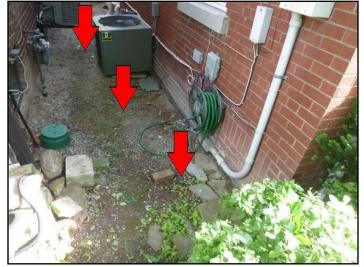
There are low areas at the garage and between houses that may not drain effectively. Monitor these areas closely. Improvements may be needed to ensure water drains away properly.

Low area between houses

Task: Monitor / Improve

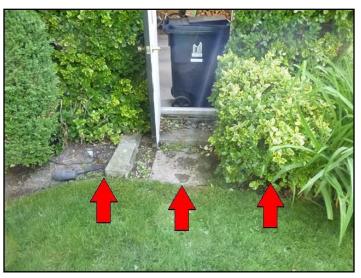
Low area- water drains towards garage

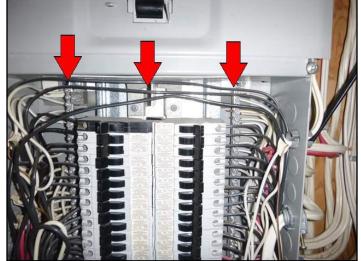
Condition: • Wire crossing bus connections Task: Correct Cost: Minor

Wires crossing bus connections

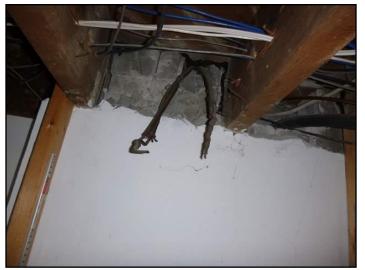
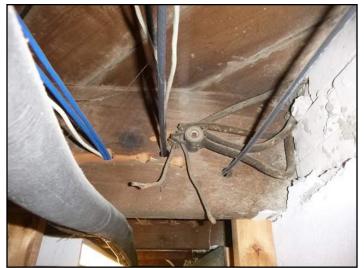
Condition: • Some remnants of knob-and-tube wiring found but appeared to be inactive. There is a possibility that there is active knob-and-tube in the home which maybe discovered in the future and/or during a renovation. Typical of many renovated homes, some abandoned knob and tube components were noted in the basement. No energized or active knob and tube wiring was found at the inspection. It is presumed that the knob and tube was removed/disconnected when renovations were done but this could not be confirmed.

Remnants of knob-and-tube wiring

Task: Replace (if found active) when remodeling. In the short term, ground fault circuit interrupters (GFCIs) are an inexpensive way to help protect against electric shocks. Further evaluation.

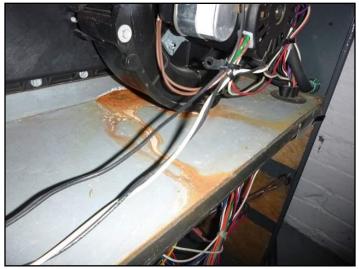
Condition: • Rust

There is a rust stain under the condensate collection area but no evidence of an active condensate leak. Have this checked out when the furnace is serviced.

Rust in furnace cabinet

Task: Further evaluation / Repair

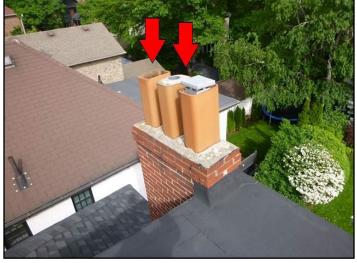
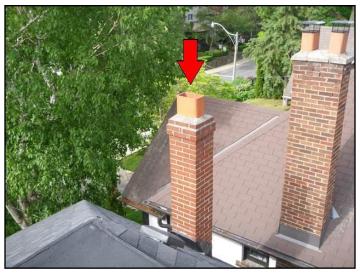
Condition: • <u>Screen missing or damaged</u> Provide screens at chimney flues to keep animals out. Location: Various Task: Provide Time: Less than 1 year Cost: Minor

Screen missing

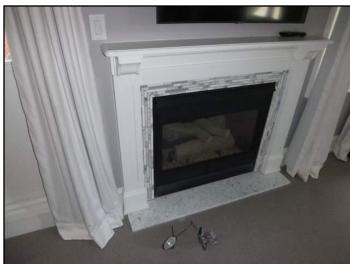
Condition: • Inoperative

Fireplace would not start up using normal controls. Ask seller to show it is functional.

Inoperative? controls not found

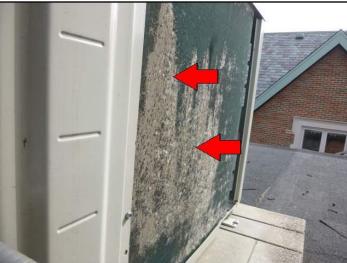
Condition: • Dirty

Dirty condenser coil (rooftop unit)

Clean coil fins with garden hose pressure only. Location: Second Floor (rooftop unit) Task: Clean

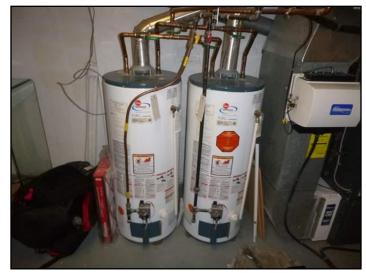
There are two water heaters in the basement. The are plumbed together to act as one big tank. Seller reports that the tanks are rented. Confirm details of the rental agreement with the seller.

Two water tanks in basement

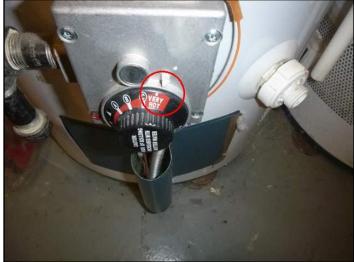
Condition: • Mixing/tempering valve - not present *Recommended to reduce risk of scalding Hot water was very hot at the inspection. Adjust the thermostats at both tanks or install a mixing valve. Task: Provide Time: If necessary Cost: Minor

Thermostat set to maximum (typ.)

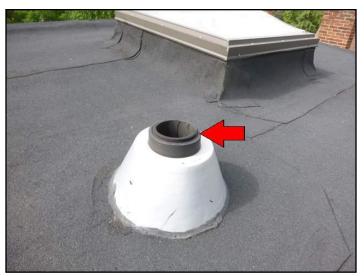
Condition: • <u>Vent termination problems</u>

Plumbing stack is too short and can be easily obstructed by snow and ice. Extension of the stack is recommended. **Location**: Upper Flat Roof

Stack too short?

Task: Improve

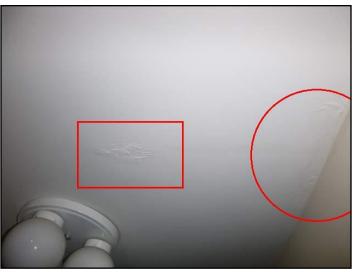
Condition: • Water damage

Suspect a prior leak at the kitchen above. This area was completely dry at the inspection. The issue appears to have been resolved.

Water damage- dry at inspection

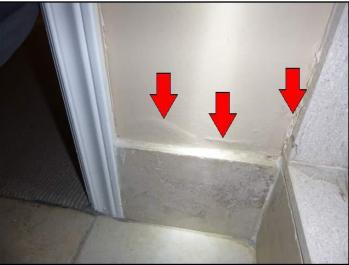
Condition: • Water stains Dry at inspection. Ensure the shower door closes and seals properly when used. **Location**: Basement Bathroom

Water stains at basement shower entrance

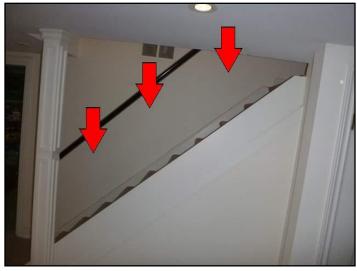
Condition: • Missing Open side at stairwell may be a fall hazard for small children. Location: Basement Staircase Task: Improve Time: If/as necessary

Missing side guard at basement stairs

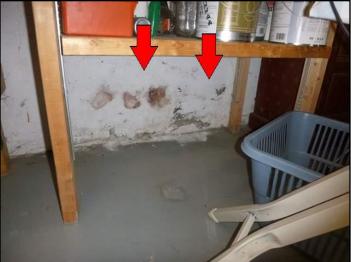
Condition: • Efflorescence

There is a small amount of efflorescence on the furnace room (west basement wall). A small amount of efflorescence is very common in houses with basements of this vintage.

Efflorescence

Task: Monitor

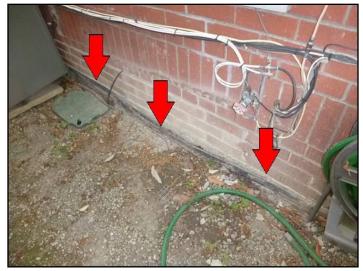
Condition:
• <u>New dampproofing material</u>

Interior and exterior waterproofing membranes were noted in the home. Ask seller for details regarding any waterproofing work done on the home.

Exterior damp proofing material (west side)

Task: Request Information
