YOUR INSPECTION REPORT

Thursday, February 9, 2012

DJ's Home Inspections
52 Irving Crescent
Red Deer, AB T4R 3R9

RE: Report No. 1046, v.7

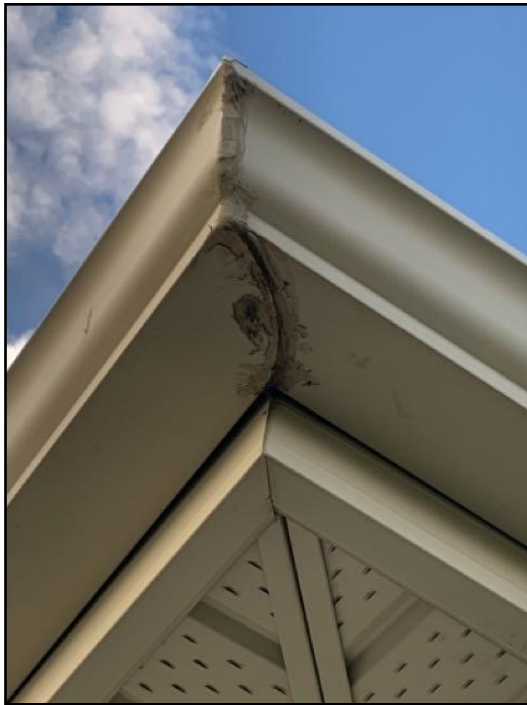
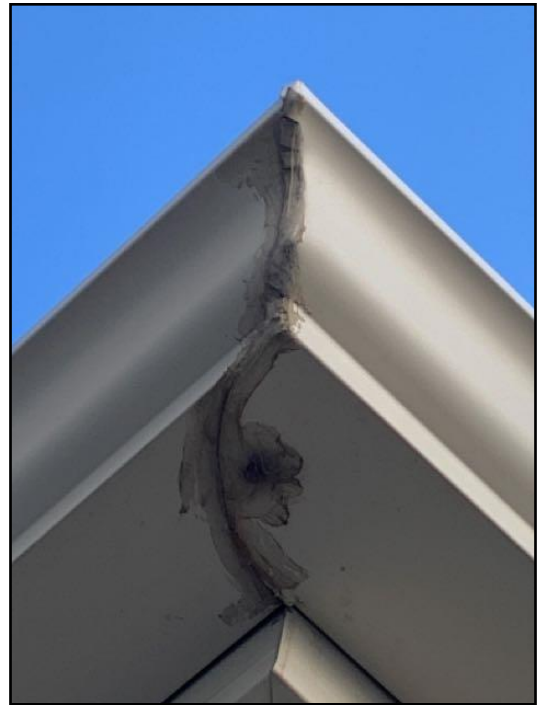
9.

3. Condition: • [Leak](#)

Implication(s): Chance of water damage to structure, finishes and contents

Location: Roof

Task: Have a certified specialist repair

Time: At time of possession

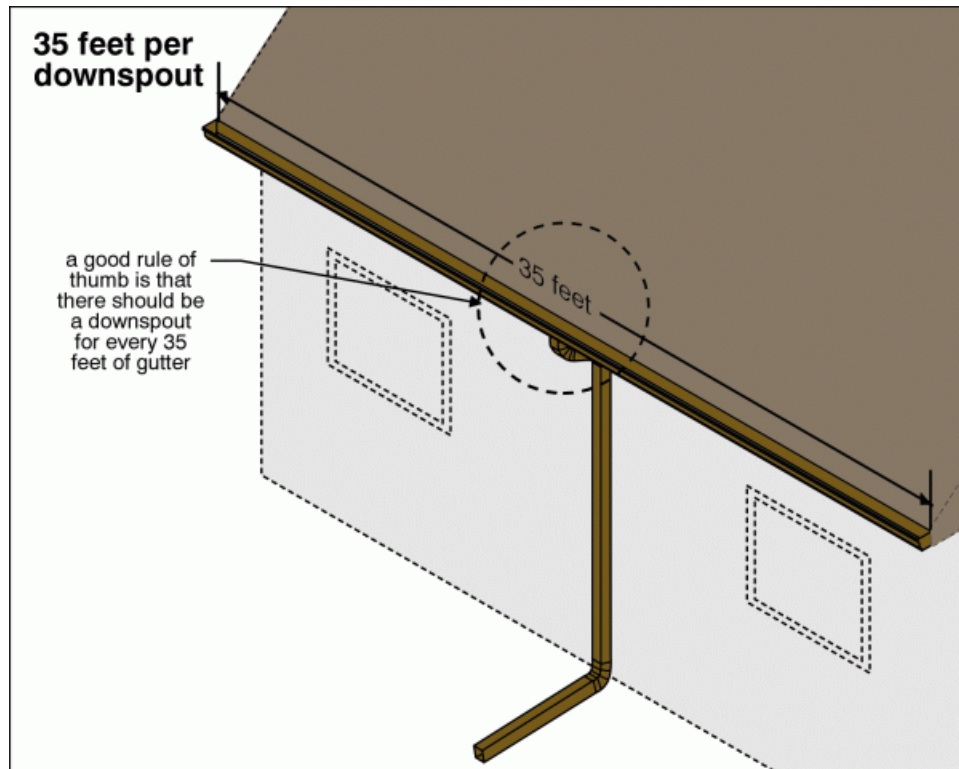
4. Condition: • [Too few](#)

It is important to keep gutters clean and free of dirt/debris when excessive gutter length without downspouts every 35 feet.

Implication(s): Chance of water damage to structure, finishes and contents

Location: Roof

Task: Have a certified specialist clean

Time: Regular Maintenance

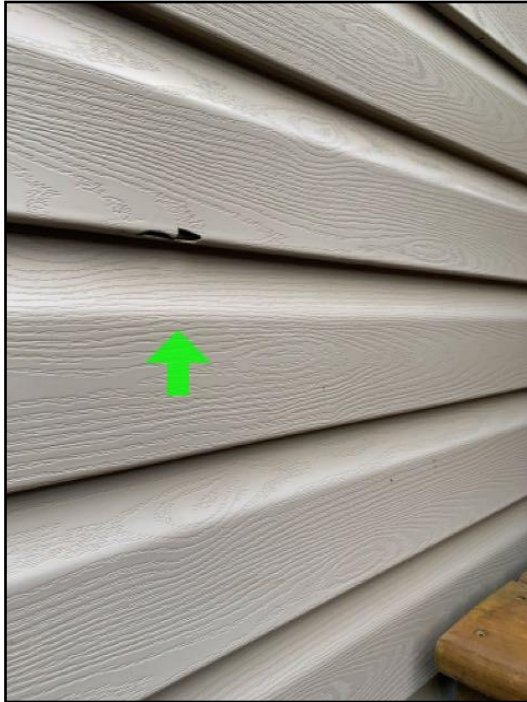
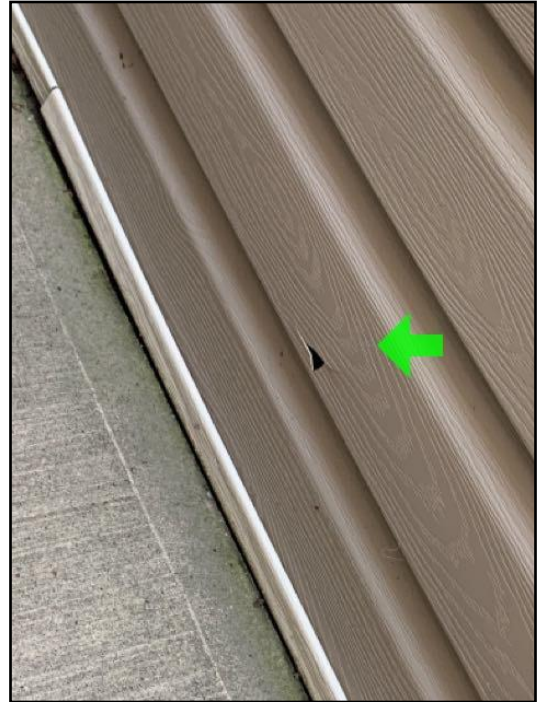
11.

5. Condition: • [Mechanical damage](#)

Implication(s): Chance of water damage to structure, finishes and contents

Location: Exterior Wall

Task: Have a certified specialist replace

Time: Discretionary

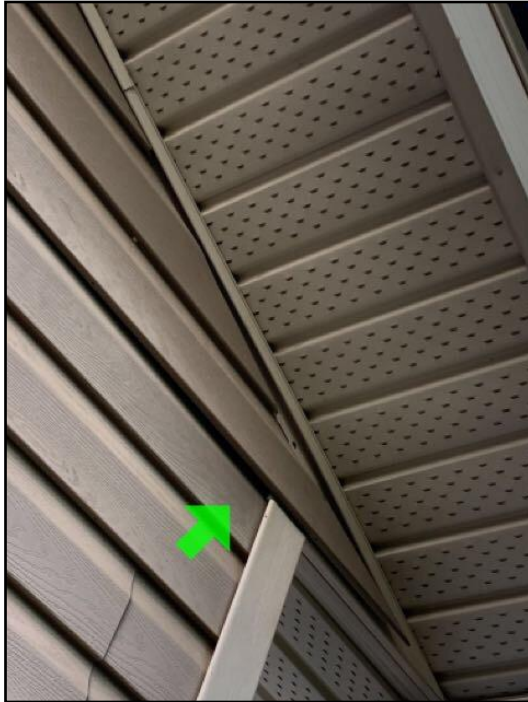
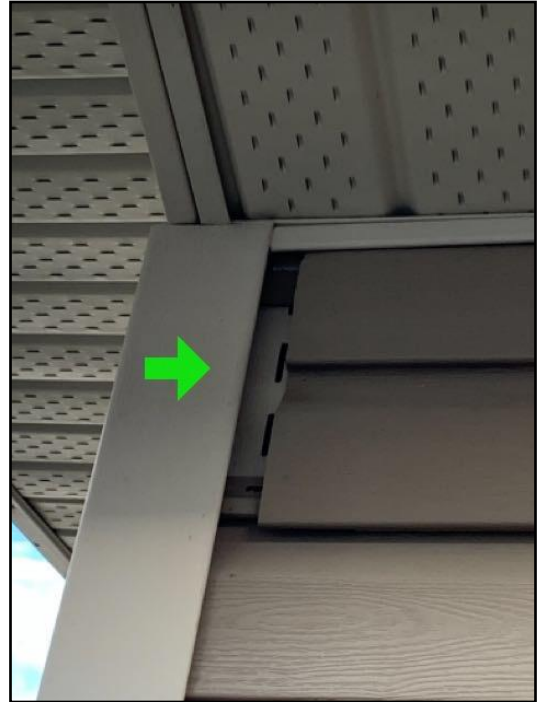
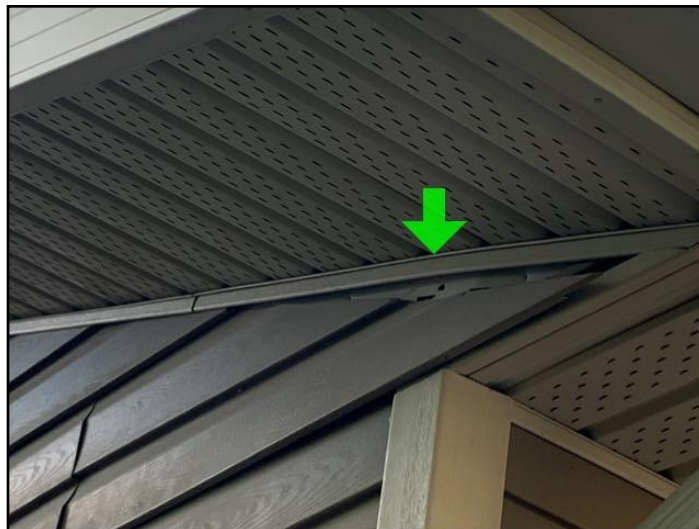
13.

6. Condition: • [Loose or missing pieces](#)

Implication(s): Chance of water damage to structure, finishes and contents

Location: Exterior Wall

Task: Have a certified specialist improve

Time: At time of possession

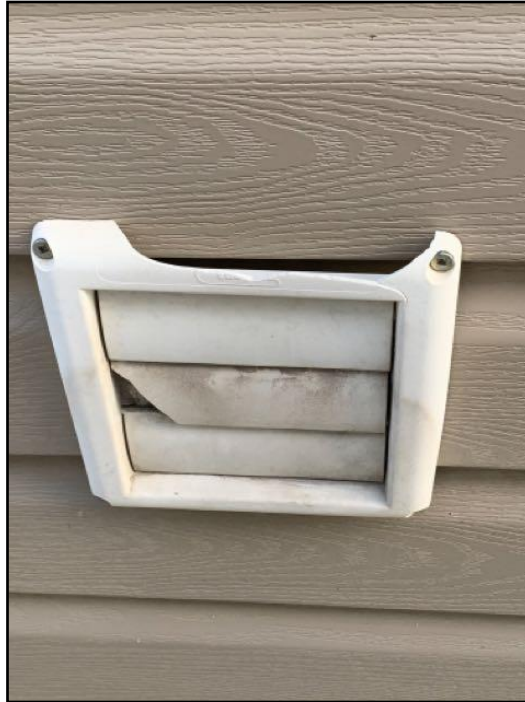
16.

7. Condition: • Cover damaged

Implication(s): Increased operating costs

Location: Exterior Wall

Task: Replace

Time: At time of possession

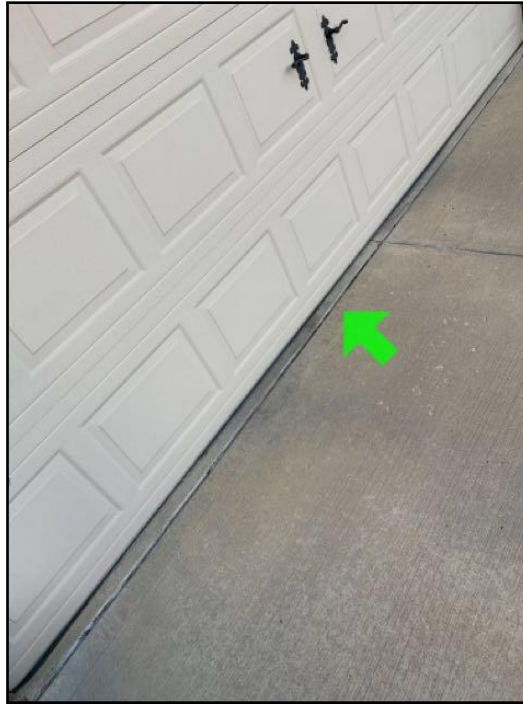
17.

11. Condition: • [Unsealed gap at building](#)

Implication(s): Chance of water damage to structure, finishes and contents

Location: Driveway

Task: Protect

Time: Regular maintenance

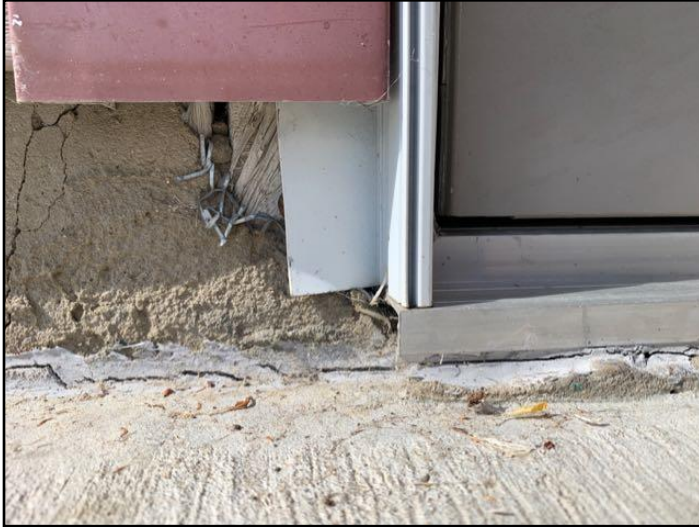
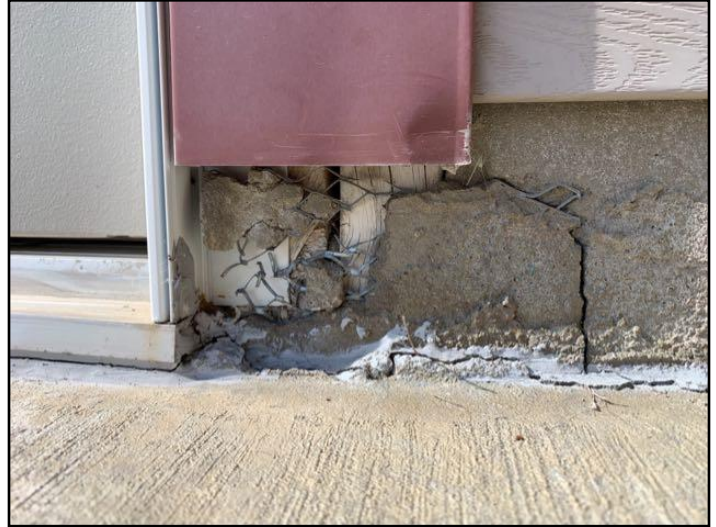
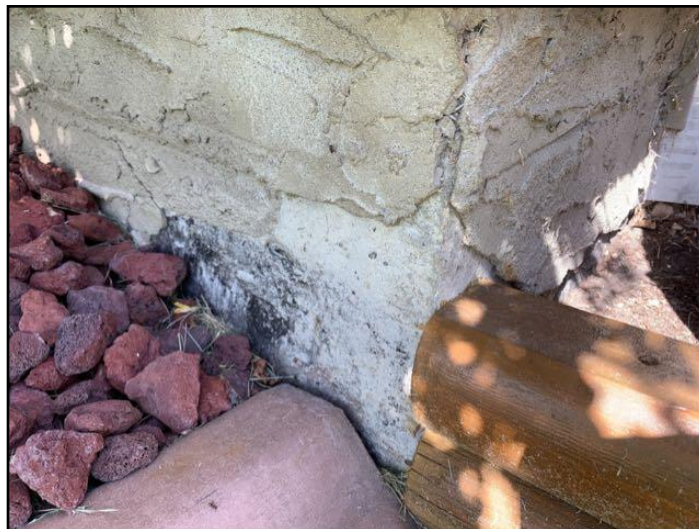
18.

13. Condition: • [Parging damaged or missing](#)

Implication(s): Chance of damage to structure | Shortened life expectancy of material

Location: Exterior Wall

Task: Have a certified specialist improve

Time: When remodeling

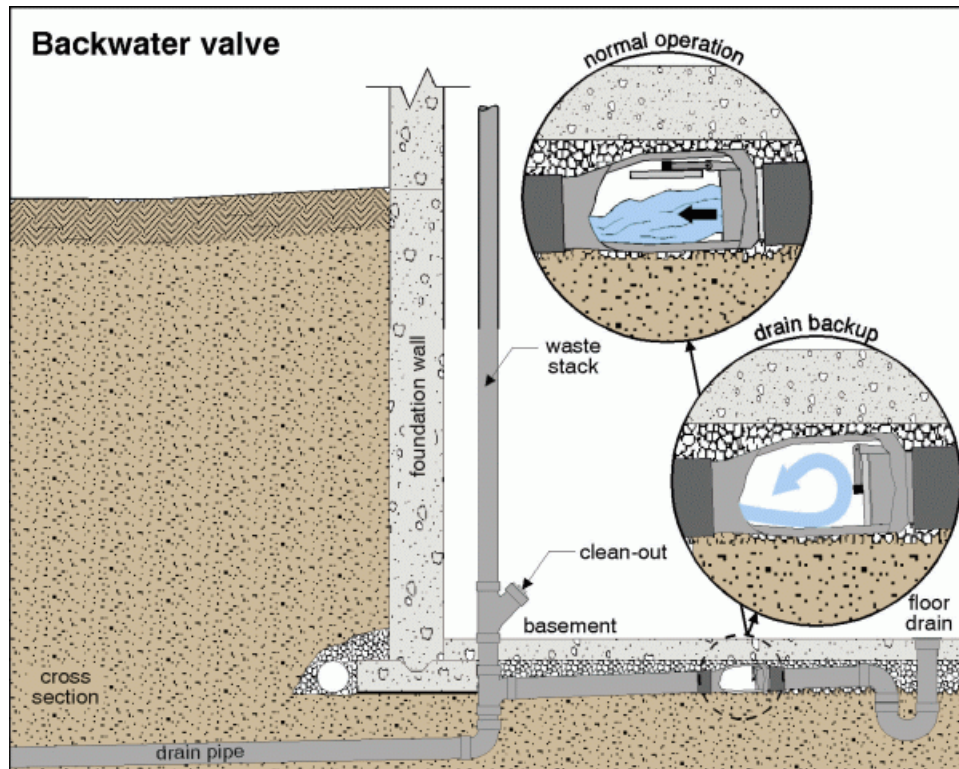
21. Condition: • Cover not removed

Recommend certified specialist locate backwater valve remove cover and inspect flapper assembly and it's performance

Task: Have a certified specialist further evaluate

Time: At time of possession

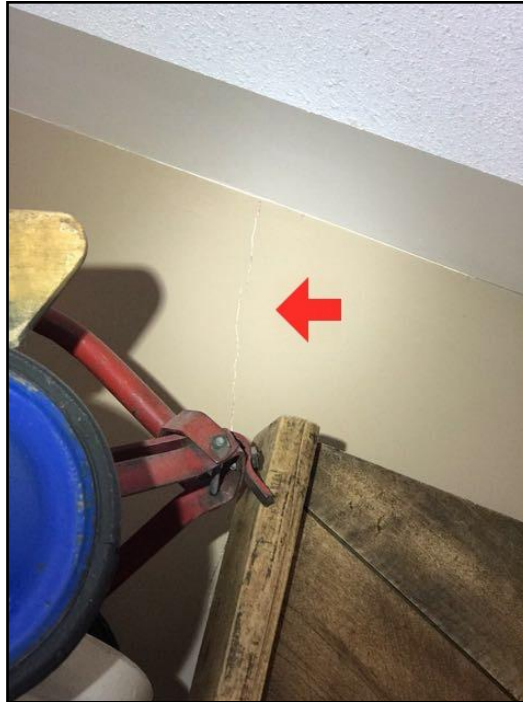
46.

22. Condition: • Cracks

Implication(s): Chance of structural movement | Damage or physical injury due to falling materials

Task: Repair

Time: When remodeling

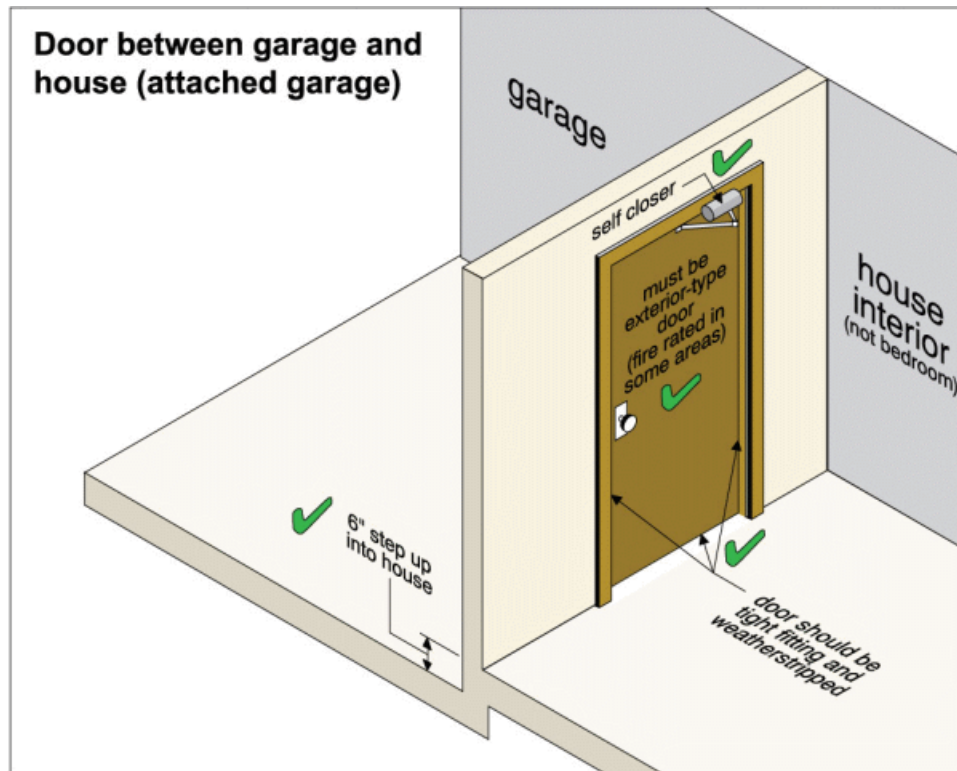
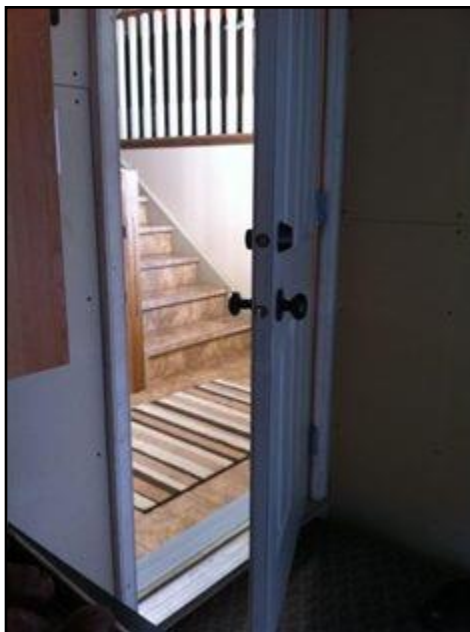
47.

25. Condition: • Does not close door fully

Implication(s): Hazardous combustion products entering home

Task: Have a certified specialist improve

Time: At time of possession

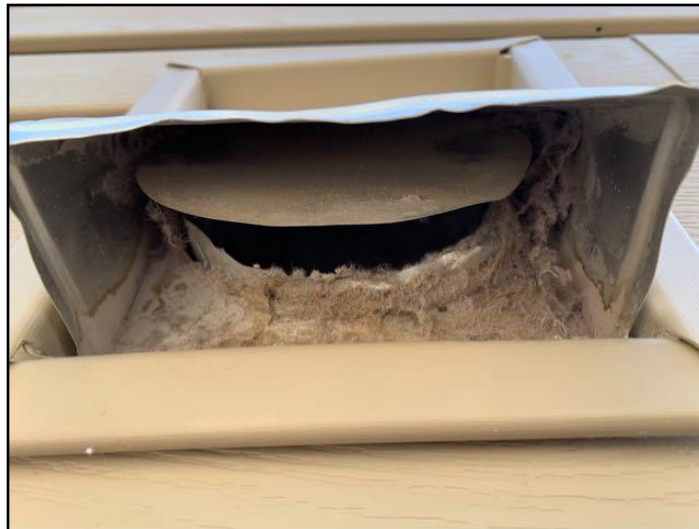
48.

26. Condition: • Dryer vent obstructed

Implication(s): Equipment ineffective | Fire hazard

Task: Clean

Time: Regular maintenance
