INSPECTION REPORT

133 Allanhurst Drive Toronto, ON M9A 4K5

RE: Report No. 1079 133 Allanhurst Drive Toronto, ON M9A 4K5

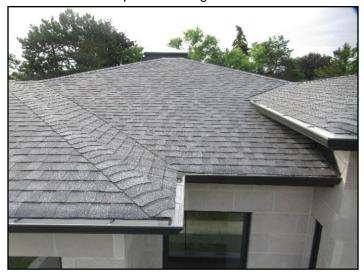
• Architectural/Composition Shingles

Ex. Architectural/Composition Shingles

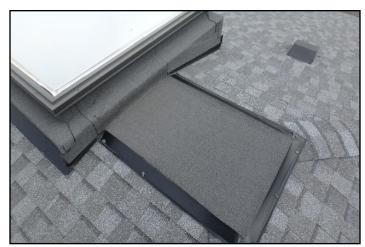
• Modified bitumen membrane

Ex. Modified bitumen membrane

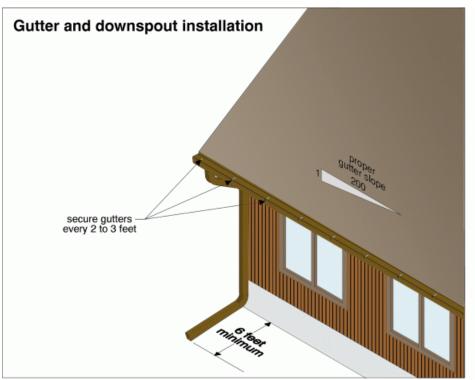
Condition: • Discharge too close to building

Location: Various exterior

It is recommended to discharge all downspouts at least 4-6' away from the building wherever possible to help prevent water penetration into the basement.

Task: Improve

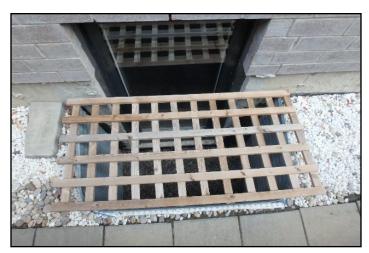
Condition: • Weak covers over the window well(s) are a potential fall/safety hazard.

Ex. Weak cover

Task: Improve

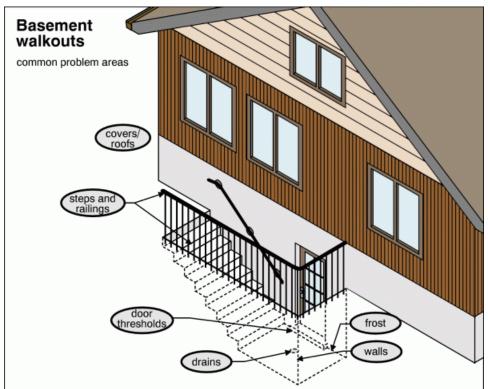
Condition: • Drains missing, clogged or undersized

Drains missing, clogged or undersized

Cost: Regular maintenance item

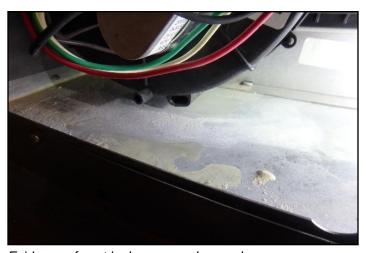
Condition: • Evidence of past leakage was observed. See COOLING section (likely source of prior leakage)

Evidence of past leakage was observed.

Task: Have looked at during the next regular servicing
