YOUR INSPECTION REPORT

321 Home Inspection Blvd.
Fresno, CA 93711

Sunday, November 25, 2012

RE: Report No. 1284, v.3
321 Home Inspection Blvd.
Fresno, CA
93711

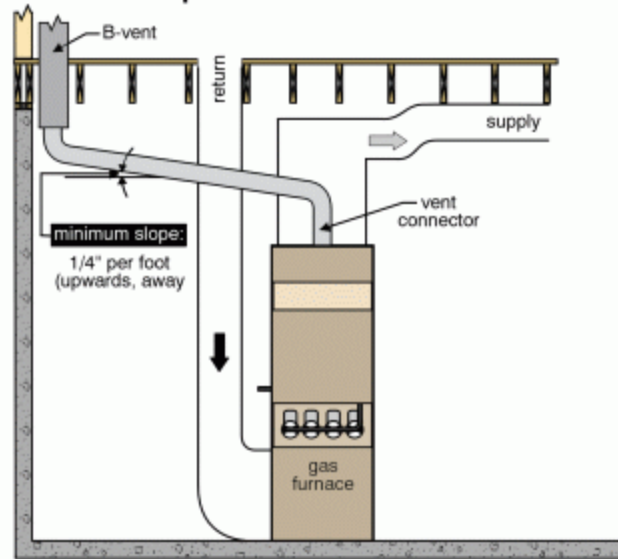
Vent connector slope

5. Condition: • [Poor slope](#)

Furnace exhaust system is terminating in crawlspace allowing flue gases to enter home. Recommend a qualified HVAC contractor to correct. HAZARD (Dangerous to human life)

Implication(s): Equipment not operating properly | Hazardous combustion products entering home
