YOUR INSPECTION REPORT

123 Any Street
Anytown, KS 11111

Monday, August 22, 2011

RE: Report No. 1160, v.6
123 Any Street
Anytown, KS
11111

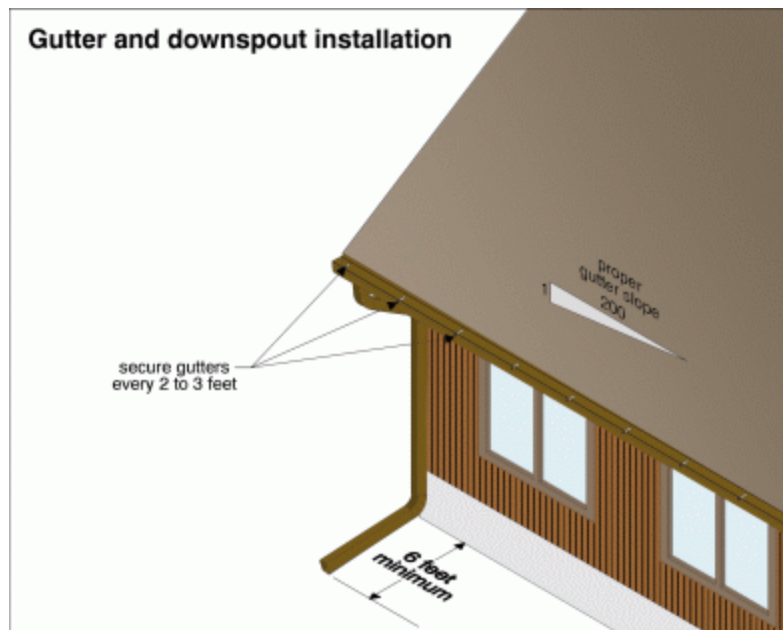
1. Condition: • Should discharge 6ft. from home

Implication(s): Chance of water damage to contents, finishes and/or structure

Task: Repair

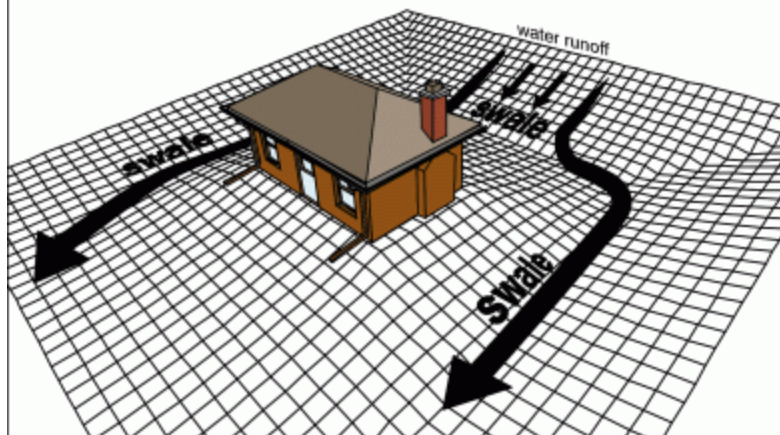
Swales

when the overall lot drainage is toward the house, swales can be used to direct surface water away from the foundation
