Your Inspection Report

123 Karter Street
Saskatoon, SK

Tuesday, October 9, 2012

RE: Report No. 1014, v.6
123 Karter Street
Saskatoon, SK

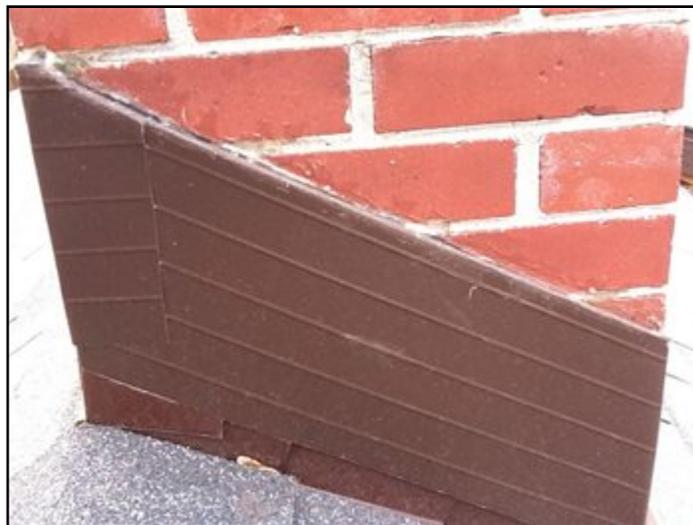
15. *Not let into mortar joints*

2. Condition: • Not let into mortar joints
flashing was not let into mortar joints but was secure and siliconed.

Implication(s): Chance of water damage to contents, finishes and/or structure

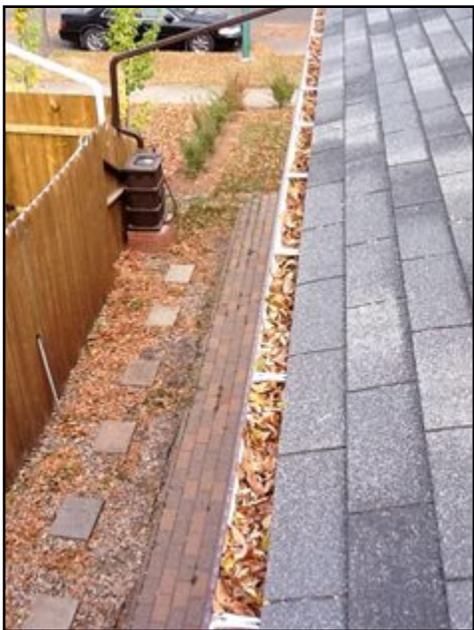
16. Clogged

3. Condition: • Clogged
gutters were full of leaves

Implication(s): Chance of water damage to contents, finishes and/or structure
