INSPECTION REPORT

For the Property at:
32819 XXXXXX AVE
MISSION, BC V2V2J9

Prepared for: TOM CUSTOMER
Inspection Date: Thursday, January 13, 2011
Prepared by: Doug Johns

RE: Report No. 1003, v.12
32819 xxxxxx Ave
Mission, BC
V2V2J9

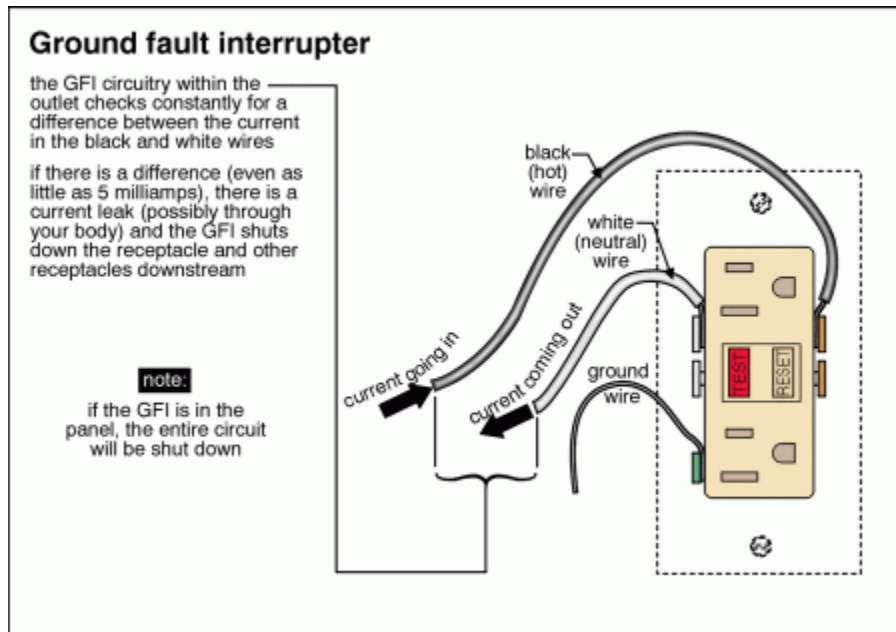
Condition: • [Ground Fault Interrupter \(GFI\) needed](#)

No GFI noted on upstairs of home.

Task: Correct Monitor Repair or replace Request disclosure

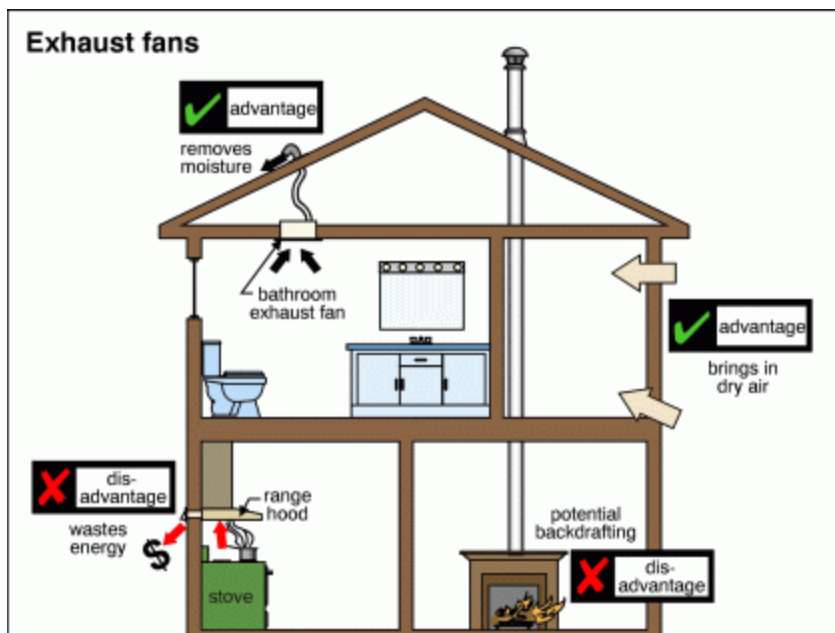
17. loose telephone wires and exhaust fan

Condition: • [Not vented to exterior](#)

Disconnected bathroom exhaust fan noted in Attic as well as loose telephone wires. Recommend further investigation by qualified professional. Mold/mildew present.

Implication(s): Chance of condensation damage to finishes and/or structure

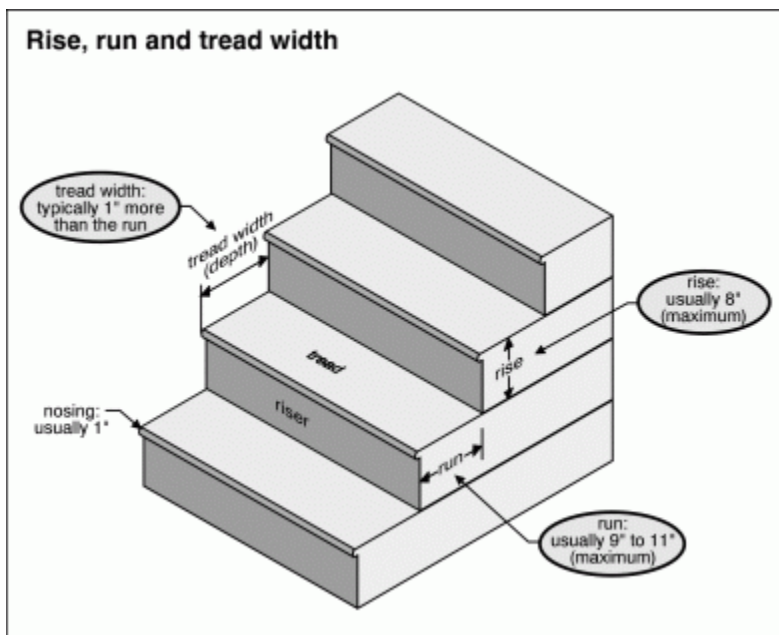
8. Condition: • [Landings missing or undersized](#)

Deck at the rear of the home has not been properly built. No newel posts have been used and Guard rail and balustrade have not been properly secured. Inspector recommends consulting a qualified carpenter to rebuild

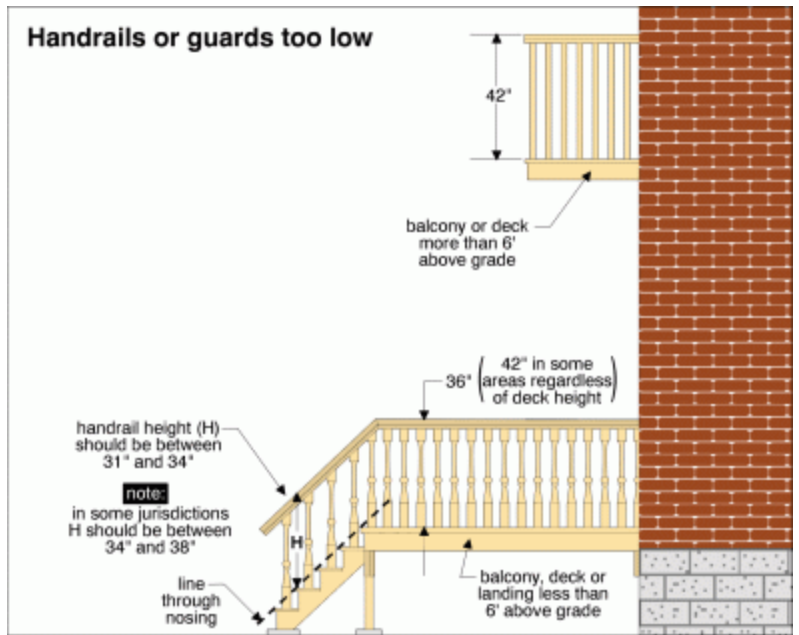
PORCHES, DECKS, STEPS, PATIOS AND BALCONIES \ General

13. Condition: • Poorly built

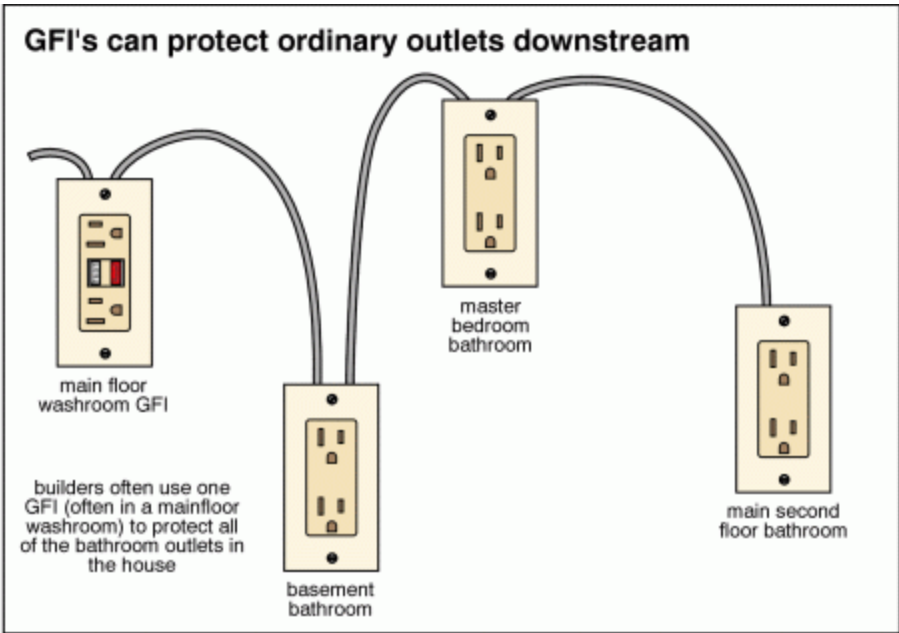
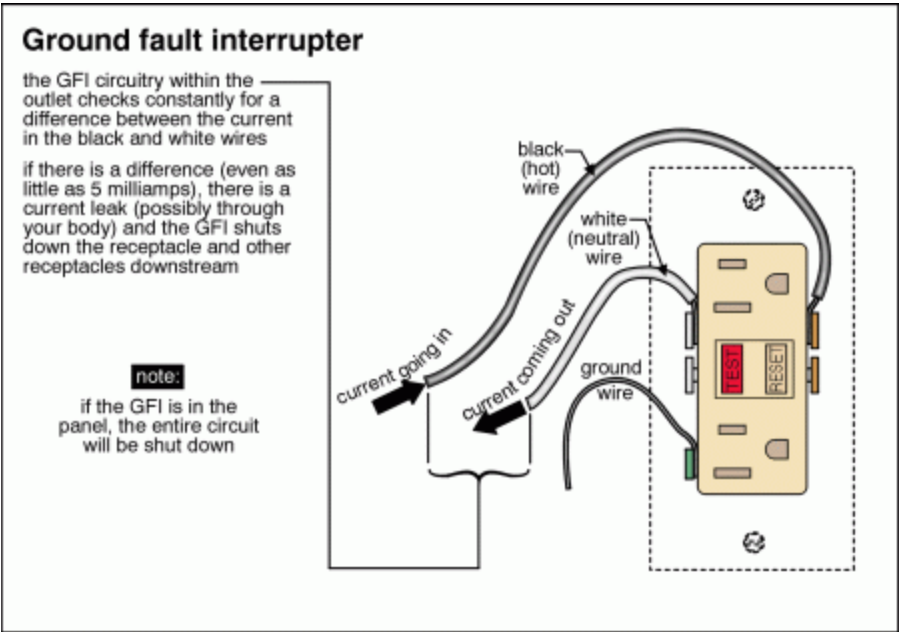
17. Condition: • [Ground Fault Interrupter \(GFI\) needed](#)
No GFI noted on upstairs of home.
Implication(s): Electric shock
Location: South Second Floor Bathroom
Task: Correct Monitor Repair or replace Request disclosure
Time: Immediate
