# Your Inspection Report

4321 2nd Street  
Surrey, BC V3W 3E5

**INSPECTION DATE:**  
Monday, November 24, 2008

Report No. 1006, v.5

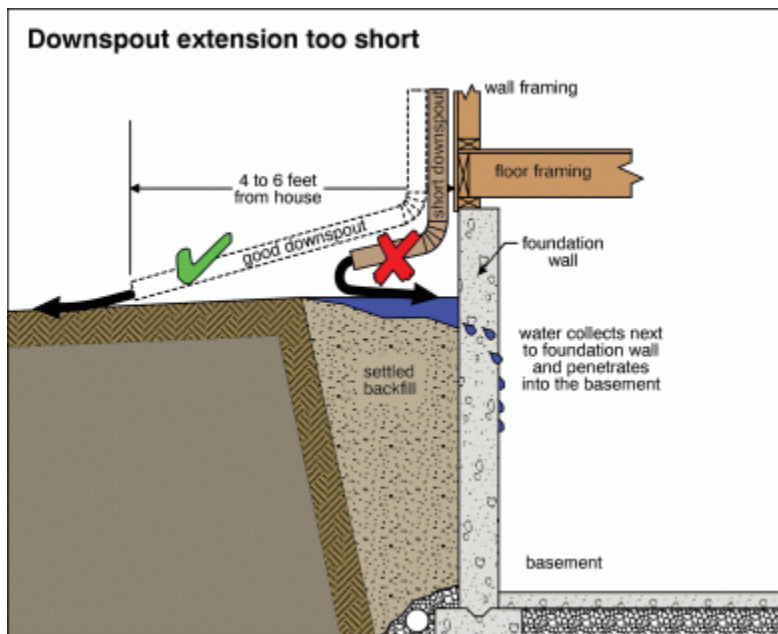
**Condition:** • [Downspouts end too close to building](#)

**Implication(s):** Chance of water damage to contents, finishes and/or structure

**Task:** Improve

**Time:** Less than 1 year
