YOUR Inspection Report

37-39 Hwy 11
Fauquier, ON

Saturday, March 14, 2015

RE: Report No. 1067
37-39 Hwy 11
Fauquier, ON

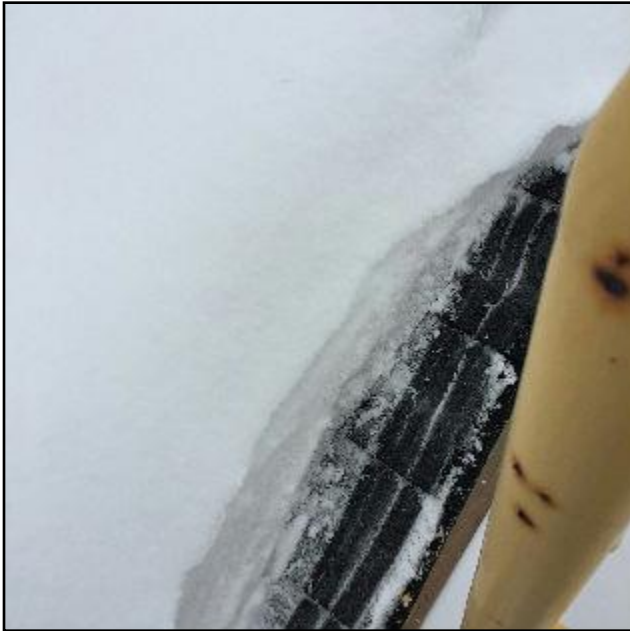
1. Asphalt shingles

The approximate age of the shingles are 10 yrs old, and appear to be in good condition.

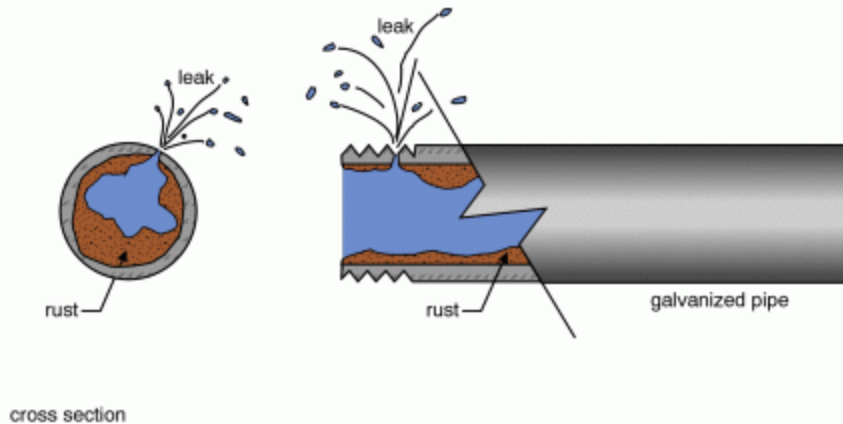
rusting of galvanized pipe can greatly reduce water pressure and will eventually cause leaks as rust creates holes in the pipe walls

problems are likely to occur soonest on pipes carrying hot water, horizontal pipes and at threaded (thinner) sections

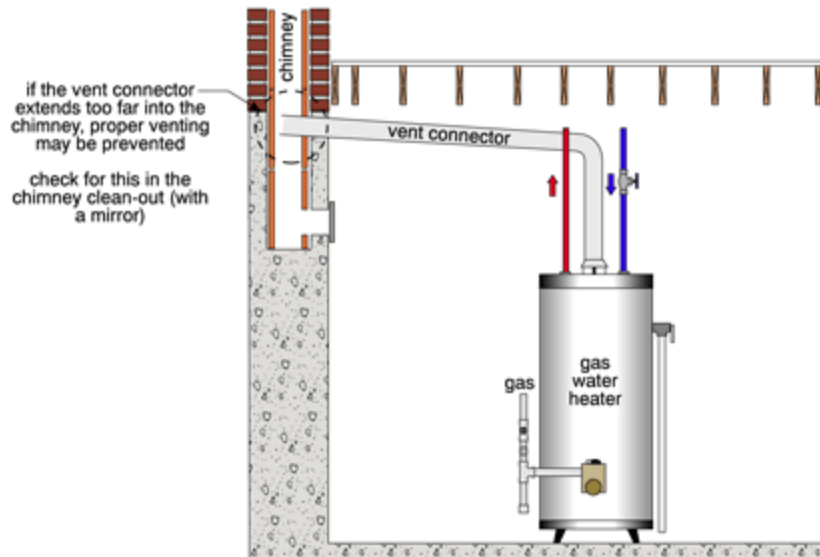
Vent connector extends too far into chimney

Time: Immediate
