YOUR INSPECTION REPORT

demo
demo, VA 11111

Thursday, April 12, 2012

Report No. 1010, v.3

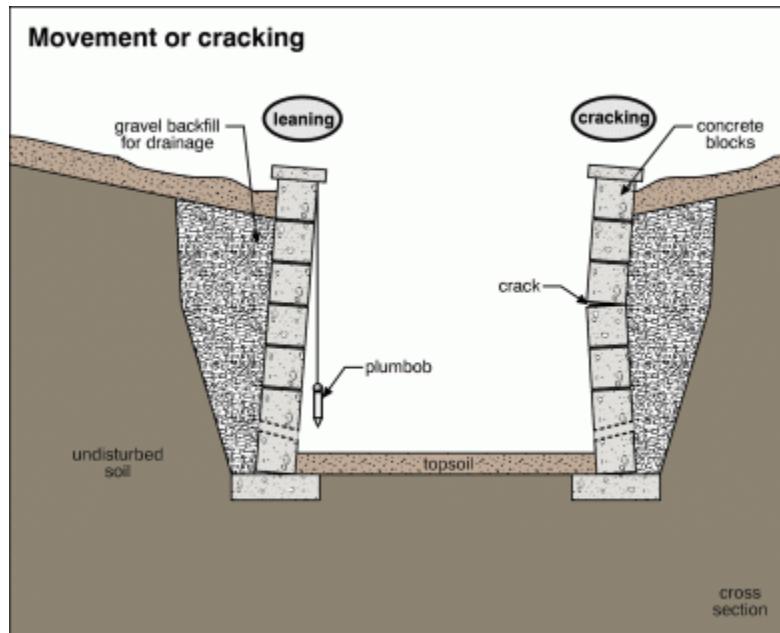
9. Condition: • Varying settlement conditions exist i.e. rotation, bulging, or settlement present in areas of retaining wall.

A licensed and insured contractor should be called to make further evaluation and repairs as needed.

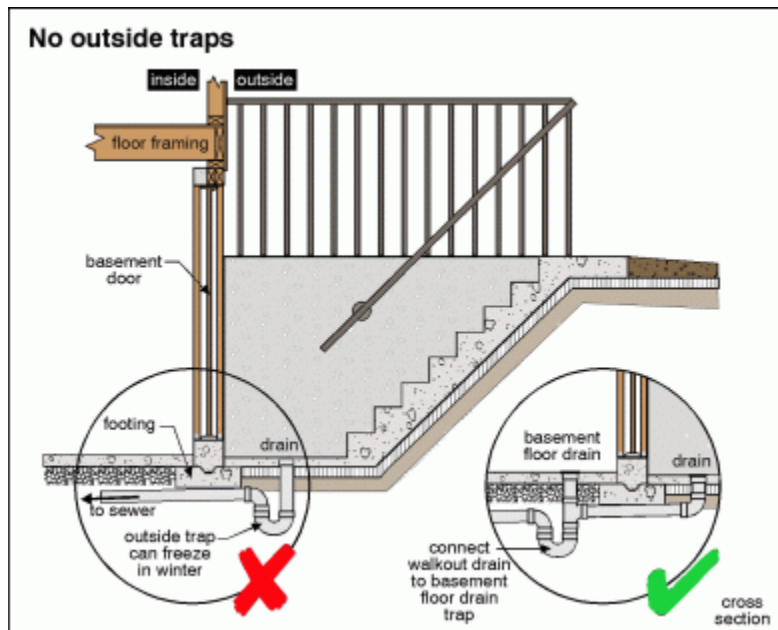
12. Condition: • The exterior entry to the basement is at the bottom of a stairwell called an areaway which has a drain to minimize water entry. The current conditions appear to be normal. It is common for the areaway drain to block up allowing water to pool and enter the dwelling. Ongoing maintenance is needed to clear the drain and control water entry.

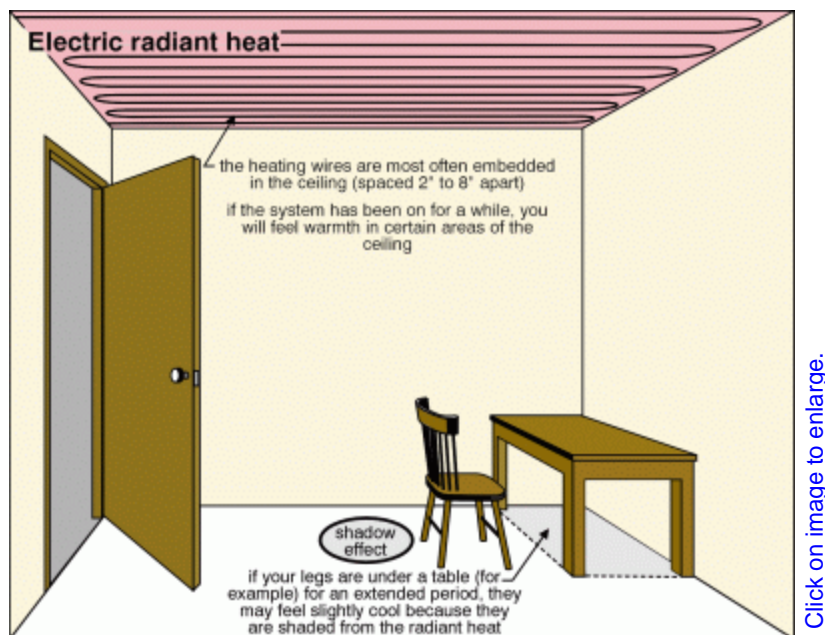
20. • Radiant Electric heat system is present on 1st floor, there are baseboard heaters in the basement area's

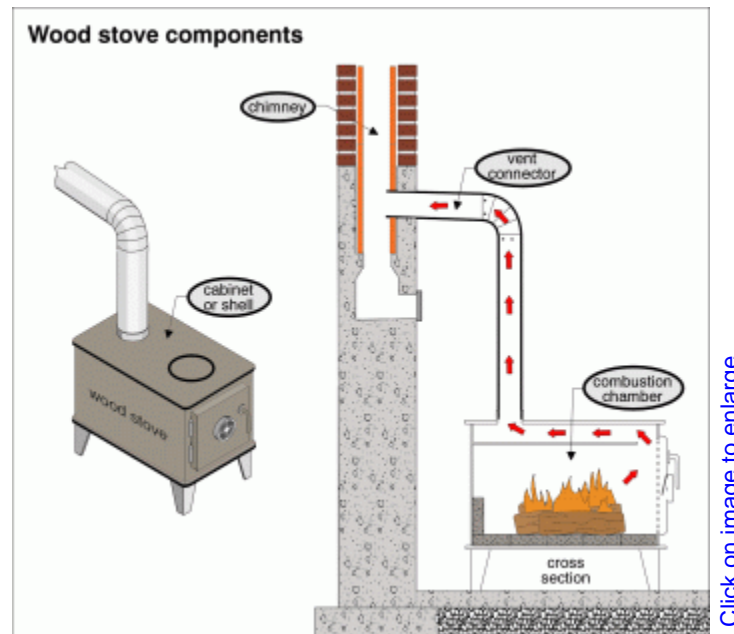
21. Condition: • A wood burning stove is installed, and the flue condition is impossible to determine without disassembly. Services of a licensed professional chimney sweep are needed to disassemble, clean, determine action, and make any needed repairs.

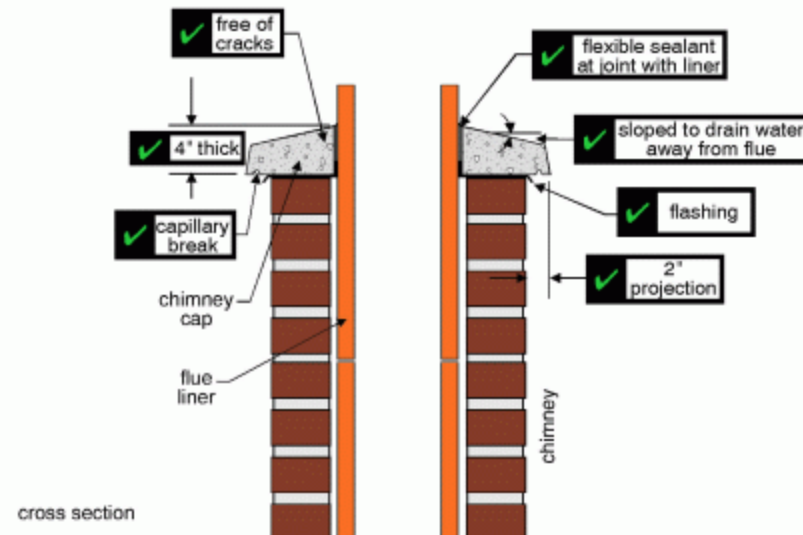
6. Attention Needed - This masonry cap has cracks and aged conditions that require repair or replacement to function as intended, which is to keep water from entering the masonry stack causing deterioration.

23. Condition: • Attention Needed - This masonry cap has cracks and aged conditions that require repair or replacement to function as intended, which is to keep water from entering the masonry stack causing deterioration.

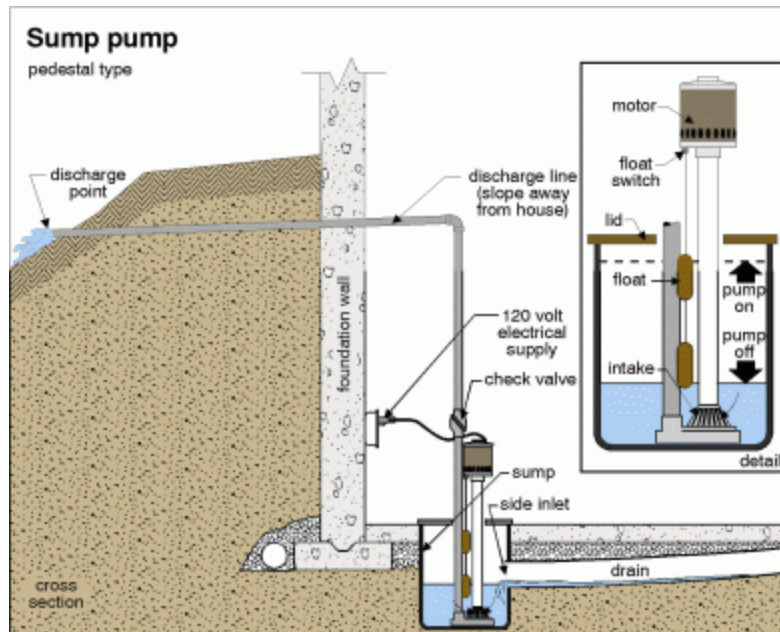
28. Condition: • Lid missing, rotted or not secure

The lid for the sump pump is not installed and can cause a damp area such as seen in the photo with mildew present at time of inspection
