INSPECTION REPORT

For the Property at:
10672 PONDEROSA WAY
NEVADA CITY, CA 95959

Prepared for: FRED BUYER
Inspection Date: Tuesday, December 29, 2009
Prepared by: Daniel Bertsch CCI

RE: Report No. 1004, v.6
10672 Ponderosa Way
Nevada City, CA
95959

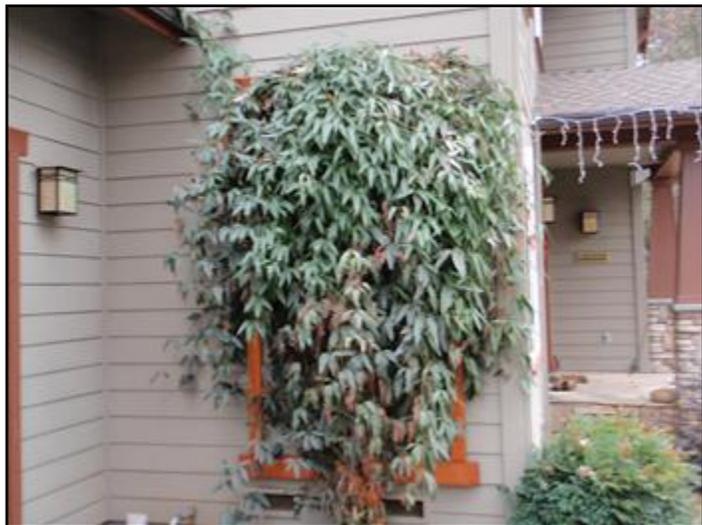
- General:** • Sprinkler systems and low voltage landscape lighting are not a part of a home inspection
- Inspection limited/prevented by:**
 - Car/storage in garage
 - Vines/shrubs/trees against wall
 - Vine on wall by garage.

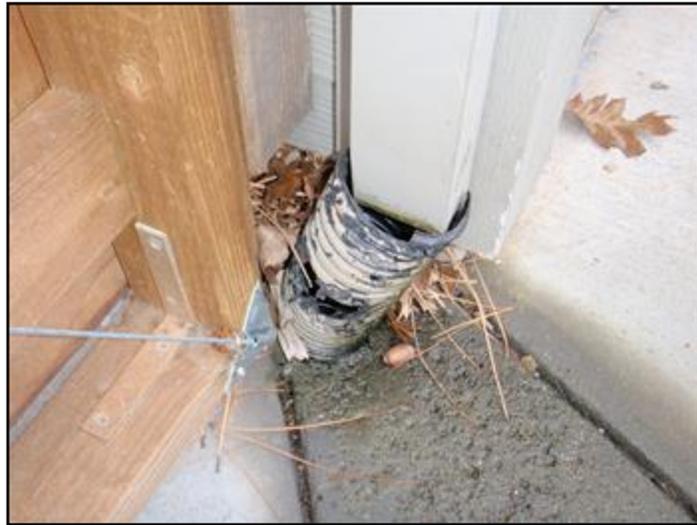
8. Condition: • [Loose connections](#)

Implication(s): Leakage

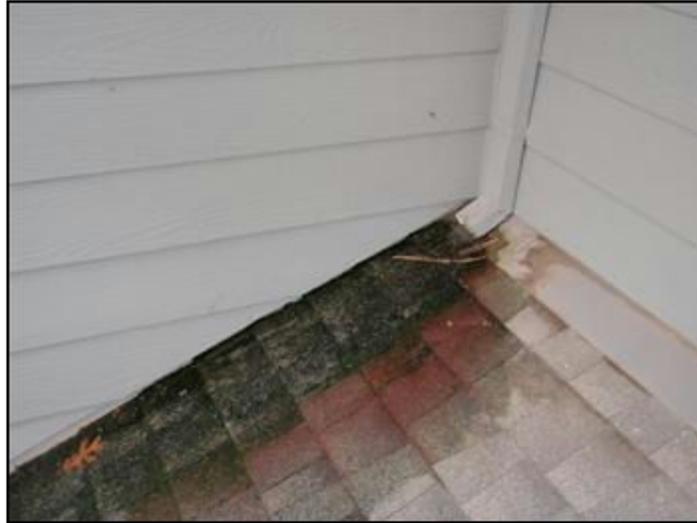
WALLS \ Soffits and fascia

11. Condition: • [Damage](#)

Bird damage noted on shingle molding. Installation of 2"x2" sheet metal drip edge may discourage wood peckers.

Implication(s): Cosmetic defects | Chance of water damage to contents, finishes and/or structure
