# YOUR Inspection Report

123 Any Street  
Kitchener, ON

Thursday, May 13, 2010

RE: Report No. 1062  
123 Any Street  
Kitchener, ON

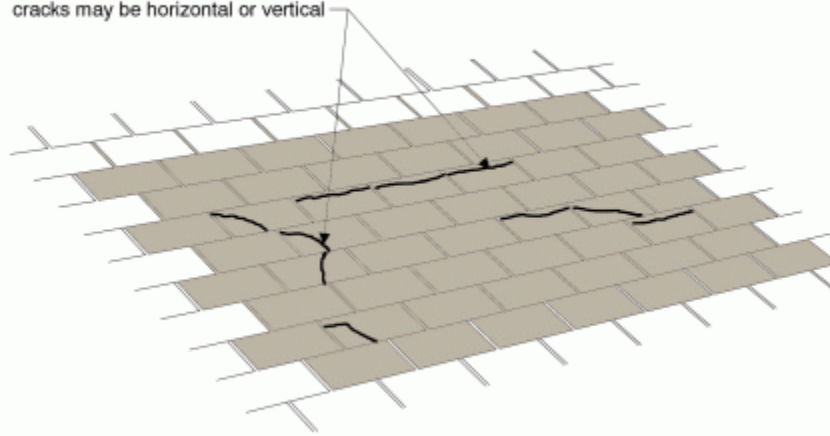
## Premature failure of asphalt shingles

premature cracking of shingles can occur even in newer asphalt shingle applications  
cracks may be horizontal or vertical

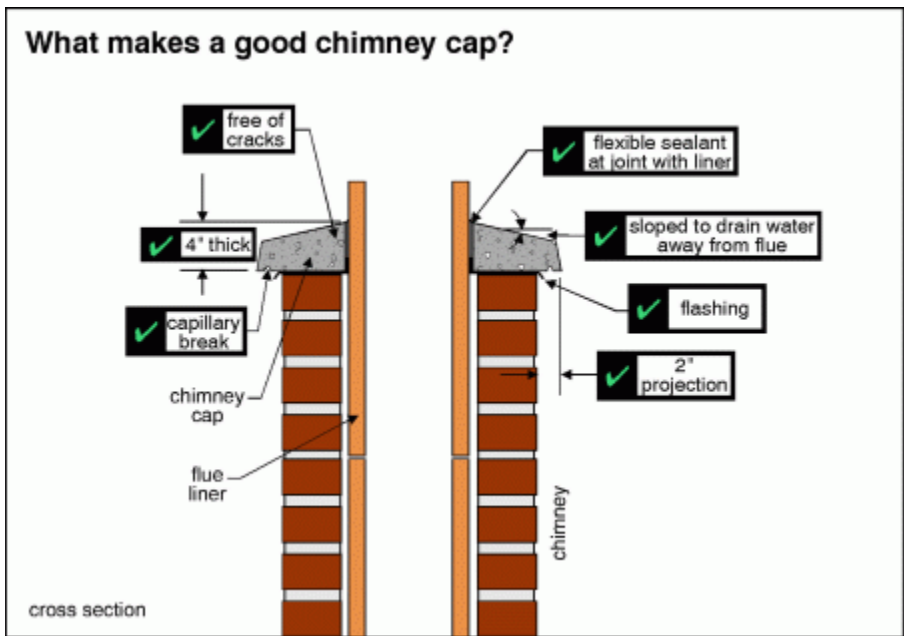
**Implication(s):** Chance of water damage to contents, finishes and/or structure | Shortened life expectancy of material

**Task:** Correct
