YOUR INSPECTION REPORT

631 Hudson Ave
Albany, NY

Sunday, January 17, 2010

Report No. 1001

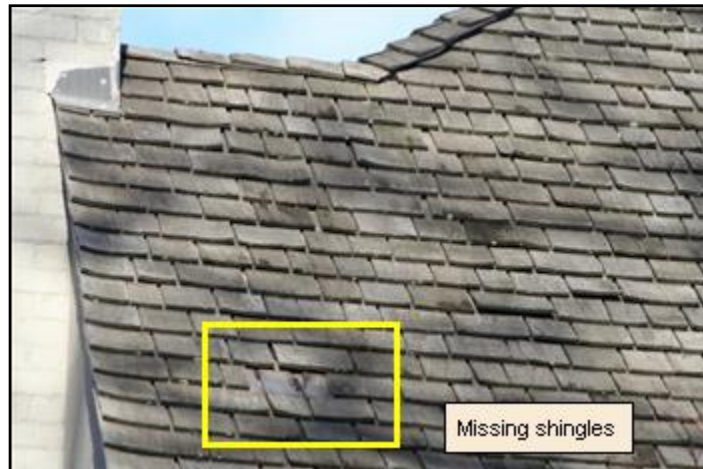
1.

SLOPED ROOFING \ Wood shingles and shakes

Condition: • [Old, worn out](#)

Implication(s): Chance of water damage to contents, finishes and/or structure

Location: Throughout

Task: Replace

Time: Less than 1 year

Cost: Major

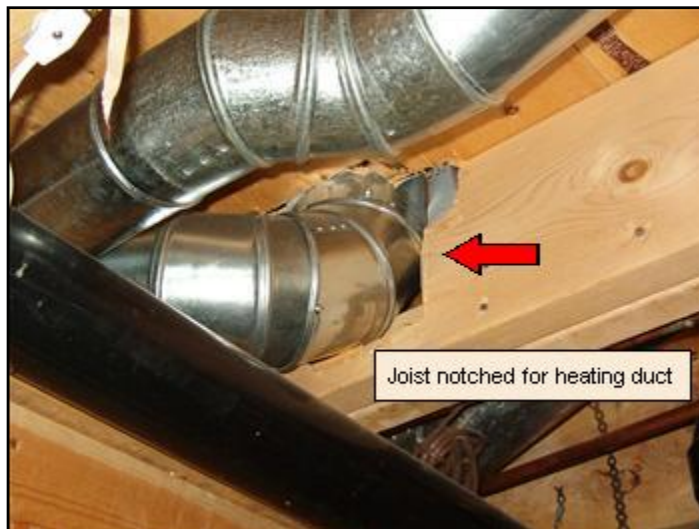
2.

FLOORS \ Joists

Condition: • [Notches or holes](#)

Implication(s): Weakened structure

Location: West Basement

Task: Repair or replace

Time: Less than 1 year
