INSPECTION REPORT

For the Property at:
123 ANY STREET
TAVERNIER, FL 33070

Prepared for: JOHN DOE
Inspection Date: Thursday, November 21, 2013
Prepared by: Mark Hall

Report No. 4911, v.3

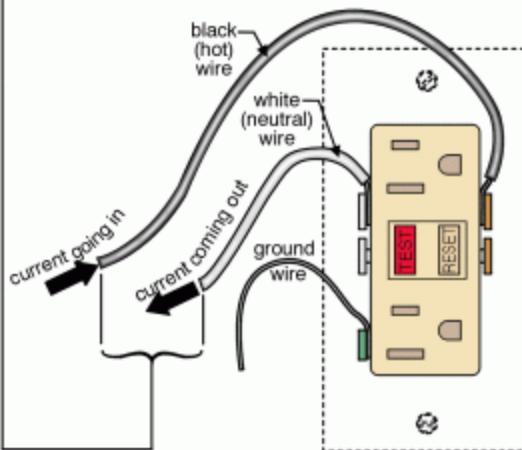
if there is a difference (even as little as 5 millamps), there is a current leak (possibly through your body) and the GFI shuts down the receptacle and other receptacles downstream

note:
if the GFI is in the panel, the entire circuit will be shut down

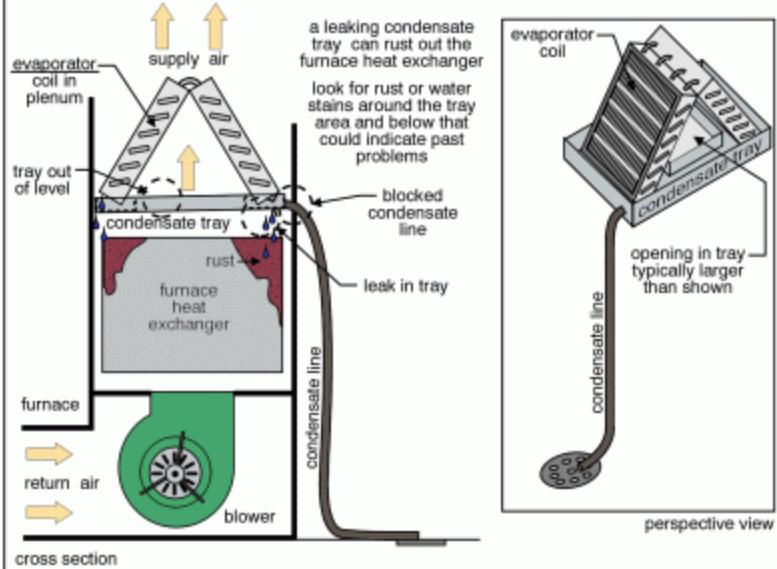
Condition: • [Blocked or crimped](#)

Implication(s): Chance of water damage to contents, finishes and/or structure | Damage to equipment

Leaking condensate tray

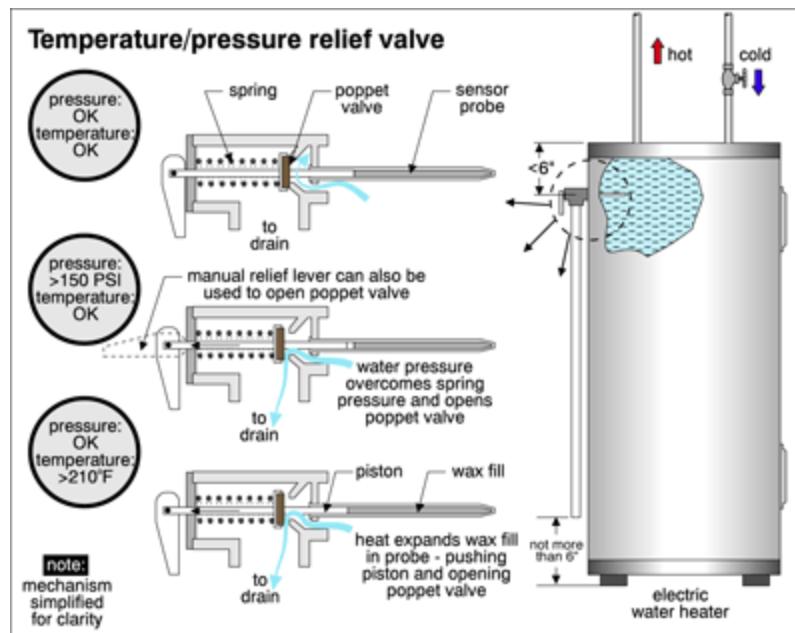
Condition: • [Discharge tube missing](#)

Task: Repair
