# INSPECTION REPORT

For the Property at:  
**4209 JEFFERSON PLACE**  
NEW ORLEANS, LA 70187

Prepared for: ROBERT SMITH  
Inspection Date: Tuesday, April 27, 2010  
Prepared by: Tom Axelrad

RE: Report No. 1426, v.3  
4209 Jefferson Place  
New Orleans, LA  
70187

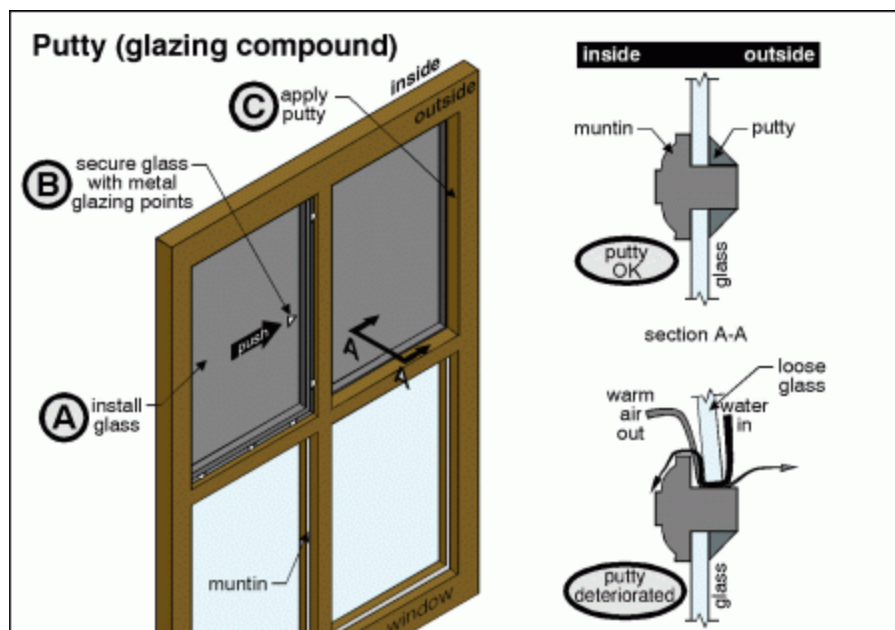
**Condition:** • [Putty missing, cracked or deteriorated](#)

2nd floor rear right bedroom window - glass was replaced and putty is missing or deteriorated.

**Task:** Replace putty, paint

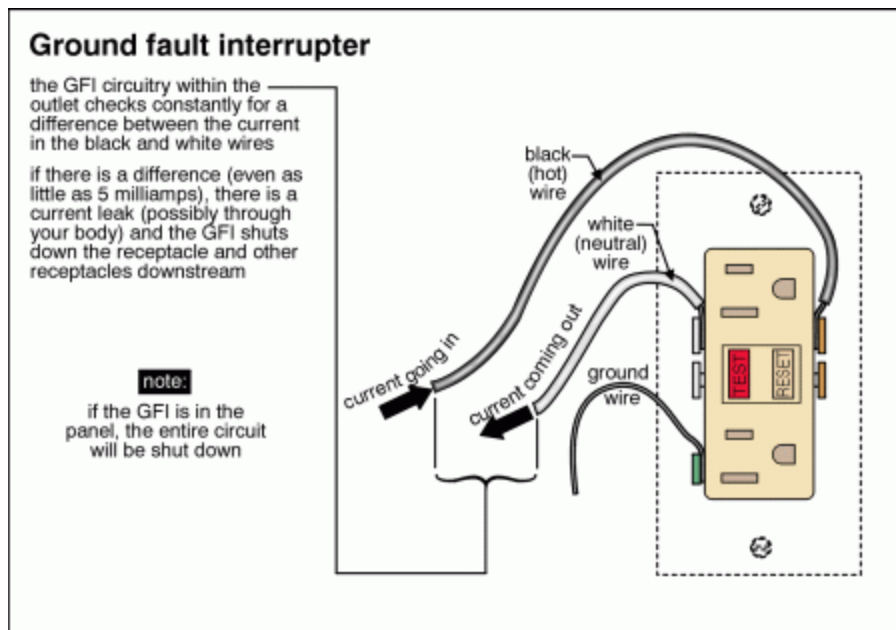
**Condition:** • [No GFI \(Ground Fault Interrupter\)](#)

2nd floor, rear bathroom. Not required, but recommended for safety and to bring to current standards.

**Implication(s):** Electric shock

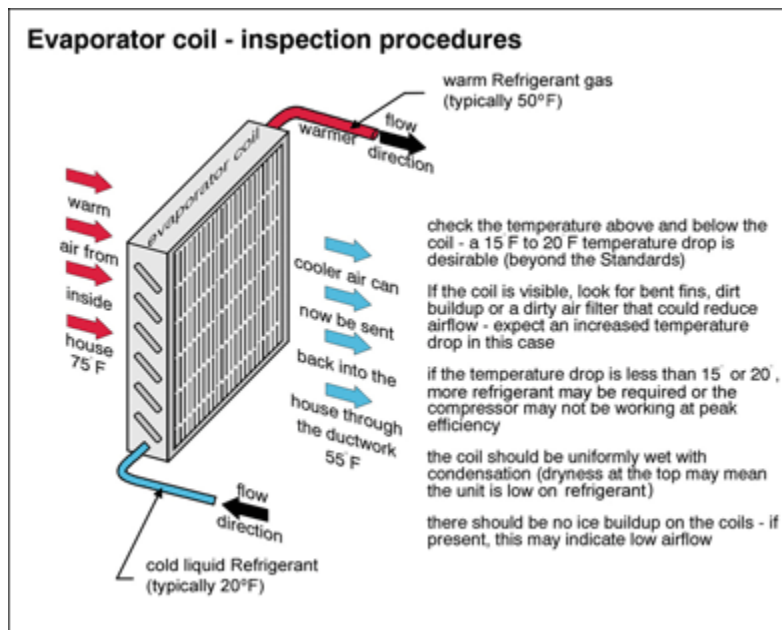
**Condition:** • [Dirty](#)

**Implication(s):** Increased cooling costs | Reduced comfort

**Task:** Include in recommended service

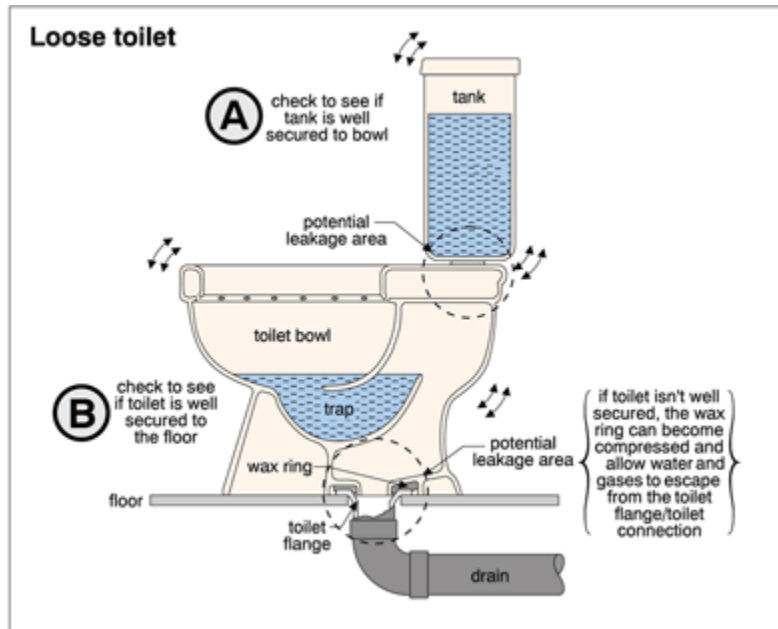
**Condition:** • [Loose](#)

Toilet in the master bath is very loose at the floor.

**Implication(s):** Chance of water damage to contents, finishes and/or structure | Sewage entering the house

**Task:** Check seal and secure.

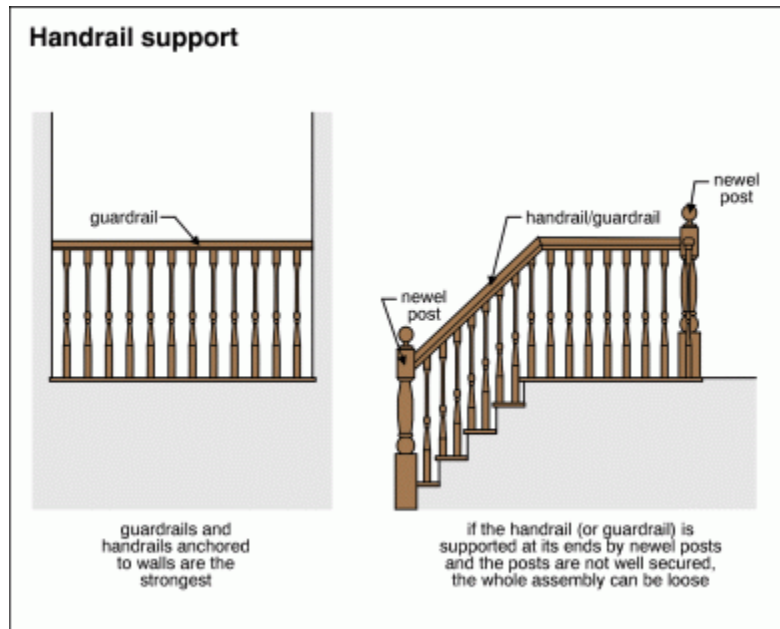
**Condition:** • [Loose](#)

Second floor guardrail is loose. This will continue to worsen if not addressed.

**Implication(s):** Fall hazard

**Task:** Repair, tighten

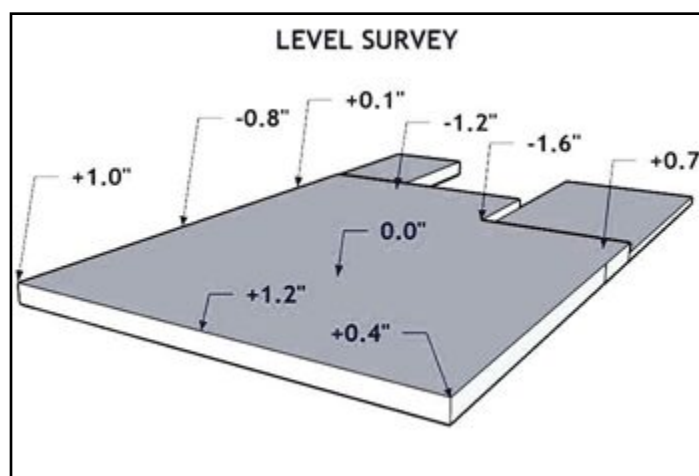
38. Not to scale. Locations approximate.

**>2.0" Maximum Relative Elevation Differential:** • Within acceptable limits for this area, age and construction type  
*Note:* The maximum differential found was 2.8" as shown on the drawing below. According to one of the leading local engineering firms, the average differential for all residential foundations in the New Orleans area is about 3.2". The average for reinforced concrete slabs about 2.9" and for pier and beam foundations about 3.6". Allowances are made for floor coverings and materials. Additions and enclosed areas built with a designed slope are not included. All measurements taken are not shown. The drawing is not to scale and locations are approximate. A larger version of the drawing is found in the Appendix at the end of this report.

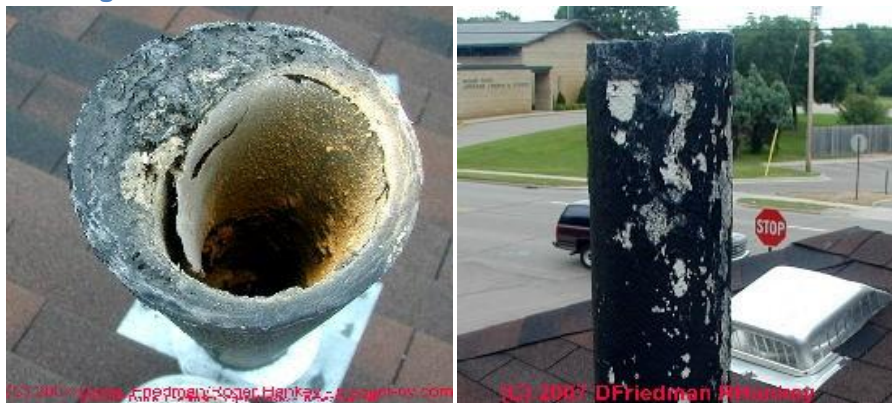
## TRANSITE PIPES OR DUCTS - Transite Chimney and Duct Material Warnings

**Unsafe transite pipe heating flue vents** may only be noticed by a careful building inspection such as shown in these rooftop photographs of a transite flue vent pipe which deteriorated, became swollen, and risk becoming blocked. In cold climates with these vents from the 1950's era, the real hazard is not so much asbestos fibers as the dangerous obstruction of the vent/flue by the deterioration of the interior of the pipe.

In the transite chimney vent photo at above right we note that the exterior has been painted black. We don't know why, possibly the naturally gray-white transite flue was painted black for cosmetic reasons, or perhaps in an effort to slow down its surface deterioration.
