# YOUR INSPECTION REPORT

1234 InterNACHI Certified  
Madera, CA

Wednesday, January 1, 2014

RE: Report No. 1072  
1234 InterNACHI Certified  
Madera, CA

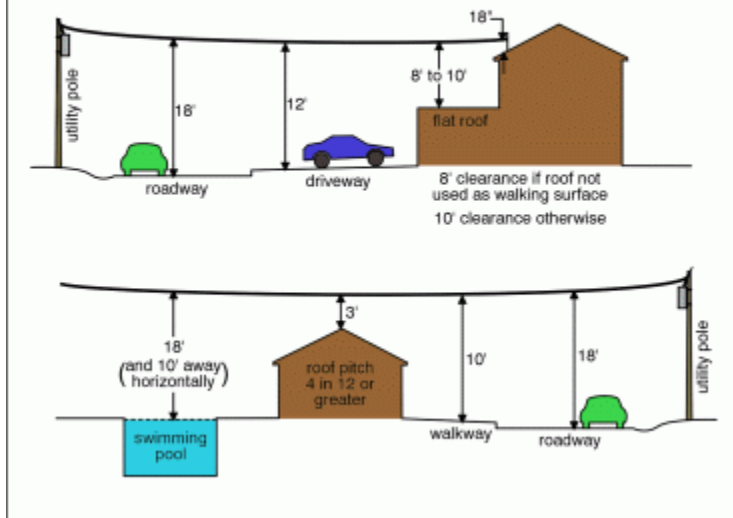
## Service drop clearances

**Condition:** • [Wires too close to roof](#)

Recommend further evaluation by qualified electrical contractor.

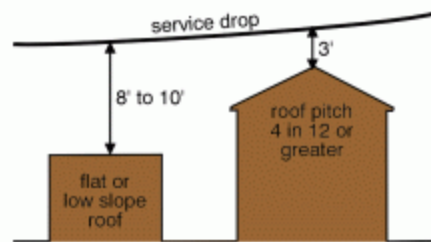
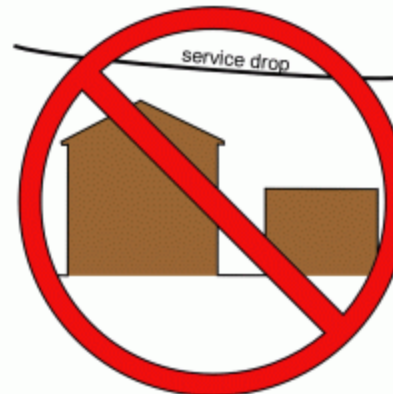
## Inadequate wire clearance over roofs

installing wires over roofs is not generally allowed except by special permission

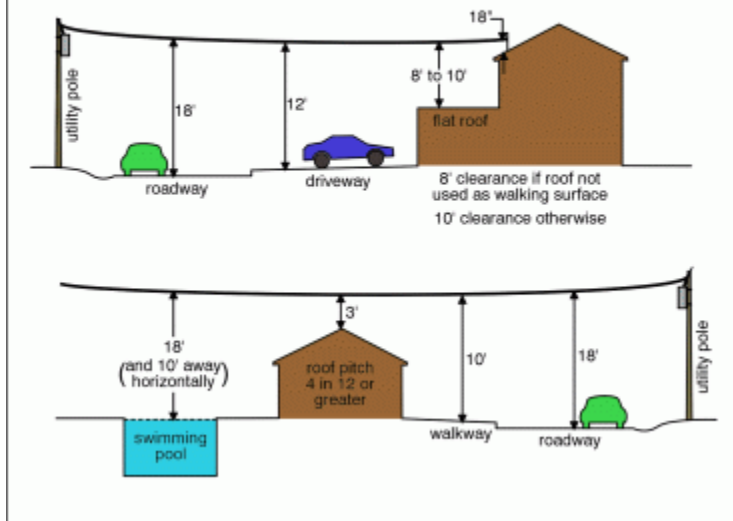
**Service drop clearances**

**4. Condition:** • [Wires too close to roof](#)

Recommend further evaluation by qualified electrical contractor.

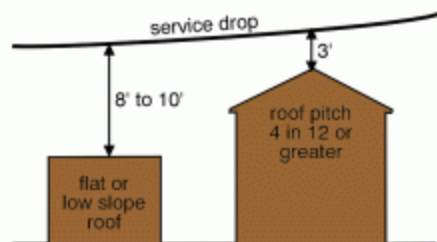
## UNITED STATES

check to ensure that the clearances indicated below have been provided

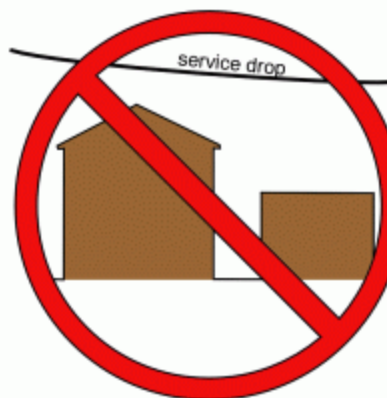
## CANADA

installing wires over roofs is not generally allowed except by special permission
