# INSPECTION REPORT

For the Property at:  
**6266 PARK RIDGE DRIVE**  
PARK CITY , UT

Prepared for: BUTCH CASSIDY  
Inspection Date: Friday, May 4, 2007  
Prepared by: Matthew Stouffer

RE: Report No. 1044, v.9  
6266 Park Ridge Drive  
Park City , UT  
84098

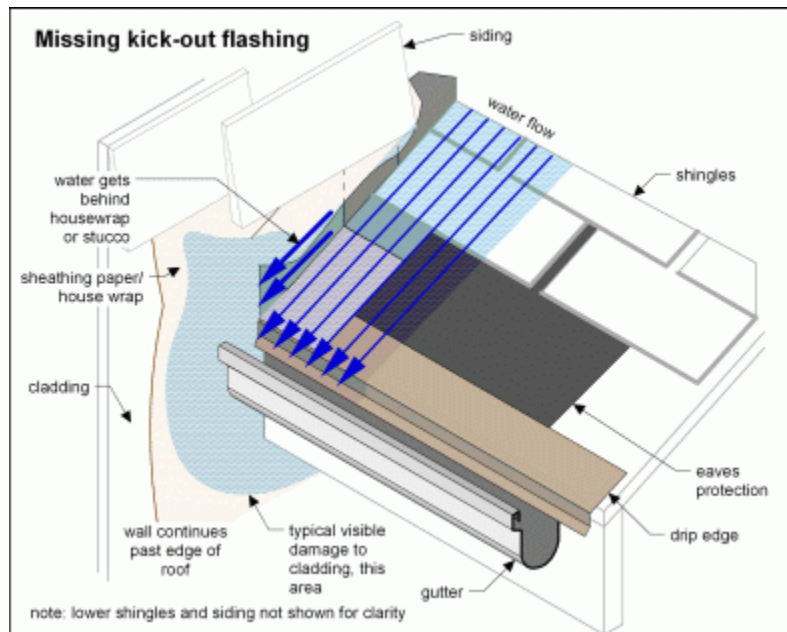
**Note:** ITEM 2. Water damage is present along the master bedroom wall and floor. Water penetration is a result of a missing kick out flashing.

2. Water damage/rot resulting from poor flashing

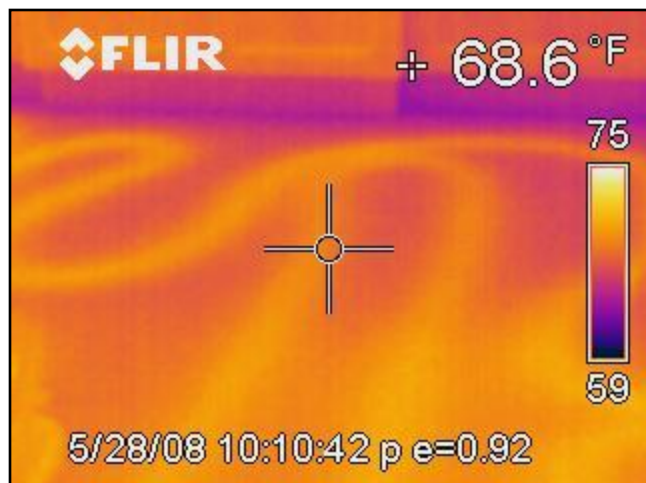
• ITEM 5. In floor radiant heating and central air conditioning systems functioned well when tested.

7. In floor radiant heating

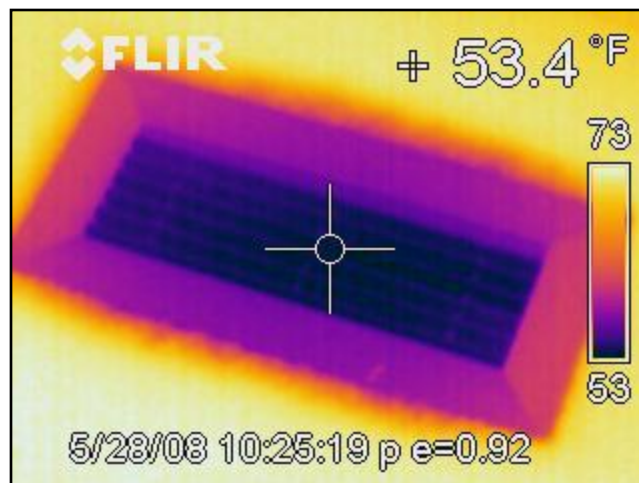
8. Functioning central air

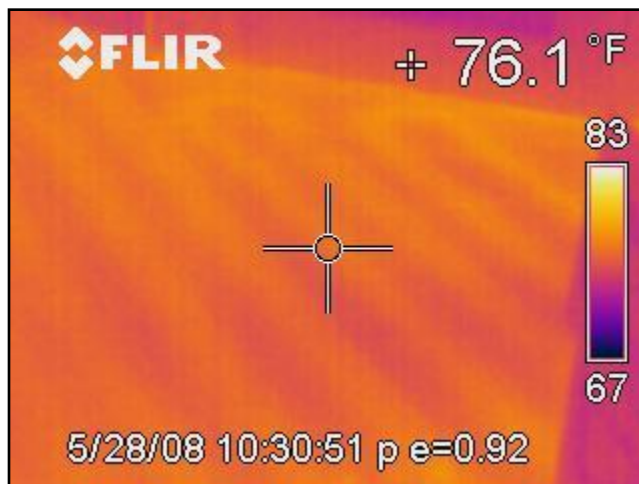
9. In floor radiant heating
