YOUR INSPECTION REPORT

123 Any Street
Anytown, NY 13xxx

Monday, April 11, 2011

Report No. 1010, v.7

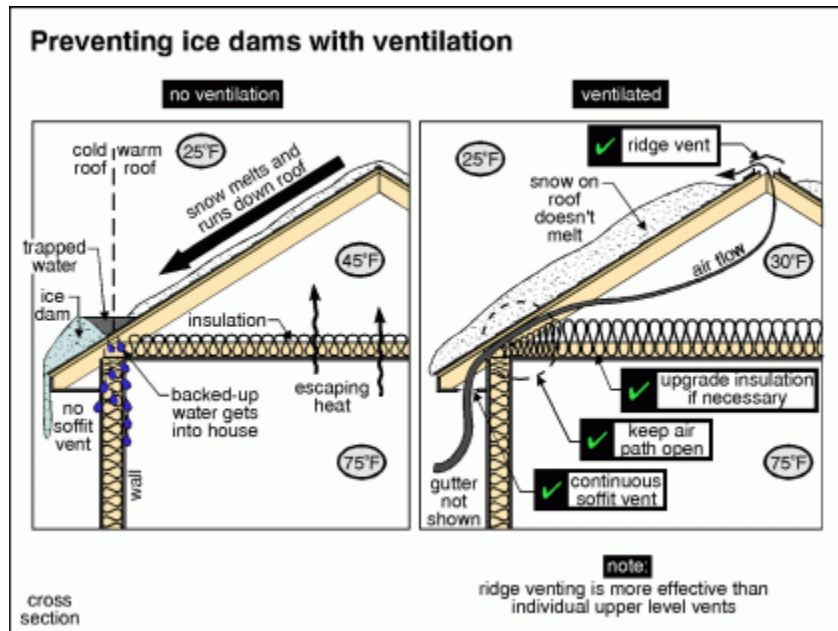
3. Condition: • [Vulnerable to ice damming](#)

Implication(s): Chance of water damage to contents, finishes and/or structure

Task: Further evaluation Improve

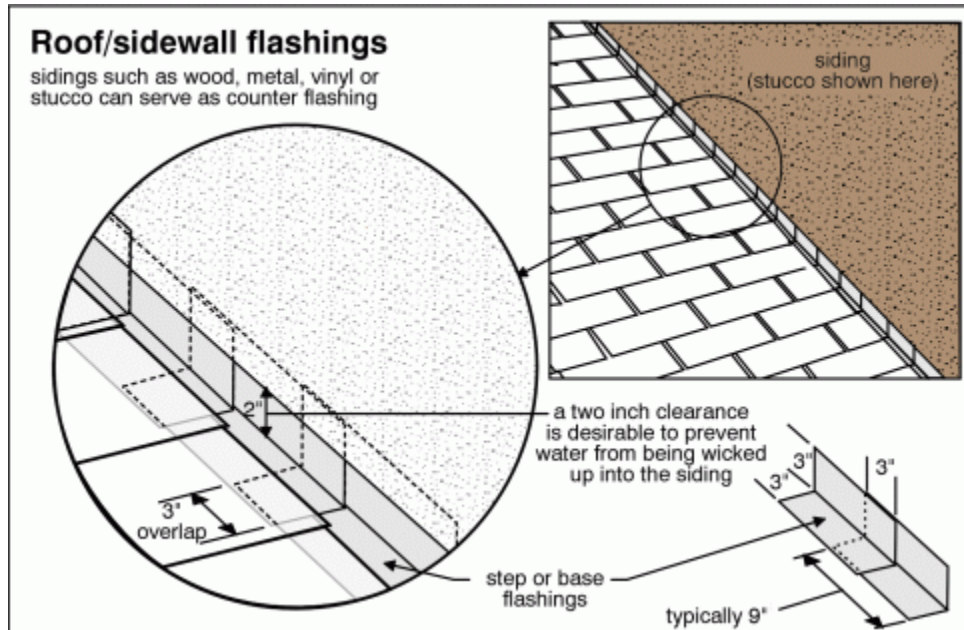
5. Condition: • [Siding not cut back](#)

Implication(s): Chance of water damage to contents, finishes and/or structure

Location: Various Exterior Wall

Task: Repair

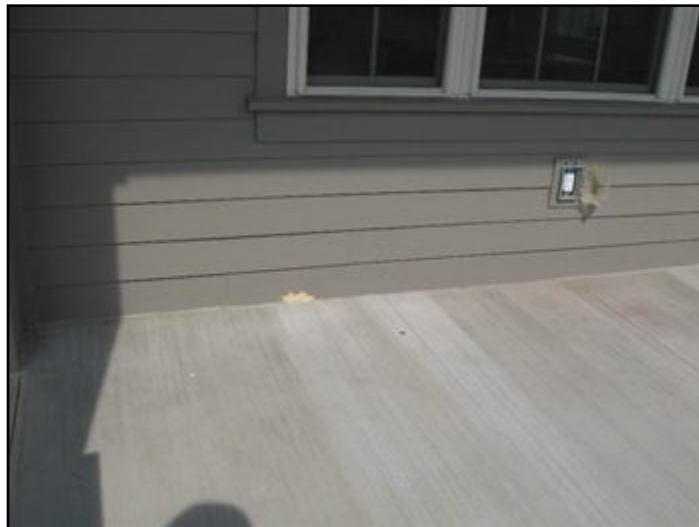
9. Front porch

9. • No landing.

Implication(s): Fall hazard

Task: Repair

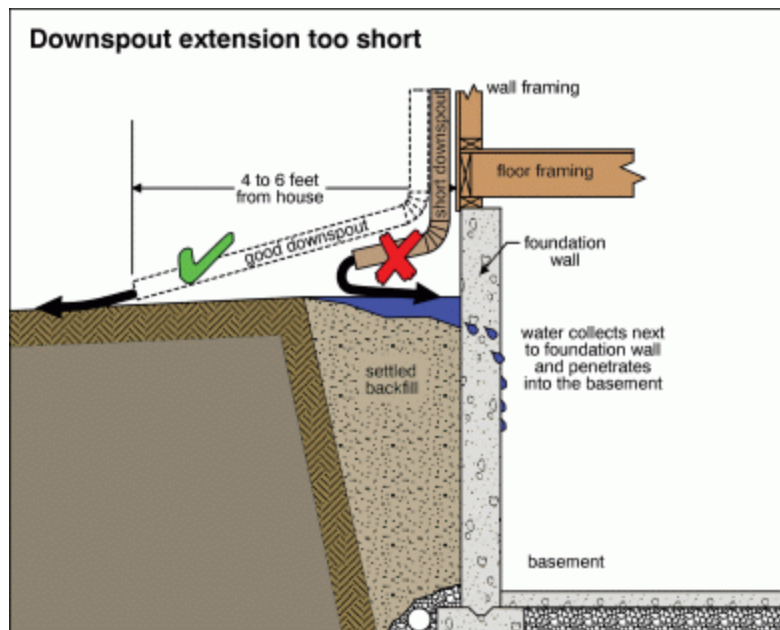
13. Condition: • Should discharge 6ft. from home

Implication(s): Chance of water damage to contents, finishes and/or structure

Task: Improve

Time: Immediate

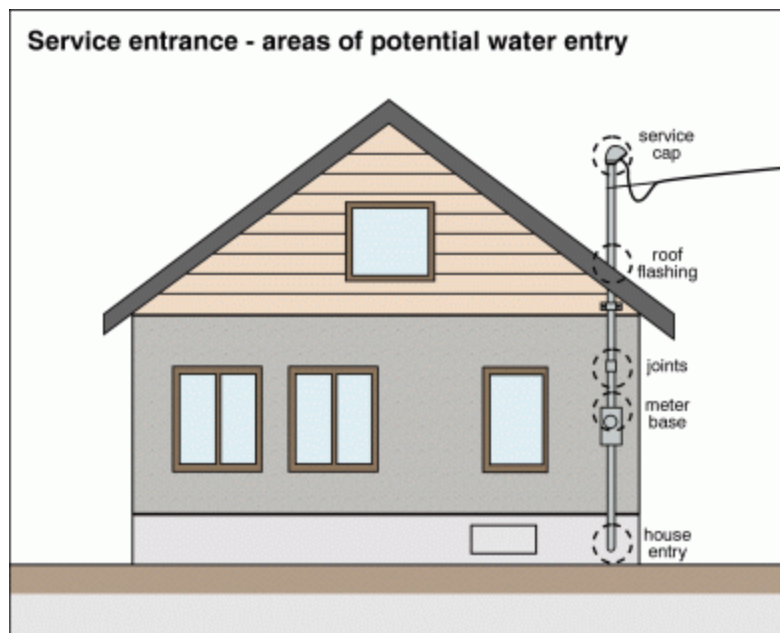
19. Condition: • [Rust or water in panel](#)

Implication(s): Electric shock | Fire hazard

Task: Repair

Time: Immediate

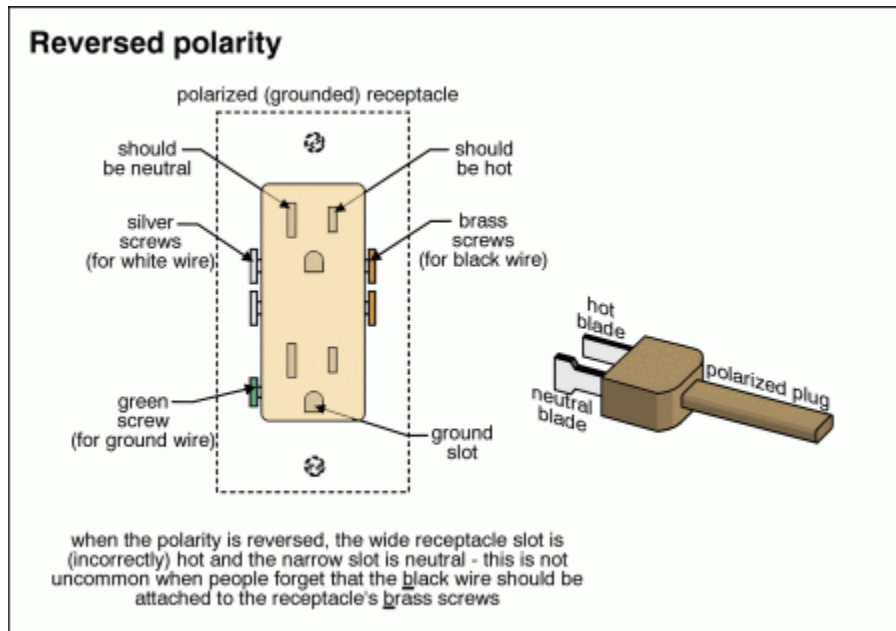
DISTRIBUTION SYSTEM \ Wiring - installation**21. Condition:** • Reversed Polarity**Implication(s):** Increased risk of shock, damage to electronics

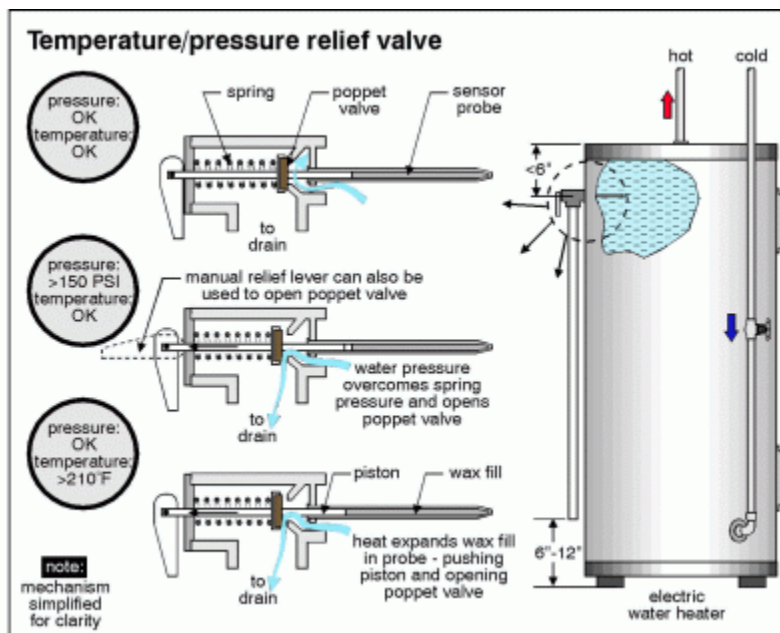
WATER HEATER \ Temperature/pressure relief valve**31. Condition:** • [Discharge tube missing](#)

Implication(s): Scalding

Task: Repair

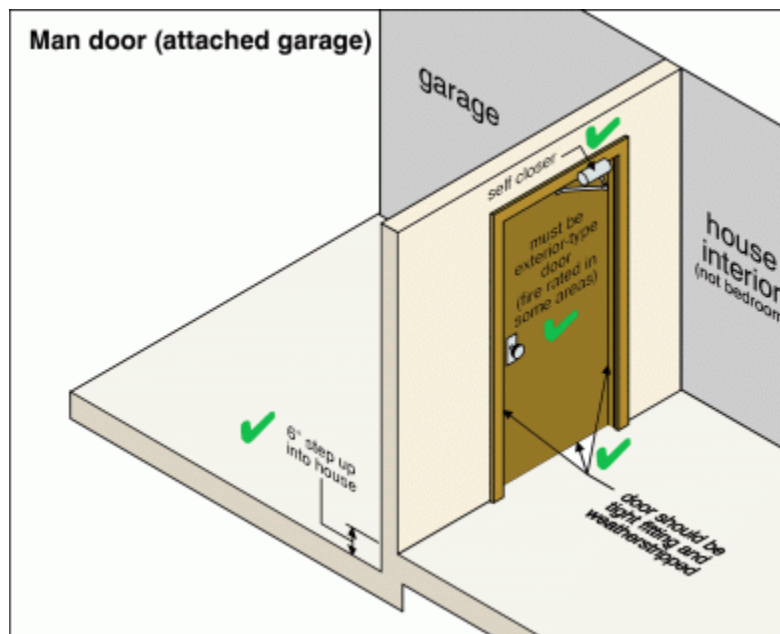
40. Condition: • [Door not fire rated or exterior type](#)

Implication(s): Increased fire hazard

Task: Improve
