INSPECTION REPORT

For the Property at:
3614 - 44 AVE
EDMONTON, AB

Prepared for: GLADYS HOUGH
Inspection Date: Tuesday, May 31, 2011
Prepared by: Don Schmidt

Report No. 1277

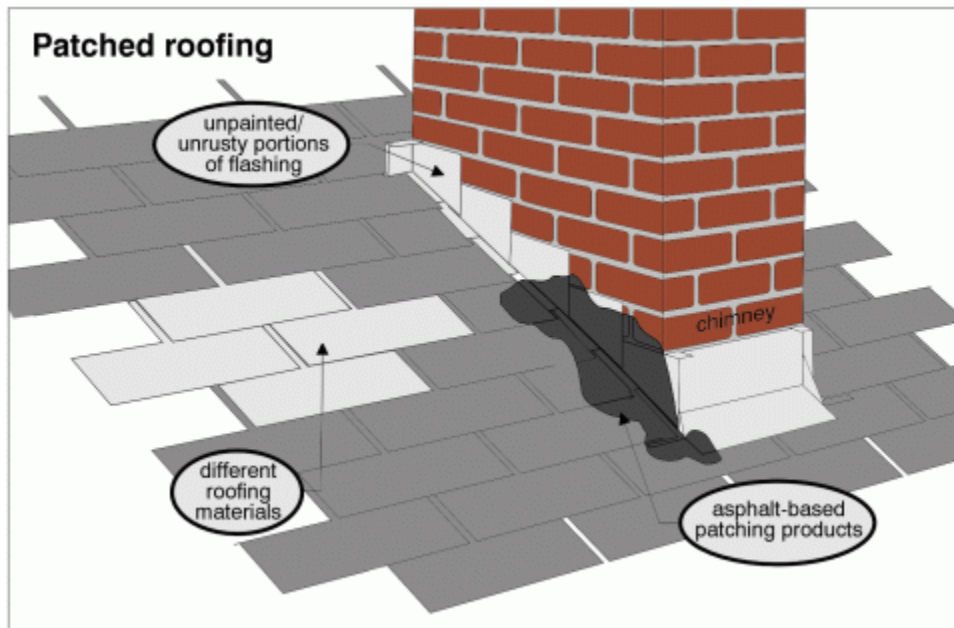
Condition: • [Patched](#)

Implication(s): Chance of water damage to contents, finishes and/or structure

Task: Inspect annually Repair

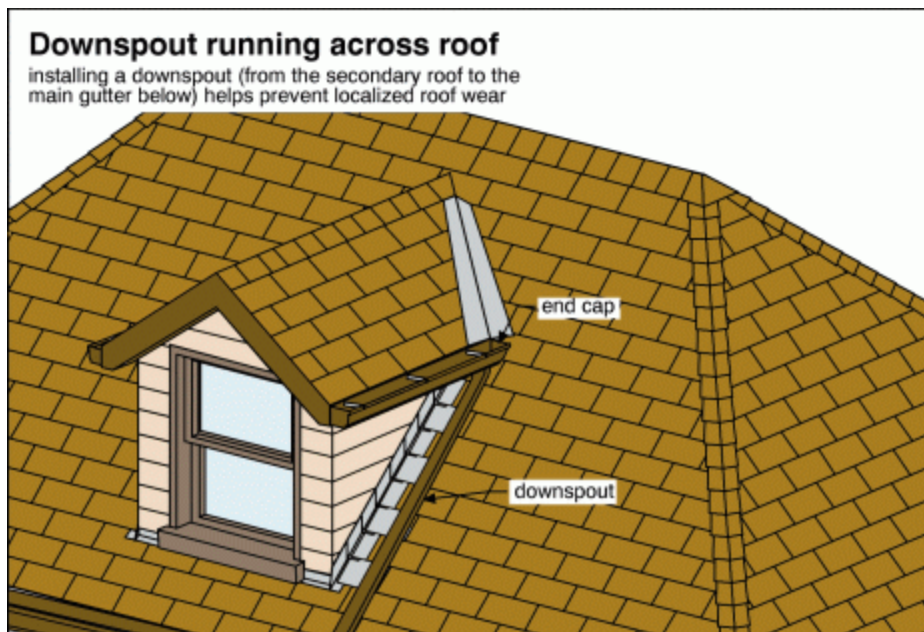
Condition: • [Downspouts discharging onto roofs](#)

Implication(s): Chance of water damage to contents, finishes and/or structure

Location: Various First Floor Roof

Task: Improve

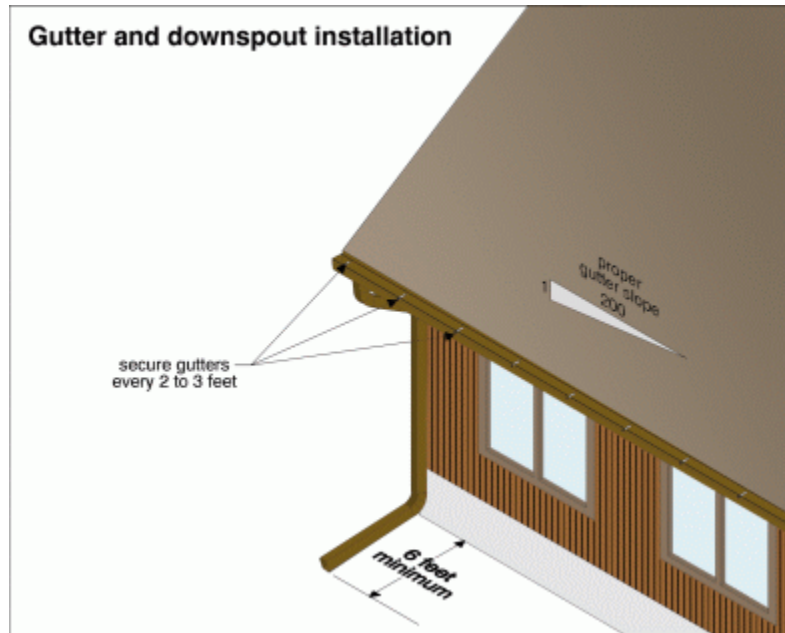
Condition: • Should discharge 6ft. from home

Implication(s): Chance of water damage to contents, finishes and/or structure

Location: Various Exterior Wall

Task: Improve

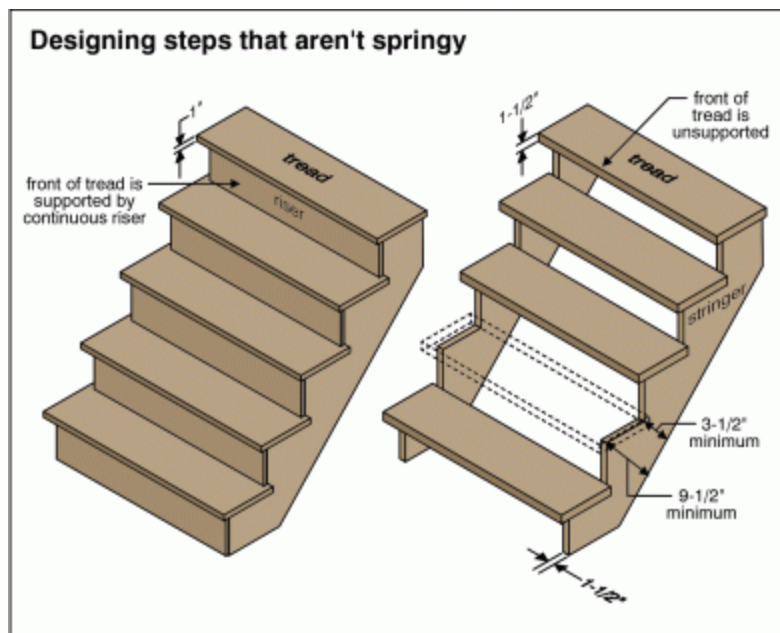
Condition: • [Steps springy, loose or sagging](#)

Implication(s): Trip or fall hazard

Location: Rear Left Side Deck

Task: Repair or replace

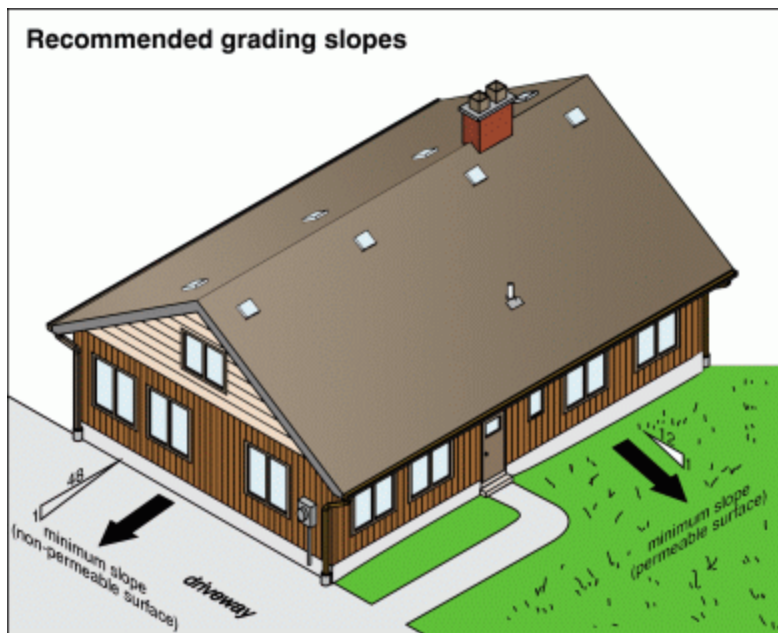
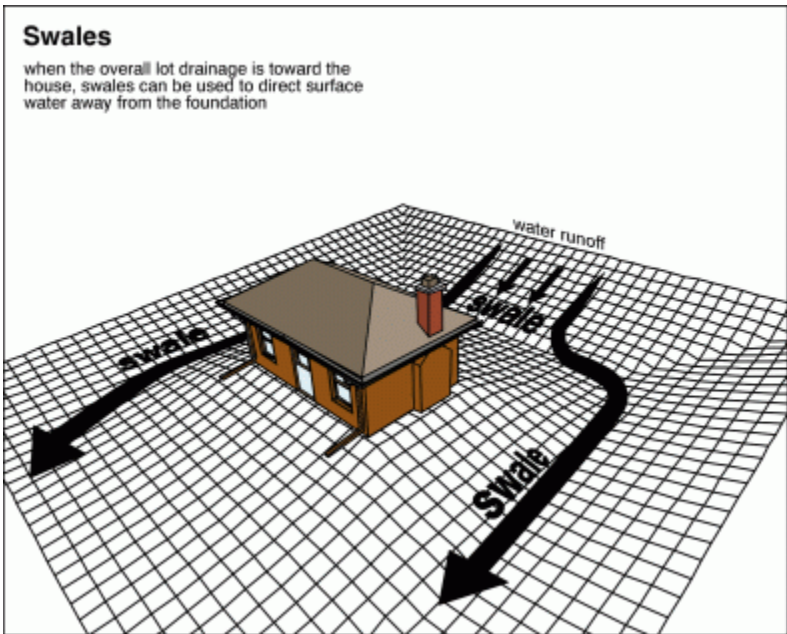
Condition: • [Improper slope](#)

Implication(s): Chance of water damage to contents, finishes and/or structure

Location: Various Yard

Task: Further evaluation Improve

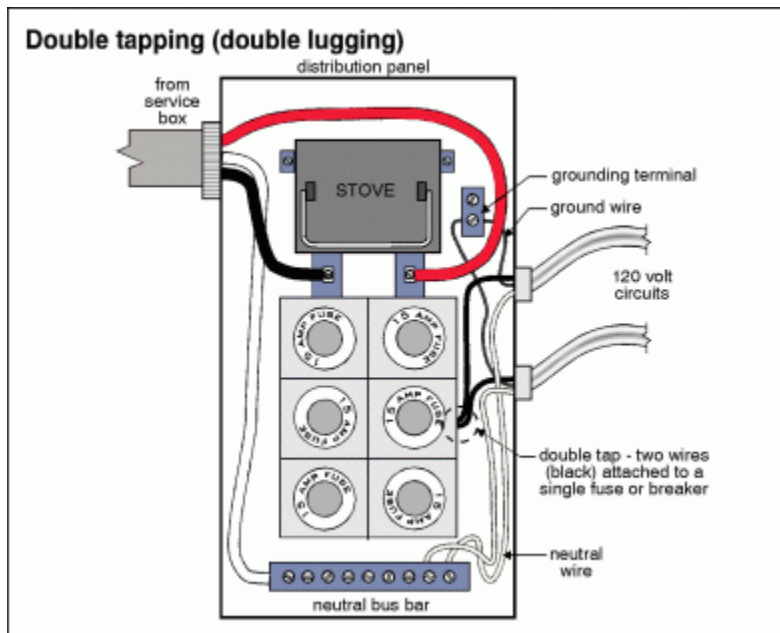
Condition: • [Double taps](#)

Implication(s): Fire hazard

Location: Basement

Task: Correct Further evaluation

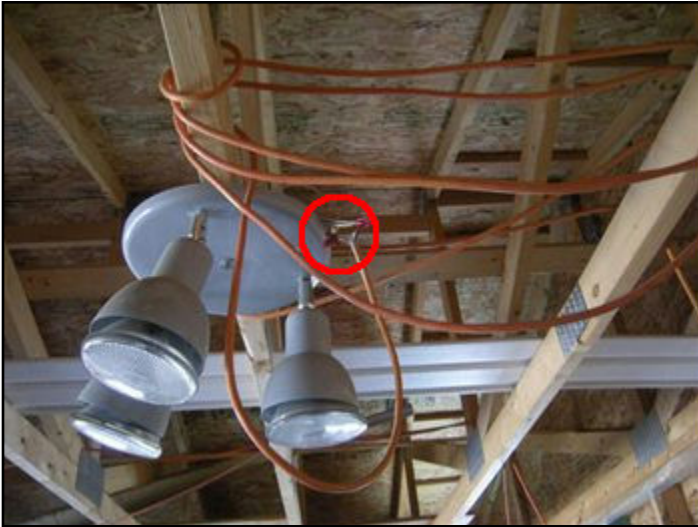
41.

Condition: • [Extension cord used as permanent wiring](#)

Implication(s): Electric shock | Fire hazard

Location: Garage

Task: Correct Further evaluation

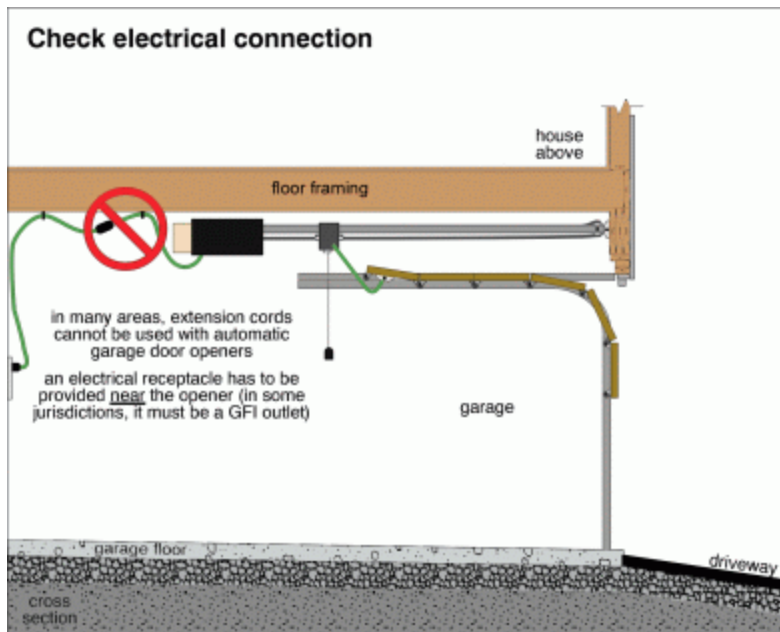
Condition: • Extension cord for garage door opener

Location: Garage

Task: Correct Improve

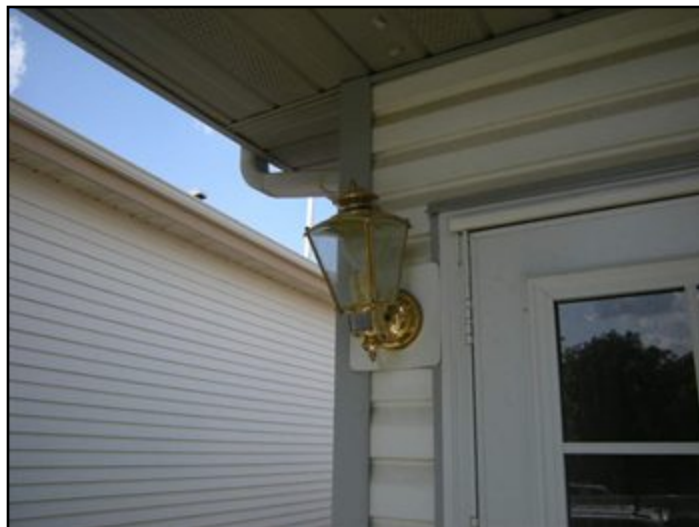
44.

Condition: • [Loose](#)

Implication(s): Electric shock | Fire hazard

Location: Various Exterior Wall

Task: Further evaluation Service

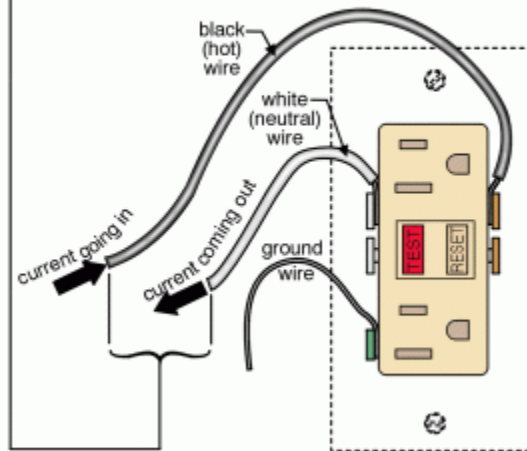
Condition: • [Ground Fault Interrupter \(GFI\) needed](#)

Recommend installing GFI breakers on all outlets not already installed, close to sinks in bathrooms and kitchen and all exterior outlets.

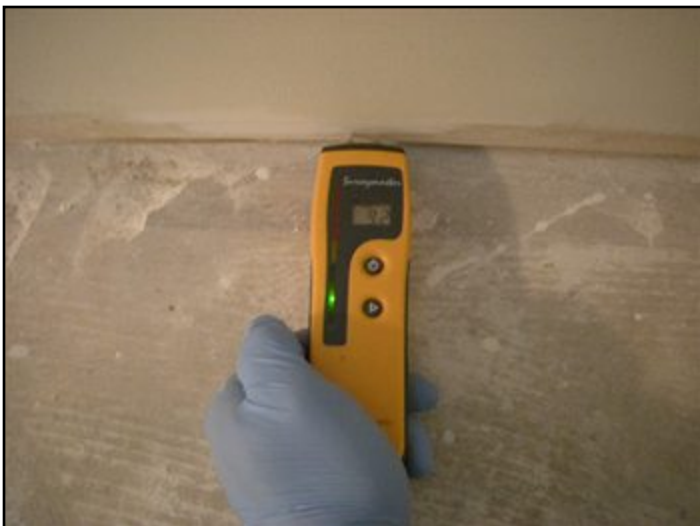
65.

General: • As part of Inspection Proof's inspection process, a moisture meter is used to survey accessible areas around the perimeter of the basement. With exception to the furnace area noted in this report, area no moisture was detected as indicated by green light on moisture meter.

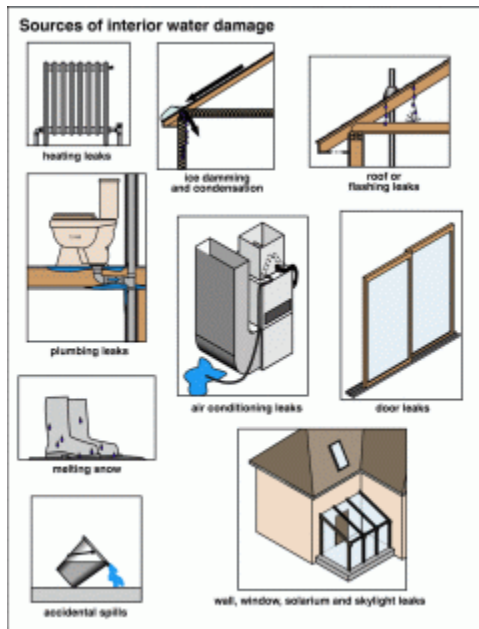
Condition: • [Water damage](#)

Active water infiltration (as indicated by red light on moisture meter) in furnace room exterior wall. Recommend removal of drywall to determine source of water and or leak.

Location: Basement Furnace Room

Task: Further evaluation Repair

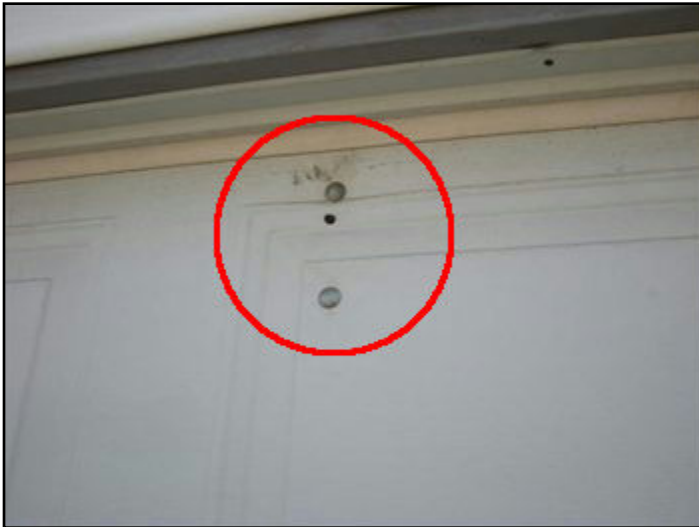
75.

Condition: • [Rusted or dented](#)

Implication(s): Material deterioration

Location: Garage

Task: Monitor
