For the Property at:  
**1234 SOMEWHERE**  
PITTSBURGH, PA 15219

Prepared for: JANE CLIENT  
Inspection Date: Friday, August 24, 2012  
Prepared by: John Fleenor

RE: Report No. 1008, v.2  
1234 Somewhere  
Pittsburgh, PA  
15219

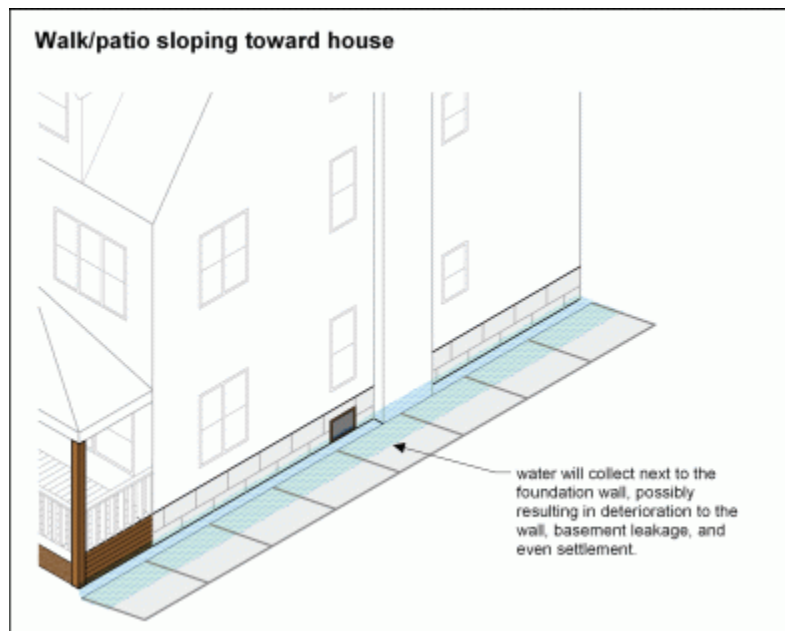
The sidewalk and paving at the back of the house has settled so that water drains towards the house. The sidewalk should be replaced and the grade improved so water sheds away from the building perimeter.

### 6. Condition: • [Improper slope or drainage](#)

**Task:** Repair

**Time:** Immediate

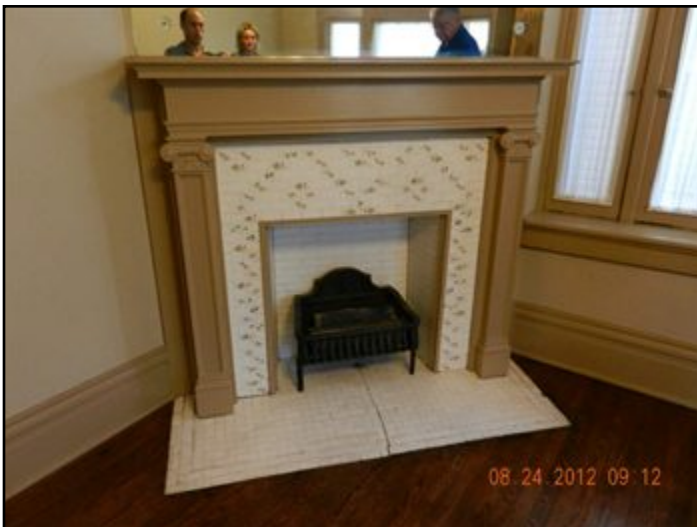
Unless and until the fireplaces and flue/venting have been evaluated by a qualified fireplace or HVAC professional, all the fireplaces in the house should be considered decorative only.

16. Decorative only

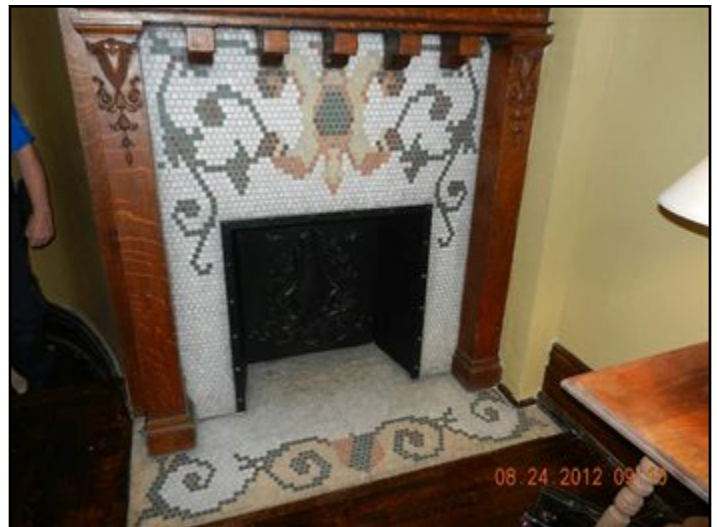
17. Decorative only

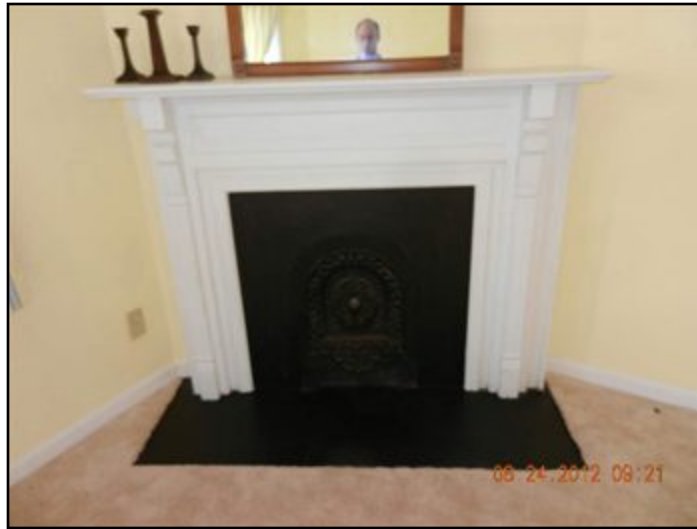
18. Decorative only
