# INSPECTION REPORT

For the Property at:  
**SE-14-26-20W**  
DAUPHIN, MB R7N3L9

Prepared for: BRIAN JAEB  
Inspection Date: Thursday, December 14, 2017  
Prepared by: Brian Jaeb

RE: Report No. 1004  
SE-14-26-20W  
Dauphin, MB  
R7N3L9

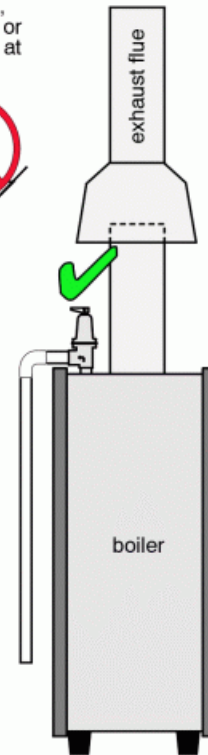
20. No piped extension/garage

3. Condition: • [No piped extension](#)

extension capped, threaded or corroded at bottom

BTU rating of valve doesn't match boiler

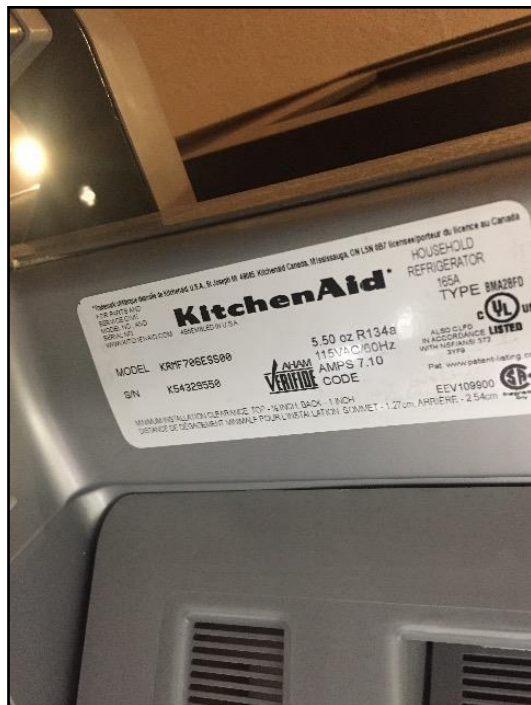
46. fridge

4. • RecallCheck appliances
